WestConnex King Georges Road M5 Interchange: Homes damaged

Ongoing structural damage to homes at and Elouera St Beverly Hills, during and after King Georges Road - M5 Interchange Upgrade (KGRM5IU) March 2018

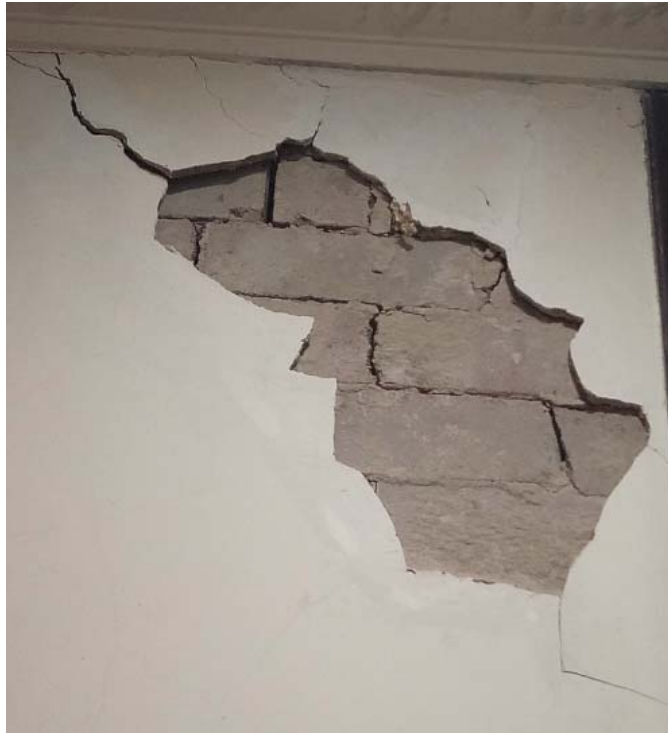
Figure 1 Hallway of No 8 identifying induced strain on internal brickwork

The new drainage has changed the soil conditions resulting in the contraction of soil beneath our homes. The consequence is that the foundations are settling unevenly, called “differential settlement”. This results in the movement of the buildings and tensile strain on the masonry. (Refer Figure 1). We have witnessed the onset of damage, such as cracked plaster work, misaligned windows and doors, and our 20 year old extension show indications it is separating from the original 1929 section. (Refer Figure 6).

Our engineer has recommended that our homes require remedial work to the foundations to address the introduced strain on the structures. Otherwise, there is little point spending over \$10,000 + to fix the internal damage to the plaster walls, built-in wardrobes, door and window frames as the continued tensile strain will cause cracks to return.

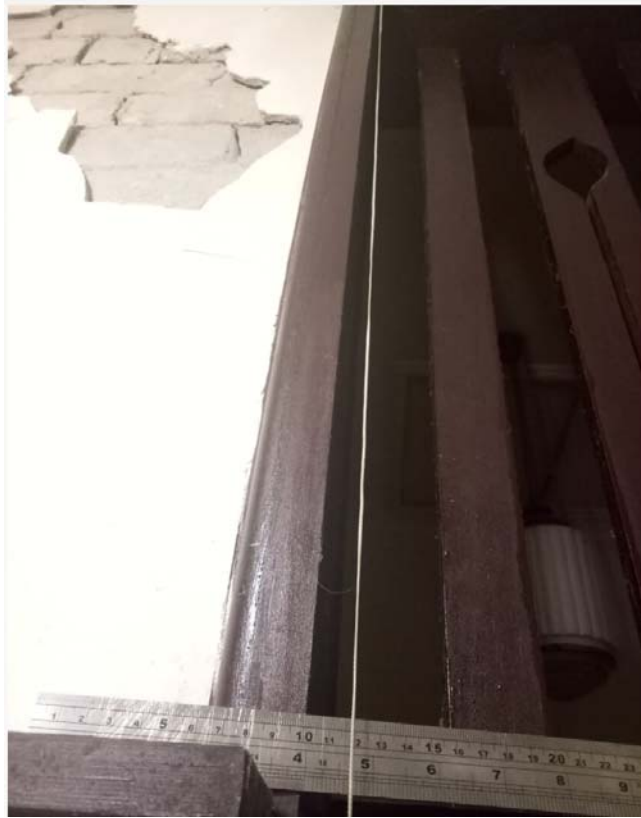
Figure 2 Hallway of No 8 identifying warped doorways

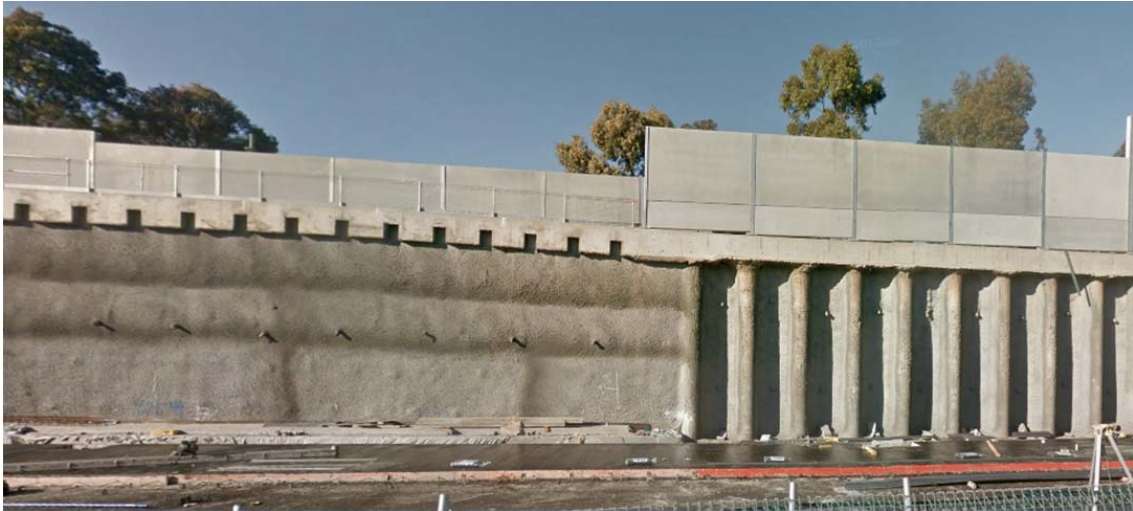
Figure 4 M5 KGR Interchange excavation under construction.

M5KGR1U excavation penetrated into the groundwater table around 6.4 to 7.4 metres below ground level, with new sub-soil drainage at the base of the excavation, and dewatering activities to facilitate the boring of over 50 pilings to a depth of some 8 metres for the vertical piled retaining walls. As can be indicated in Figure 2, the distance of the M5 road surface drainage system shifted much closer to homes from 48 metres to 30 metres. This additional drainage has caused dewatering of the groundwater table that would naturally flow towards Wolli Creek situated behind our homes, to now flow forwards to the significantly deeper M5 drain at the front of these premises.

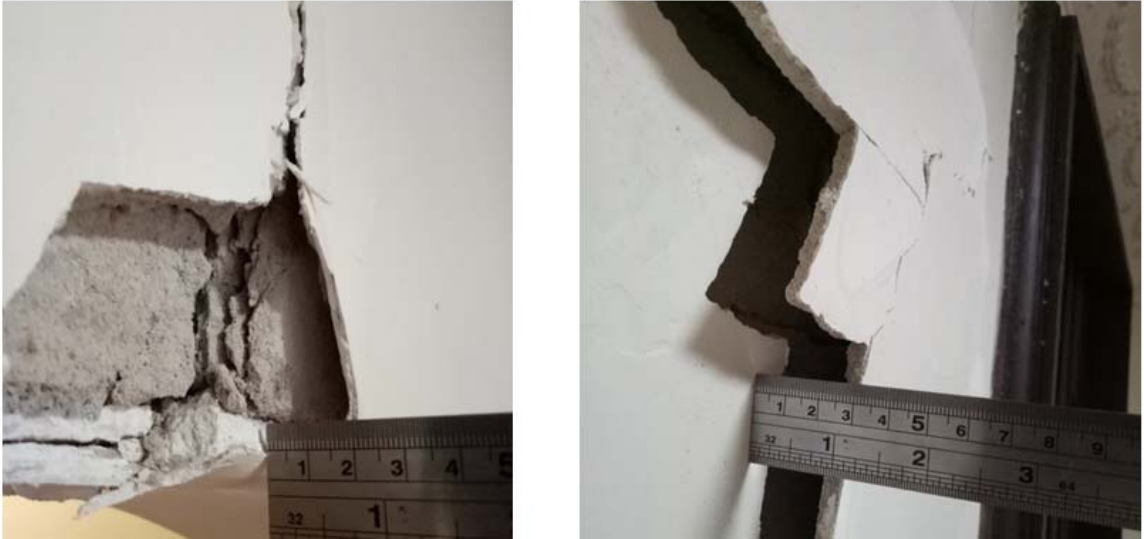
Figure 5 Major cracks in plaster work – alleged possible cause a “dripping garden tap”

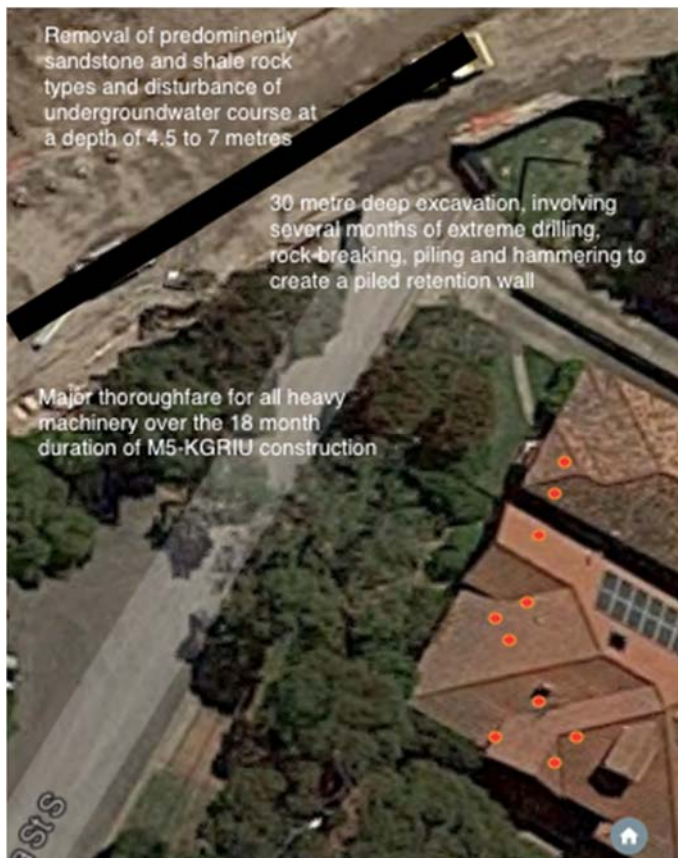
Figure 6 Pattern of initial damage through No 10 and No 8 suggesting a groundwater fault line. Damage is now extended through both homes.

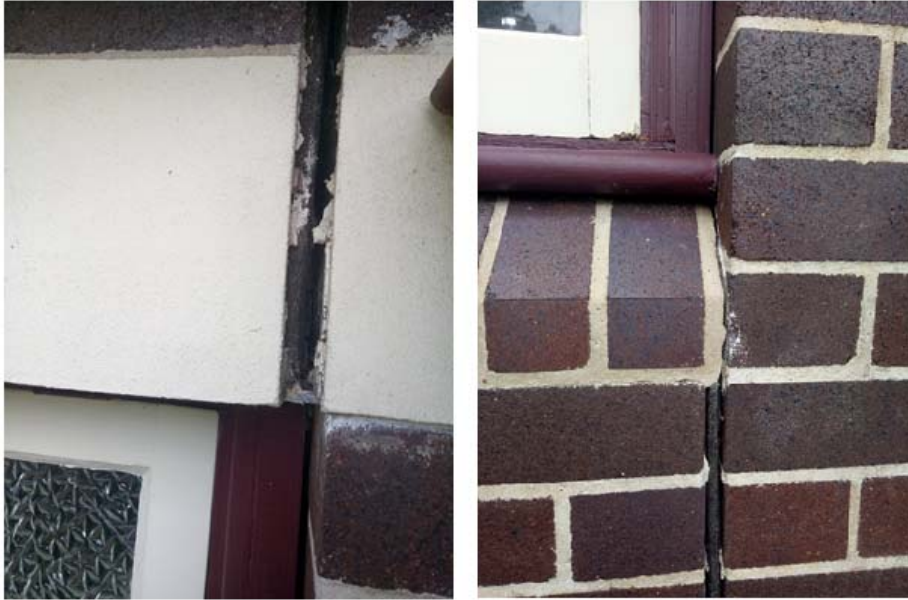
Figure 7 Separation of 1999 extension from original 1929 section
