# Medium Complex, NEWCASTLE

# **PHOTOS IN SUPPORT OF ORAL SUBMISSION**

by Grahame Vile

**20 Feb 2020, Newcastle**

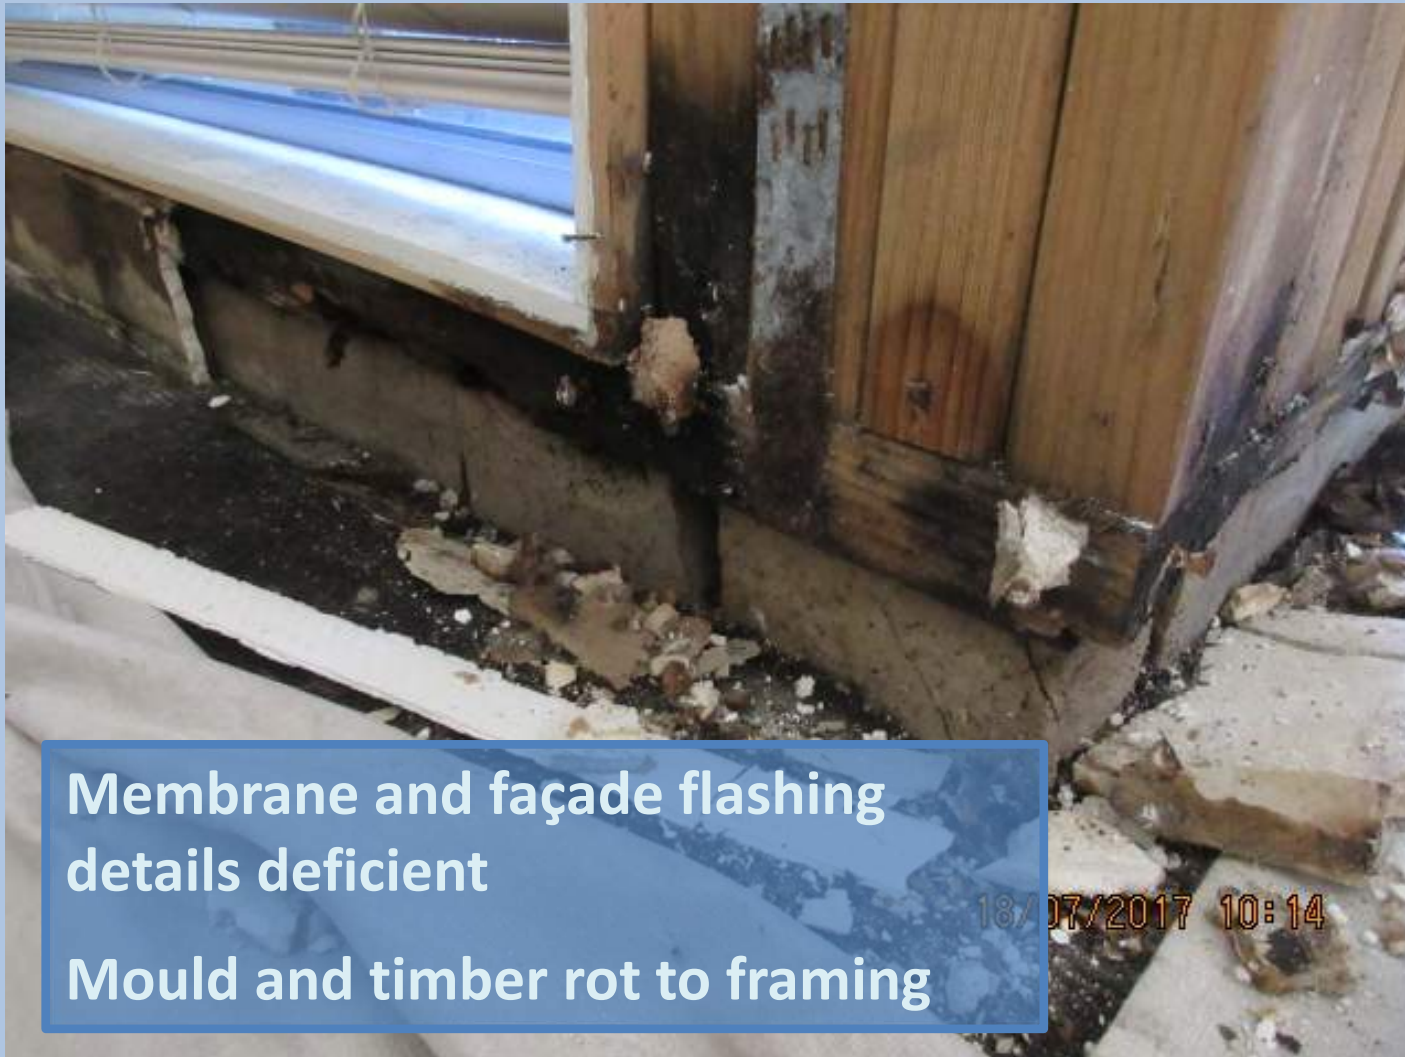
## Internal Courtyard Poor Waterproofing & Hob

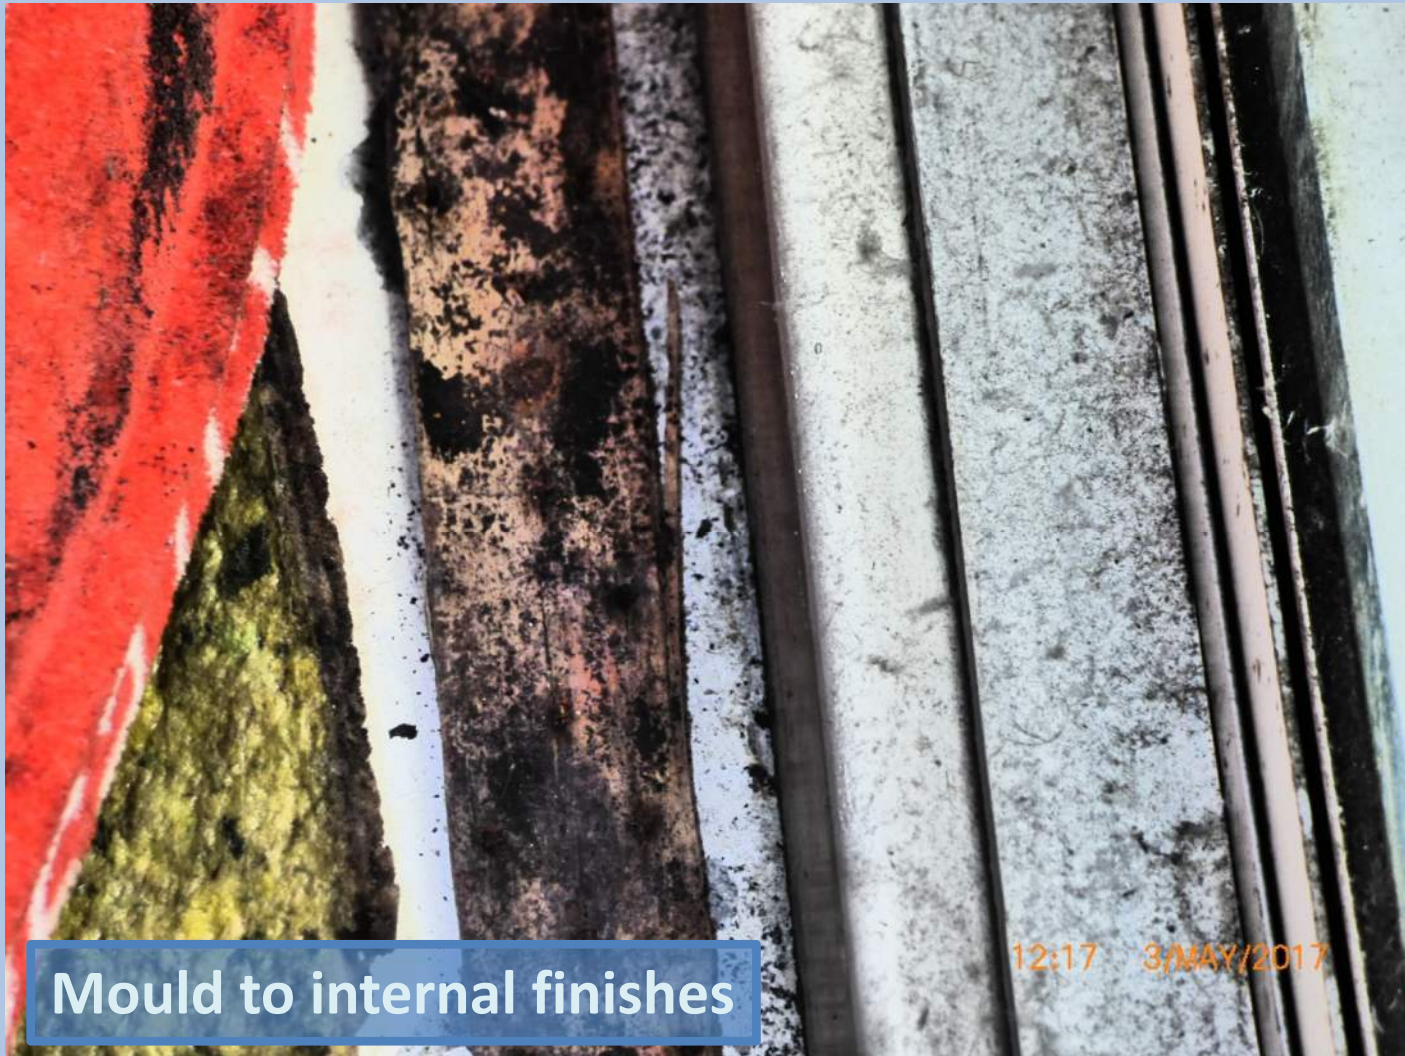
## Internal Courtyard – membrane-hob defect

Mould to internal finishes

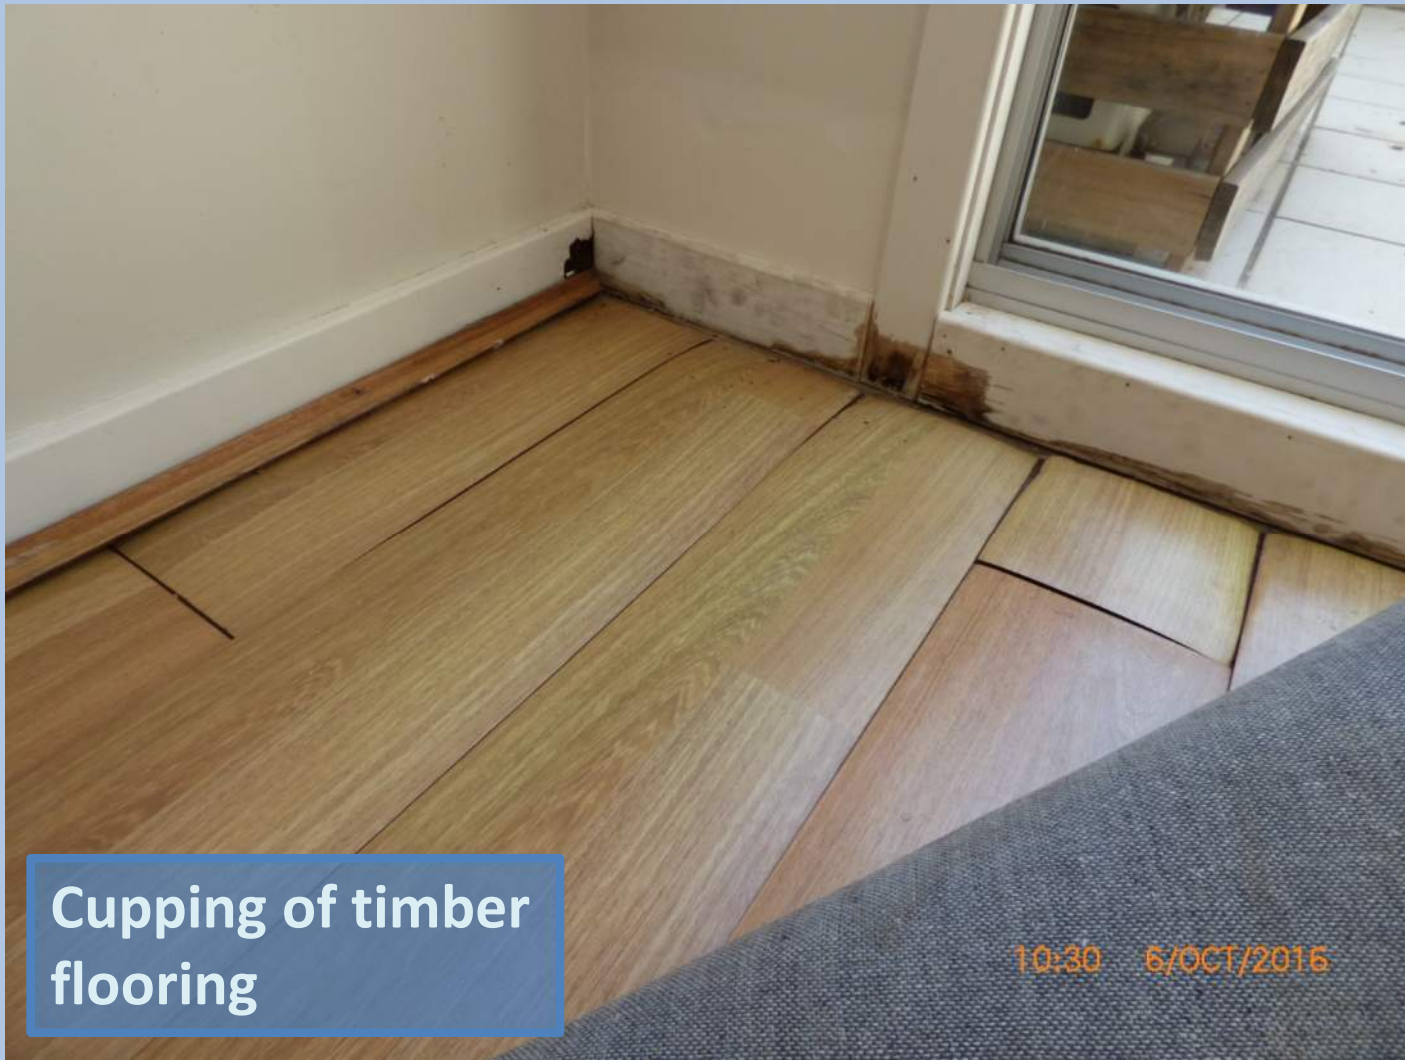
## Internal Courtyard Poor Waterproofing

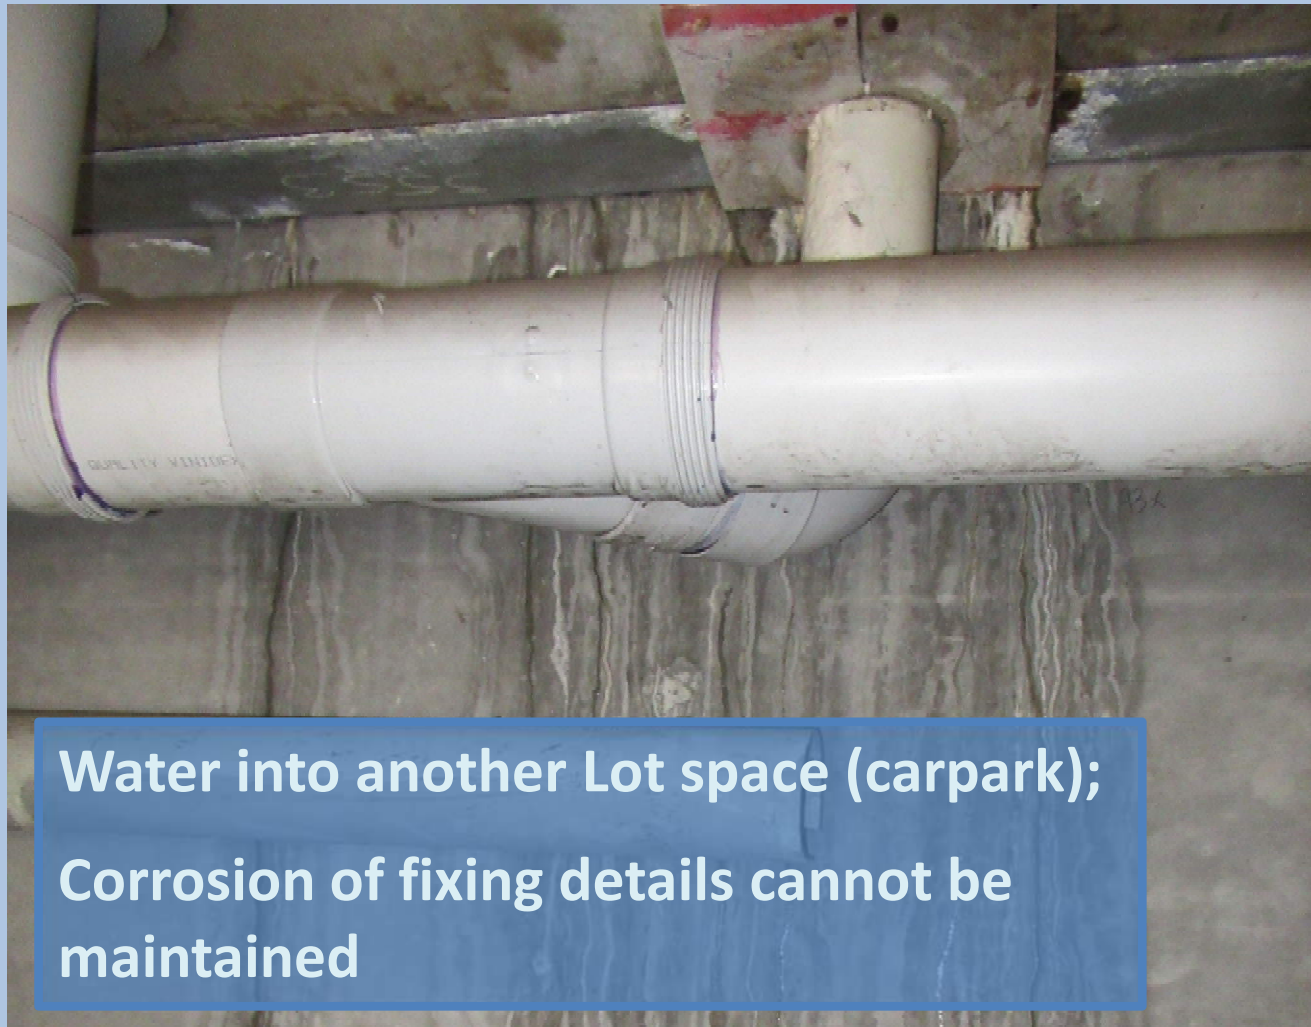
## Internal Courtyard and Concrete Façade

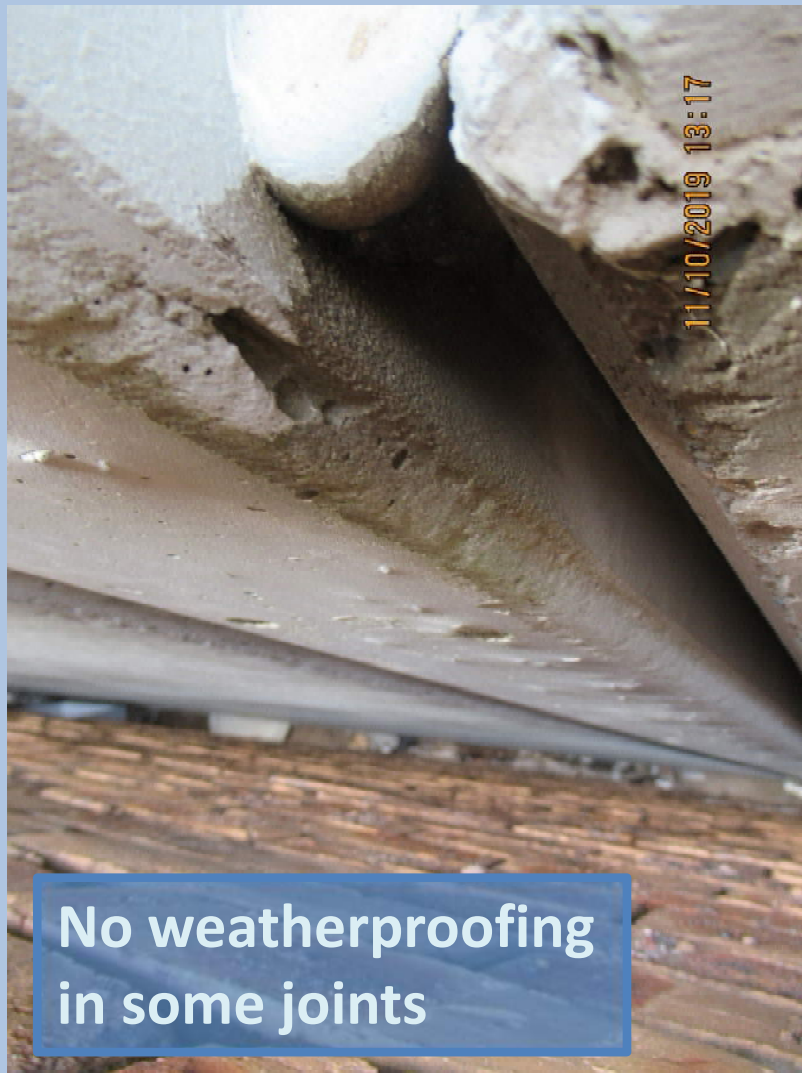
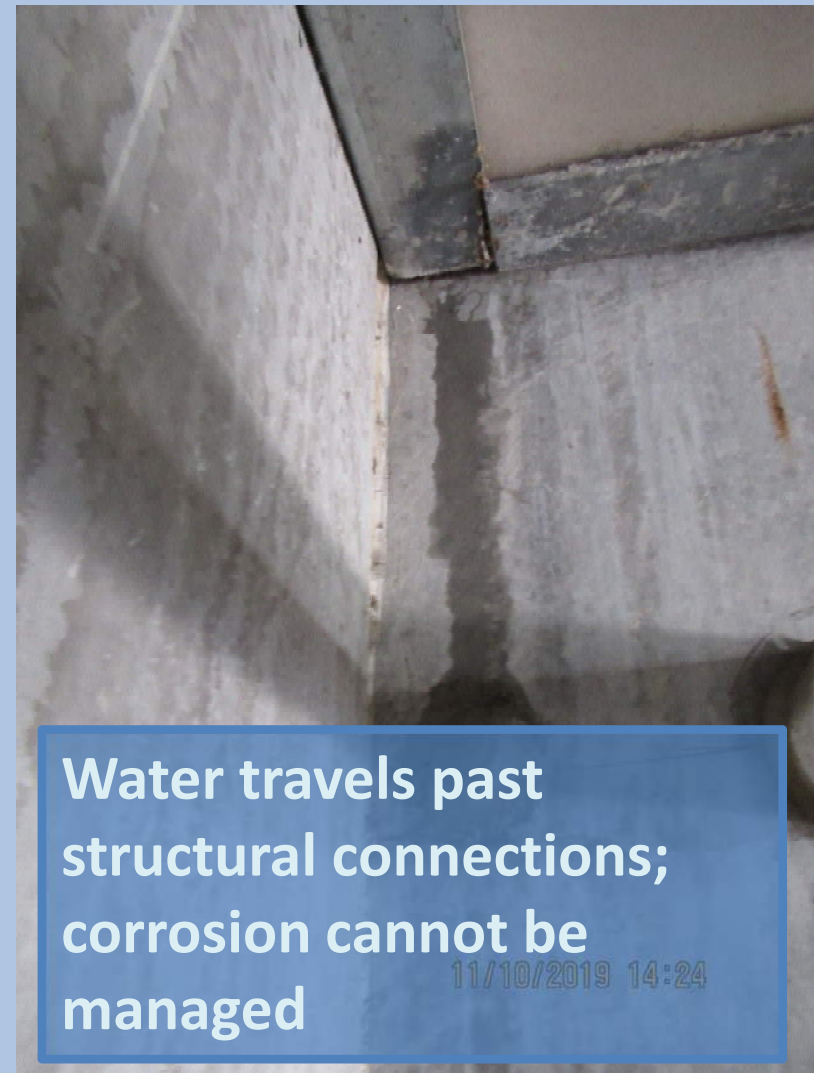
## Detailing of Precast Panel Joints – moisture to carpark

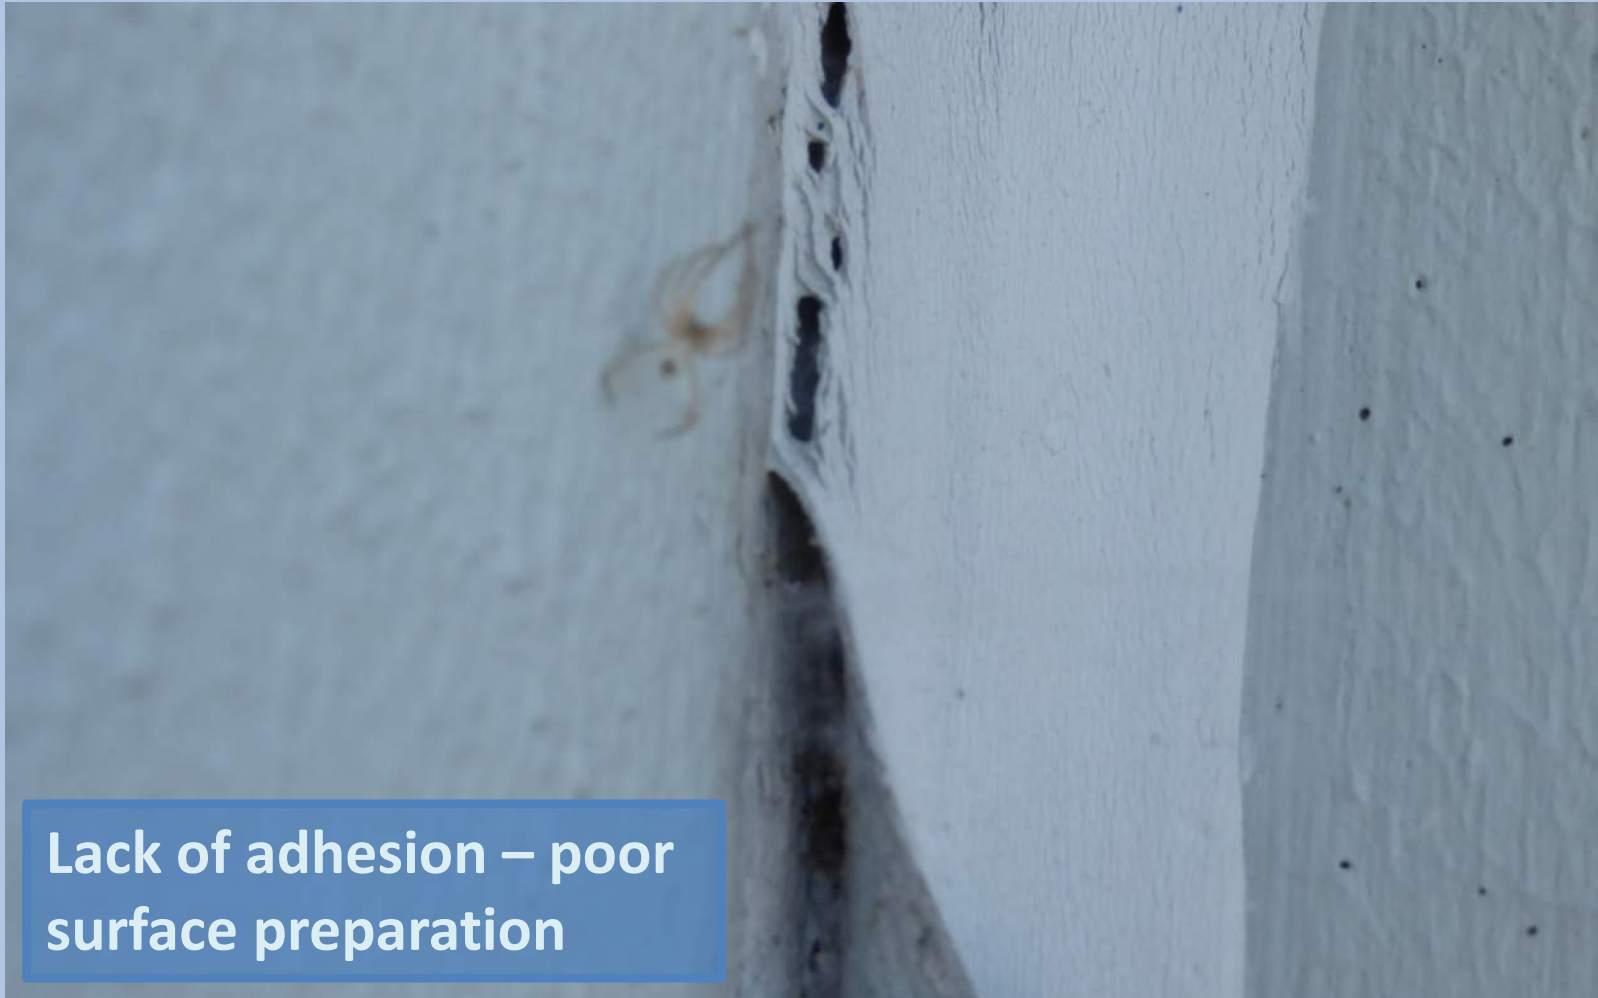
## Pre-cast Panel Joint Detailing

**Lack of adhesion – poor  
surface preparation**

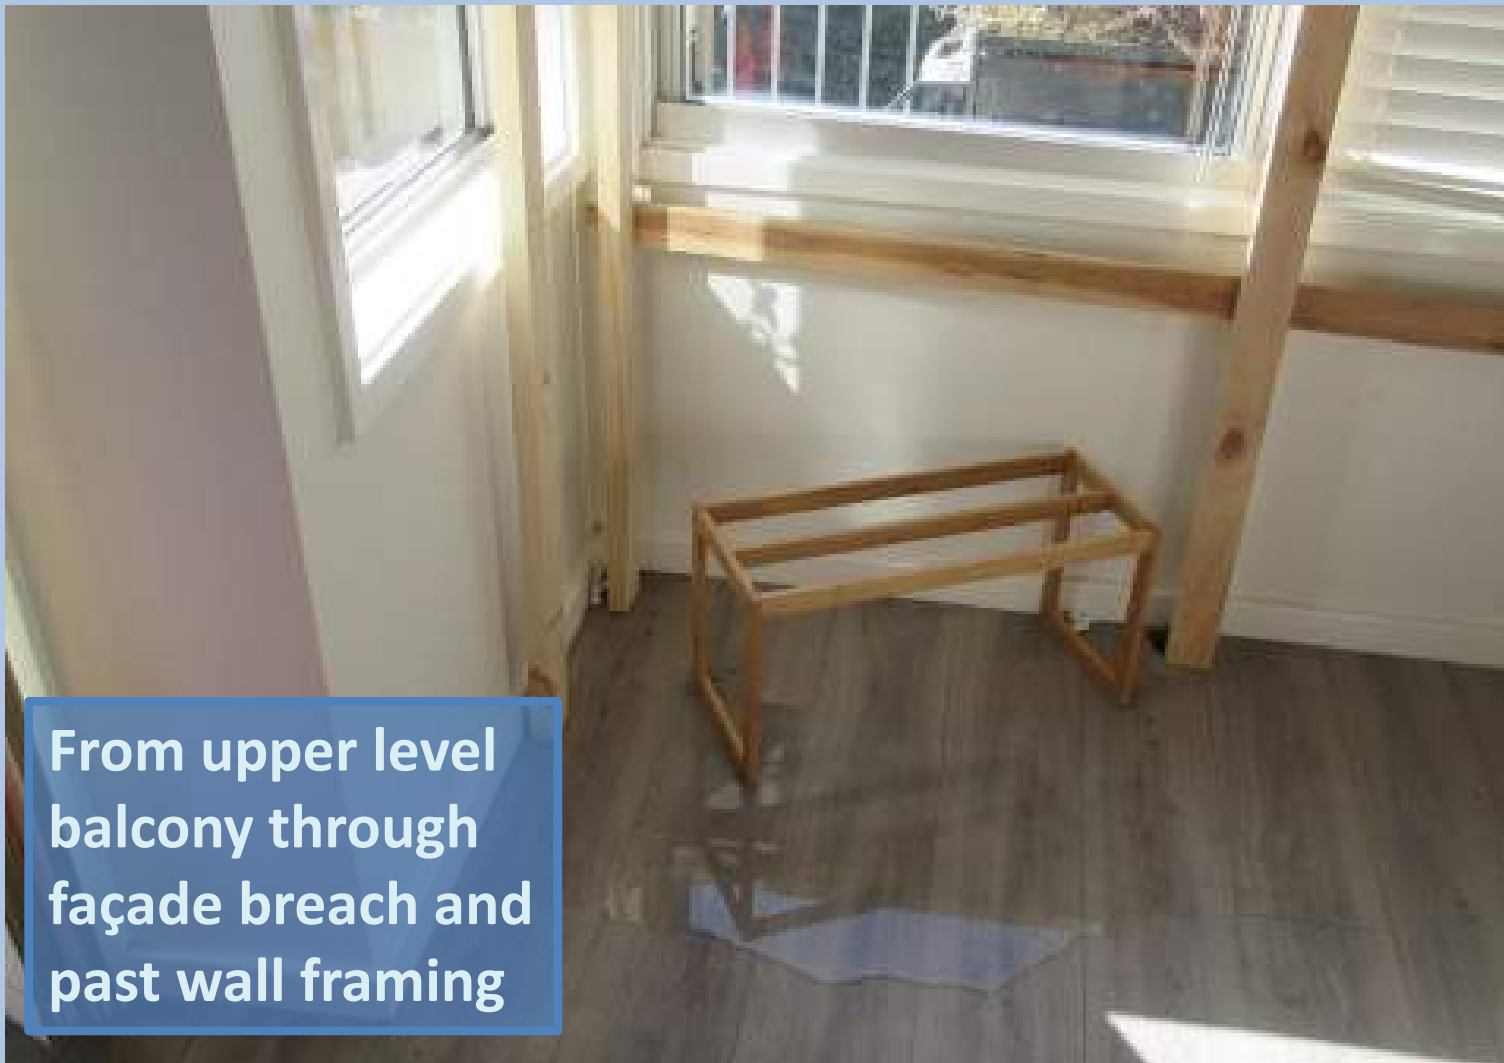
## Open Balcony Poor Waterproofing and Hob

From upper level  
balcony through  
façade breach and  
past wall framing

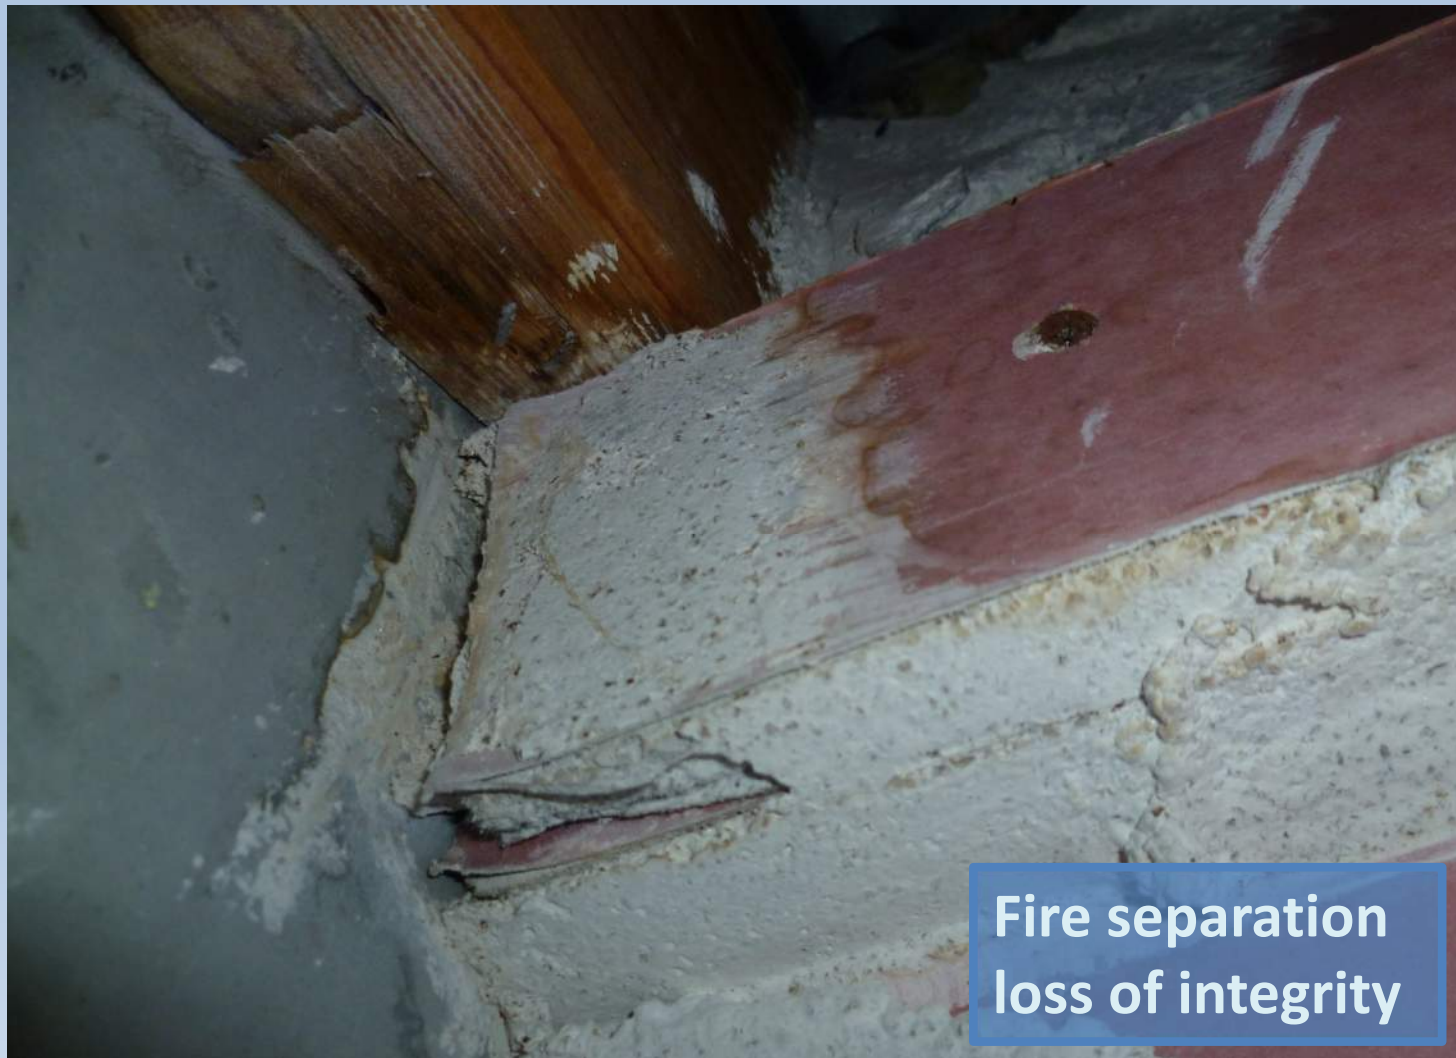
## Moisture affected Fireboard – due to roof flashing and cladding leaks

Fire separation  
loss of integrity

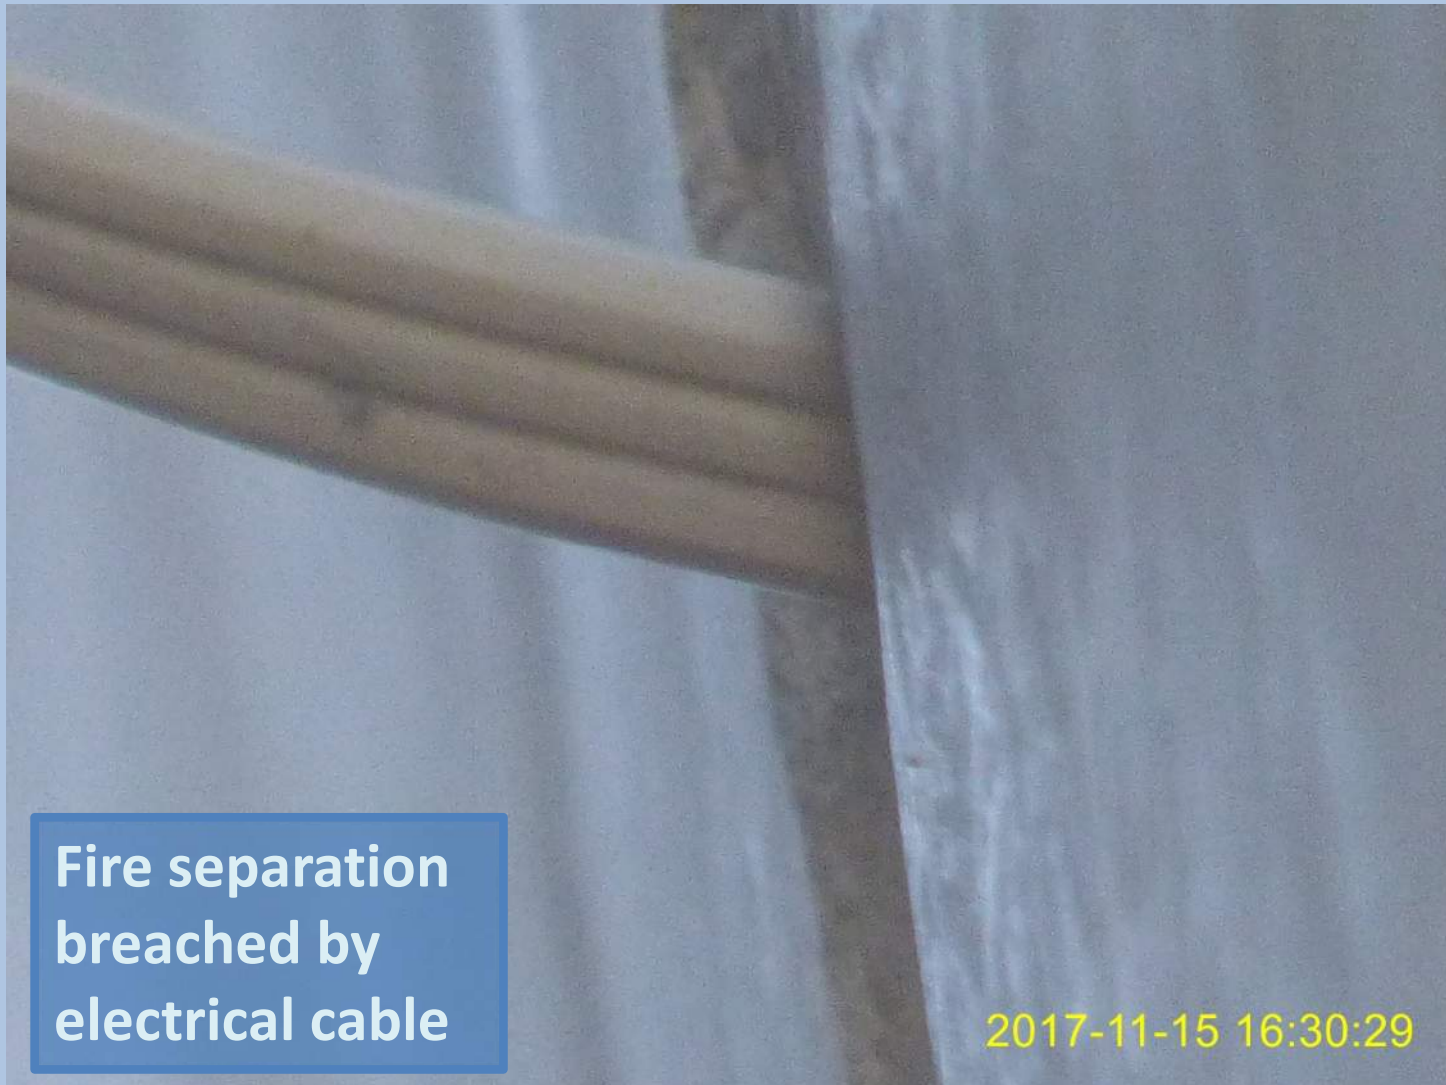
## Service cable penetrates external concrete panel join

**Fire separation  
breached by  
electrical cable**

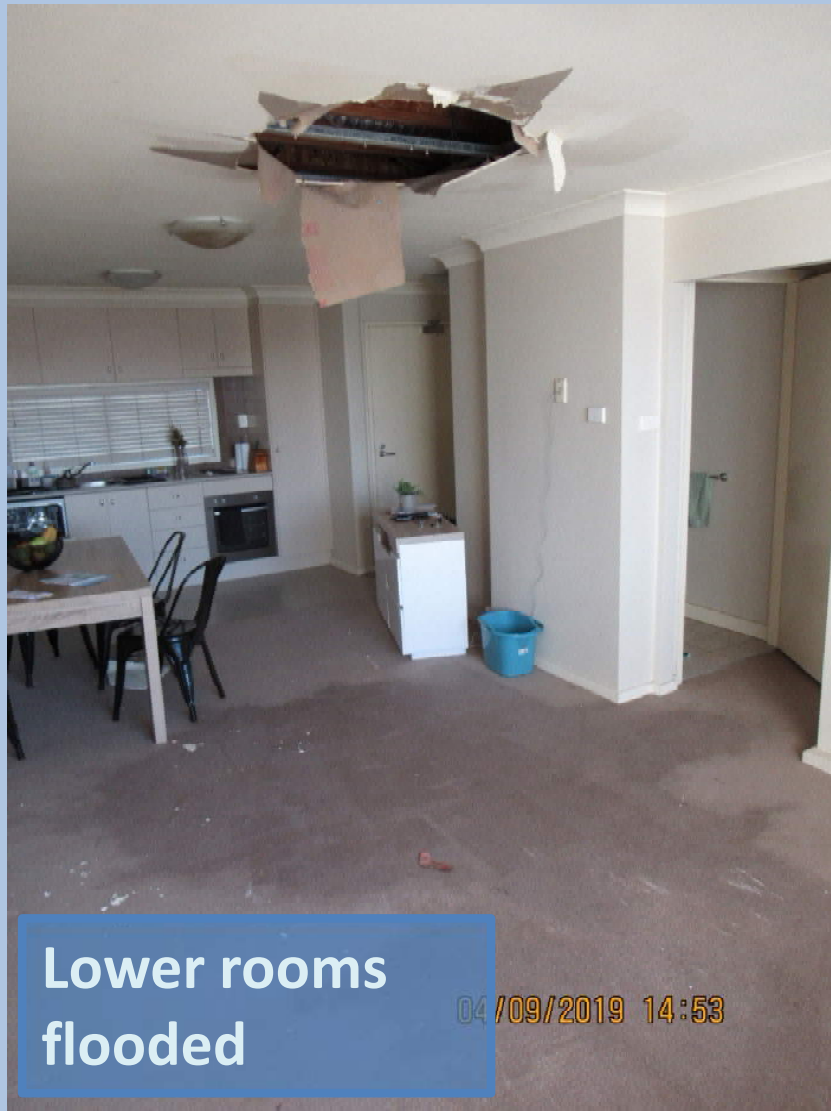
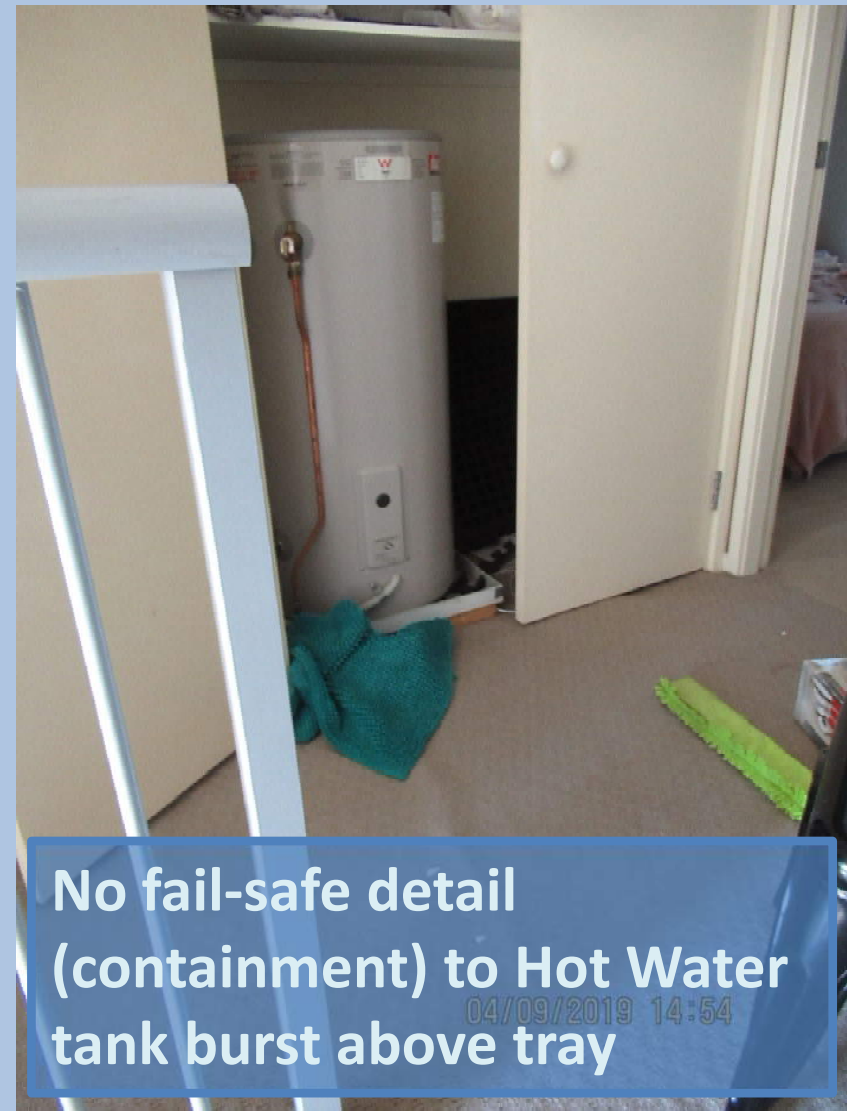
## Poor design & consequence of hot water system failure

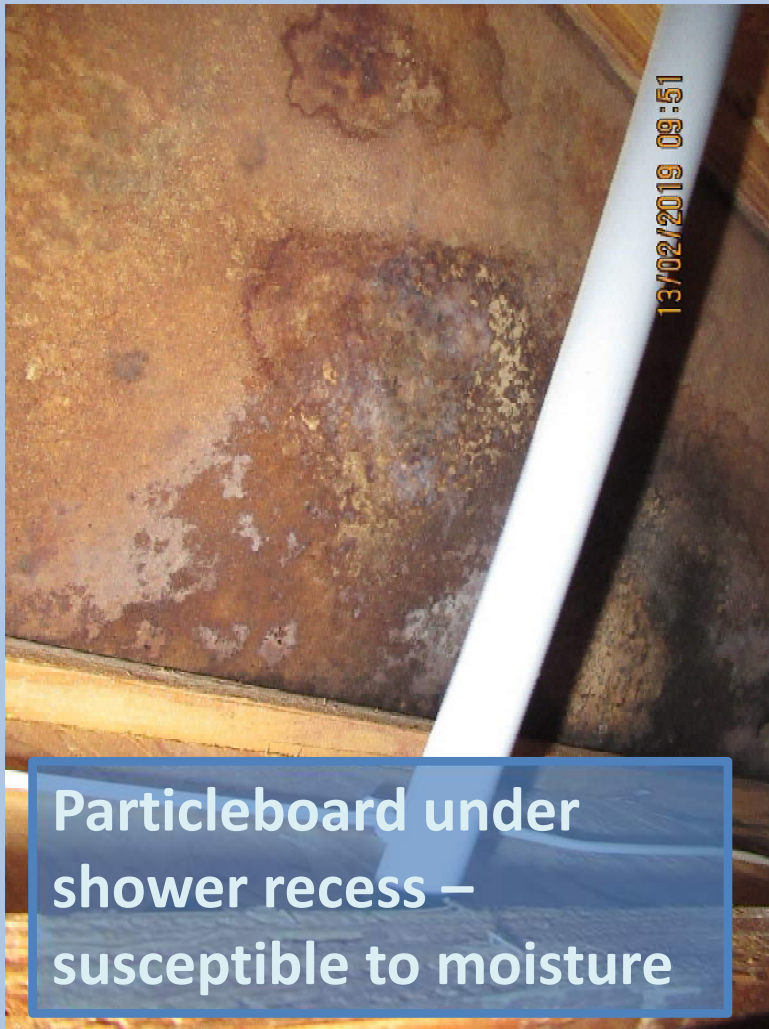
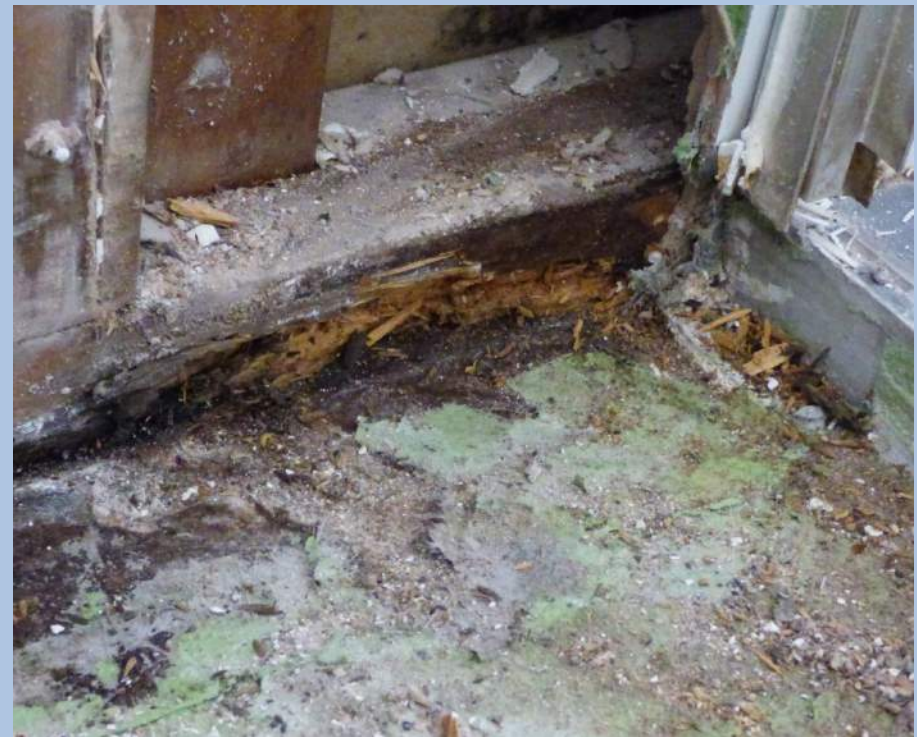
## Poor Material choice and wet area waterproofing failure

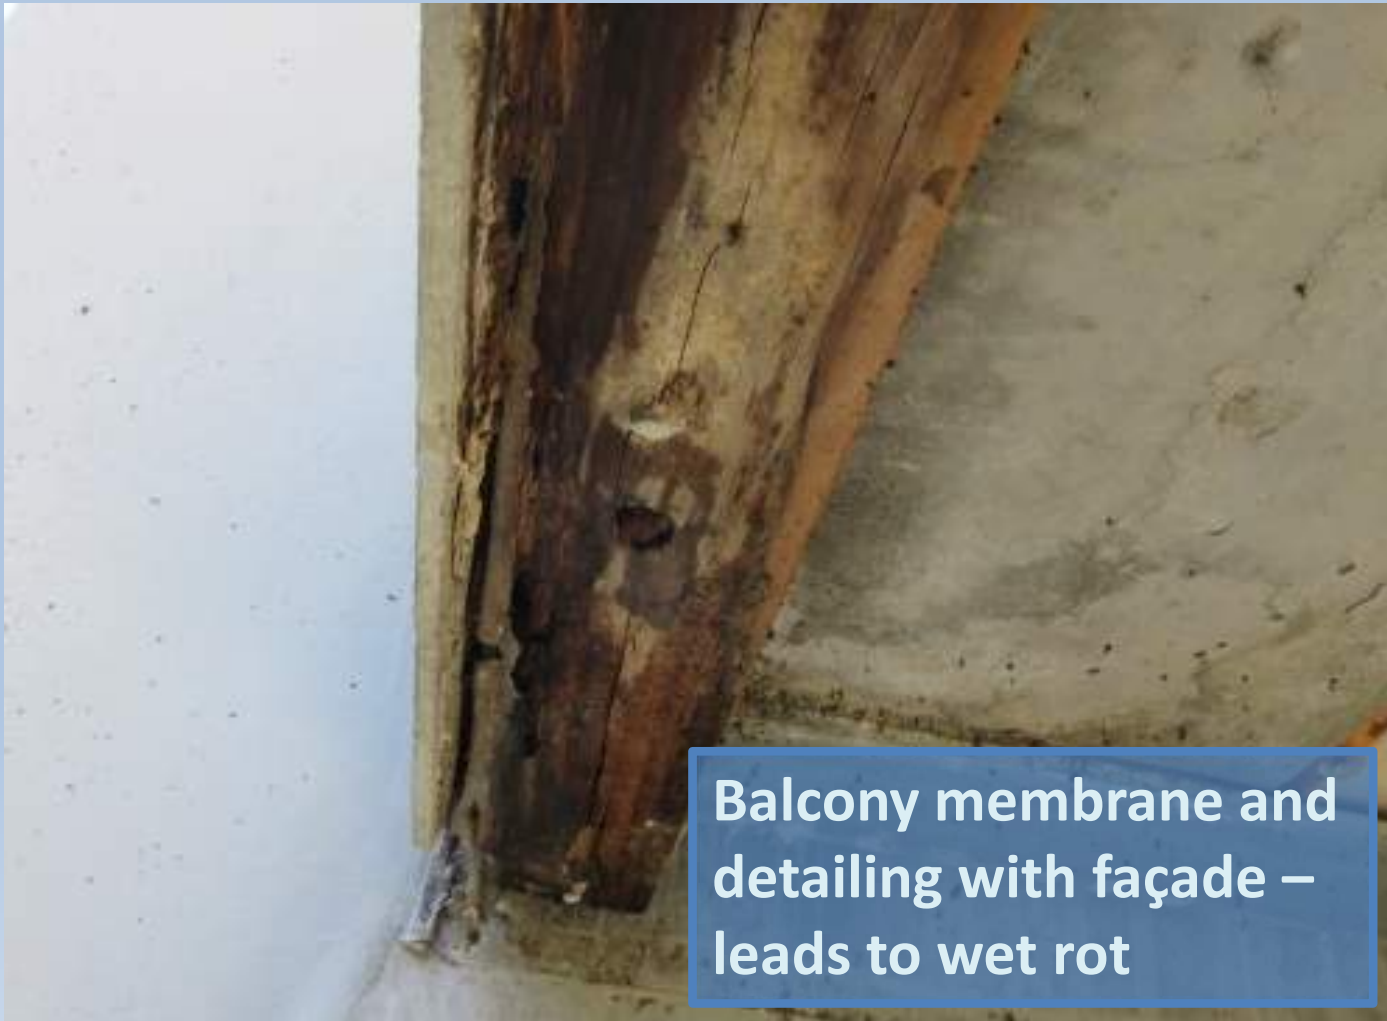
## Deteriorated Timber framing at Fascia – membrane defects.

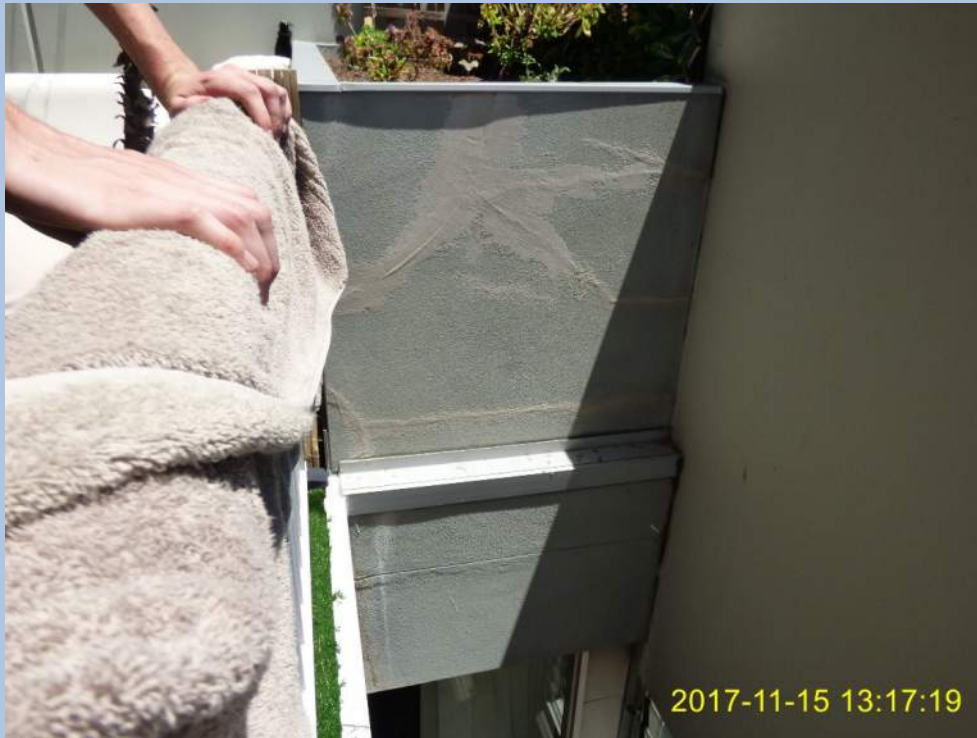
Failed joint  
detailing end of  
precast against  
facade

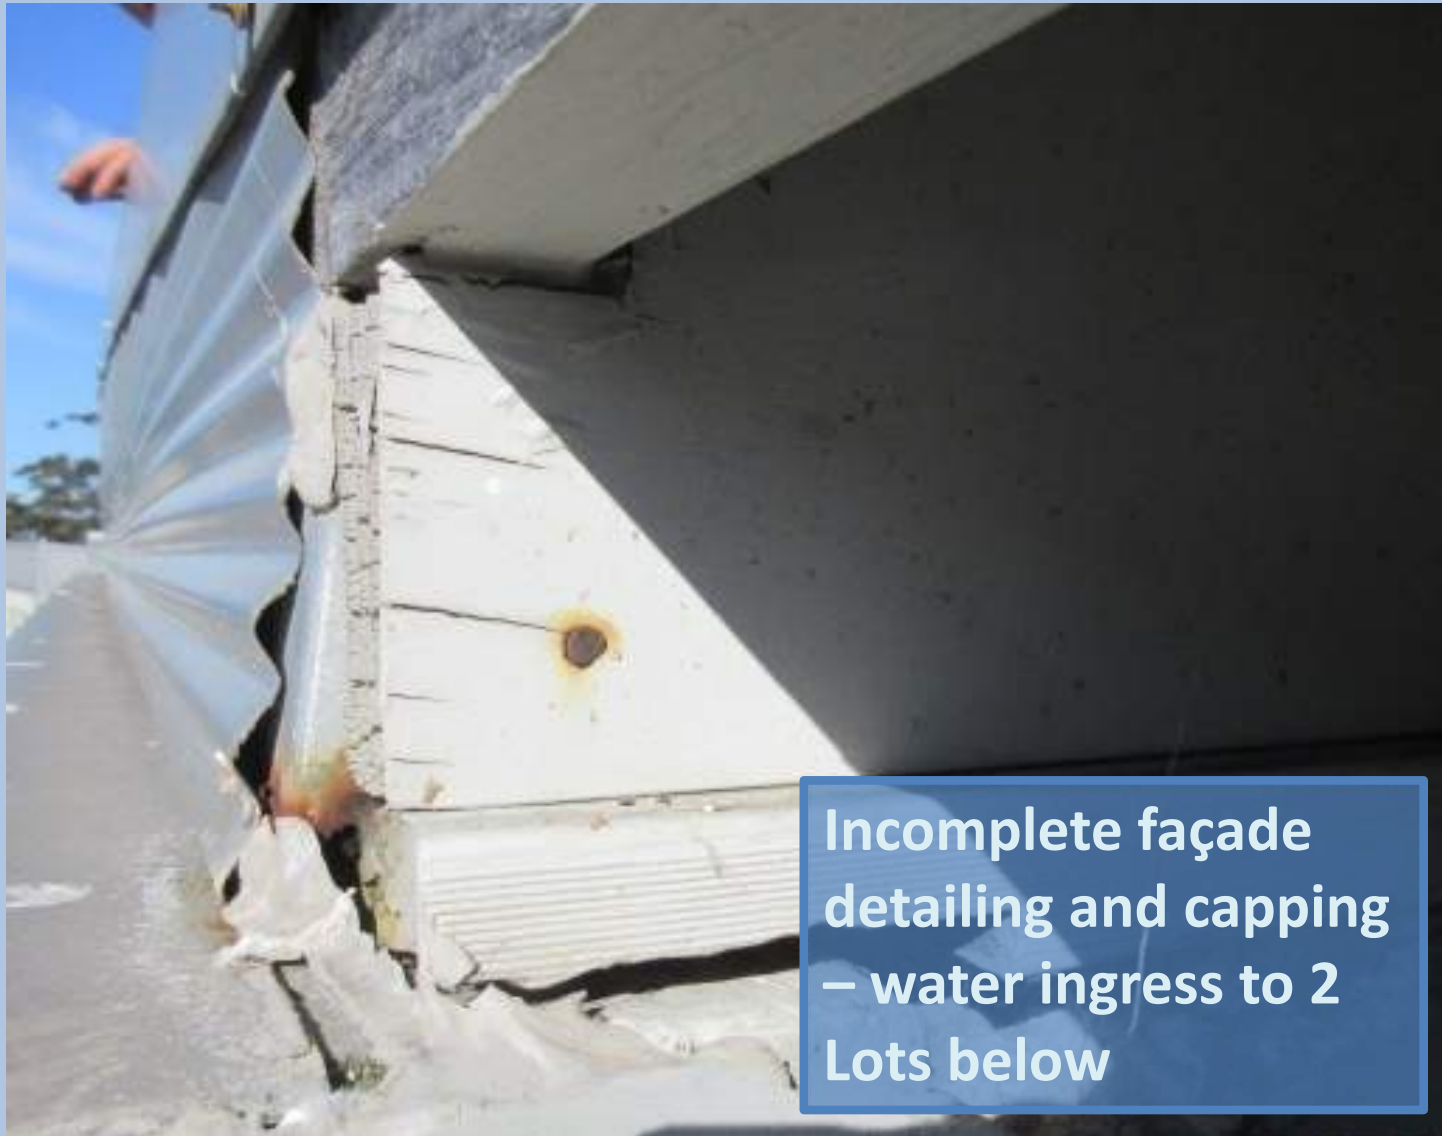
## Capping /Flashing Repairs

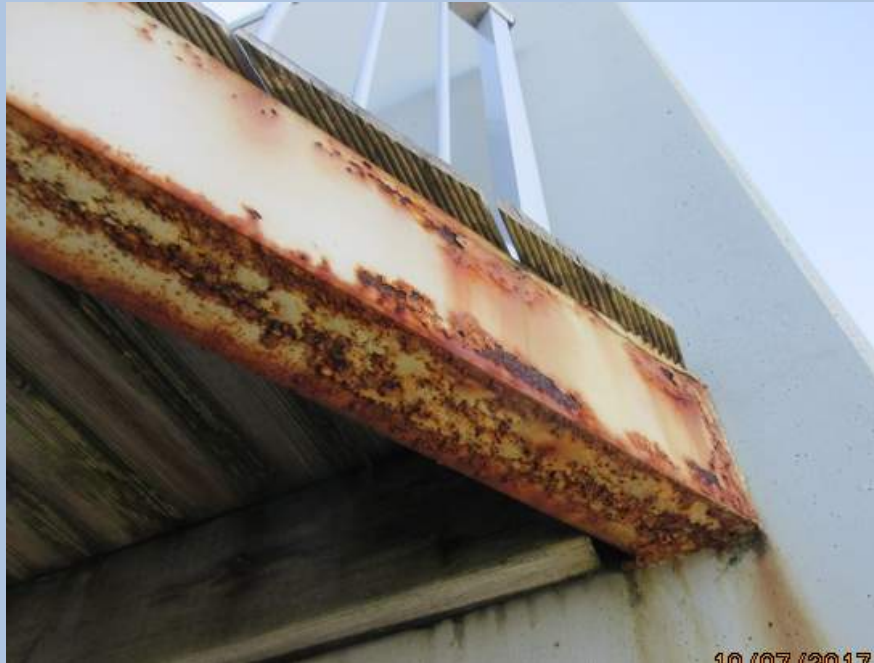
## Framing of upper Decks

Steel member projects into façade – excessive maintenance effort required

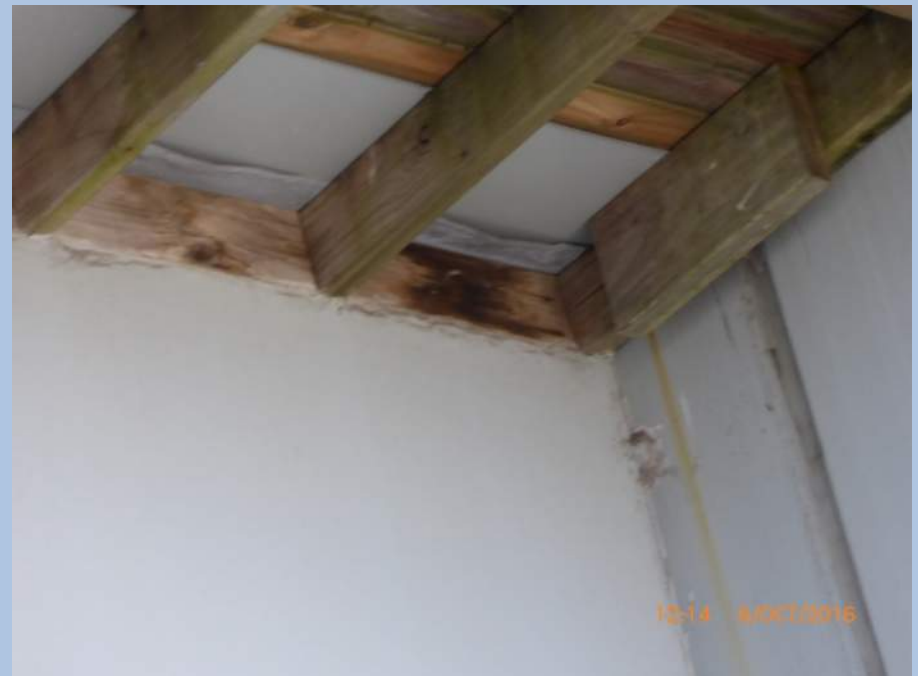
Wall-mounted timber with water impacting, rendered against
