# Medium Complex, NEWCASTLE

# **PHOTOS IN SUPPORT OF ORAL SUBMISSION**

by Grahame Vile

**20 Feb 2020, Newcastle**

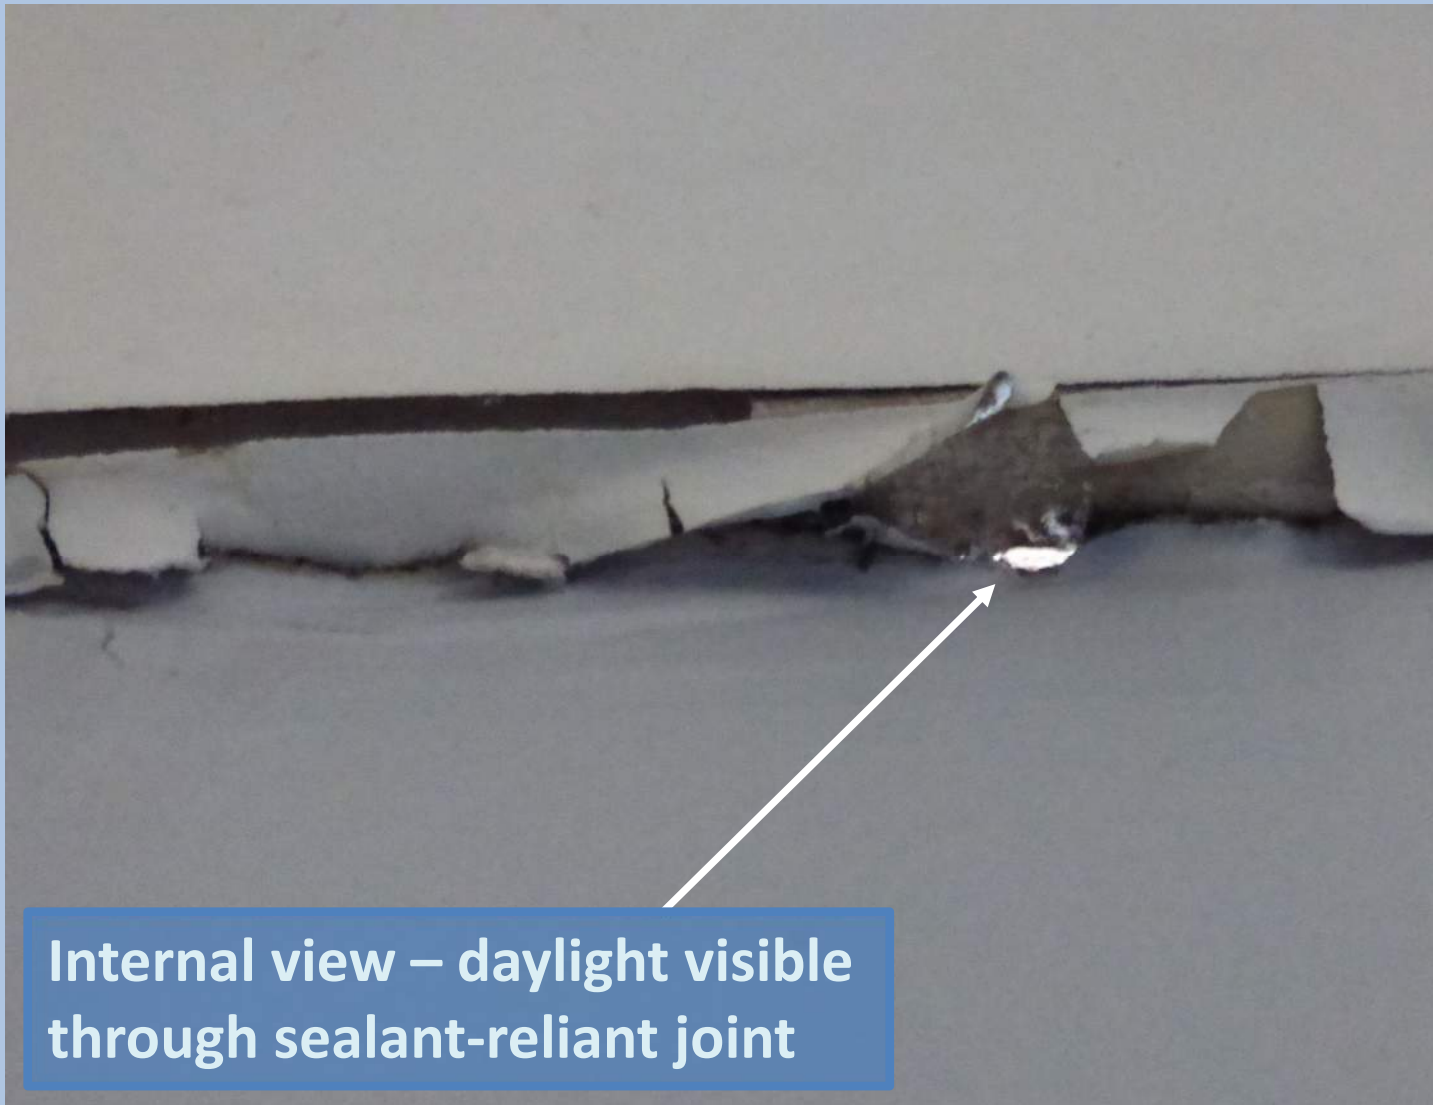
## Flashing Repairs – deteriorated cornice/wall

Internal view – daylight visible  
through sealant-reliant joint

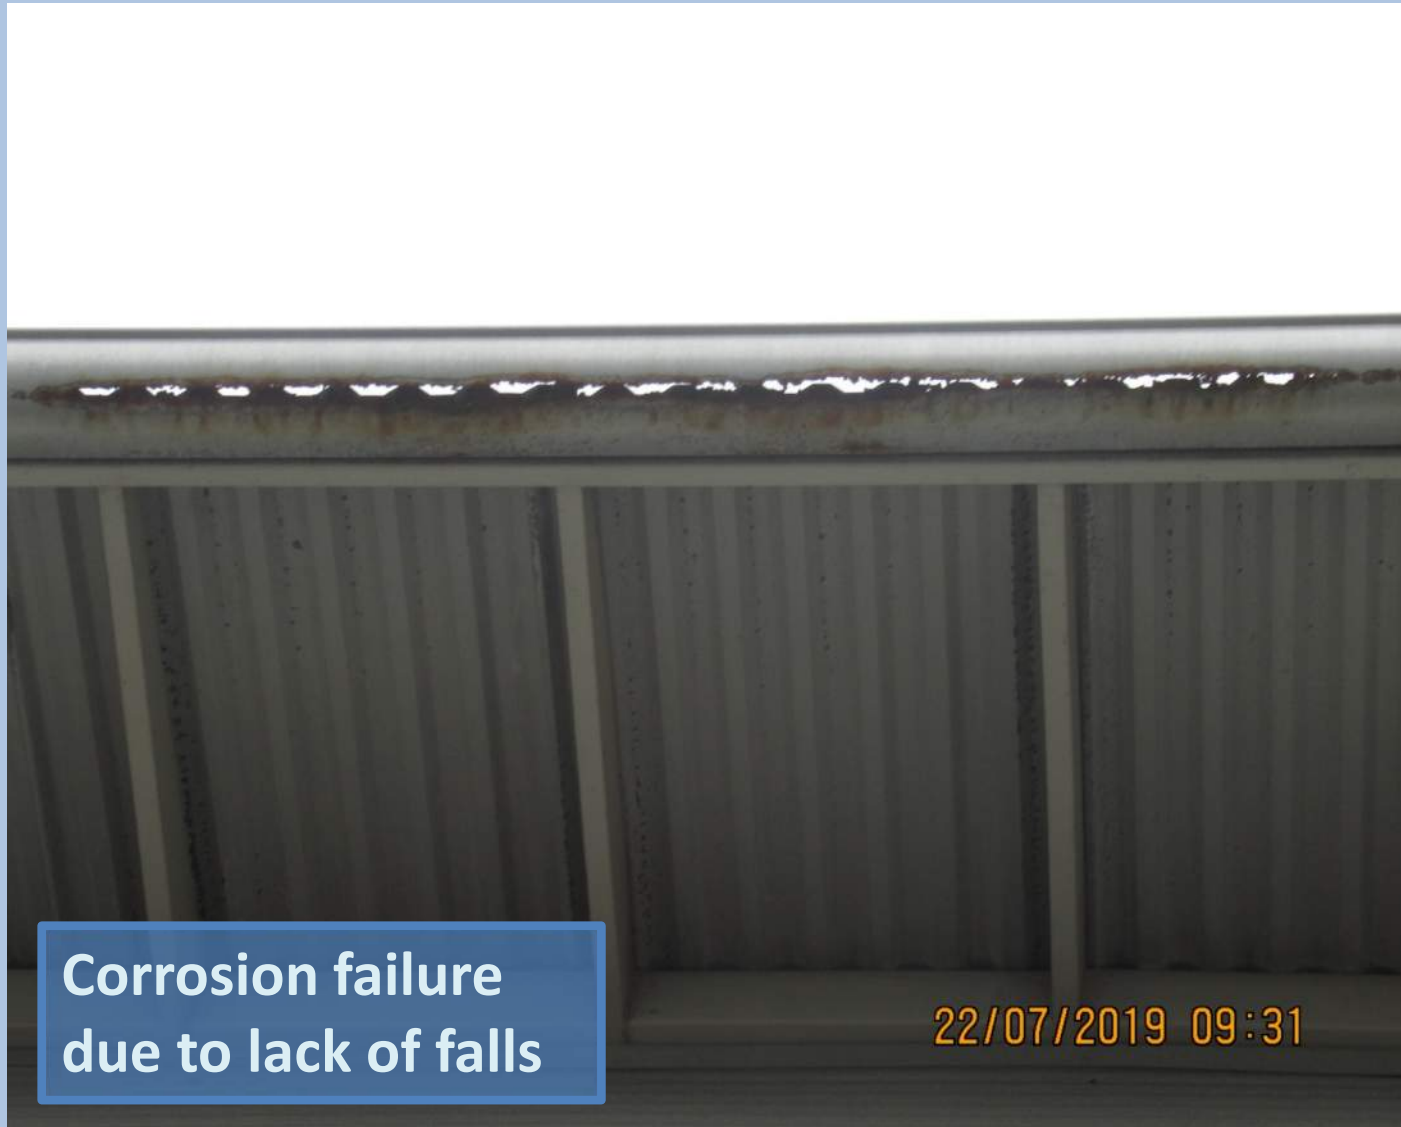
## Guttering failed at less than half Service Life

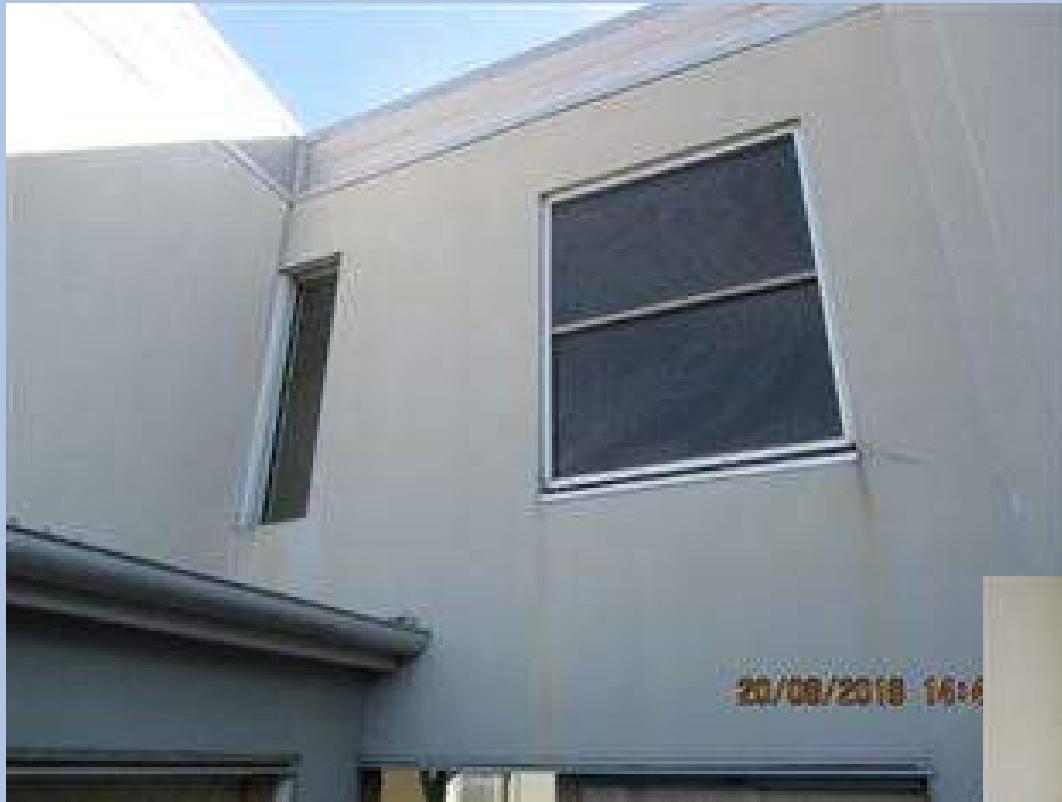
# Flammable cladding

Typical appearance  
of cladding

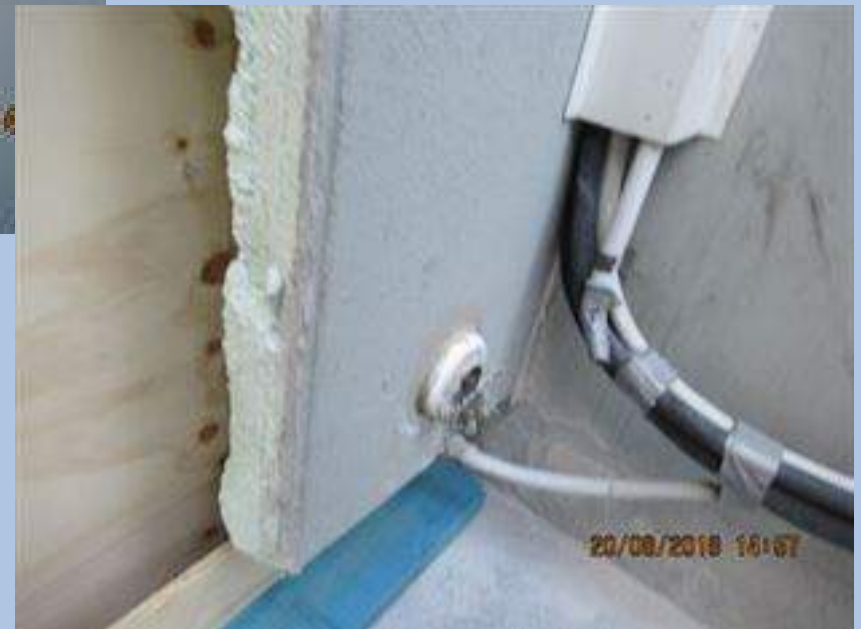
Styrene board, thin  
render coating, no  
sarking, insulation  
or fireboard and  
deficient timber  
framing.
