Bicentenary – condition of buildings

Department of Parliamentary Services

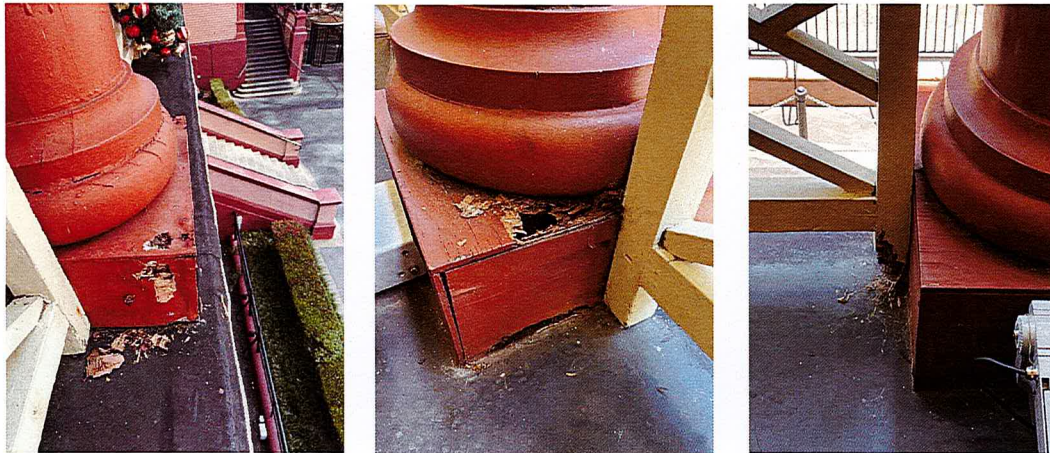
Damage to level 8 verandah timber column base

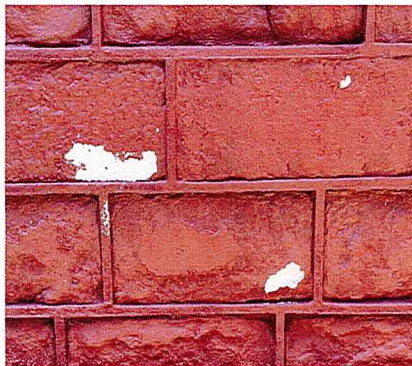
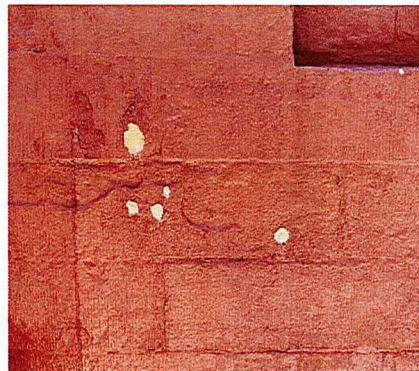
Water and salt damage to sandstone on Macquarie St

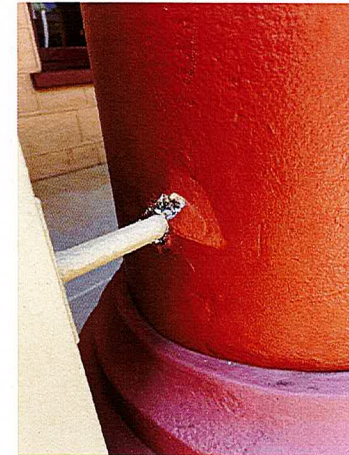
Corrosion expansion and damage to sandstone column

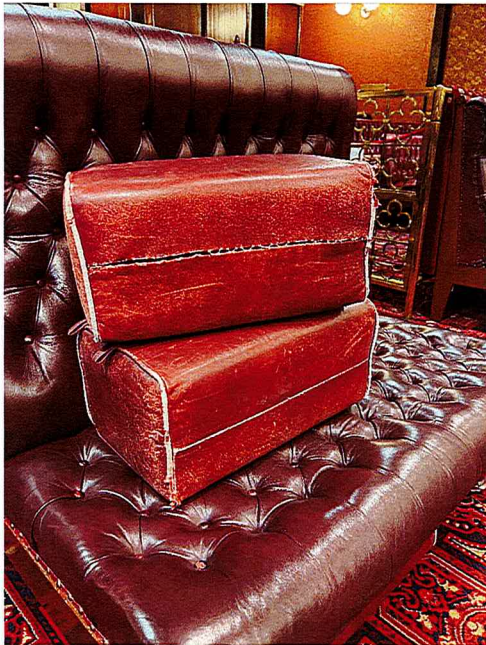
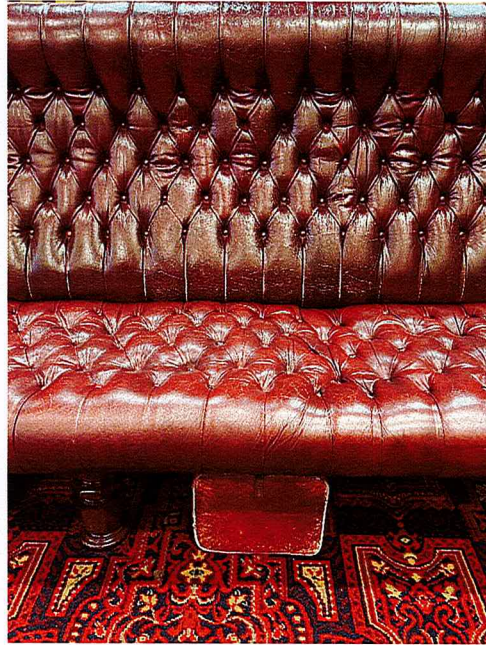
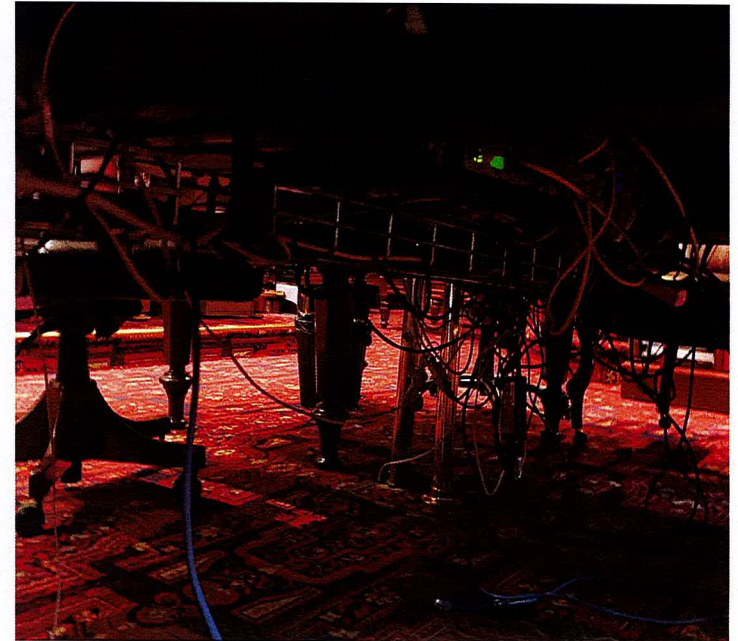
Deterioration of leather in LC Chamber plus cabling issues

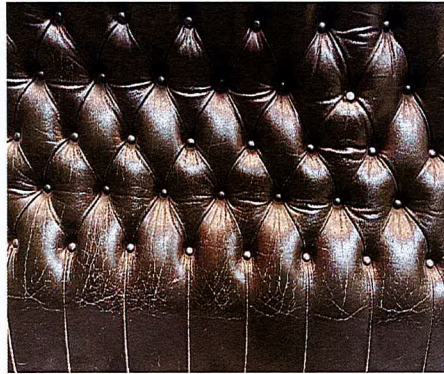
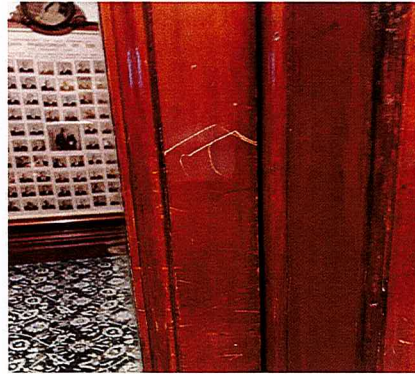
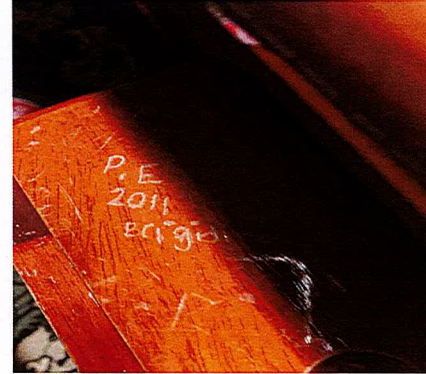
Deterioration of leather in LA Chamber + woodwork

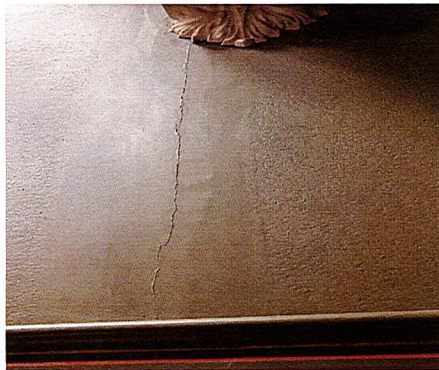
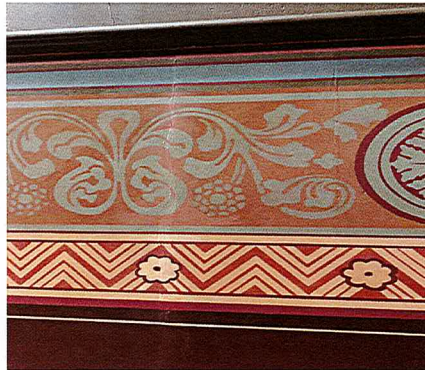
LA Chamber paintwork

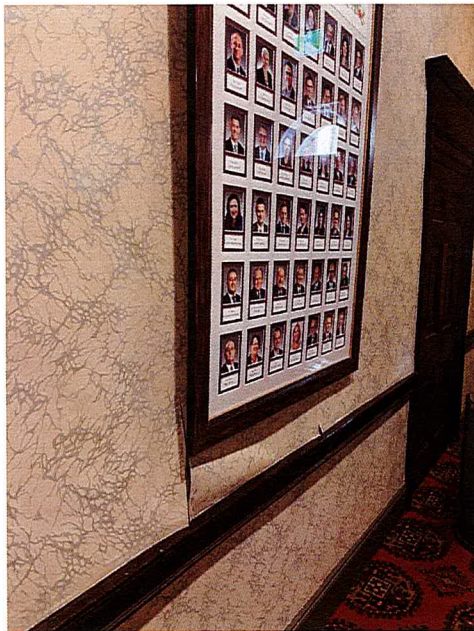
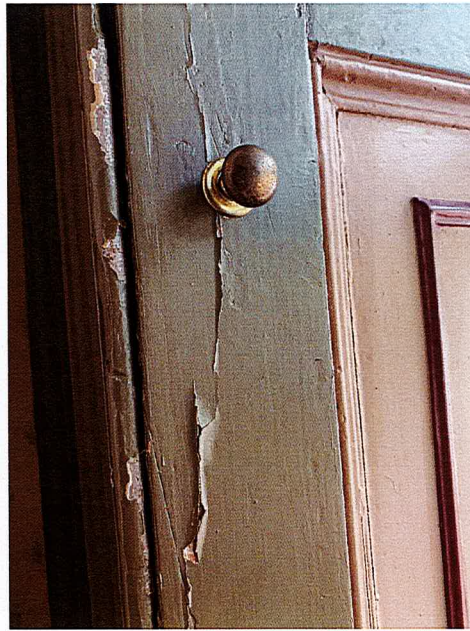
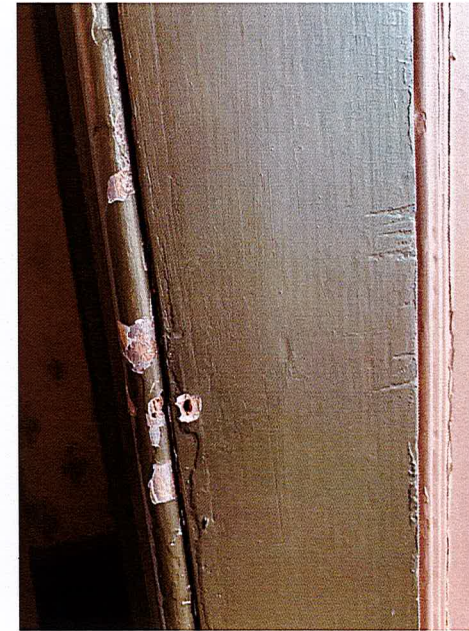
Rum Hospital wall paper and woodwork

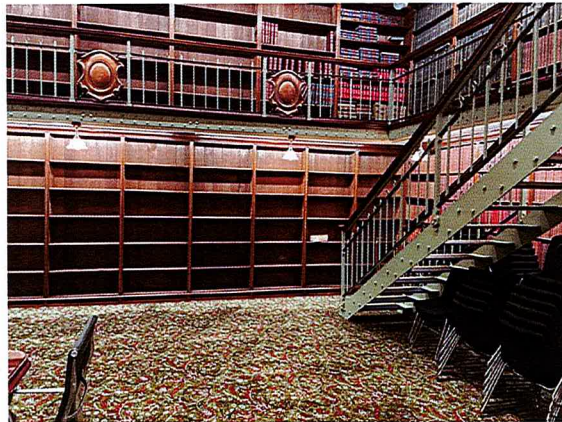
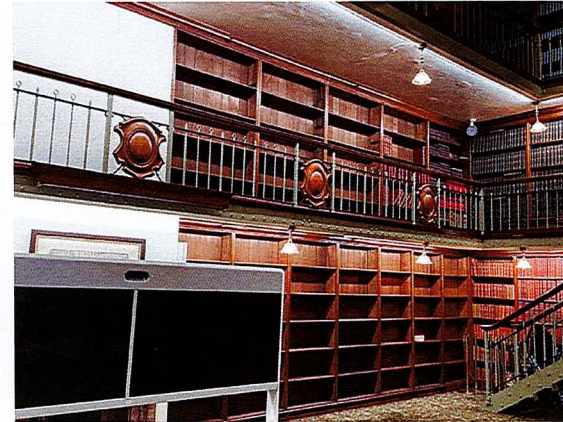
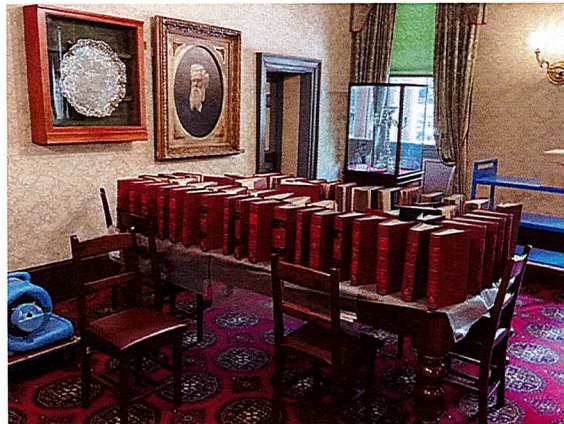
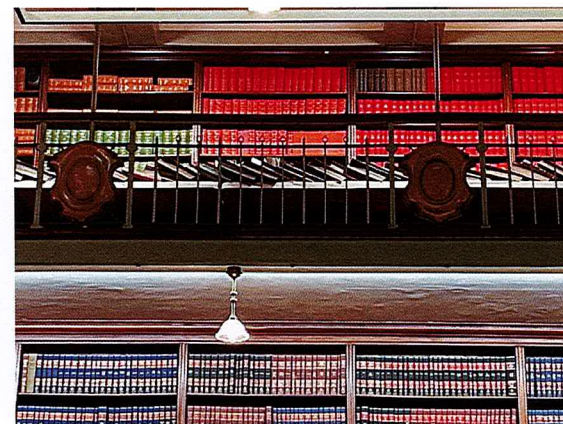
Jubilee Room water leak

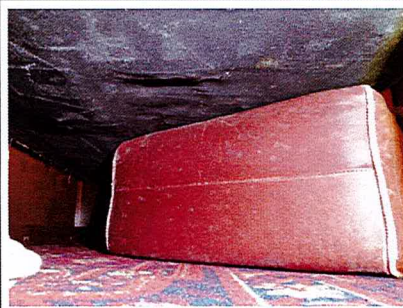
Recurring mould and air conditioning

Photo 1: LC Chamber, seats underside prior to remediation works

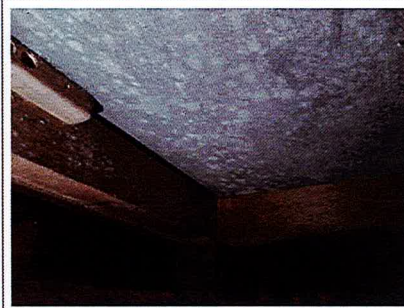
Photo 2: LC Chamber, seats underside prior to remediation works

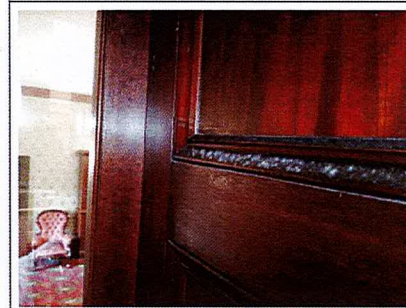
Photo 5: LC Chamber, horizontal surfaces prior to remediation works

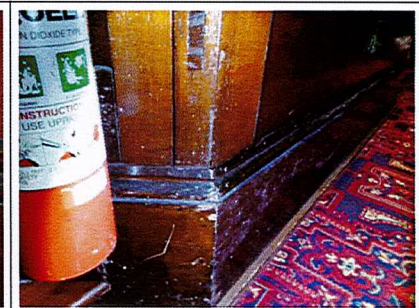
Photo 6: LC Chamber, walls skirtings prior to remediation works

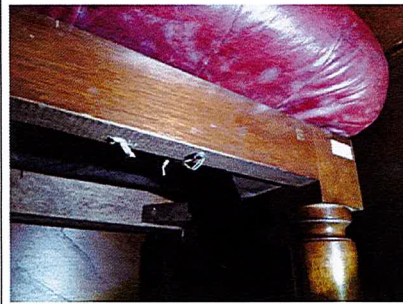
Photo 3: LC Chamber, seats leather surface prior to remediation works

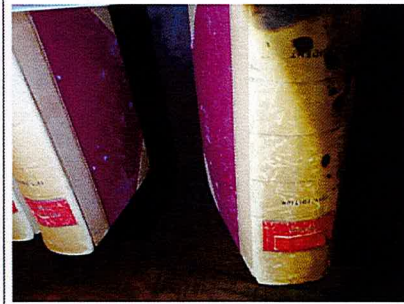
Photo 4: LC Chamber, book covers prior to remediation works

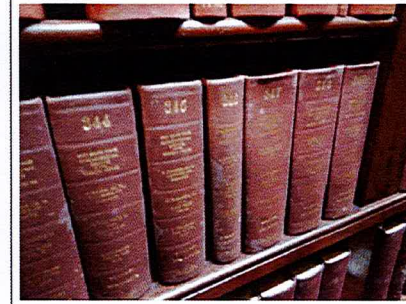
Photo 7: LC Chamber, book covers prior to remediation works

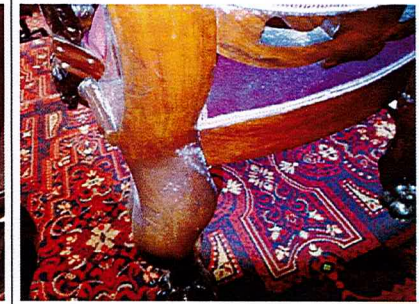
Photo 8: LC Chamber, Presidents chair prior to remediation works

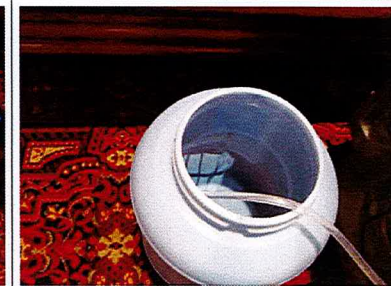
Photo 8: LC Chamber, 25 liters of water extracted from within by each Dehumidifier running overnight
