Peer reviewed paper

Managing the suspension bridge in Kangaroo Valley (Hampden Bridge)

Henry Fok, Bridge Inspection Engineer, Transport for NSW

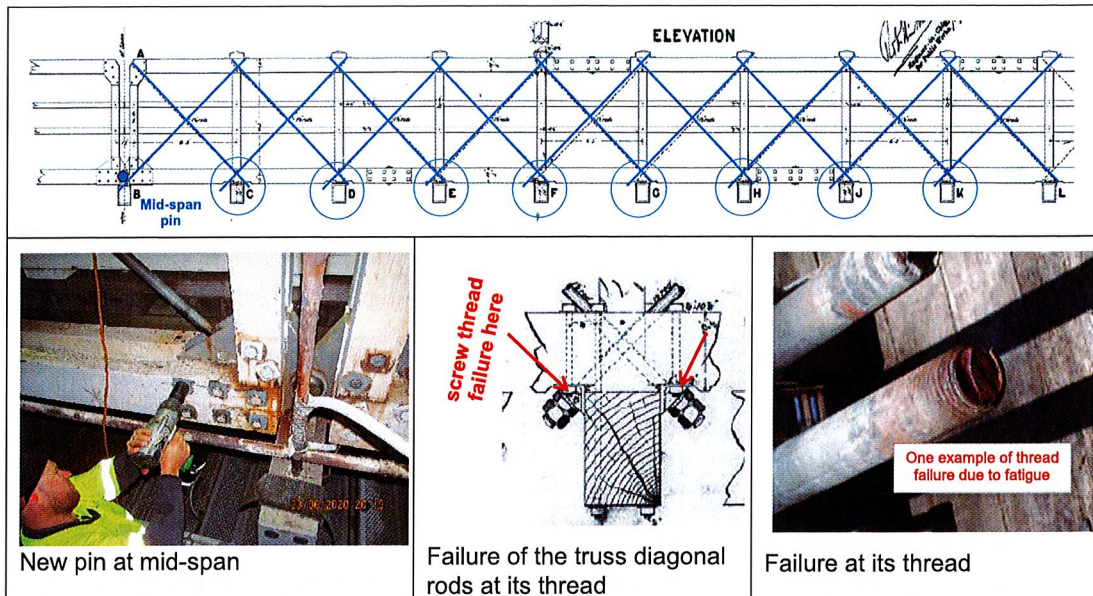
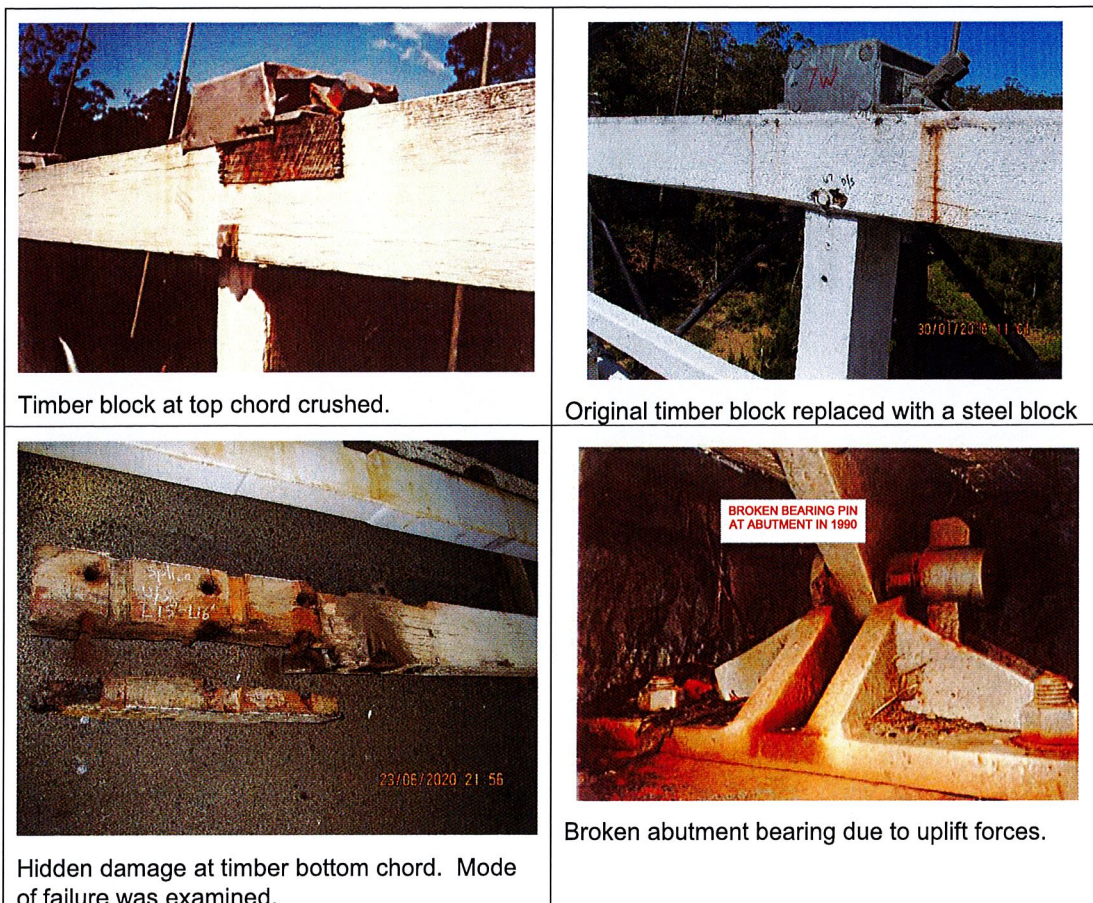
- Timber stringers and cross girders,
- The abutment bearings and the mid-span pin,
- Parts of the top and bottom chords of the timber stiffening truss at splice locations,
- Diagonal rods at the stiffening truss were failing and falling into the river,
- Few hangers were slipping down the main cables.

Some examples of failures are shown in the photographs below.

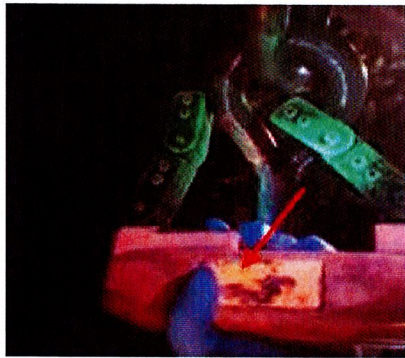
Magnetic Particle test

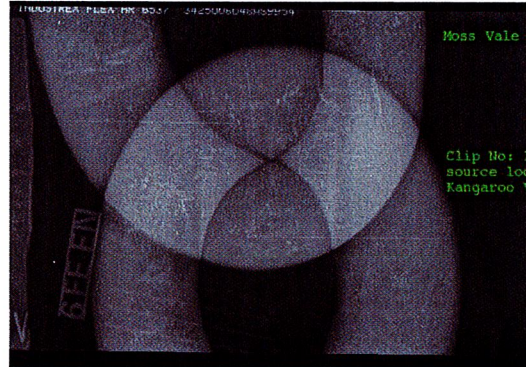
X-ray of one connection

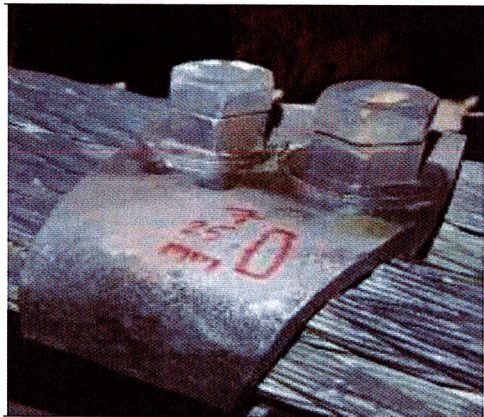
Eddy Current test finding.

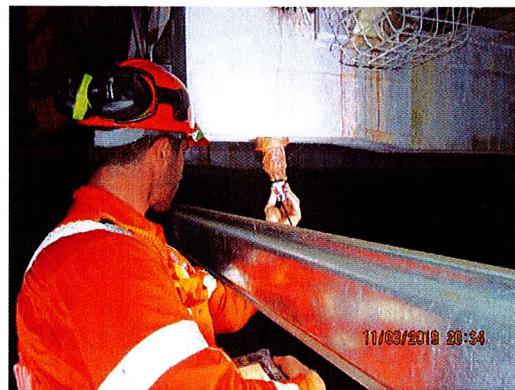
Conducting Ultrasonic test on one hanger

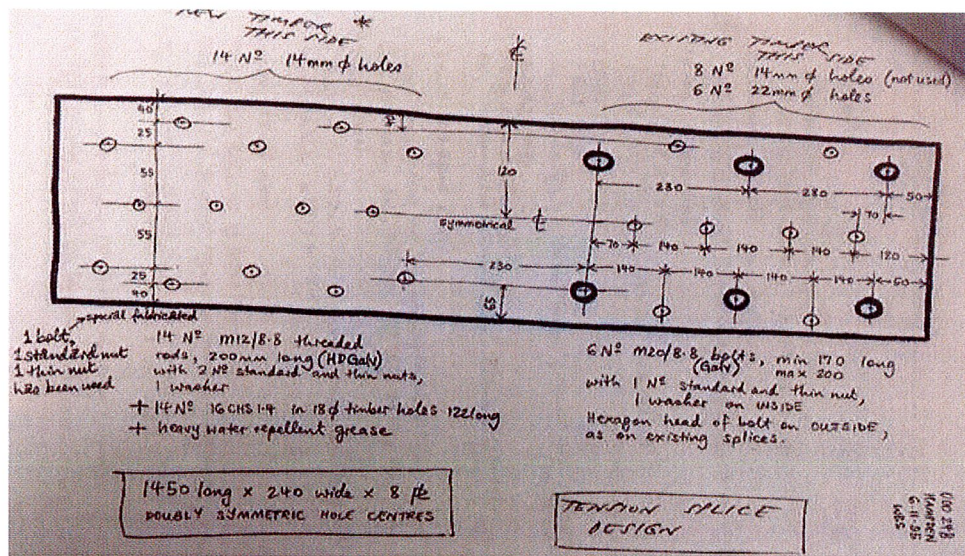
- There is multiple different splice plates and bolting connections installed in the top and bottom chords along the truss. Resulting in Splice connections showing distress and affecting distribution of loads across hangers, also changing over the M12 splice bolts consistently and tightening of diagonal tension rods which causes weakness in the timber chords resulting in tensile failure.
- The original splice plate has shear keys, It appears that shear keys were removed in the new designed splice plate (Ray Taylor design) to prevent section loss in the timber elements which were compensated by a large numbers of small diameter shear connectors (bolt).

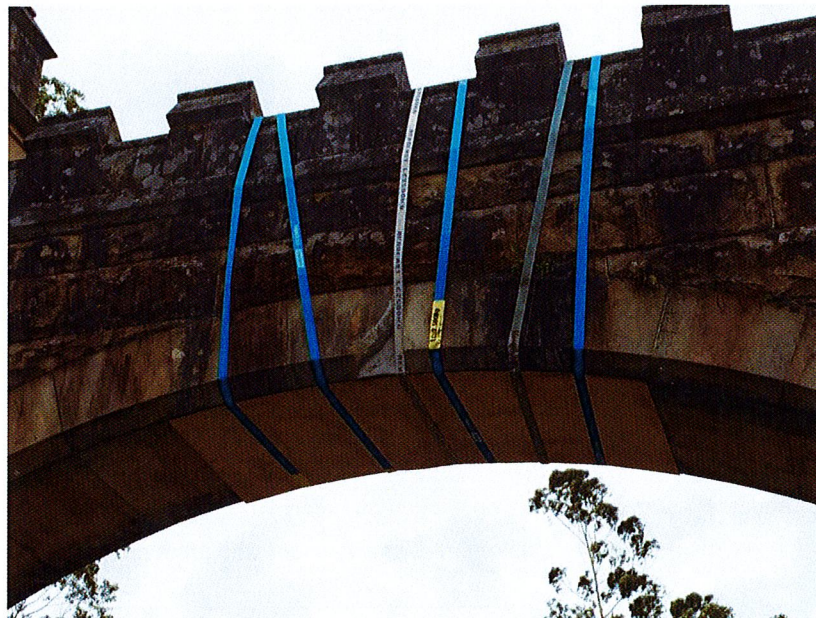
On October 2018 at about 4pm, a southbound (from the Moss Vale side towards the Kangaroo side) truck with an attached loader crane (aka "hi-ab") failed to lower the arm of the crane, which struck the centre of the elliptical arch of the northern suspension tower. The collision caused a piece of the centre dressed masonry to be dislodged and damage to the attached plaque

Strap and plywood sheet

The inspection found that the collision had caused cracks to appear along the interface between the dressed masonry at the bottom of the arch and the quarry faced masonry above. Cracks were also found between the vertical joints of the quarry faced masonry.

A section of standard plywood was strapped to the underside of the arch with six 2.5 tonne capacity straps to support the concrete patch and minimise the falling of any small debris.

A remedial solution was adopted by installing four tie rods (two at front, two at rear) x 316 grade stainless steel 16mm diameter into the 20mm drilled holes, these tie rods were mechanically attached top and bottom with 50mm stainless steel washers and nuts set inside stone surface. These were rebated and chemset into the existing stone and the drill hole were patched with colour matched mortar.
