## **INQUIRY INTO WINDSOR BRIDGE REPLACEMENT PROJECT**

**Supplementary  
Submission  
No 114b**

**From:** Peter Nicholson  
**Sent:** Thursday, 19 April 2018 6:09 PM  
**To:** Portfolio Committee 5  
**Subject:** Windsor Bridge project

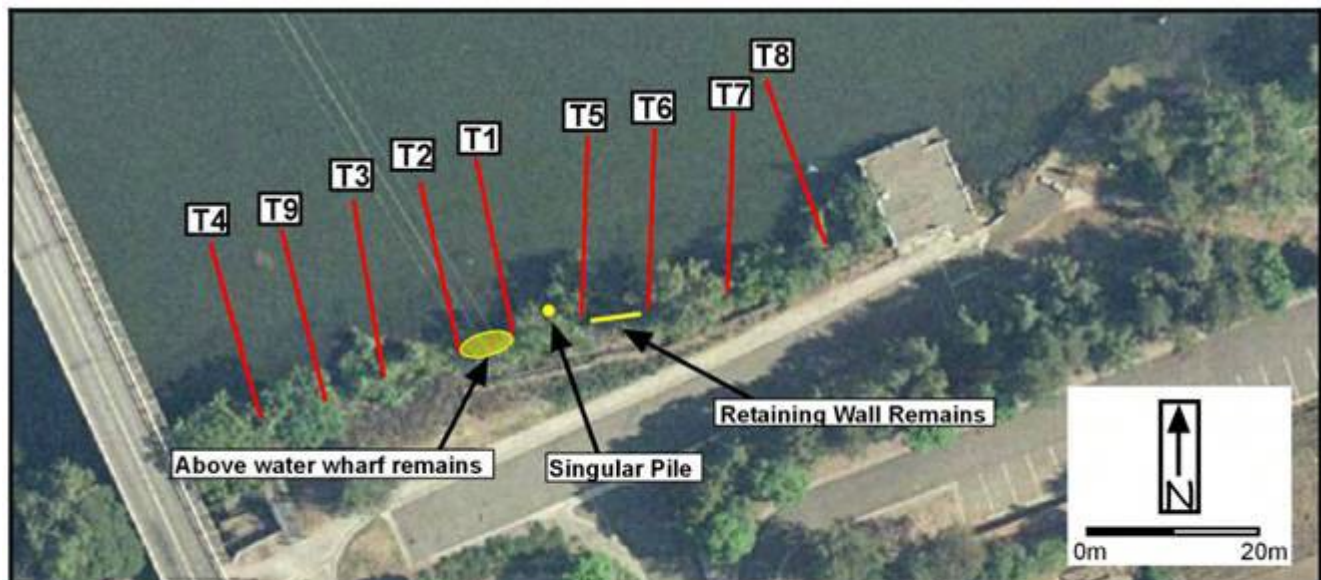
**Figure 6: Location of the recorded above water features.**

Note Figure 6 shows the "old" wharf which was replaced with the current wharf in 2014 according to the SCMP.

While the identified remains are still in situ, the area between T4 and T2 in Figure 6 has been found to contain further remains including the end point of the brick barrel drain, and additional piles have been located within the "above water wharf remains" between T2 and T1. These additional "finds" were easily visible once the vegetation was removed.

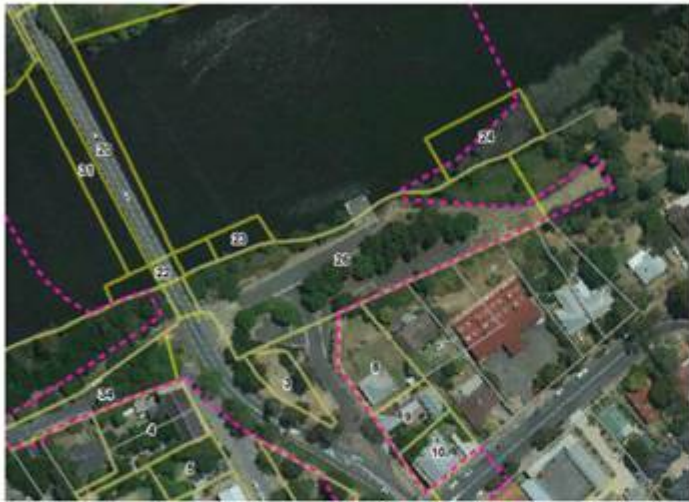
<b>Map:</b> Detail of Figure 3. The location of the wharf is shown as 23 on the plan.	
<b>Condition:</b>	<b>Integrity:</b>	<b>Current Use:</b> describe use	
<b>No statutory heritage listings</b>			
<b>Level of Significance:</b>	State: ✓	Local: ✓	Assessed: ✓ Potential: ✓
<b>Statement of Significance:</b>

Oddly, this is the area that contains the additional remains.

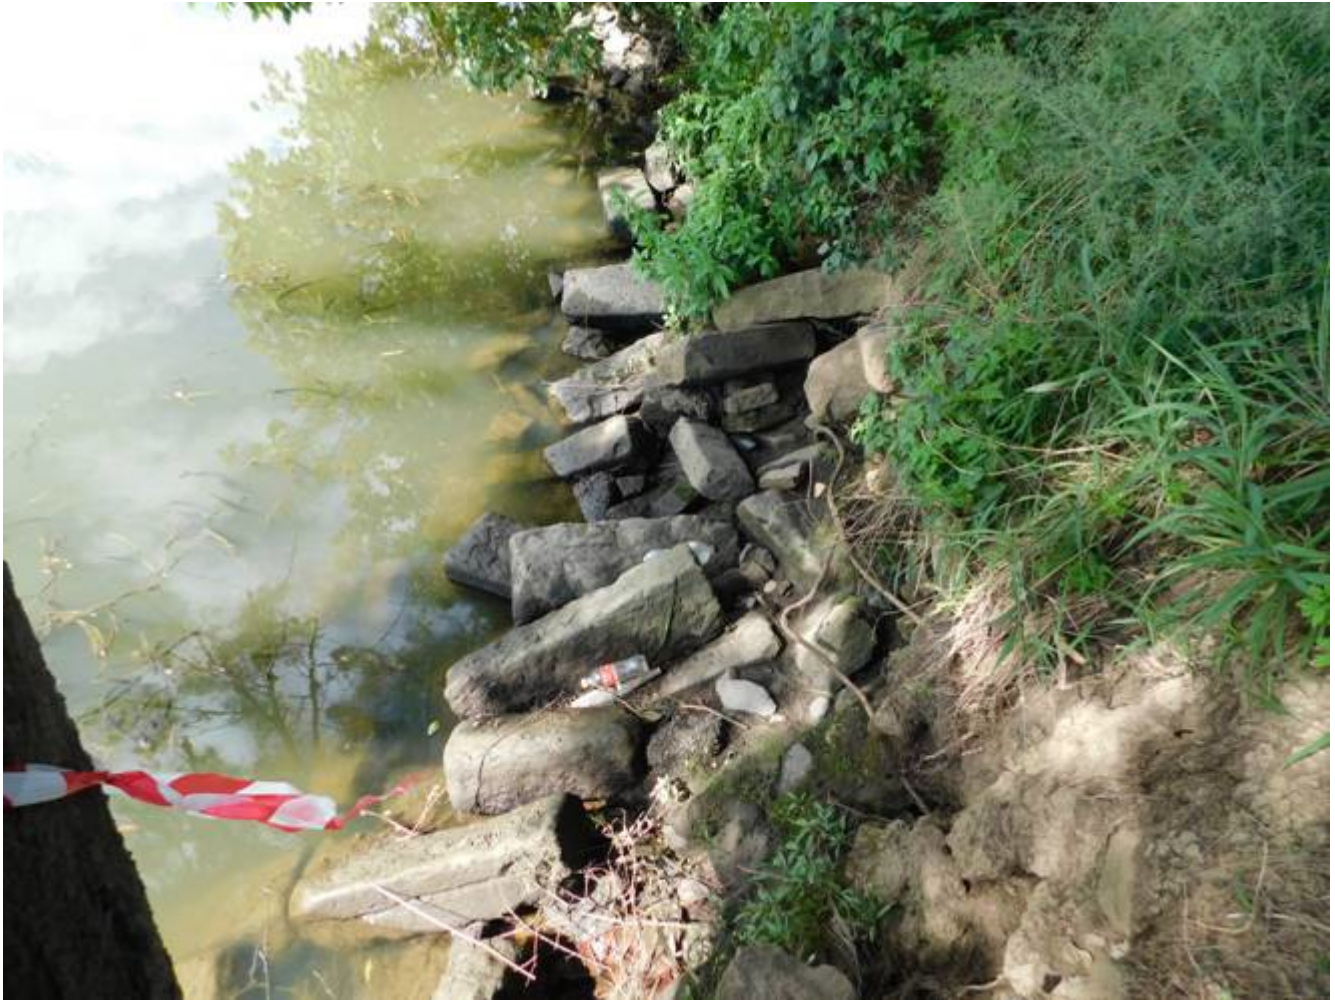
Photo 1. This rubble appears to be sandstone and may have been kerbing removed in the construction of Windsor Mall. It is located immediately east of the end of the retaining wall.

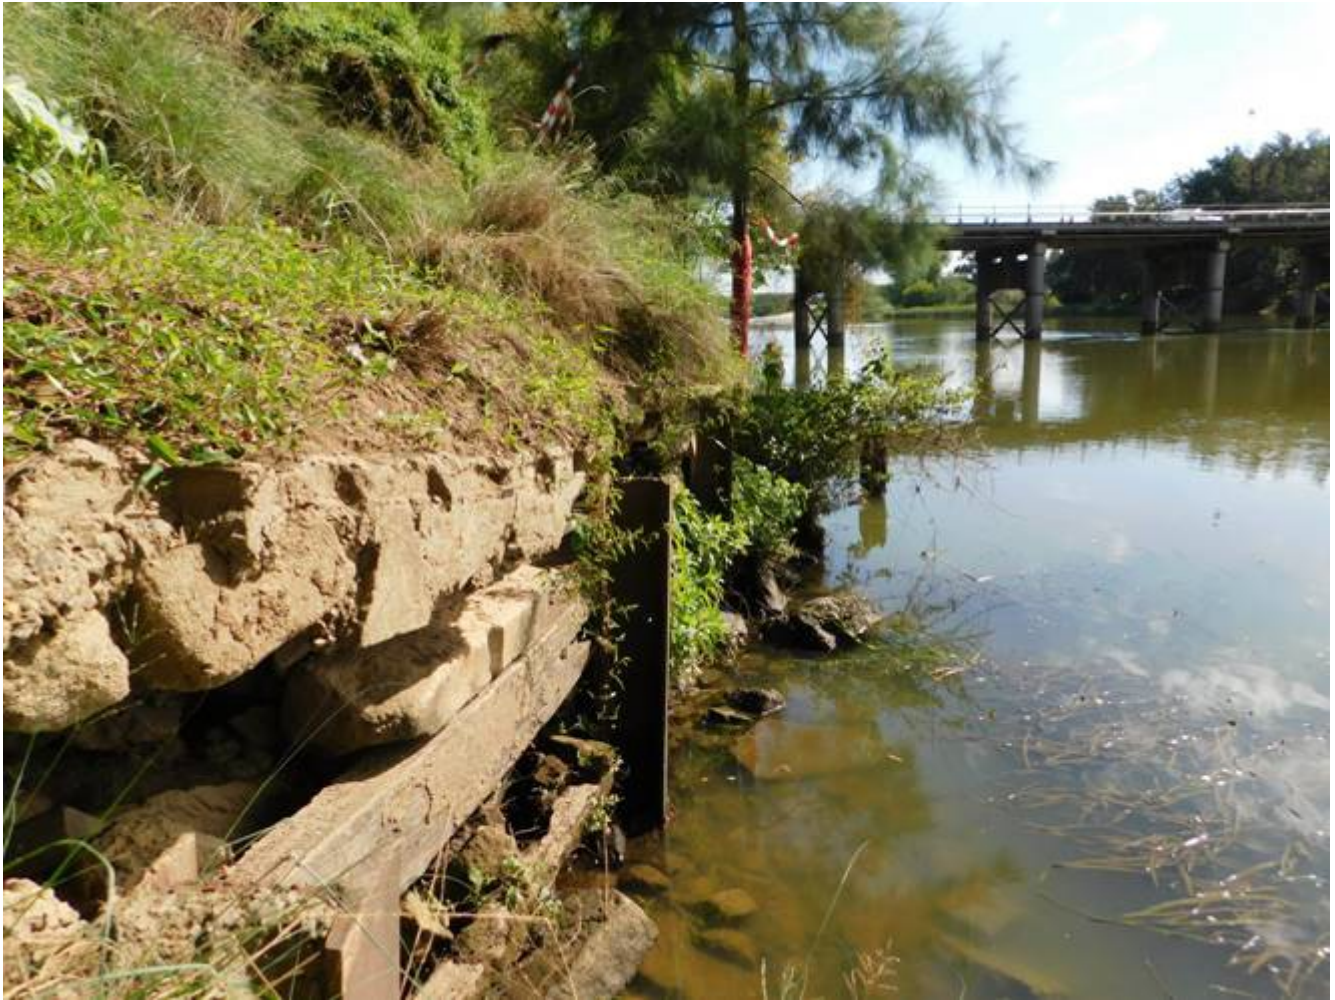
Photo 2. The remains of the retaining wall identified by Cosmos Archaeology. Cleared of vegetation 20/2/2018.

Cosmos described the retaining wall as “The retaining wall consisted of two iron girders 2 m apart with two timber cross pieces. The iron girders are square in shape and stand 1.5 m above the riverbank, and are 0.20 m wide. The two timber cross pieces are approximately 2.5 m long x 0.30 m wide and 0.11m thick, and are spaced close together. Material behind the wall consists of dressed sandstone blocks, bricks and broken up concrete deposited onto up the riverbank. A concrete cap has been placed over the top of the fill at one stage, possibly to create a surface or to contain the backfilled material.

This is blatantly incorrect as 3 posts are clearly visible, and they are I-beams or RSJ's, not square..

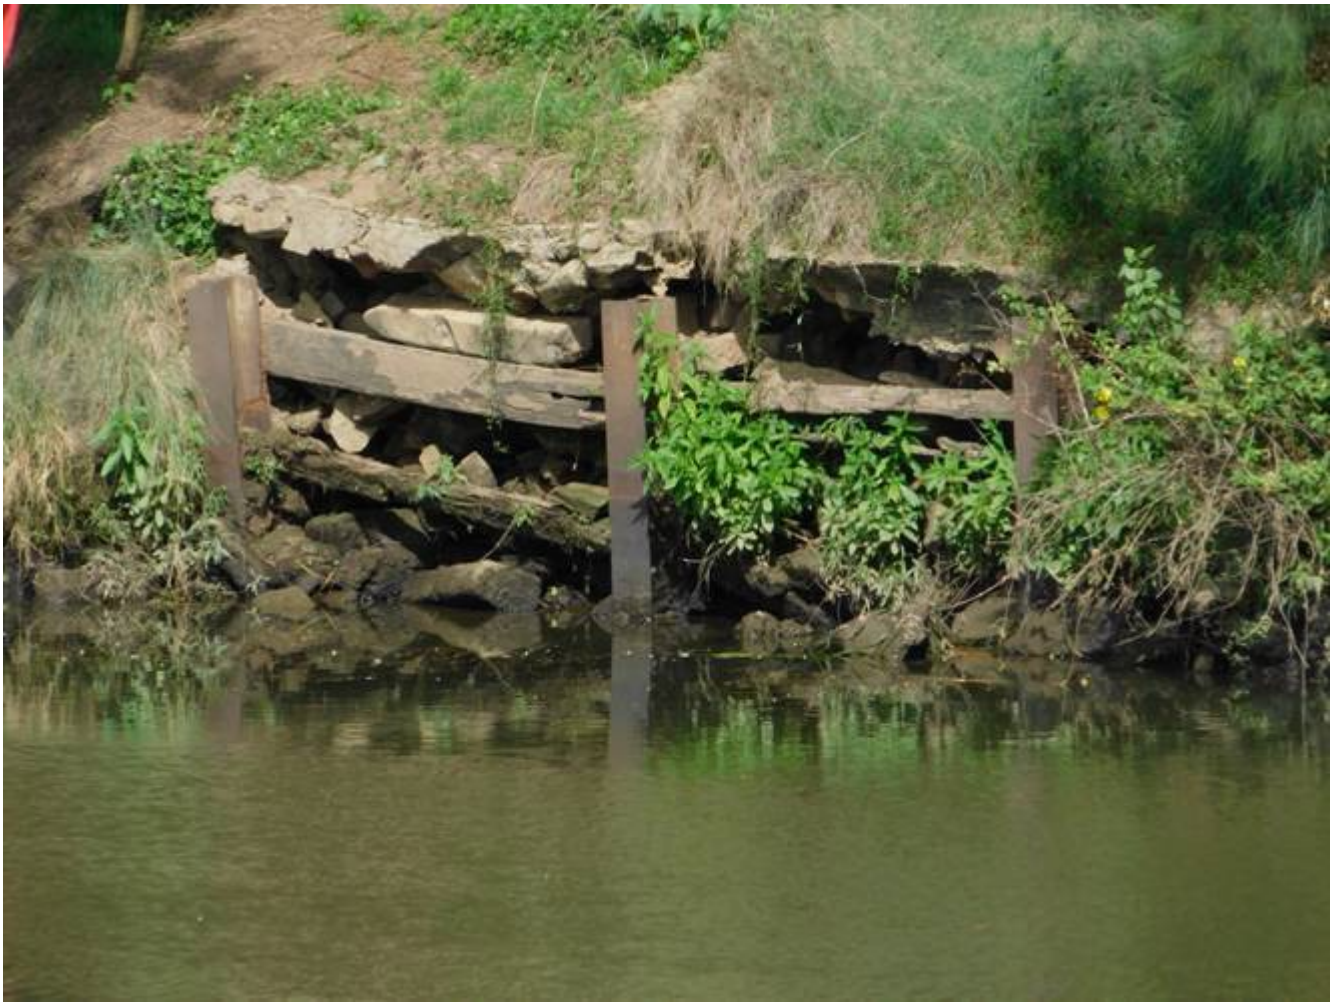
Photo 2a. The retaining wall viewed from the northern bank, showing the concrete capping

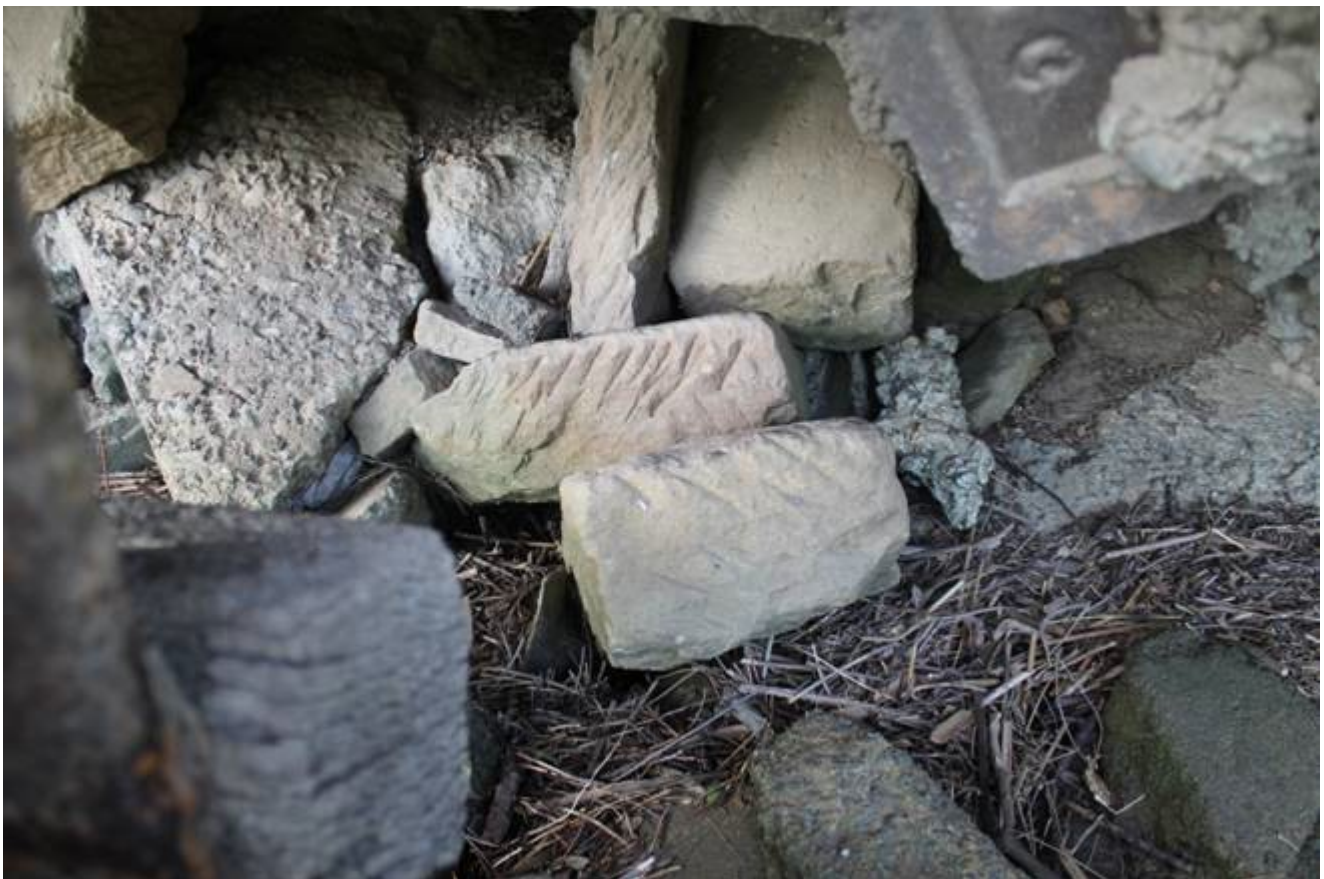
Photo 2b showing sandstone under the concrete capping. Most bricks under capping are frogged PBC but source and age unknown to date.

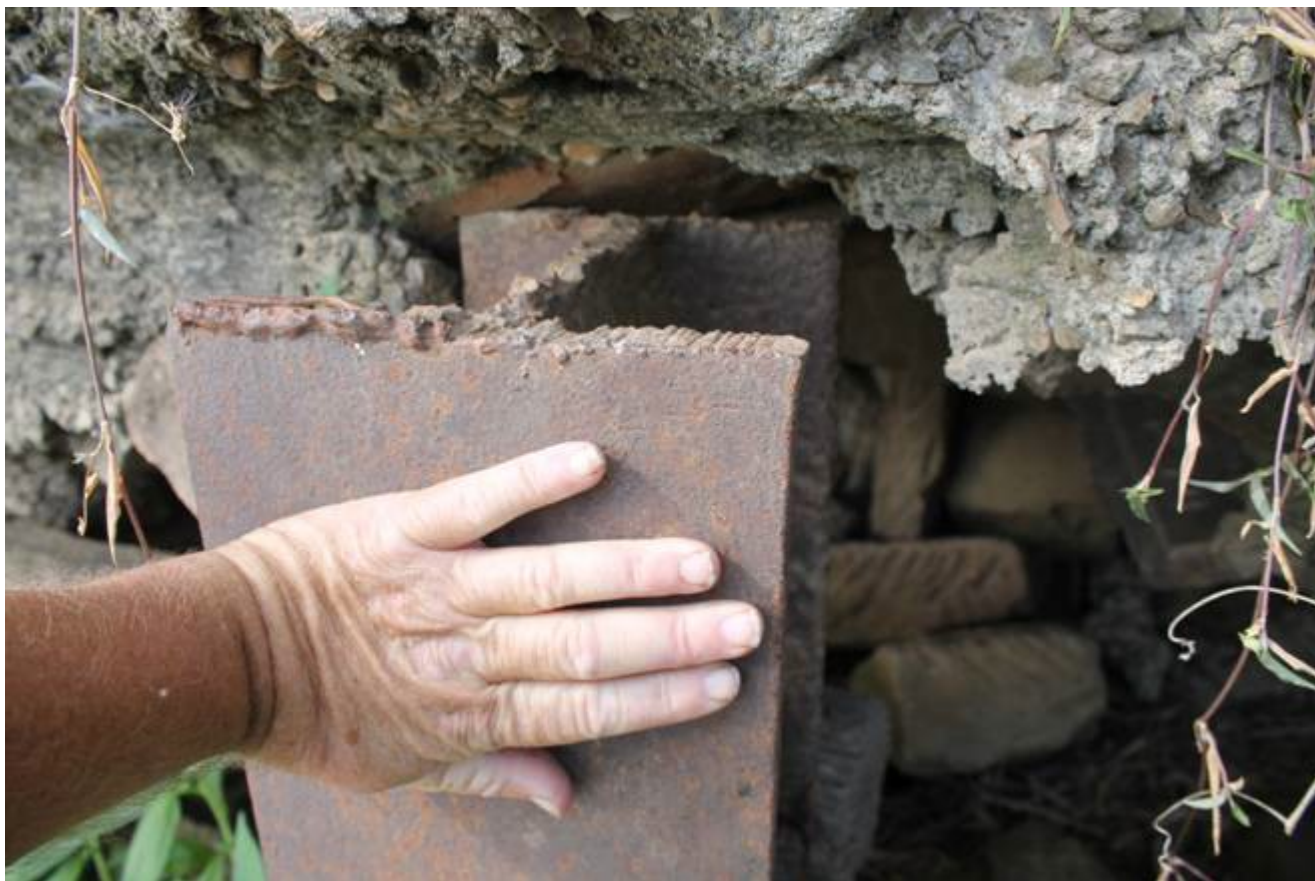
Photo 2c. Beams holding retaining wall are 20cm wide, clearly not square.

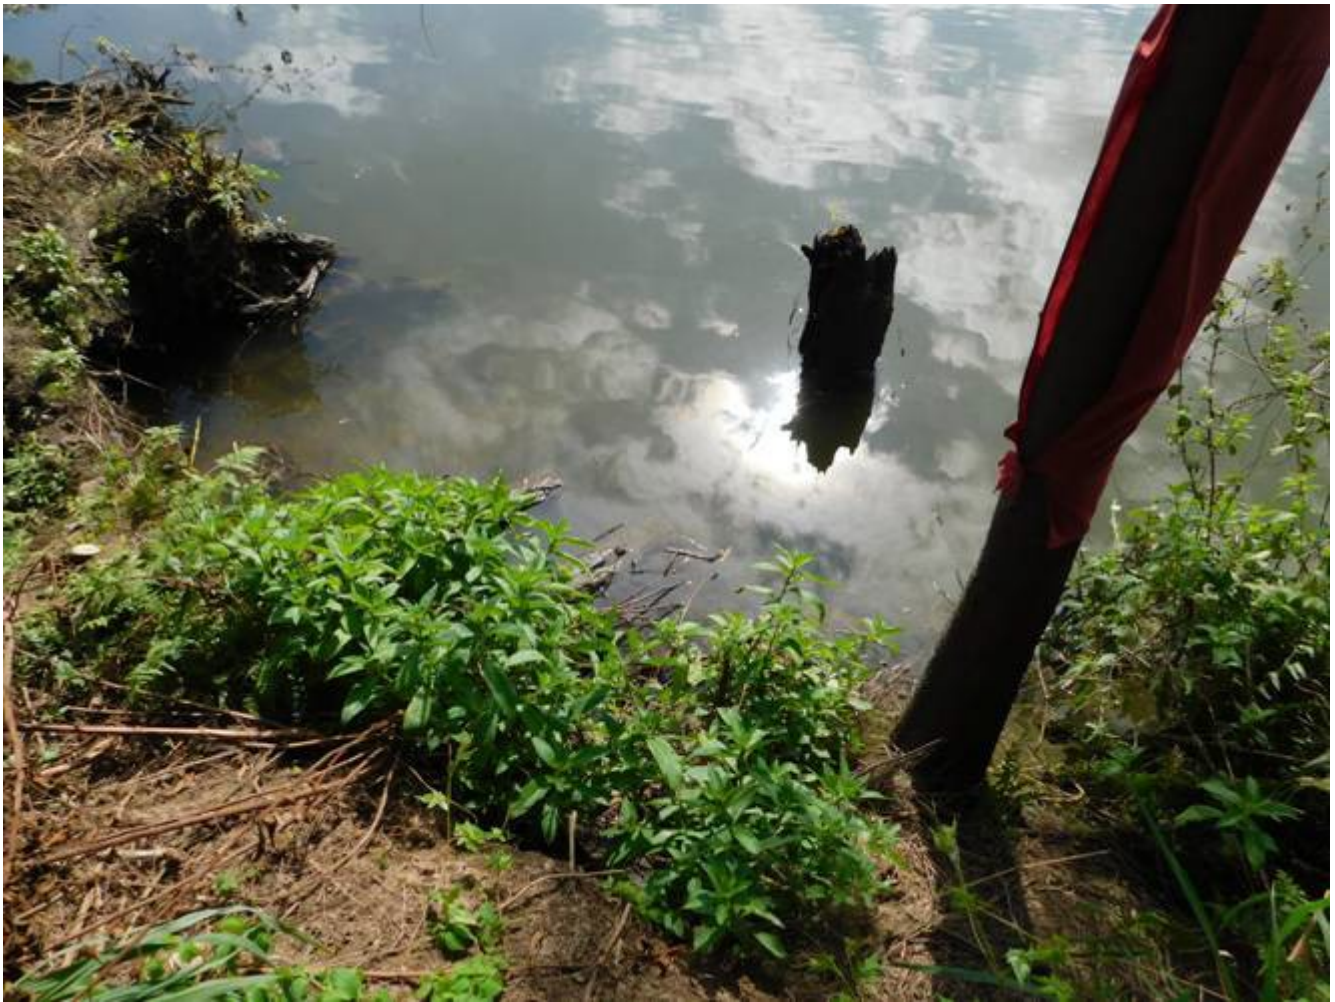
Photo 3. The solitary pile identified by Cosmos Archaeology

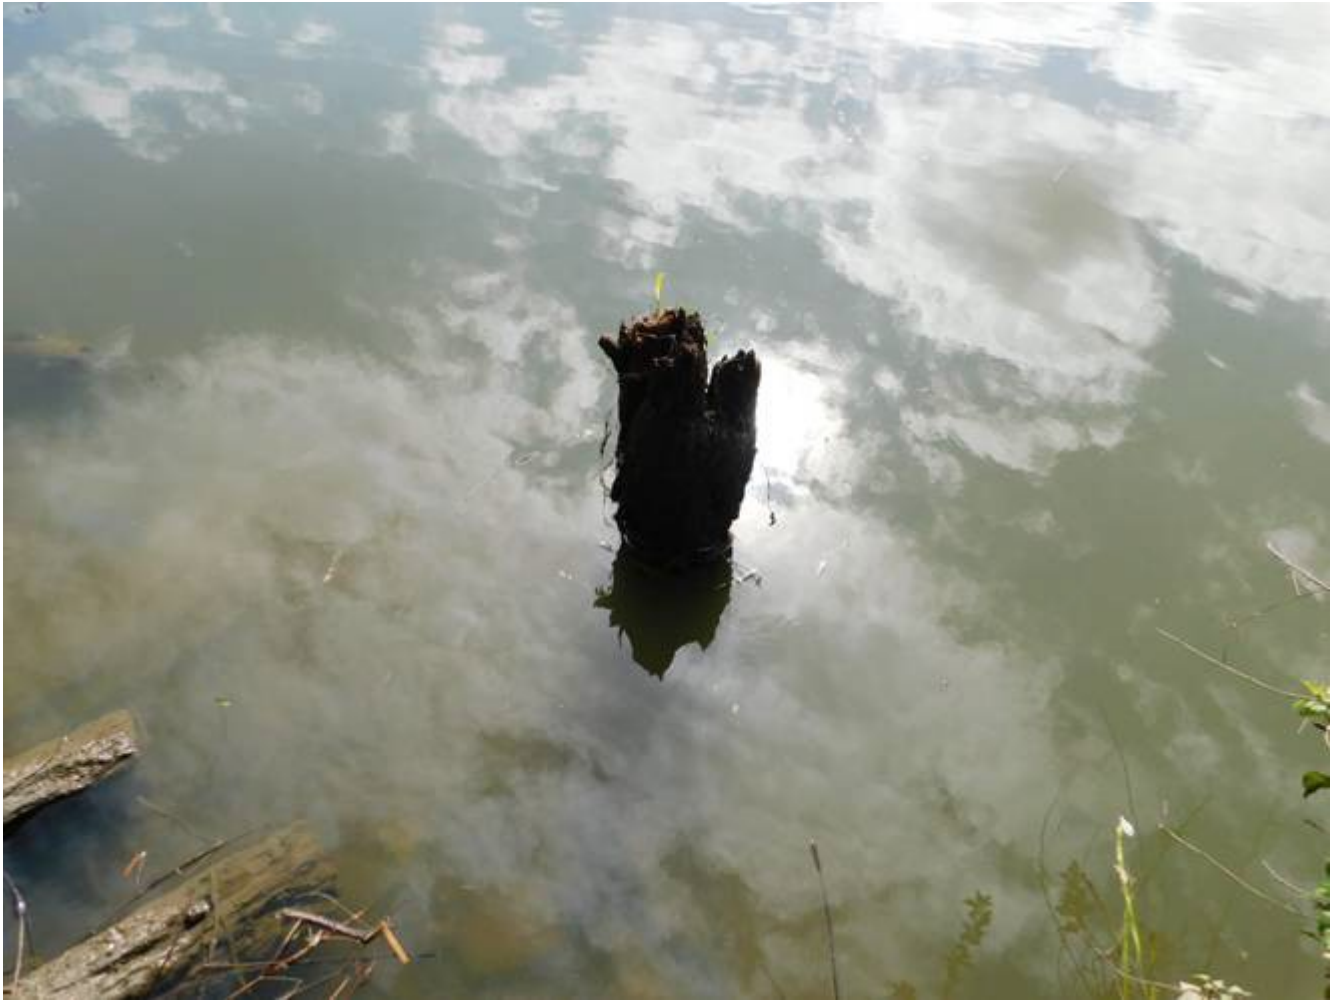
Photo 4. Two walers protruding from the riverbank toward the “solitary pile”.

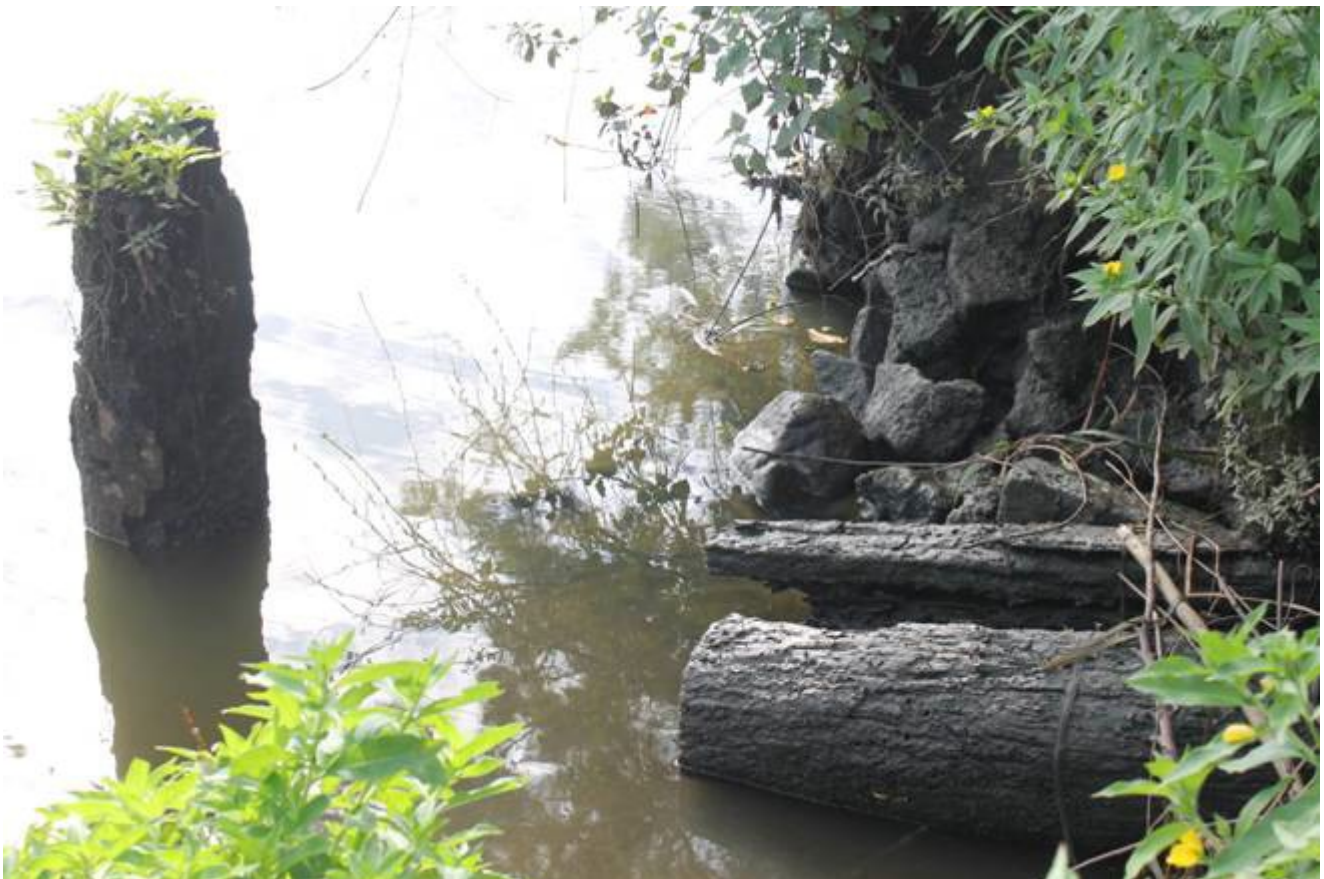
Photo 4a. The 2 walers near the solitary pile.

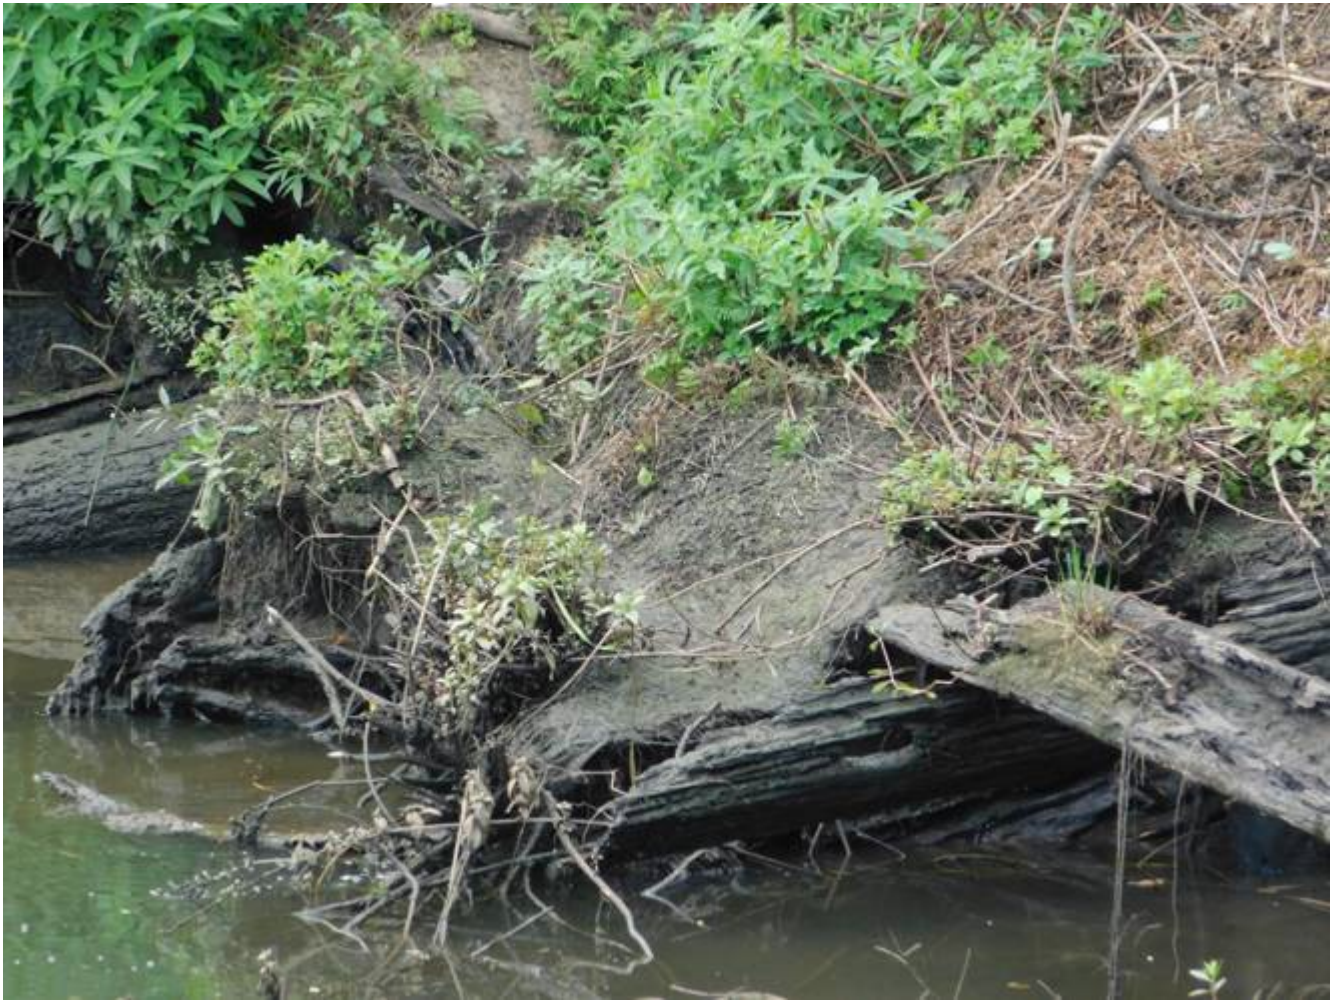
Photo 5. Shows the two walers in Photo 4 on the left, to the east of the “above water wharf remains” on the right.

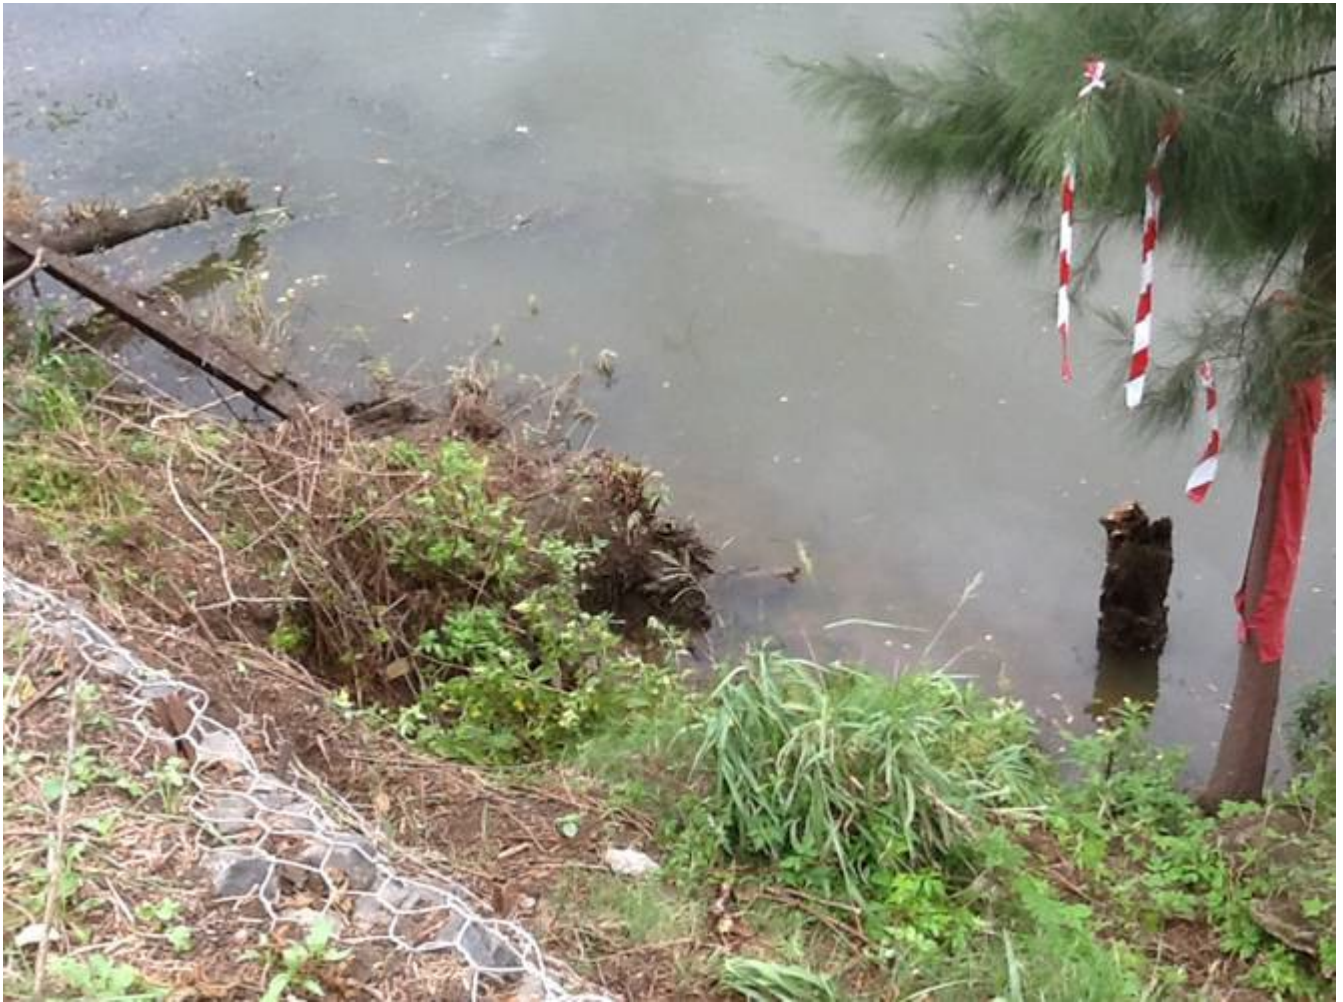
Photo 5a 22/3/2018. Shows proximity of wharf remains to solitary pile.

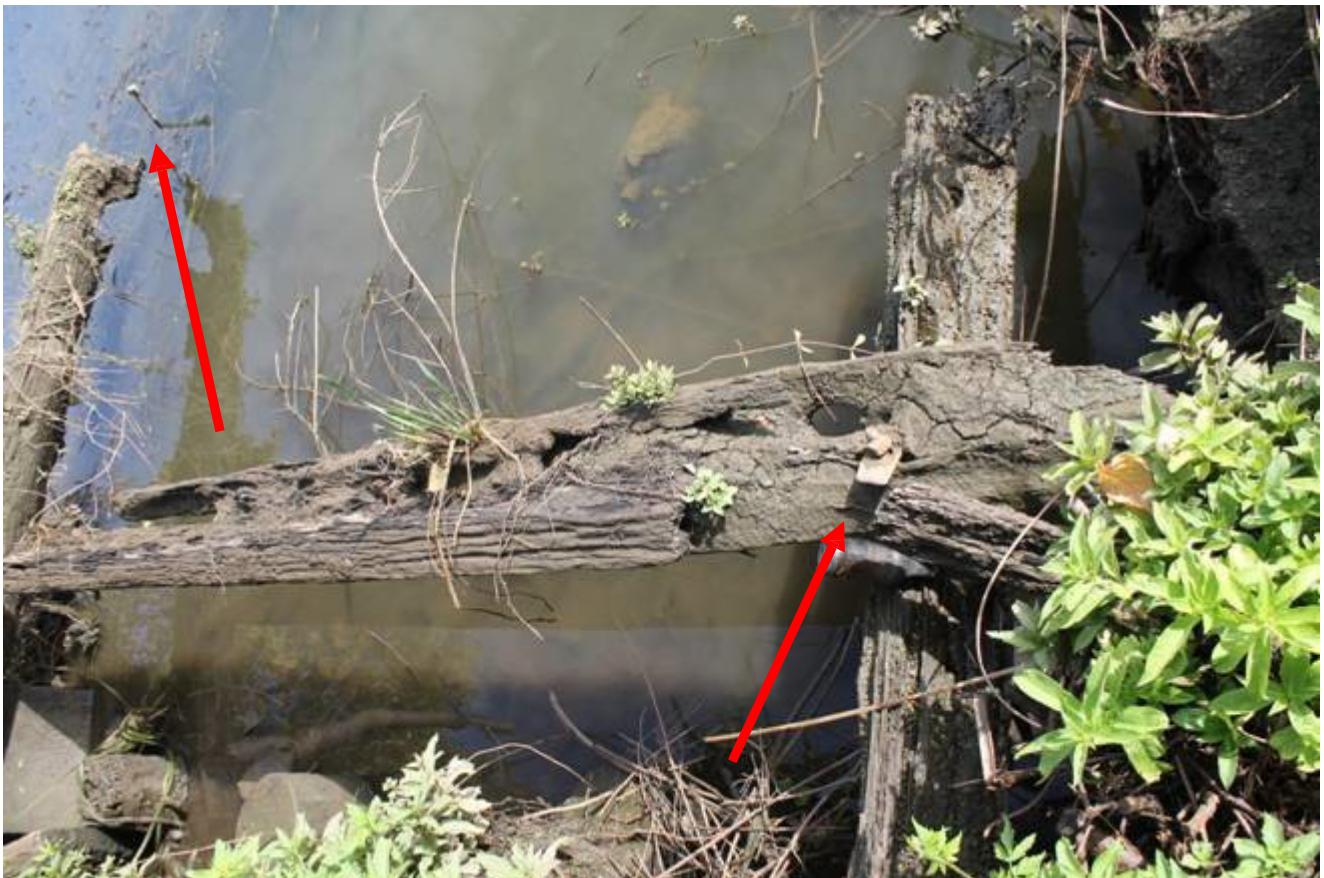
Photo 6. Above water remains showing 2 iron fasteners (and a beer bottle).

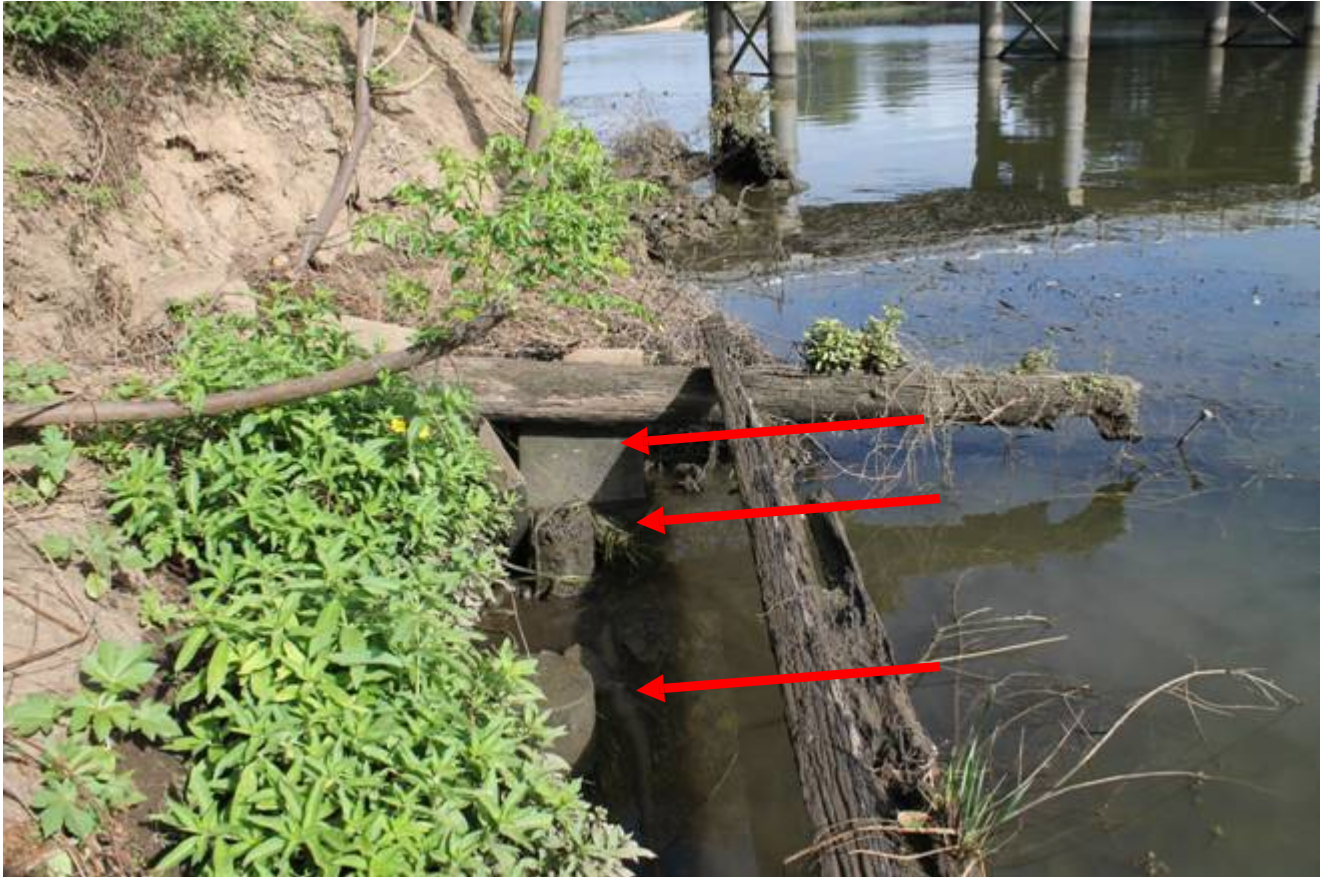
Photo 6a showing 2 piles spaced 3 feet apart as per contract, and sandstone slab between walers. There are 2 other sandstone slabs buried under the pile of weeds at the west adjacent to these remains (top end of picture)

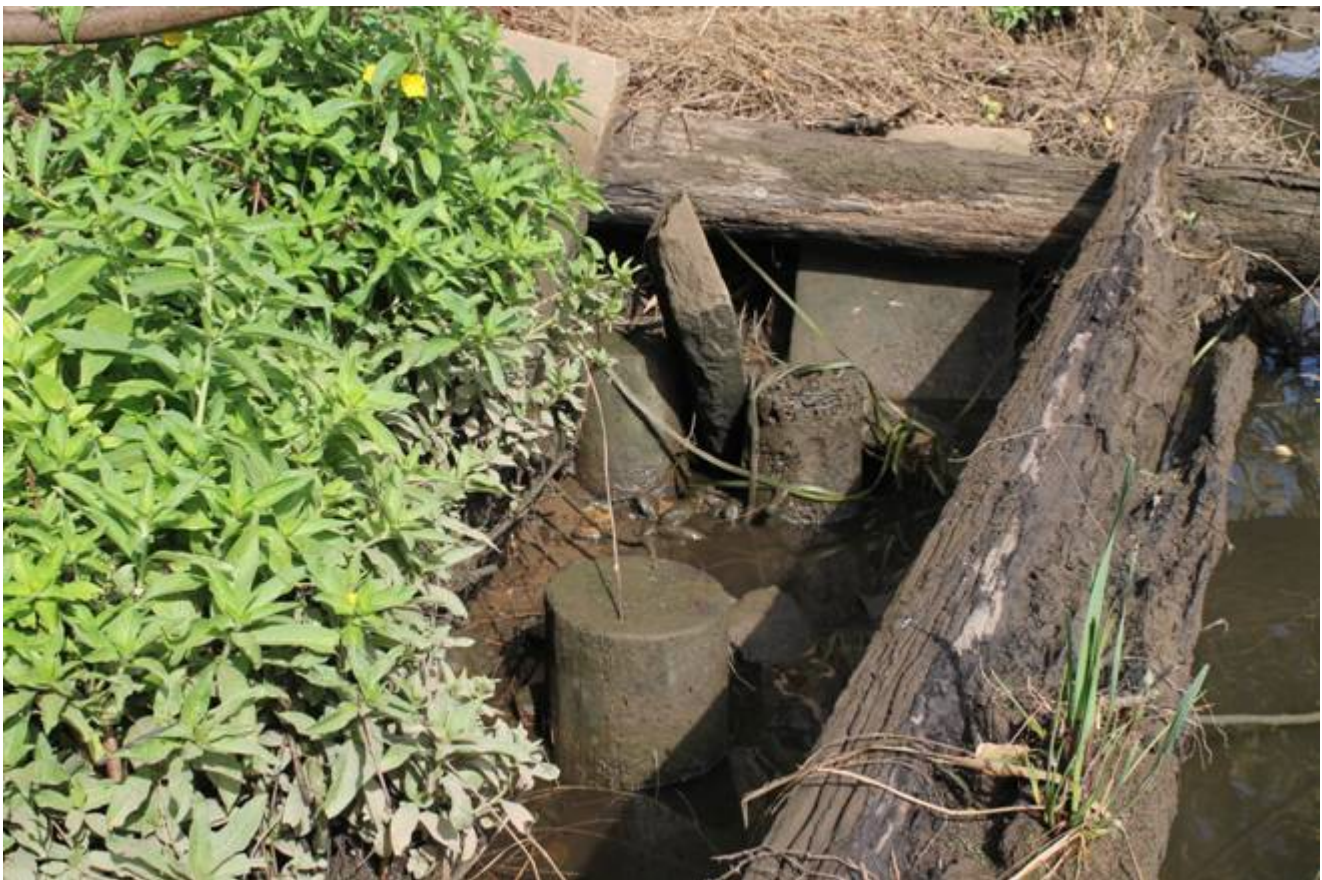
Photo 6b showing closer shot of piles (third now visible). These piles were not mentioned by Cosmos.

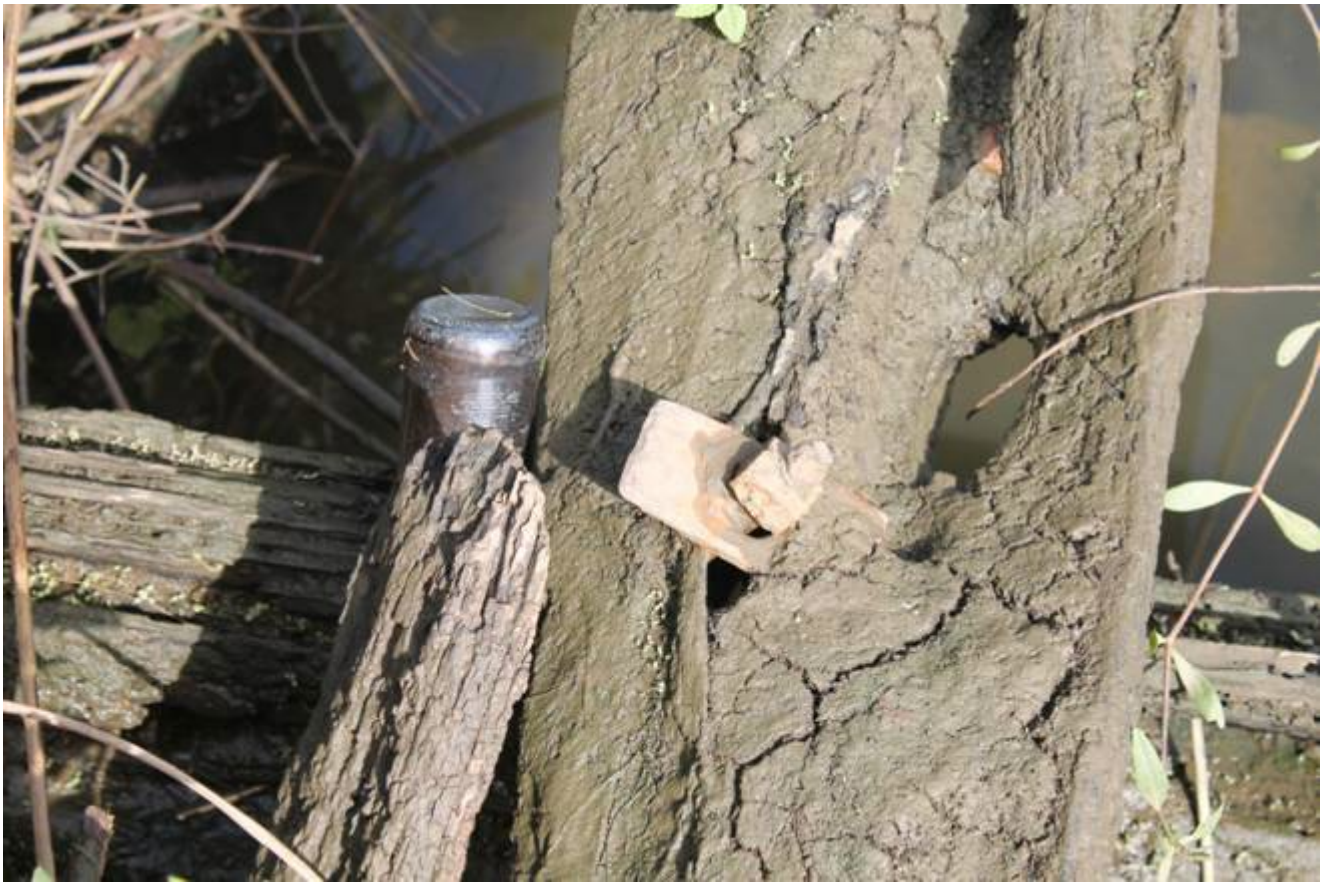
Photo 6c closer image of iron fastener through Waler and beam

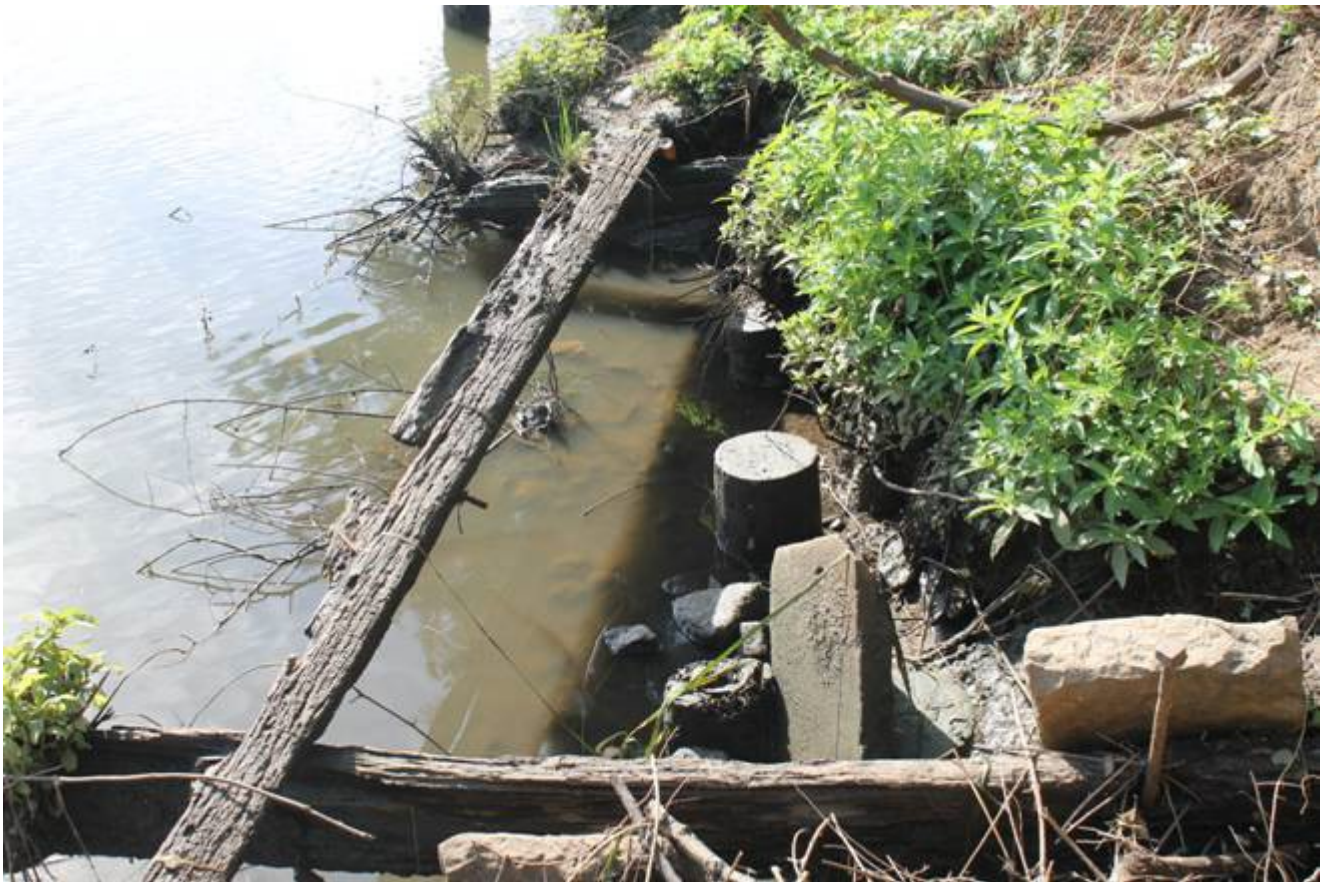
Photo 6d. Additional sandstone slabs now visible and 3 piles clearly shown.

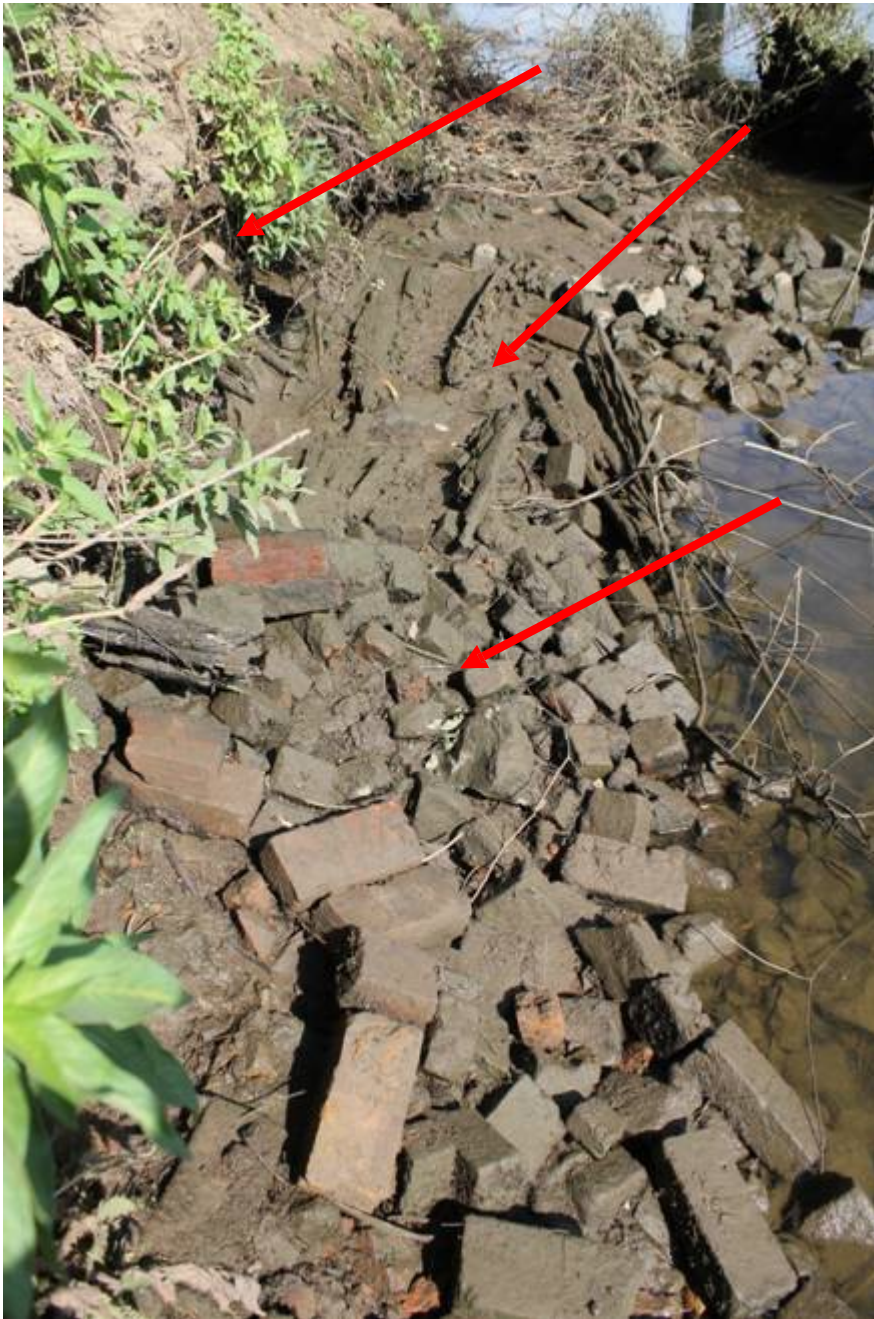
Photo 7. Bricks consistent with barrel drain, wharf deck timbers and an iron fastener, to the west of the above water wharf remains. Most of this is visible only at low tide. Brick position consistent with estimated drain outlet.

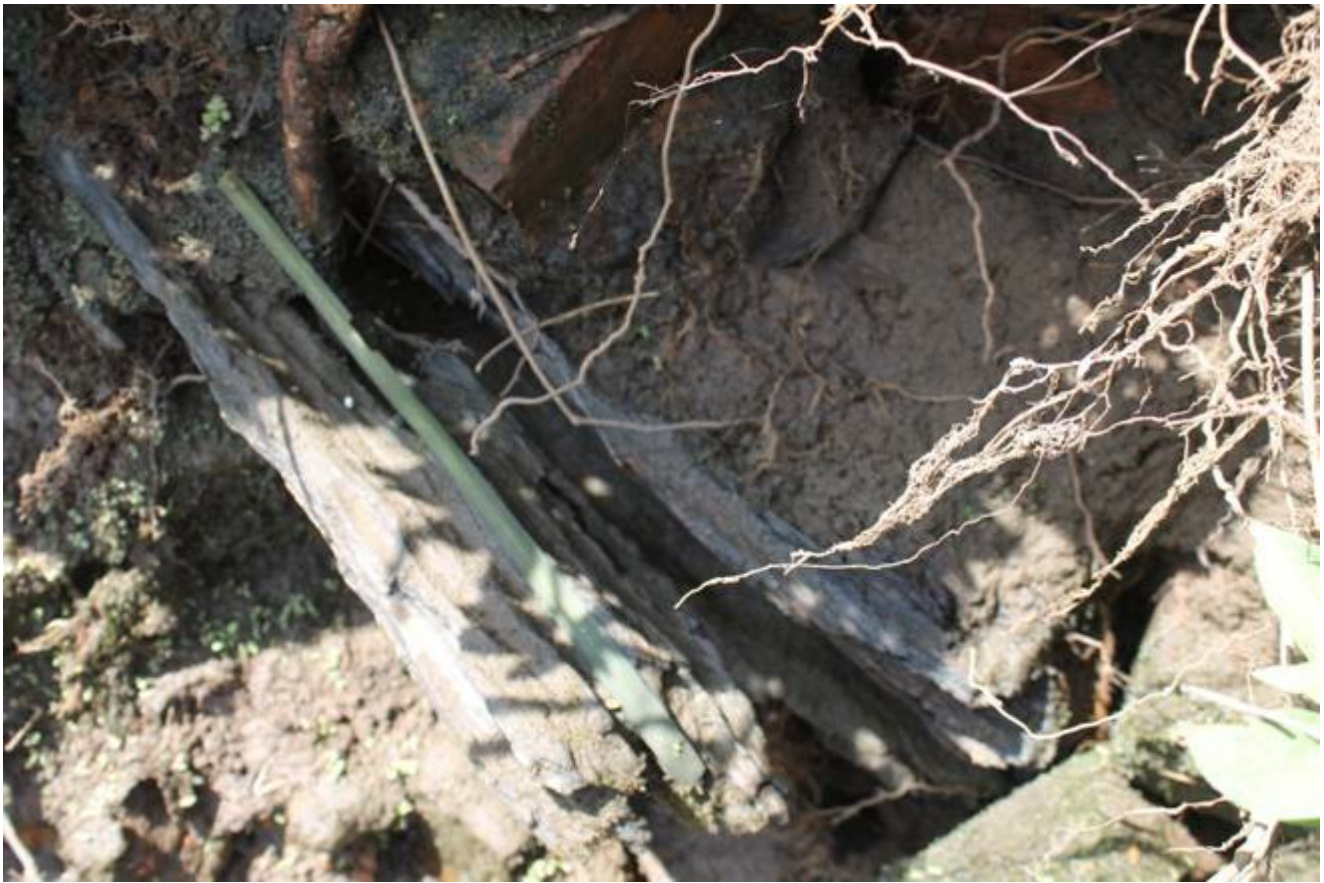
Photo 7a. Wharf timber embedded in river bank.
