## **INQUIRY INTO WINDSOR BRIDGE REPLACEMENT PROJECT**

**Supplementary  
Submission  
No 114b**

**From:** Peter Nicholson  
**Sent:** Thursday, 19 April 2018 6:09 PM  
**To:** Portfolio Committee 5  
**Subject:** Windsor Bridge project

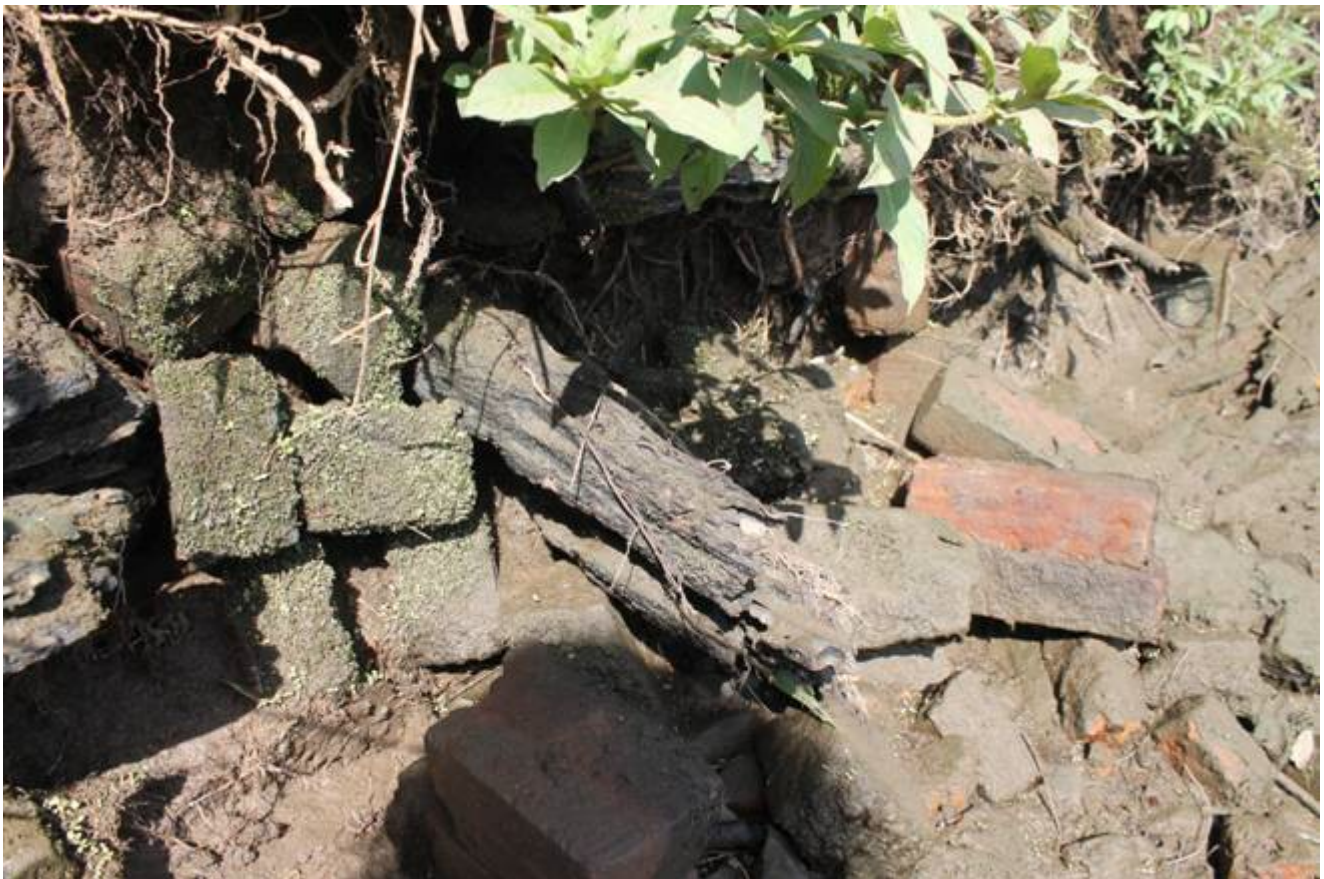
Photo 7b. Wharf timbers and bricks embedded in riverbank. All bricks unfrosted.

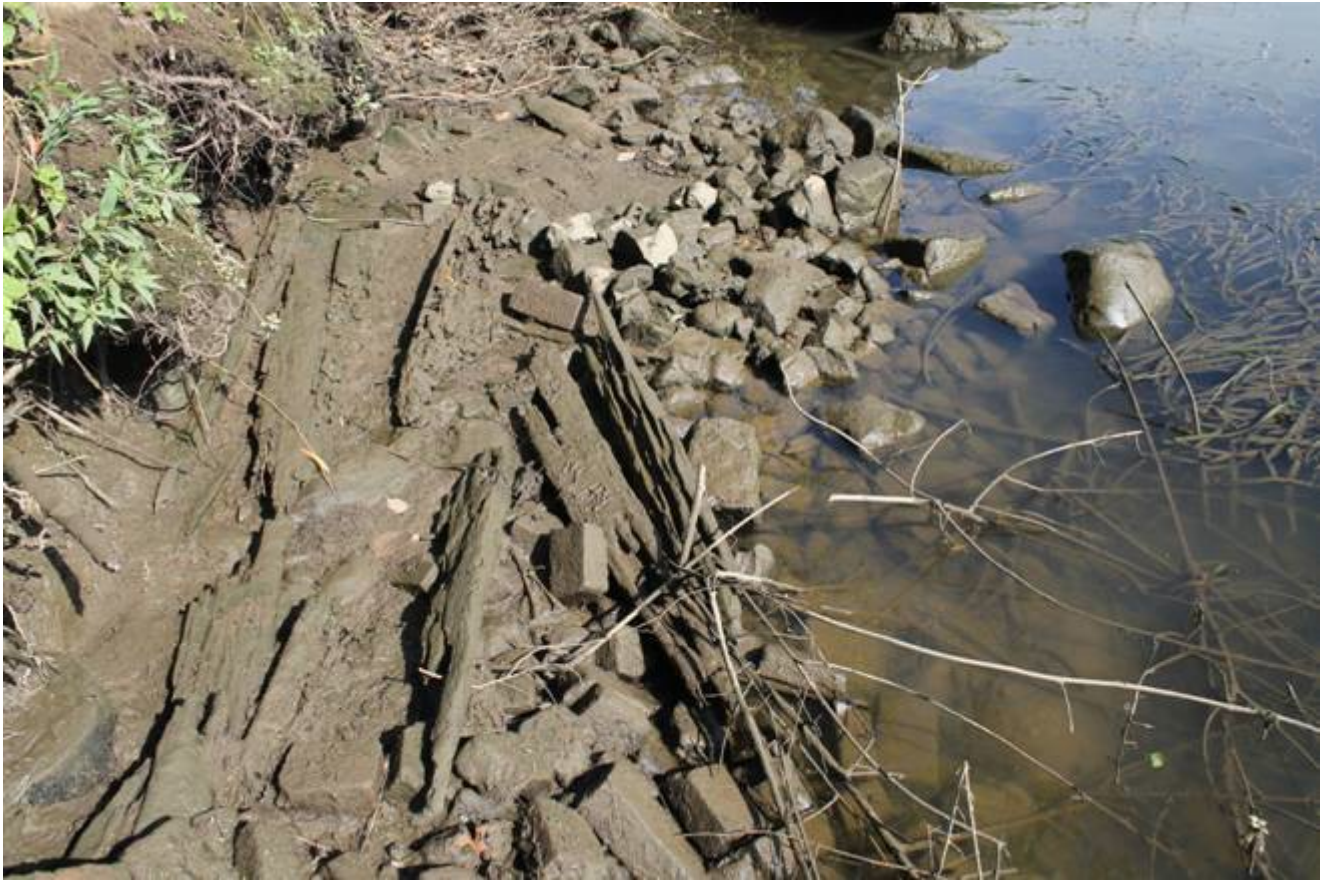
Photo 7c. Wharf deck timbers on river bed. Remains of a beam are contained in the bank.

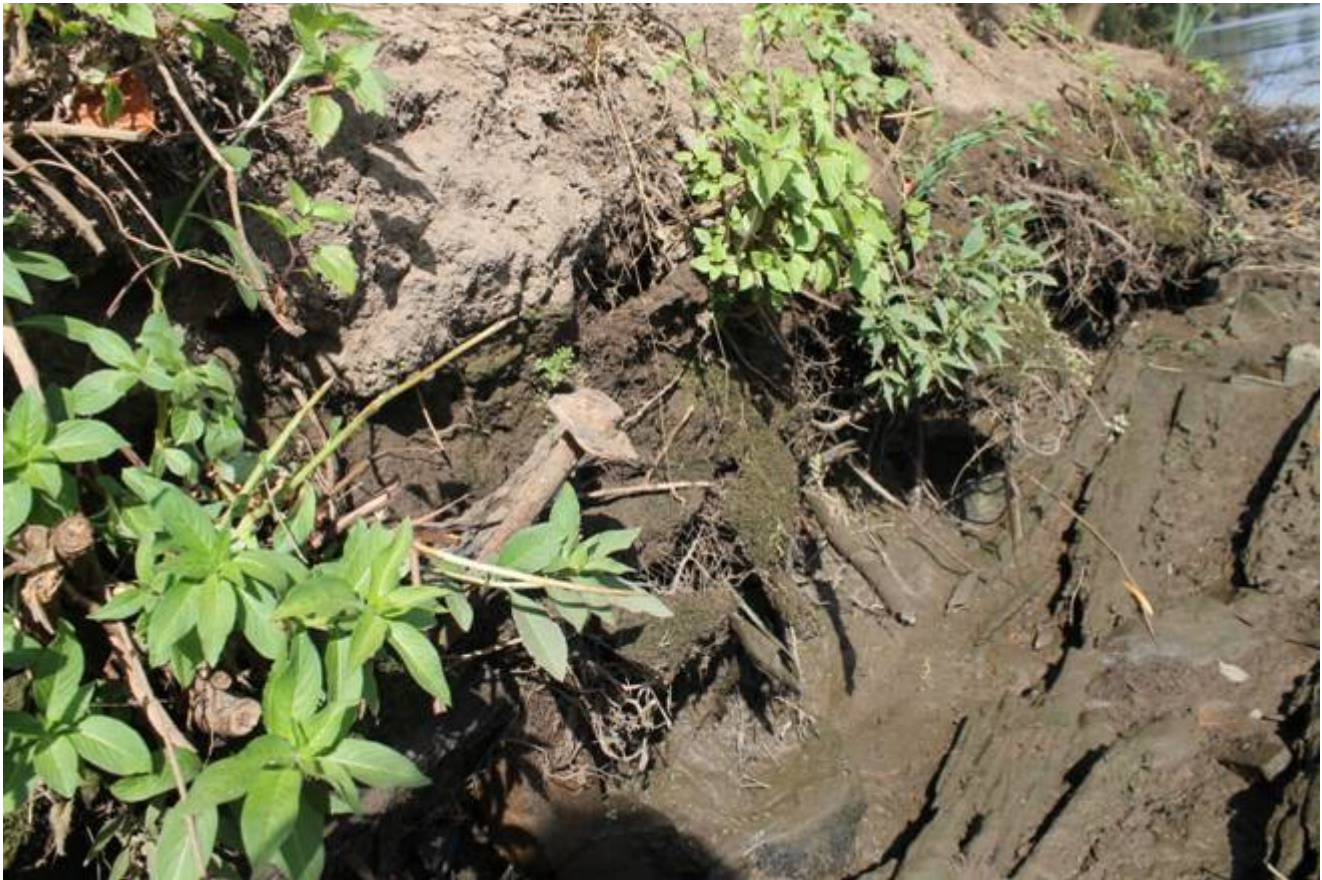
Photo 7d. Iron fastener in remains of beam in bank.

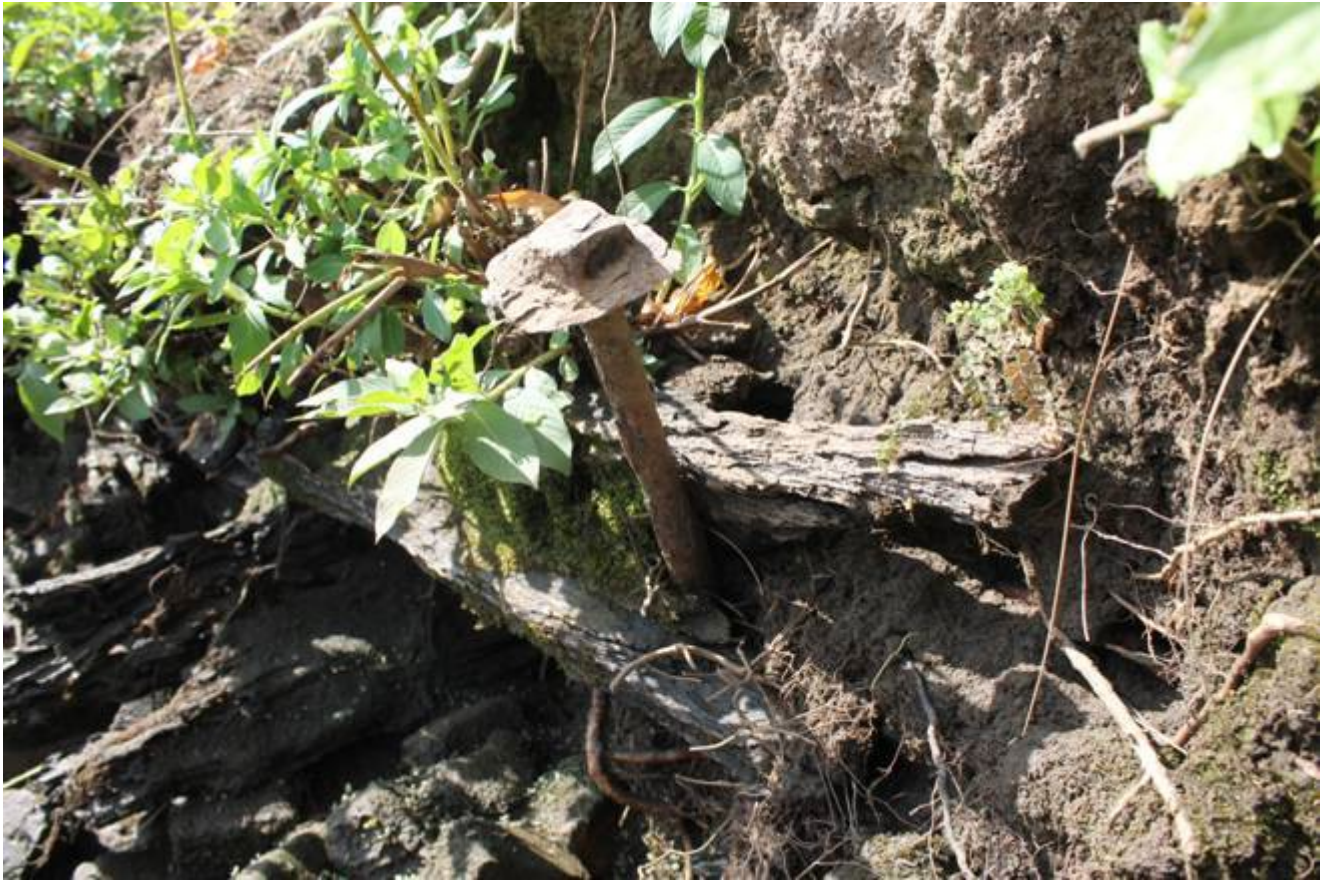
Photo 7e. Iron fastener in remains of beam in bank.

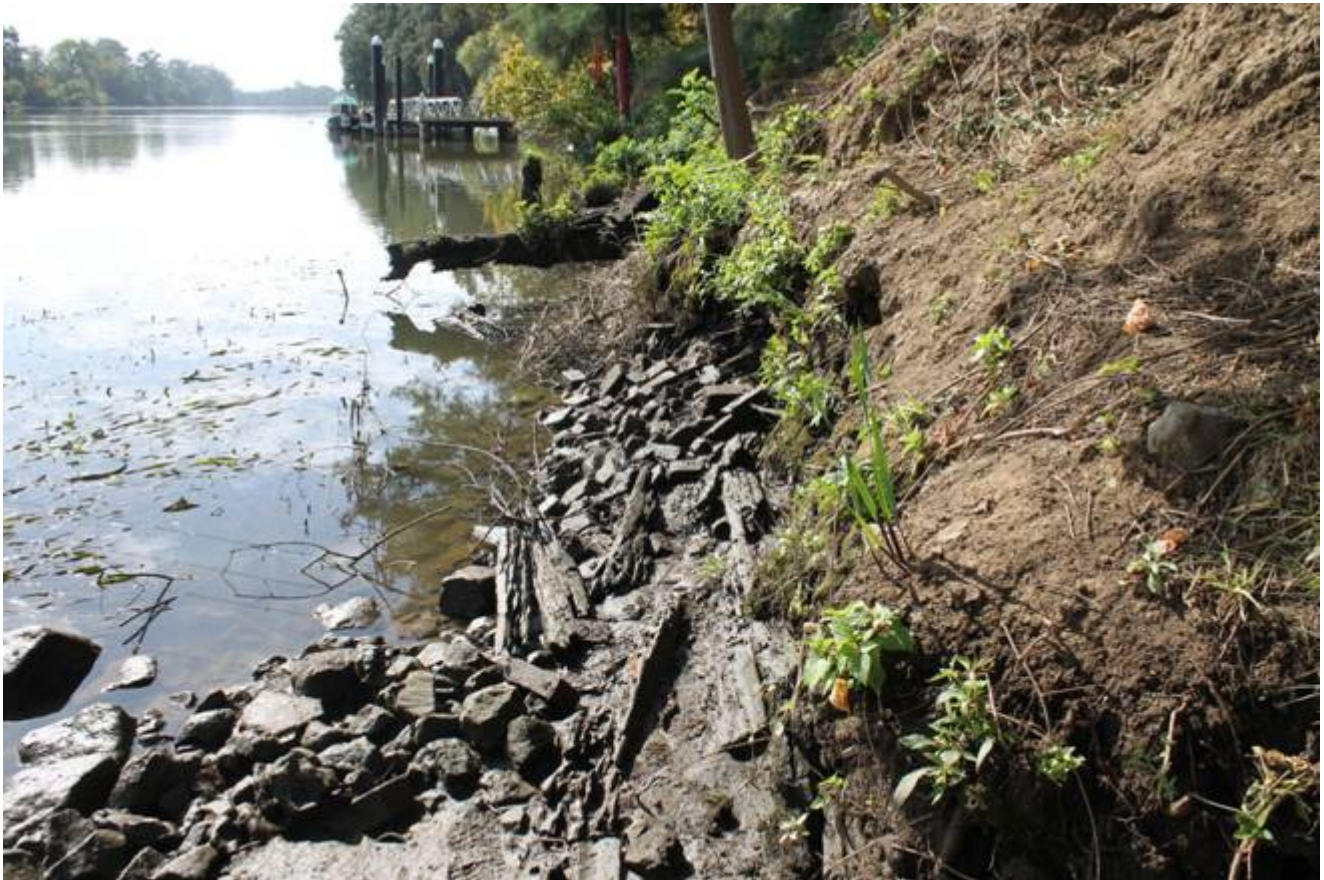
Photo 7f showing proximity to new wharf to east. The above water remains are central with the solitary pile just above.

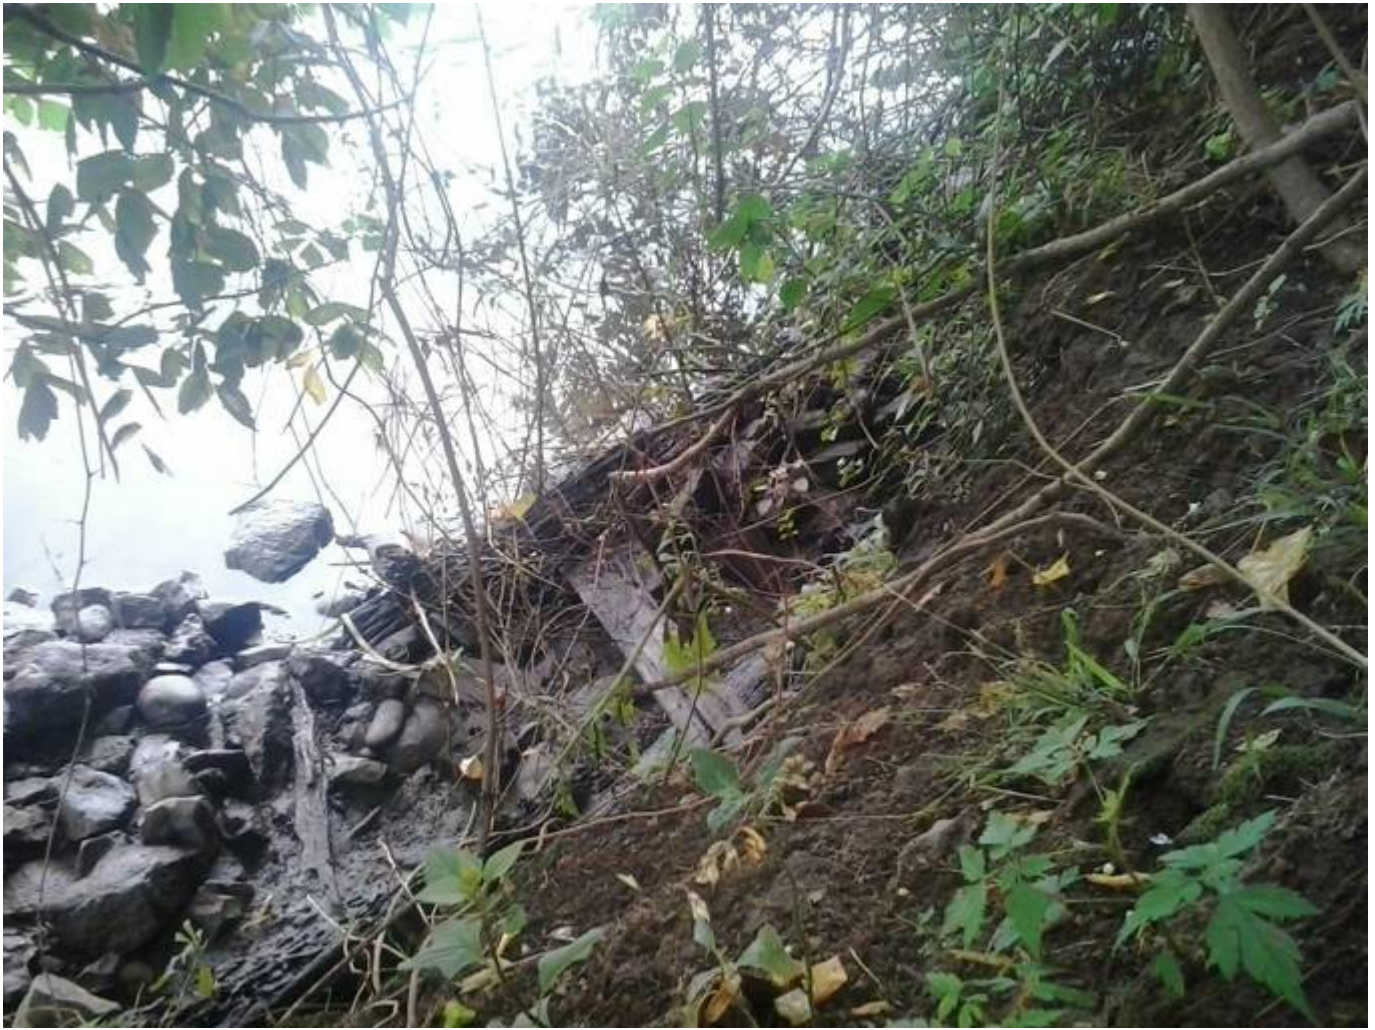
Photo 7g 1/3/2018. Additional wharf timbers some of which appear to have been later removed.

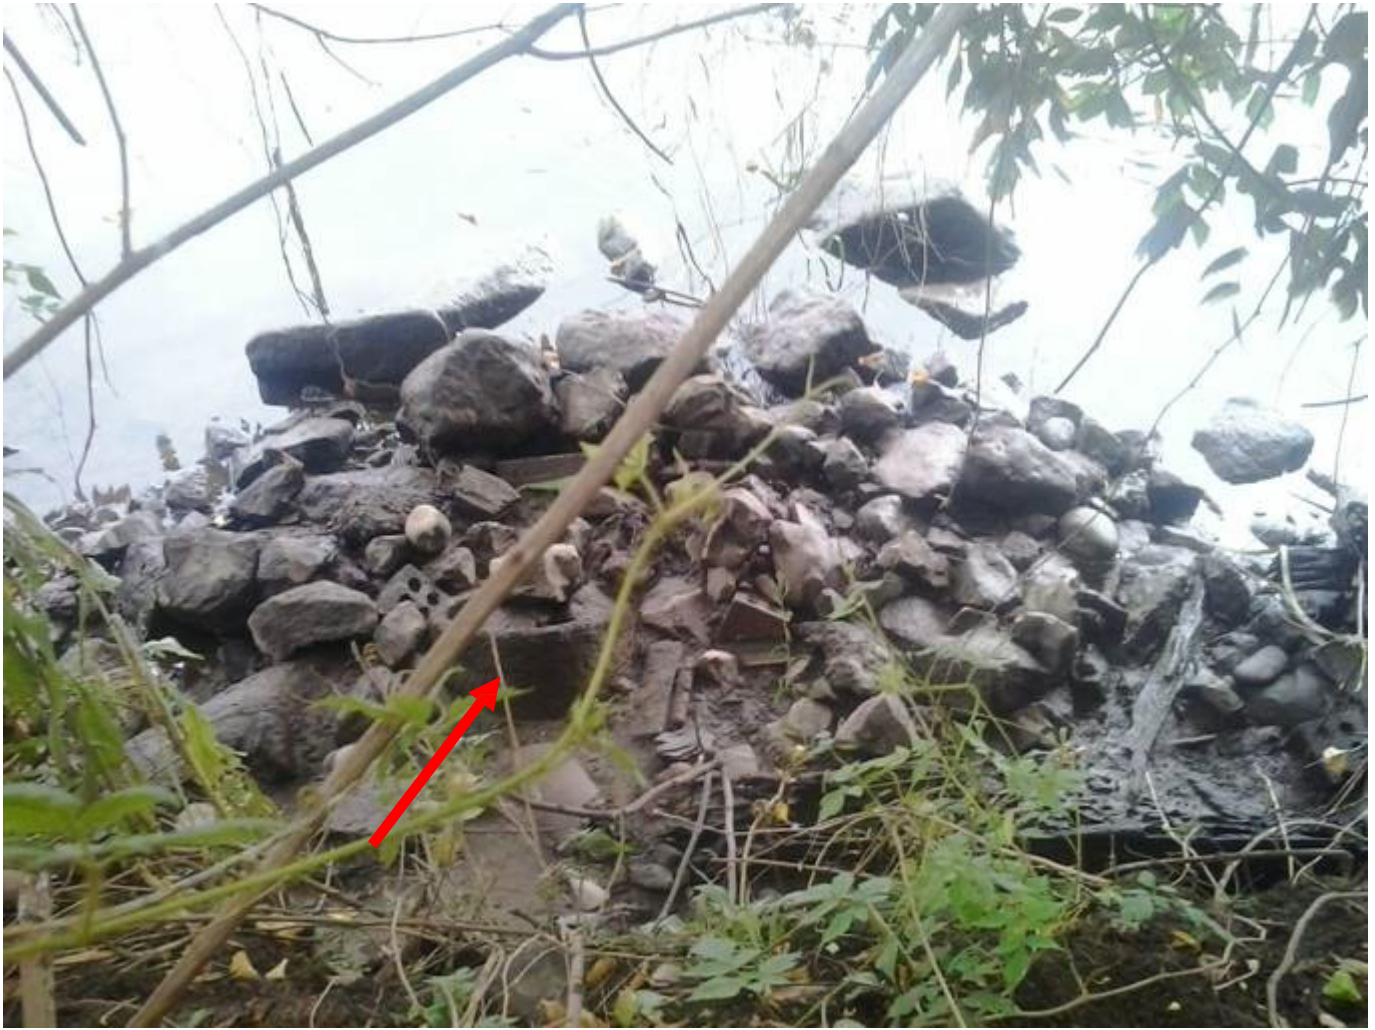
Photo 7h 1/3/2018. Note concrete pipe fragment appears to be consistent with that located at the "end" of the barrel drain, and wharf timber bottom right. Modern bricks and other fill in general area.

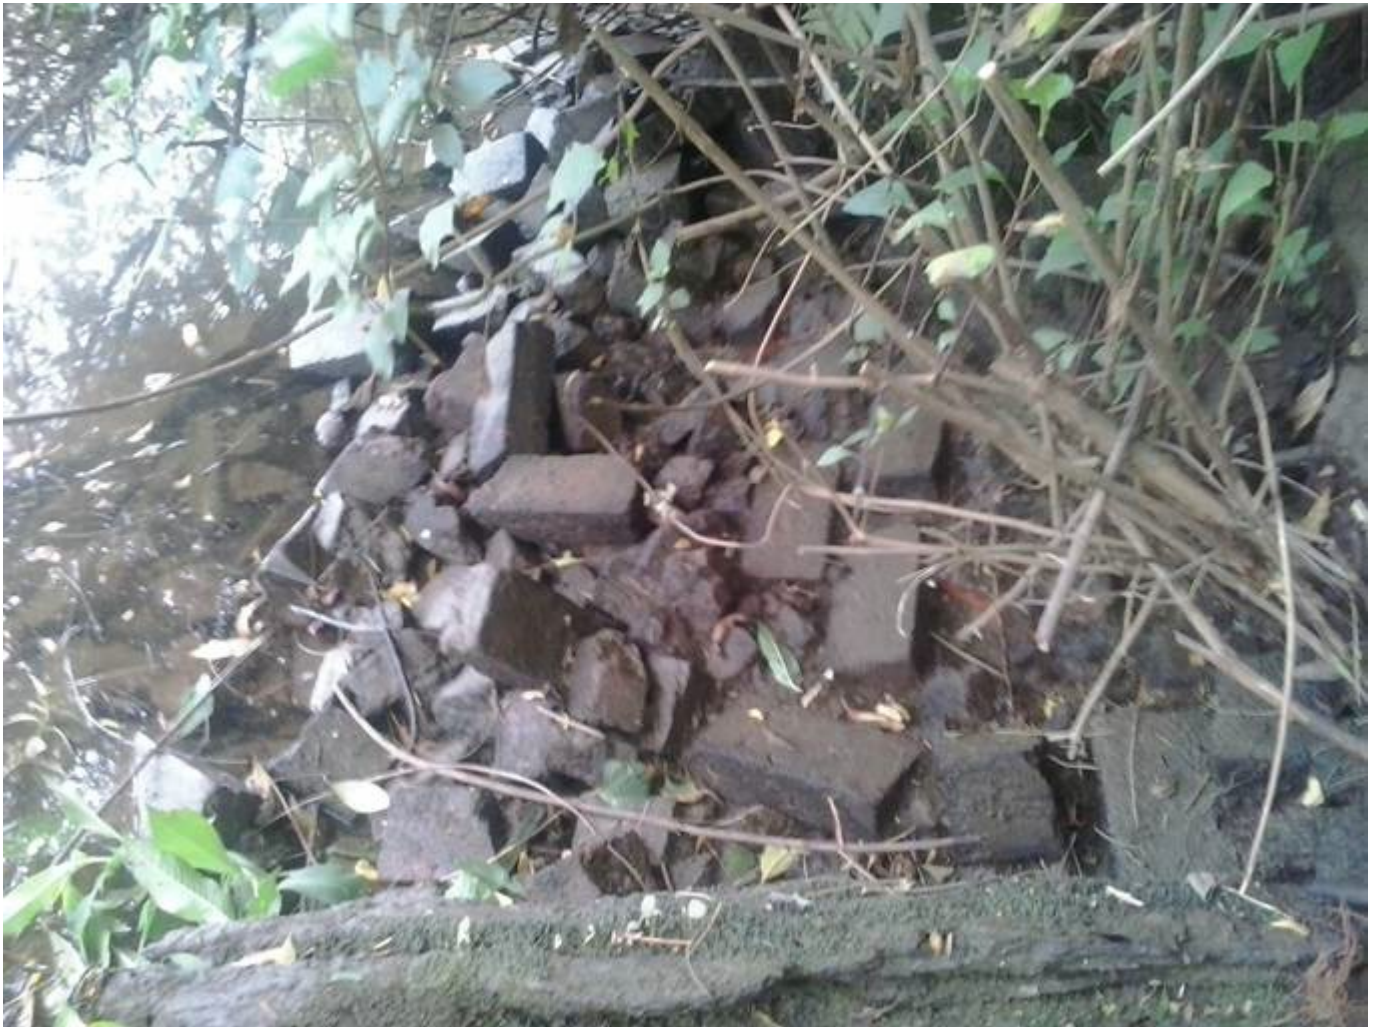
Photo 7i 1/3/2018. Convict bricks on river bed in approximate location of barrel drain outlet. Wharf timber at bottom

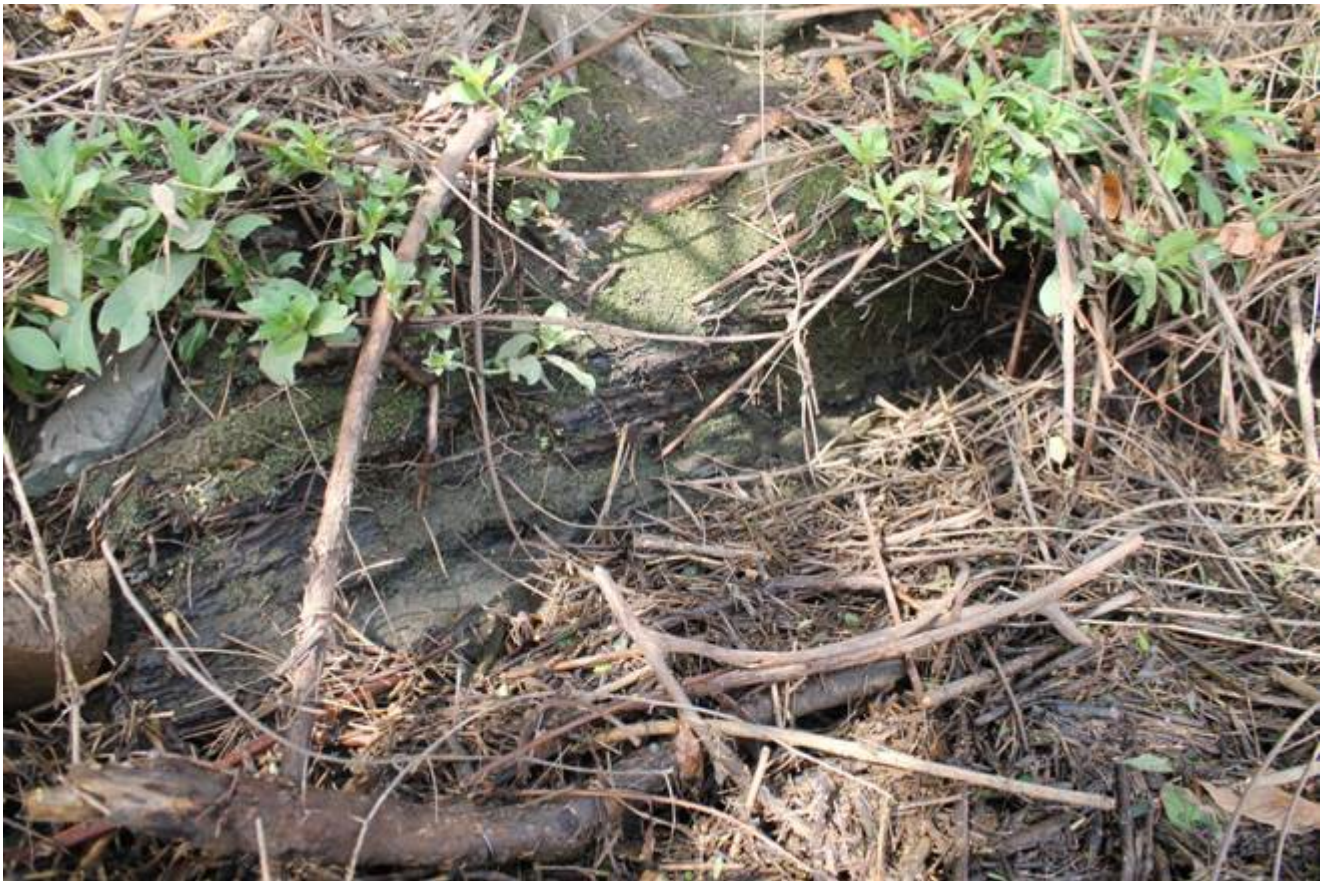
Photo 8. Beam embedded in bank to the west of area in Photo 7.

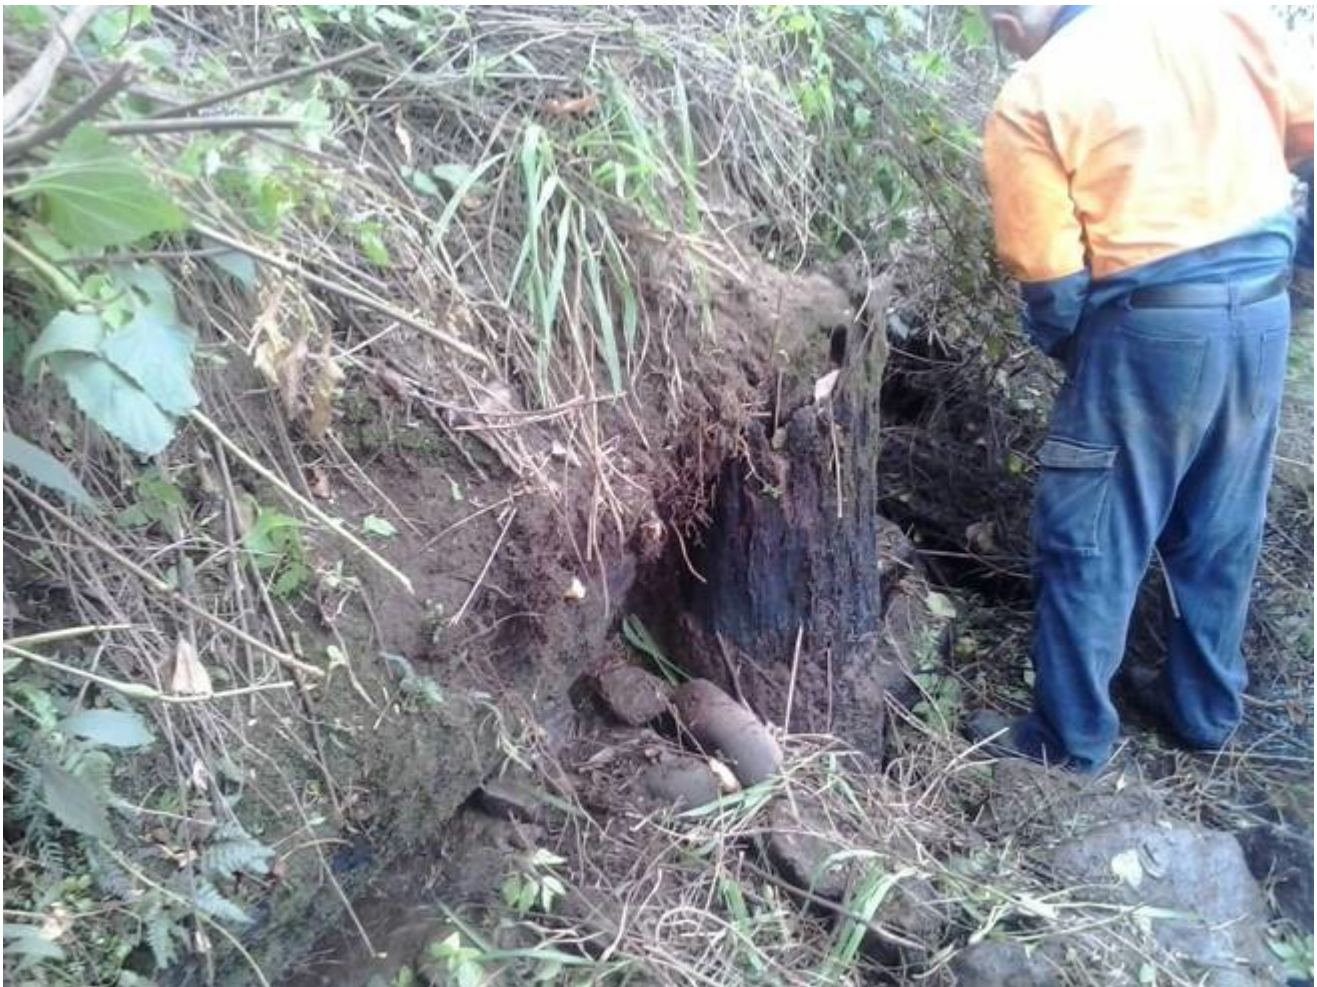
Photo 9. 3/4/2018 Uncovering the western end of the wharf. Beam and pile visible.

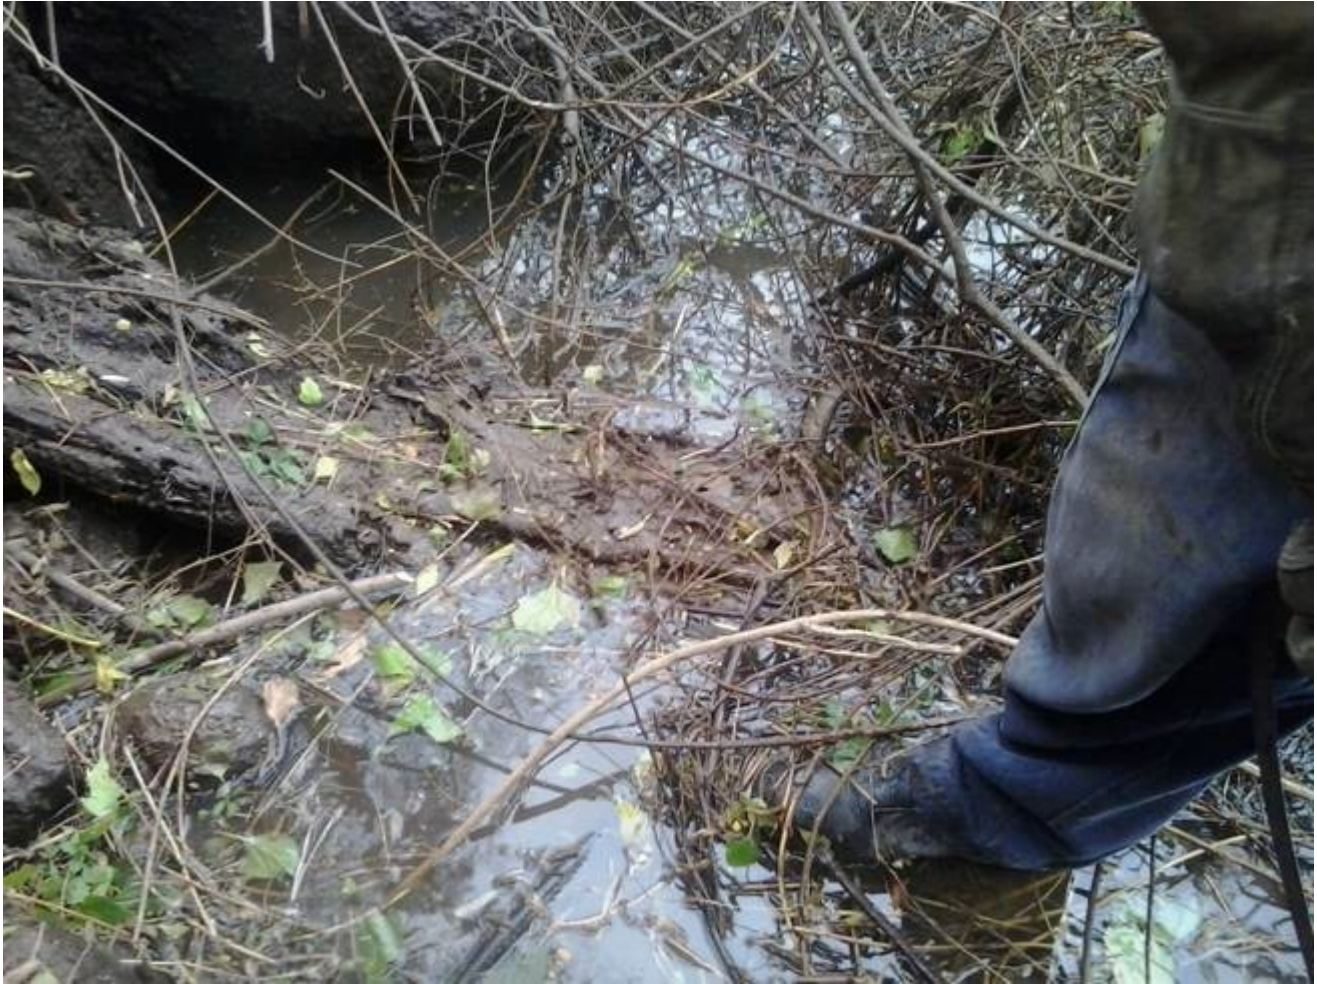
Photo 9b 3/4/2018. Rotted beam in water disintegrated due to weight of iron fastener in one end.

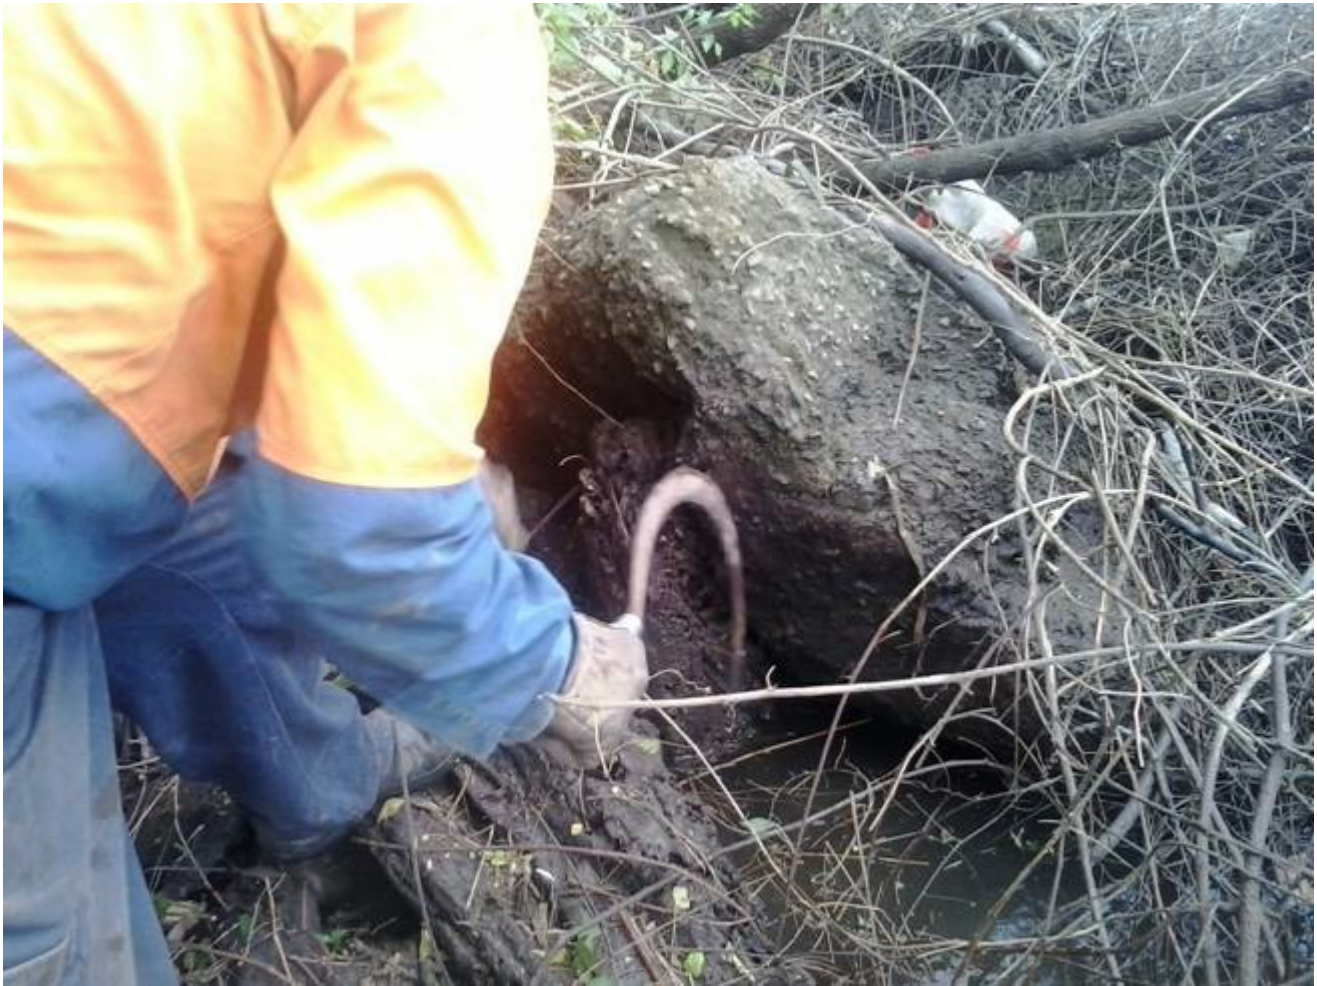
Photo 9c 3/4/2018. Westernmost pile obscured by large piece of concrete.

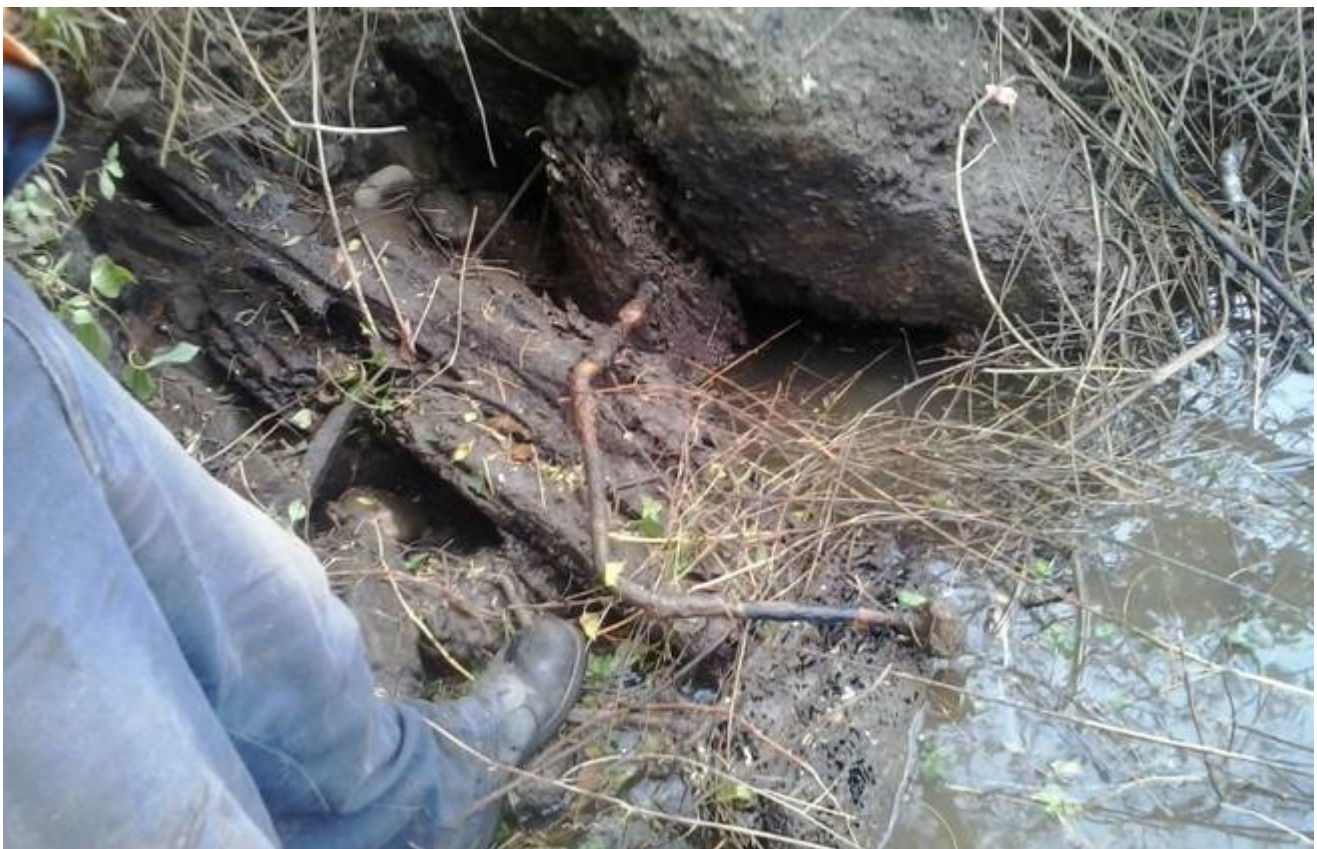
Photo 9d 3/4/2018. Iron fastener, now held by Hawkesbury Museum. Disintegrated beam under iron.

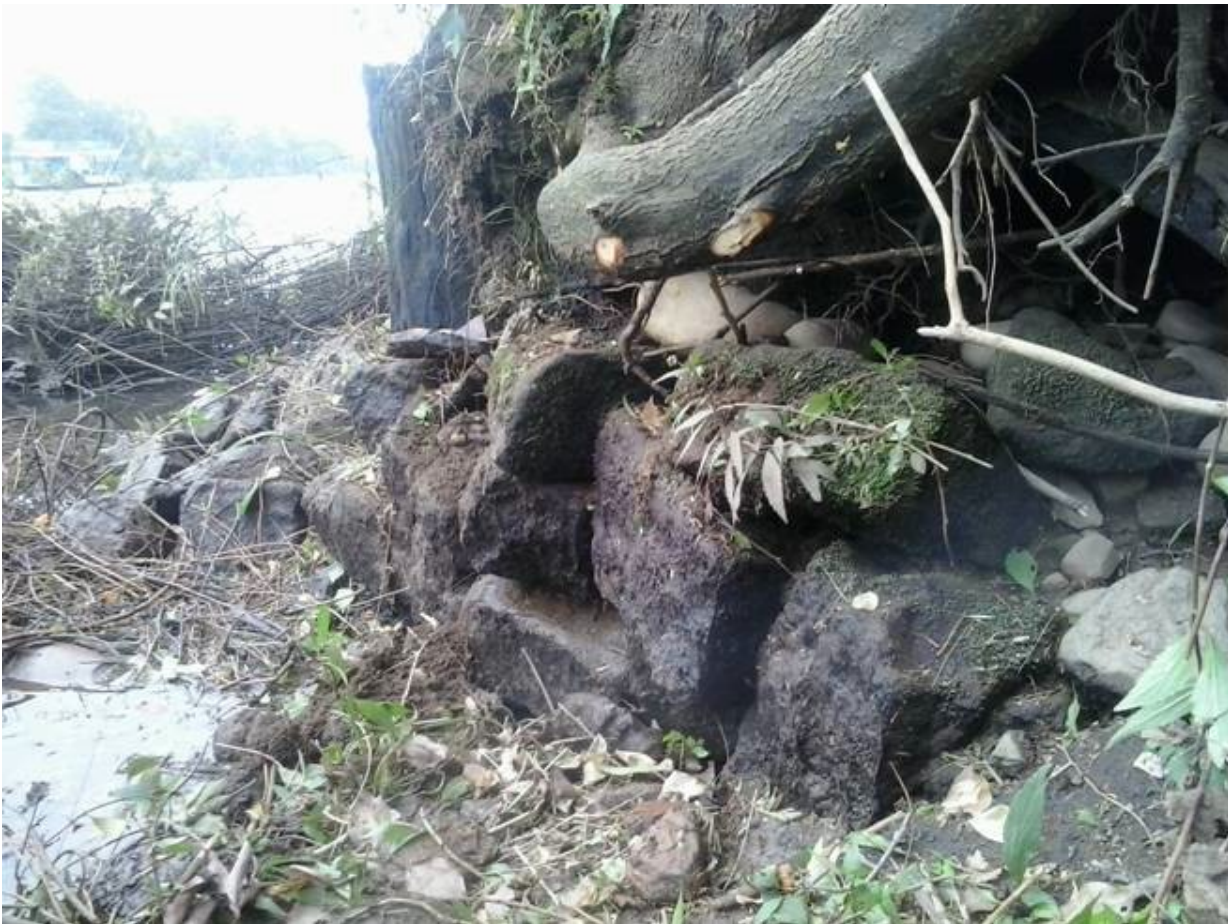
Photo 10 3/4/2018. Scour protection at western end of wharf, pile at left of looped tree root.

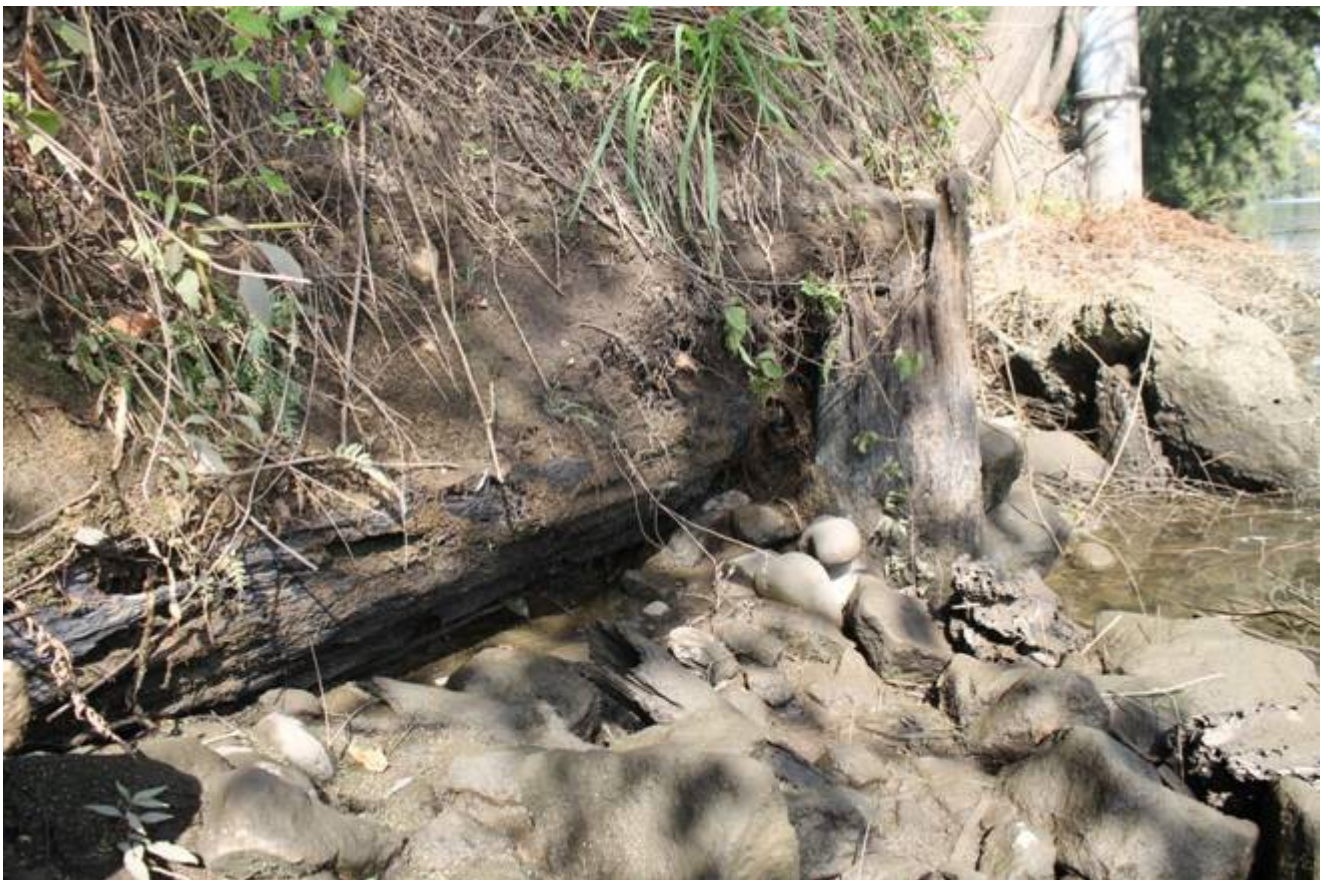
Photo 10a. This appears to be the most western pile attached to any beams, the pile next to the concrete (photo 9c) is smaller and lower, and the fill angles back toward the bank per photo 10. The southern bridge pylon is visible in the background.

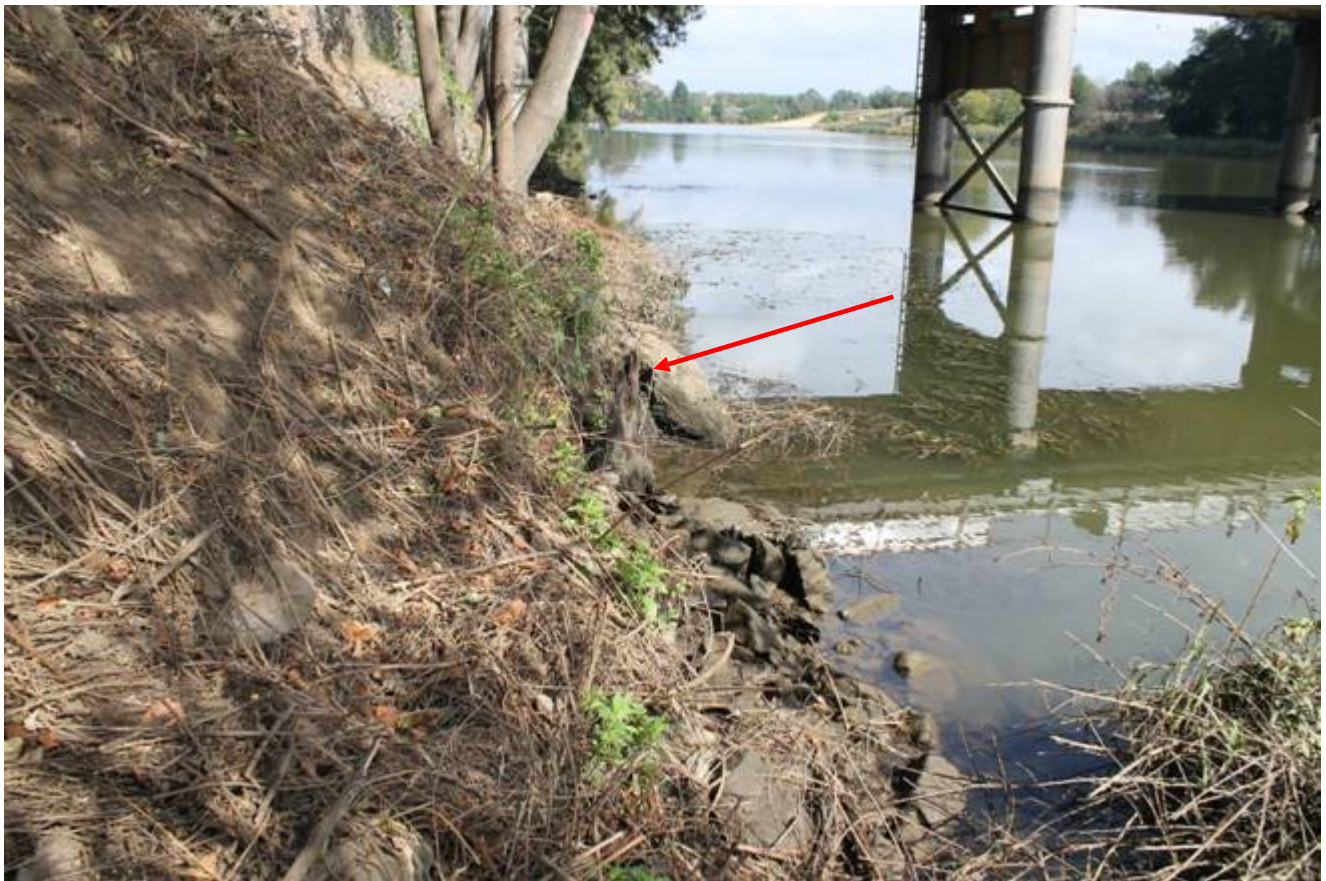
Photo 10b. Arrowed westernmost piles show proximity to bridge.
