**INQUIRY INTO CURRENT AND POTENTIAL IMPACTS OF
GOLD, SILVER, LEAD AND ZINC MINING ON HUMAN
HEALTH, LAND, AIR AND WATER QUALITY IN NEW
SOUTH WALES**

***Inquiry into
current and
potential impacts
of gold, silver,
lead and zinc
mining on human
health, land, air
and water quality
in New South
Wales***

Submission by
Catherine Sullivan and
Craig Day, landowners in
the Central West near
Cowra.

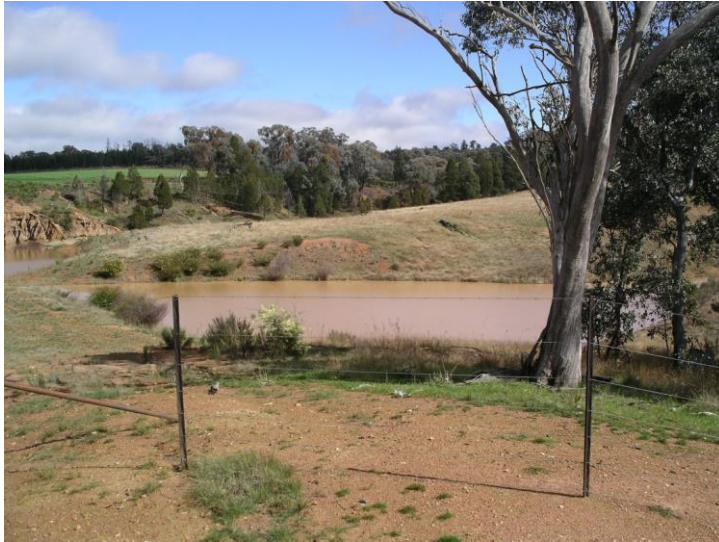
Photo 1 and 2

2010 farm dams, incorrectly called Sediment Basin 9 and 10. These were healthy farm dams, well able to support an irrigation initiative. They are brown because they are not salty. Salt makes the dams become clear.

This is 10 years after the rehabilitation of the old tailings which are located upstream, so a successful outcome.

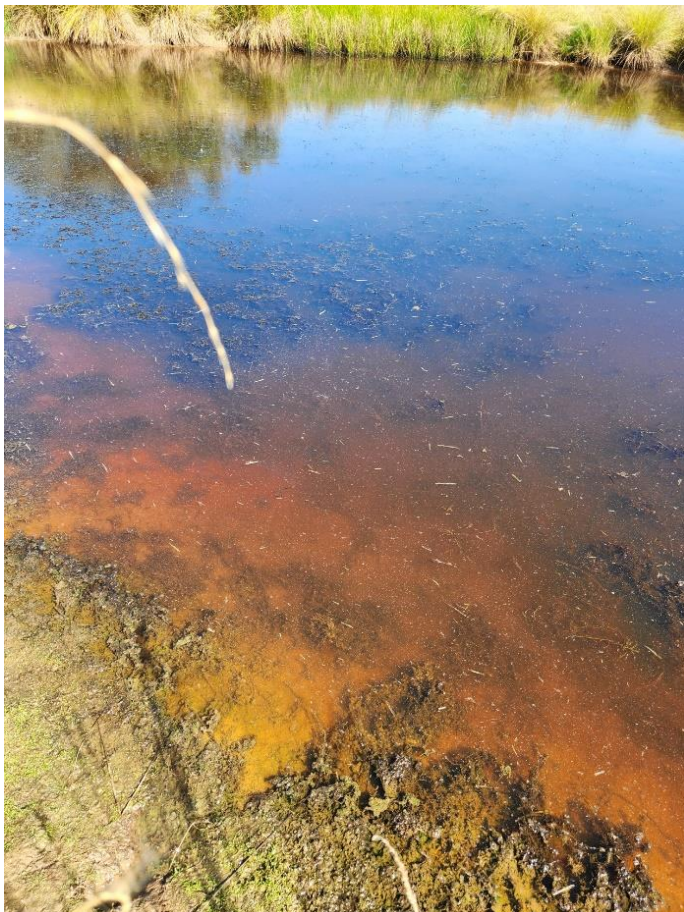
Photo 3 (above)

Farm dam used to water garden Jan 2021 – still looks the same. Notice the red rusty material – iron leachate. See Photos 7, 8 and 9.

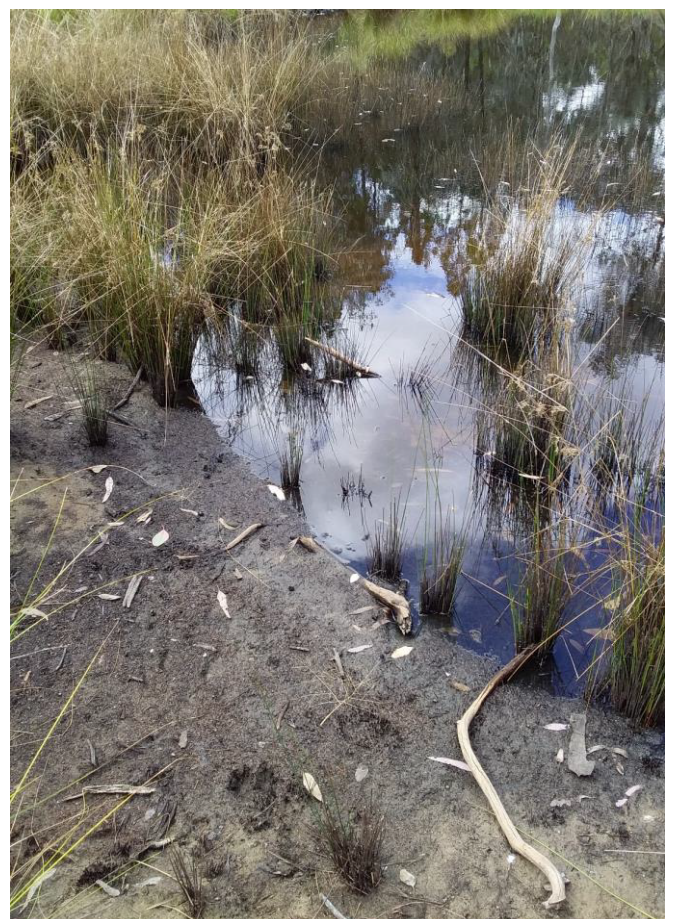
Photo 4 (Right)

Dam below the mine site. 26 March 2022
Reinforces **Photo 15**.

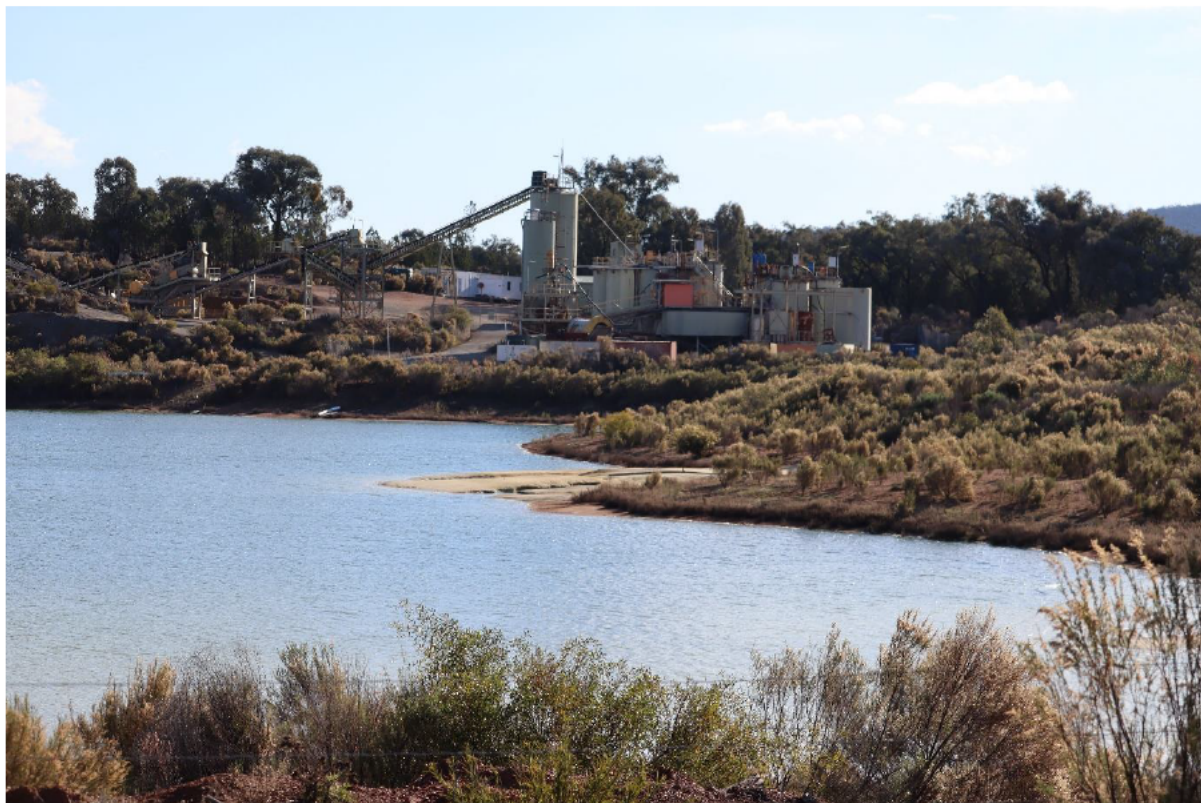
In 2023, the TSF resembles a small lake (**see Attachment 3 and Photos 5, 6 and 25**). Water management is still not resolved; our dams are now so contaminated they cannot be used to hold irrigation water. These dams, without our consent and outside land covered by ML 1617 (and any compensation agreement), are referred to by BKJV as Sediment Basins 9 and 10 when that was never to be their function.

Photo 5
 Broula King TSF dam - northern section. The TSF should not hold water but dry material from the mining process. The lack of water management on site has created a small lake of contaminated water. Photo taken 10 July 2021, but the TSF looks the same in August 2023.

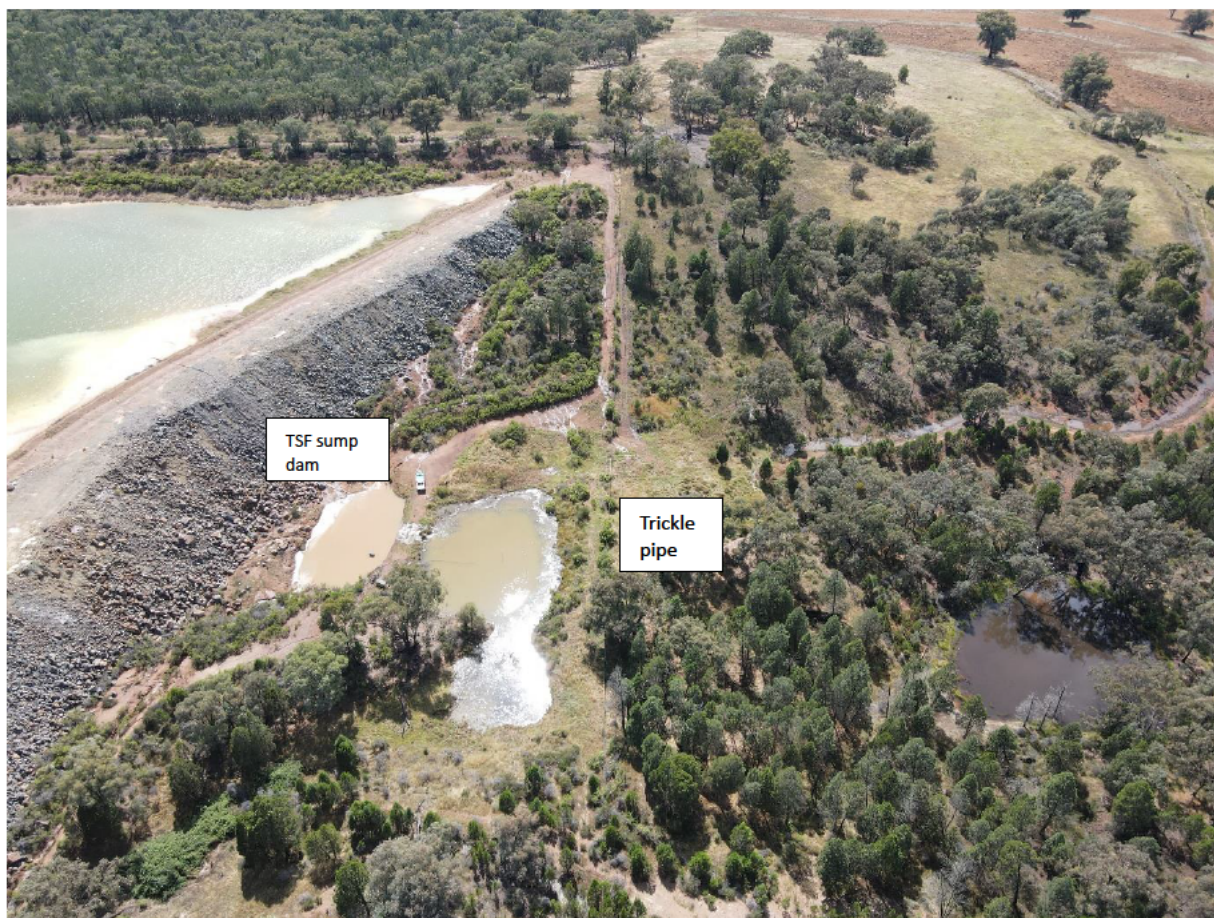
Photo 6 2022
 TSF wall showing over steep batter. Small dam in the middle is the sump and adjacent dam contains the trickle pipe. At times of high rainfall these dams merge and the low pH water containing heavy metals, including cadmium, exits the site, initially to a concrete flume then to the dam on the lower right. See Photo 9 and 10

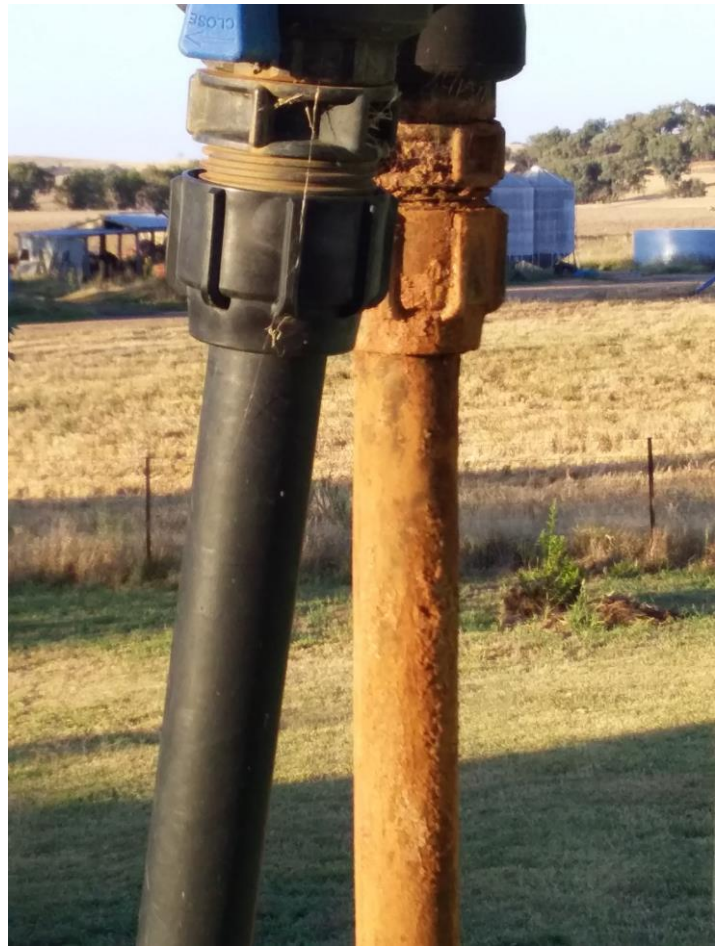
Photo 7

This is the black plastic poly pipe through which water moved from the affected farm dam to the holding tank at the house. It was used to water the garden. This is the result a slow leak as it entered the tank. Jan 2021

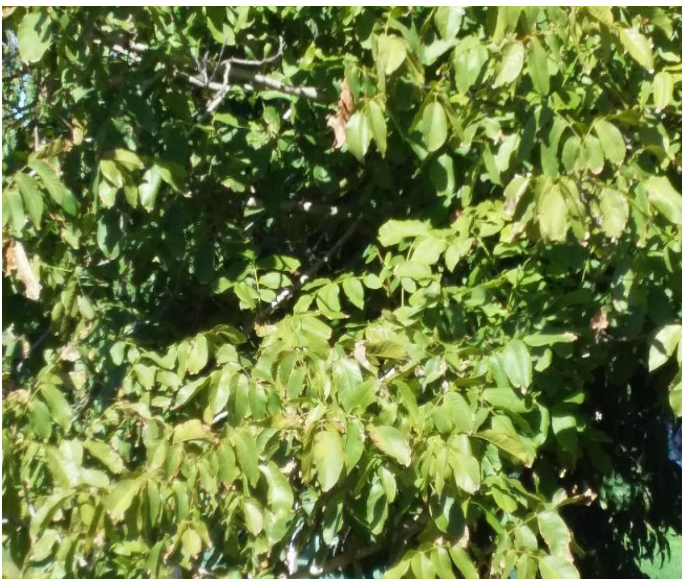
Unwatered walnut tree

**Photo 8 and 9**

The experiment we conducted to try and understand why the garden looked so unwell was to water half of a walnut tree and leave half unwatered by the sprinkler. Where the tree was watered the leaves turned brown and then died, while the other side was unaffected. January 2021

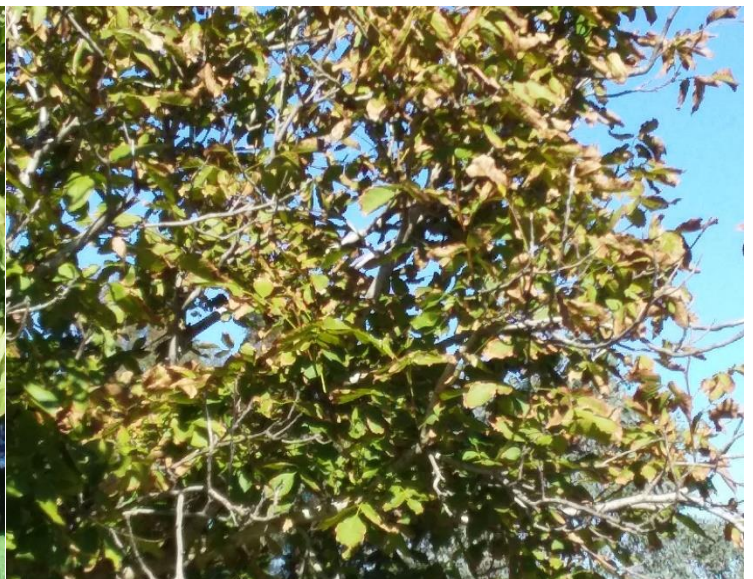
Watered walnut tree

This dam was used to water our garden. Using an in-ground sprinkler, half an established walnut tree was watered. Leaves on the watered side turned brown and died while the unwatered side remained green. On the basis of this experiment, and death/injury to other plants, we stopped agistment and sourced an alternate garden water supply which is now showing early signs of the same issue. **(See Photos 7, 8 and 9)**

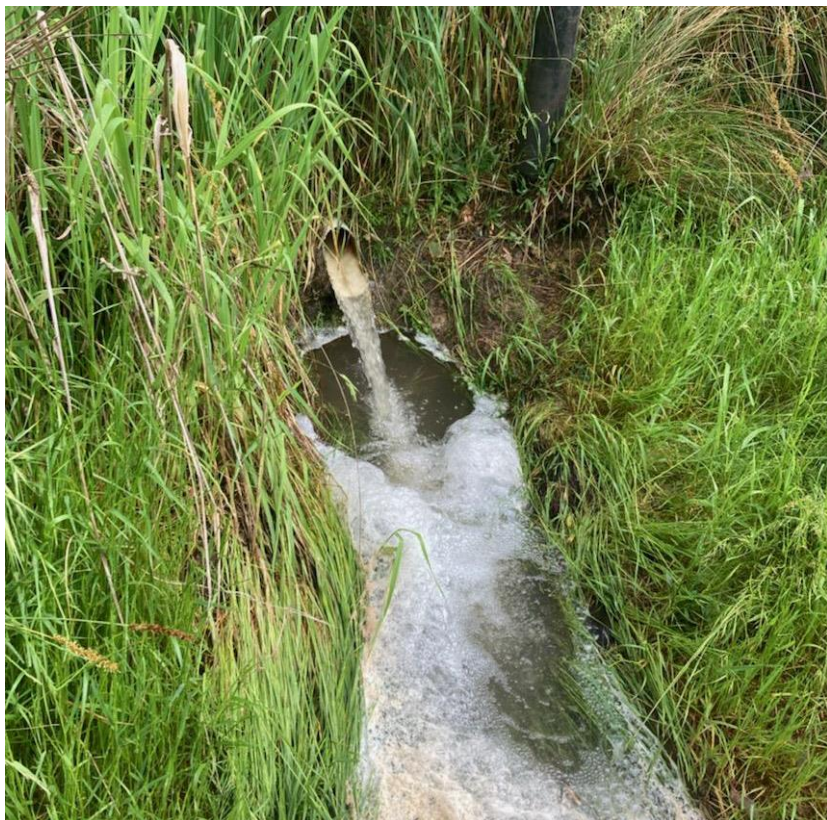
**Photo 10**

Discharge from trickle pipe Oct 2022

This was just one of multiple events in October and November 2022, let alone all the years since mining commenced in 2012.

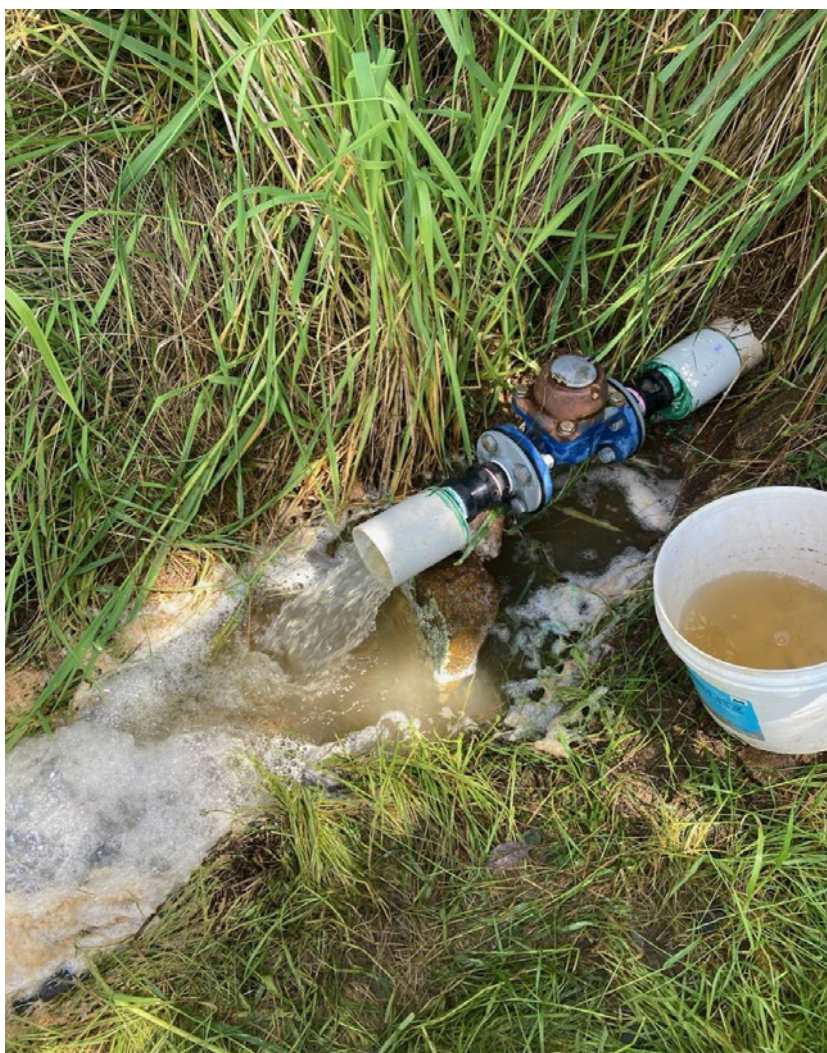
**Photo 11 Oct 2022**

Measuring the outflow from the trickle pipe or (as per the Environmental Protection Licence 12845 - Point 15). This pipe was to be monitored and measured by the miner. If the pH was below 6.5 the EPA was to be notified. If the daily volume limit was exceeded, they were to be notified.

Despite testing the sump dam in 2015, 2020 and 2021, the EPL was never varied to ask BKJV Pty Ltd to measure heavy metals, for example, cadmium. BKJV Pty Ltd has never put a flow monitor on this pipe. Conducting this experiment was to determine how much contaminated water was flowing through our land.

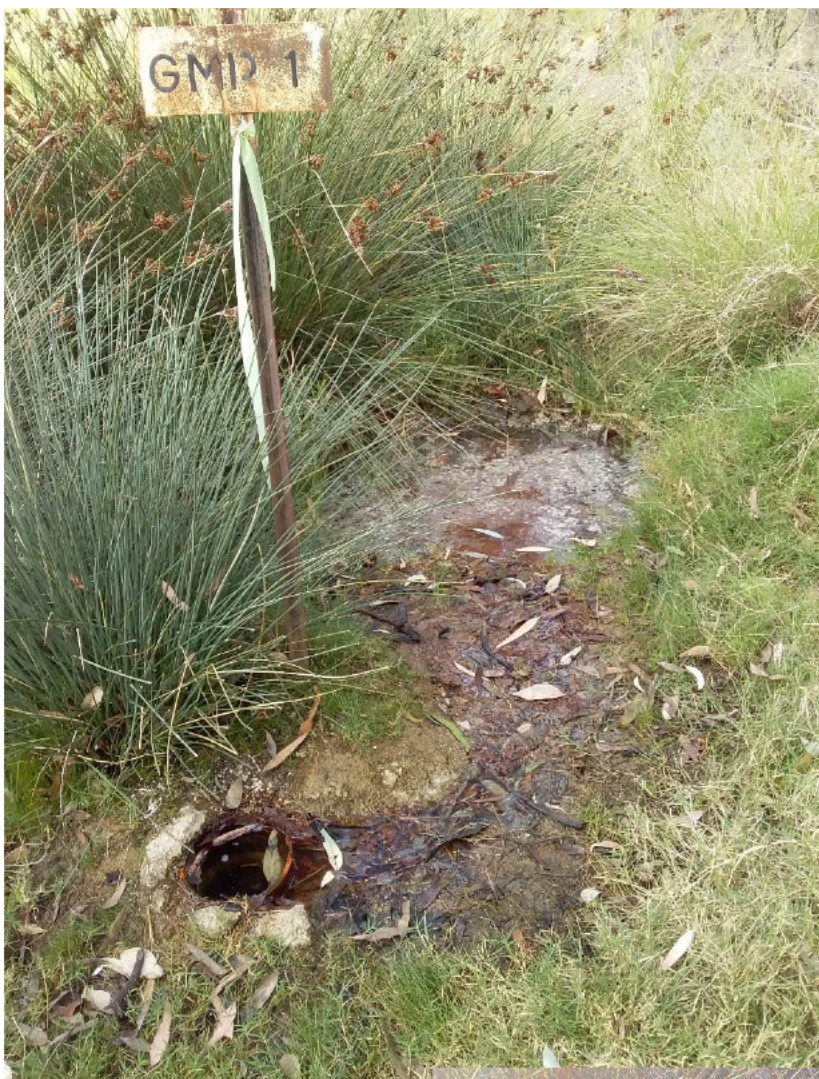
Photo 12

At the base of the TSF, just outside the high fenced area, is Ground Monitoring Point 1 (**GMP1**). It is a monitoring bore used to measure water level and water quality. This piezometer should have water at least 2-3 metres down. Unfortunately, despite the pipe being 80cm above the ground, it continues to overflow with bubbling, discoloured water and if the top is screwed on, water simply bubbles out of the ground surrounding the pipe. The unsuccessful capping of the pipe was the outcome of our repeated requests to the NSW EPA and BKJV for the seepage to stop. This monitoring point needs to be concrete capped and plugged. **(See Photos 12 and 13)**

We have estimated that this water has been leaking at a rate of almost a litre per minute since 2015, with varying levels of contamination. (1,440L per day, 525,600L per year). In 7 and a half years that is 3,942,000 litres of contaminated water that has flowed through our land. Initially it was the highly saline content that affected our downstream environment, changing vegetation and ultimately causing plant death. Now it is the high levels of lead, zinc and iron with increased chromium levels in the surrounding soil, that are of concern, plus salinity.

Ground Monitoring Point 1 (GMP1) was established as a place to check the depth and quality of the groundwater near the mine on the downstream side. It is located approximately 100 metres from the TSF wall on the southern side.

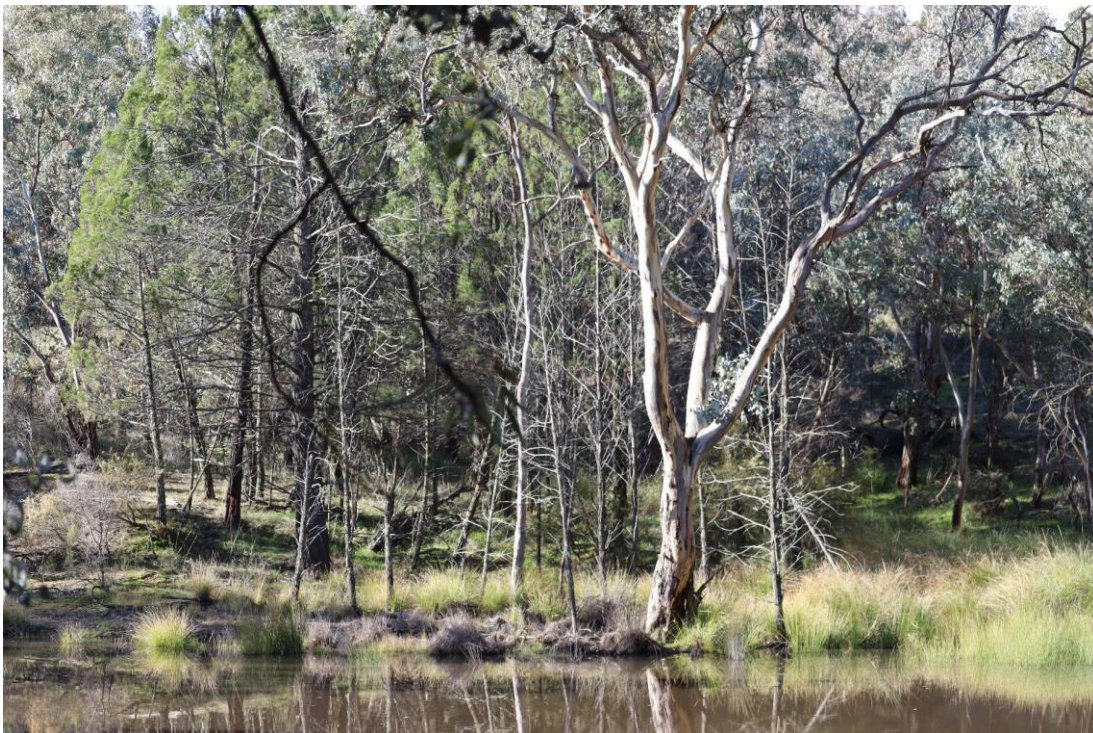
**Photo 15 - 2020**

These dead trees surround the dam below the two dams at the base of the TSF and GMP1.

All southerly water from the mine site and the slow leak from GMP1 flows to this dam.

The water is black, lacking aquatic life and surrounded by dead and dying vegetation.

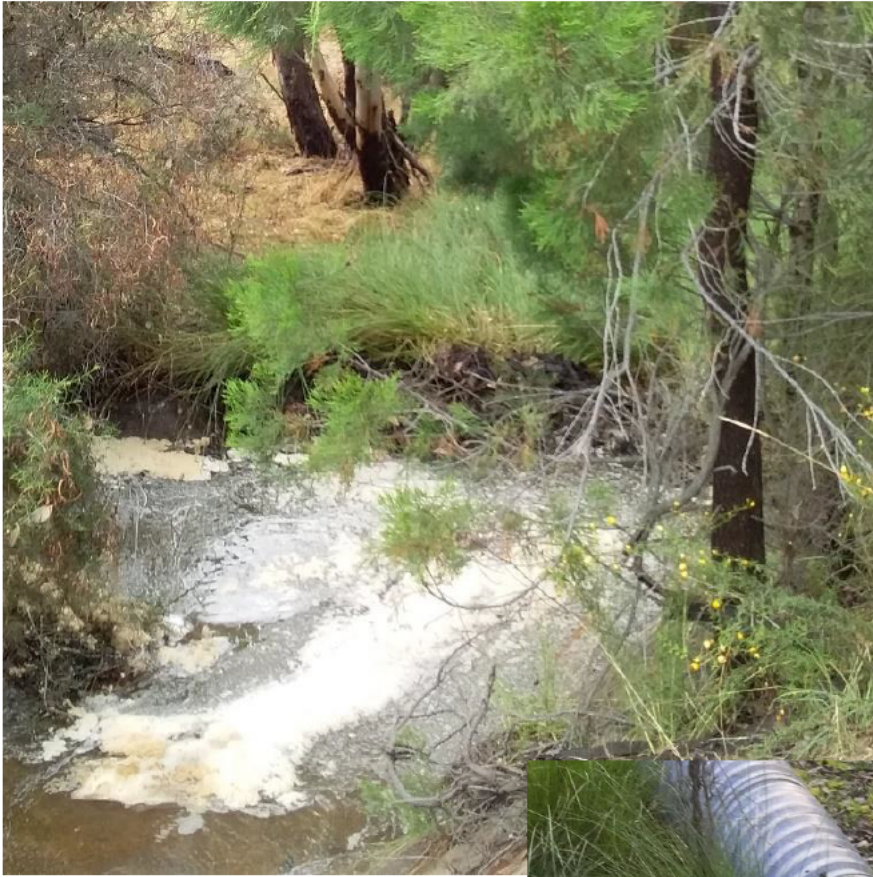
Photo 16

2015 out flow event leading to NSW EPA testing.

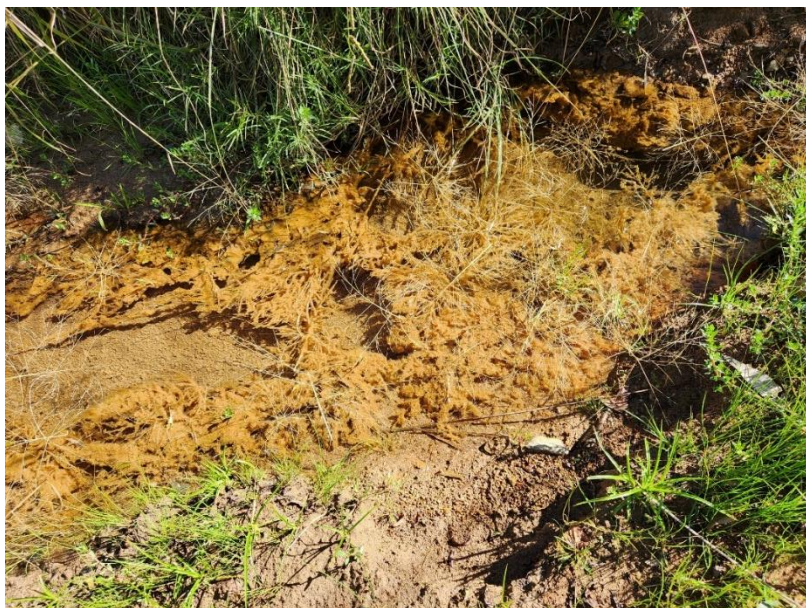
Photo 18

This was taken in April 2023 with more taken in June 2023. It is approximately 2 metres from the edge of our farm, about to go under a road and then to the neighbour's property.

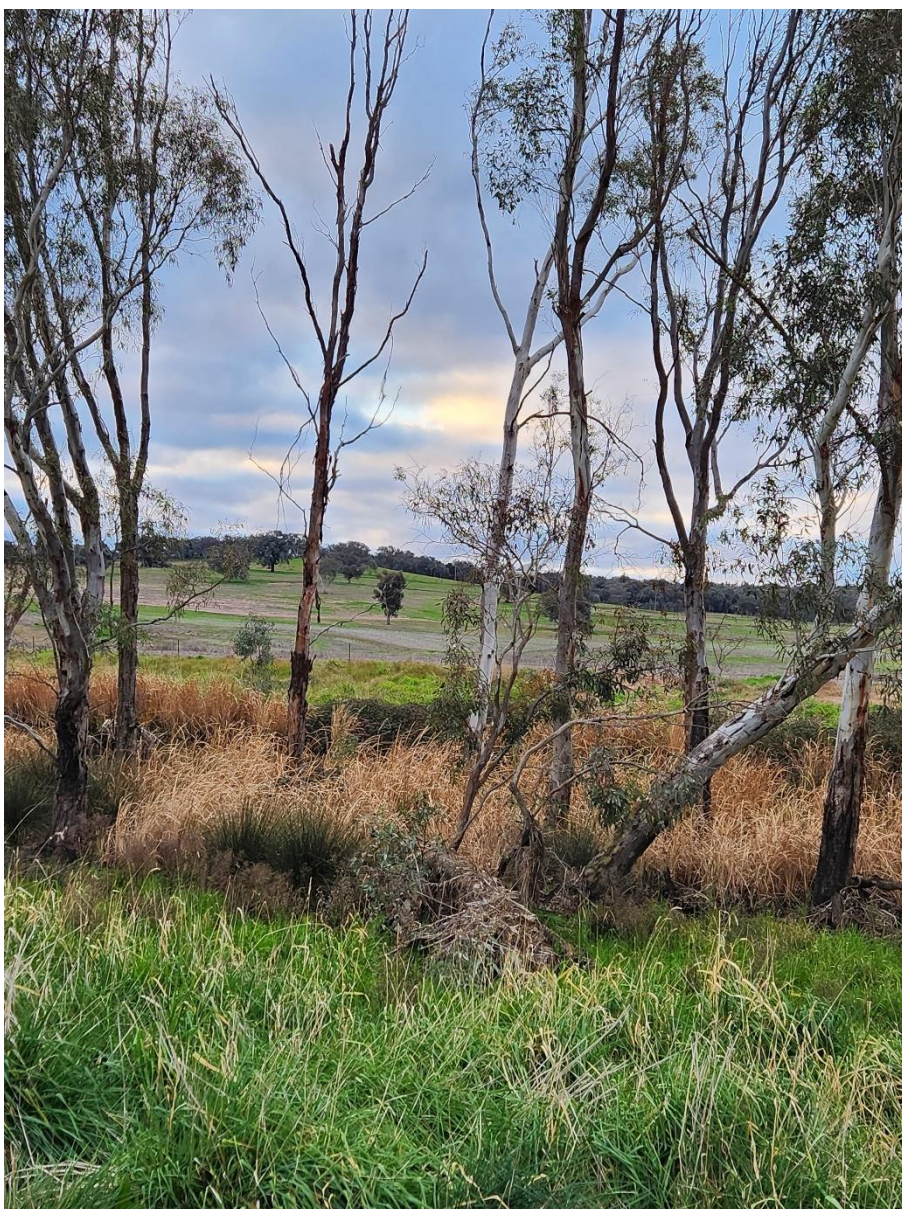
Dead trees in the Tyagong Creek at the point where it meets overland flow. The February 2023 electromagnetic survey showed this is where underground water carrying high levels of sulphites flows into the creek as well.

These trees are River Red gums specifically bred to be tolerant of highly saline soils/water.

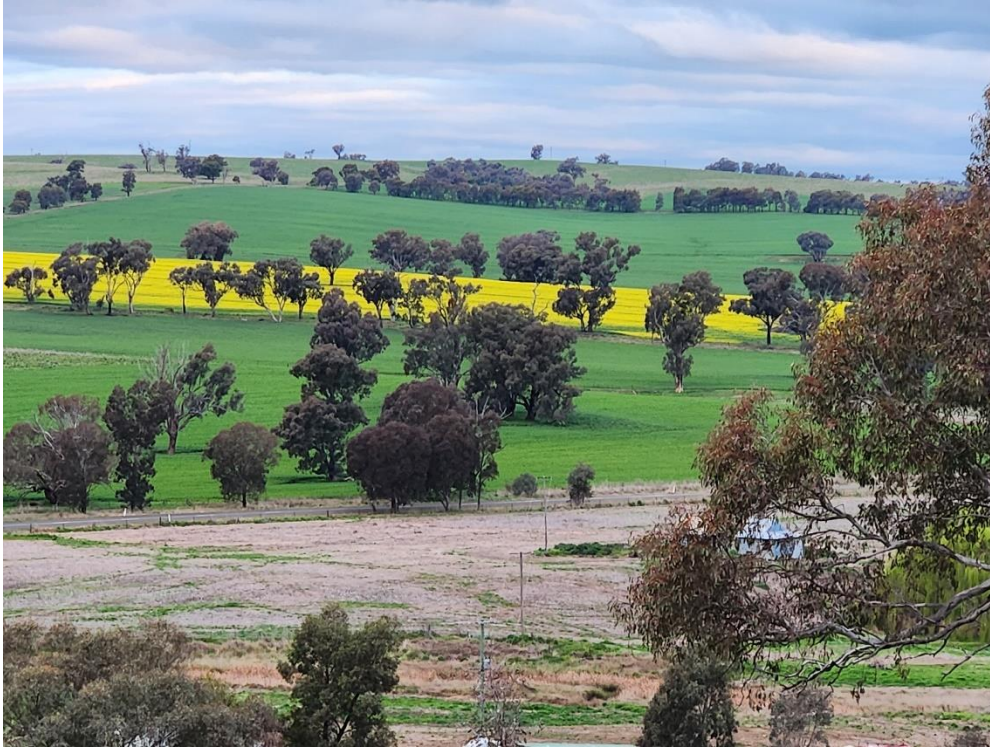
Photo 20

August 2023 - A view to the east of our property of wheat and canola crops.

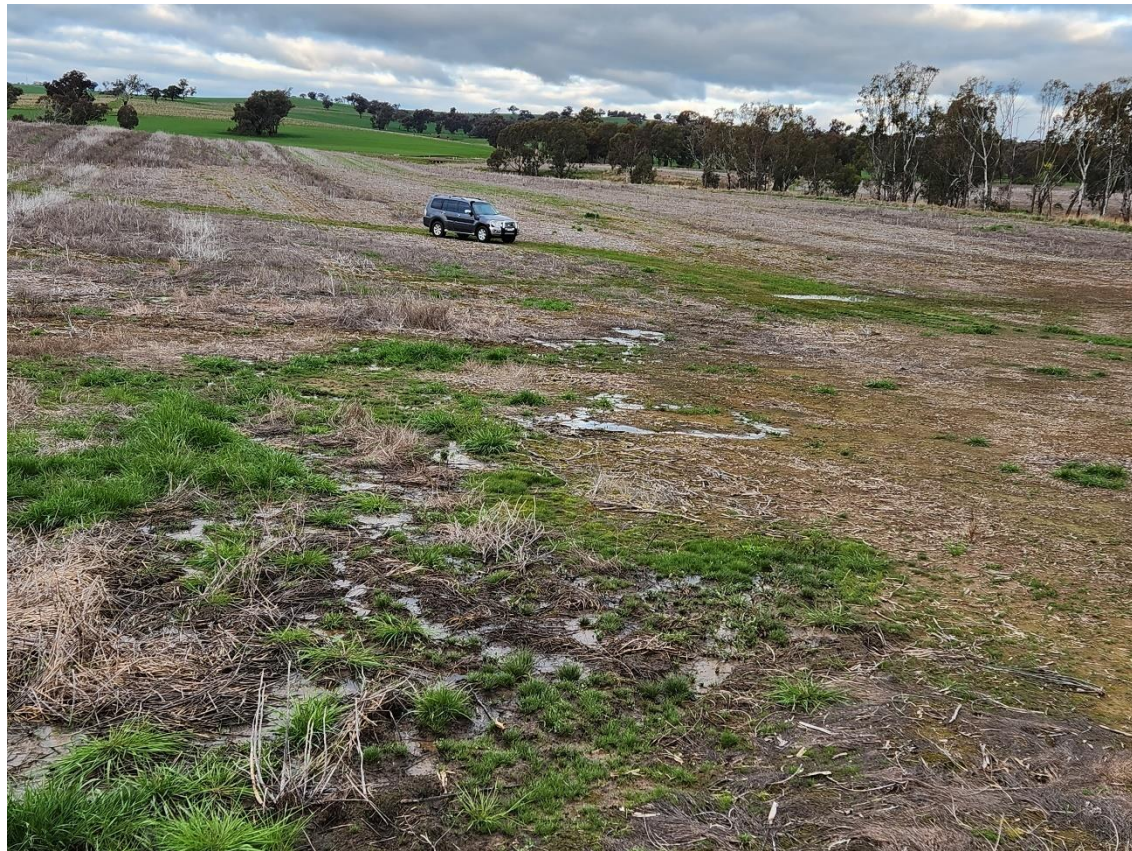
This water has been present for over two years. Its makeup has changed as the seepage from the water table has occurred.

In July 2023, it contained Copper, Chromium, Lead and Zinc at levels above the ecological threshold. (Envirowest Consulting)

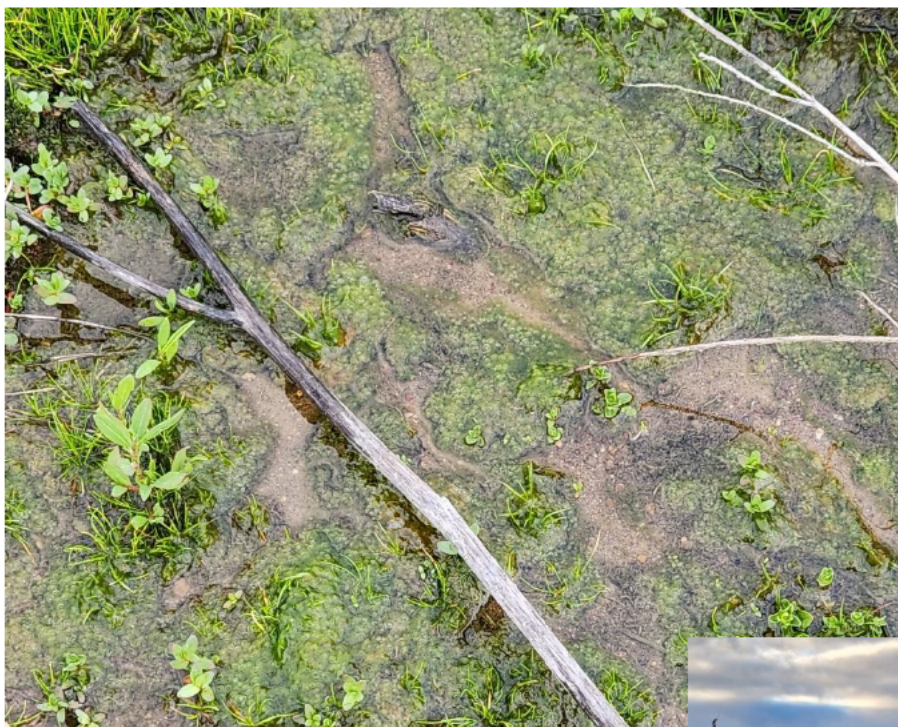
Photo 22

This is the same paddock and is visible from the Greenethorpe Bumbaldry Rd. This is why are neighbours have been asking, Why are your paddocks so wet?

The same outbreaks are occurring on the top of hills, as well as over farm roads and low spots in paddocks.

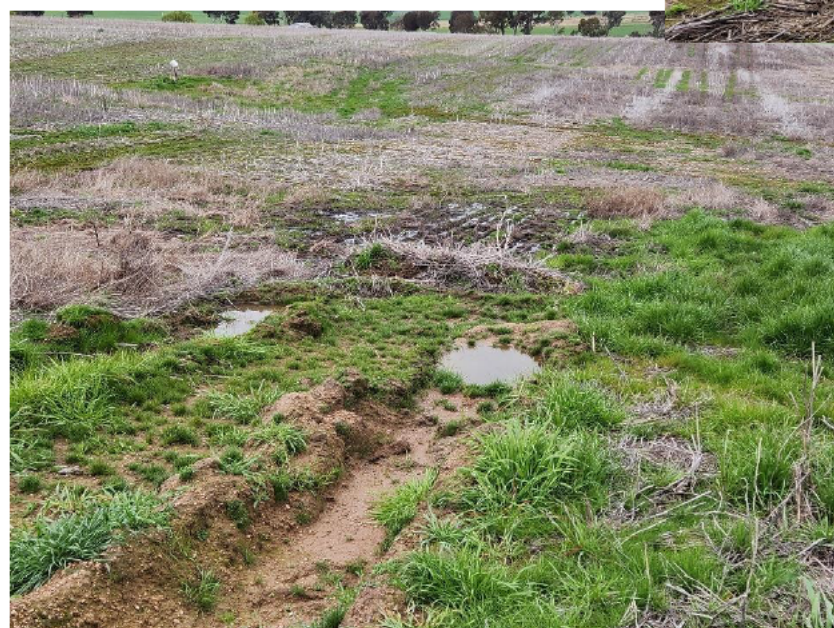
Photo 24

Attempts to prepare for sowing were aborted because of the lack of trafficability and contamination concerns.

These alluvial creek flats have always been highly productive for cropping and pasture and in 100 years have never had these outbreaks.

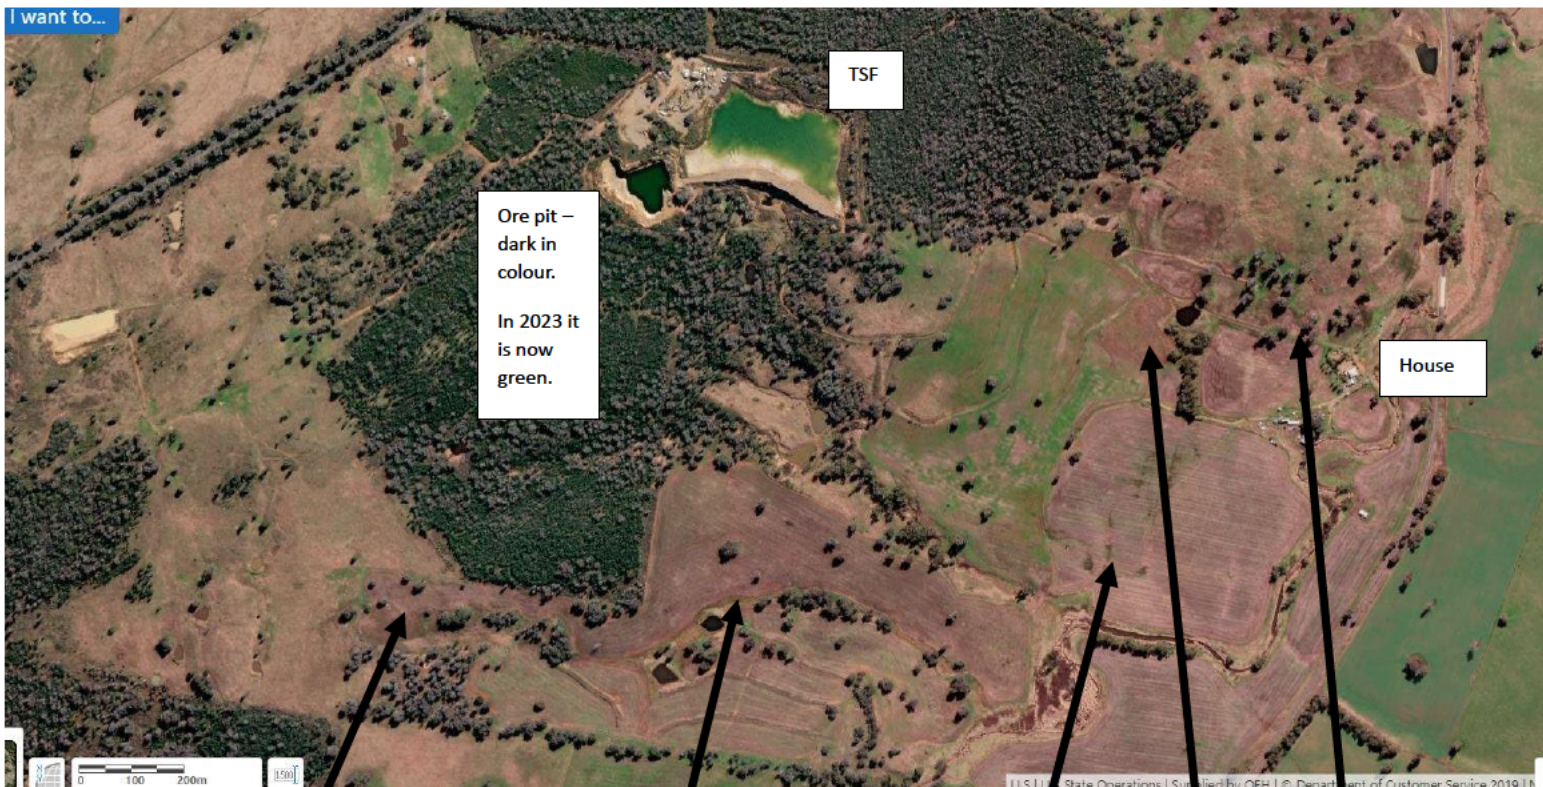
Photo 25

Another wet area, again not seen in 100 years of farming
