INQUIRY INTO IMPACT OF THE ROZELLE INTERCHANGE

Organisation: Inner West Bicycle Coalition

Rozelle Interchange and Parklands Cycling Defects and Recommendations Report February 2024

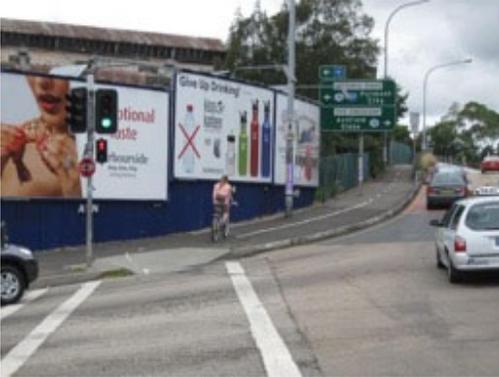
Item	Problem	Recommendation	Illustration
1	Victoria Rd shared path past White Bay Power Station remains narrow, is obstructed by dangerous signage and poles and has poorly designed ramping. No bicycle lights on crossing.	Ramp needs to be wider (or better angled) to cater for two directional bicycle traffic along Victoria Rd shared path near Robert St. Consider running the path behind the hoarding and fence allowing more space and a better grade. Install bicycle lanterns at Robert St crossing.

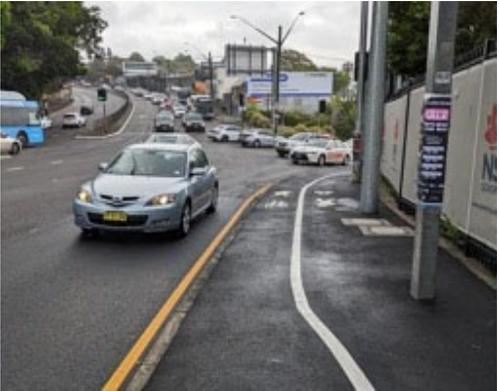
2	No protection from errant vehicles mounting kerb.	Provide protective barriers, or relocate cycleway behind fence on White Bay Power Station land.

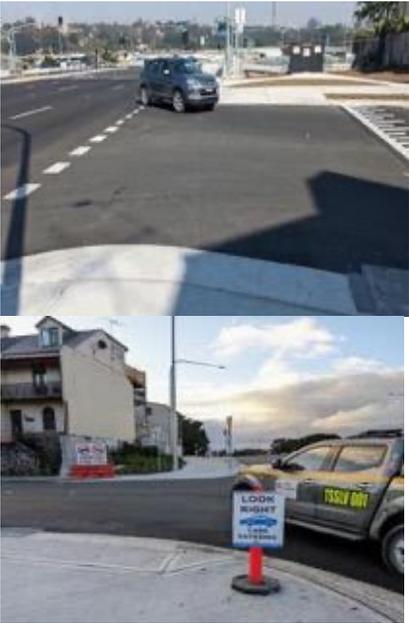
Item	Problem	Recommendation	Illustration
3	Turn into Lilyfield Rd from Victoria Rd is dangerous for cyclists, with no permanent clear warning to motorists of cyclists' presence	Provide formal pedestrian/cyclist crossing of Lilyfield Rd further west of Victoria Rd to allow safe passage of cyclists across Lilyfield Rd and clear notice to motorists of cyclist/pedestrian presence and movements.

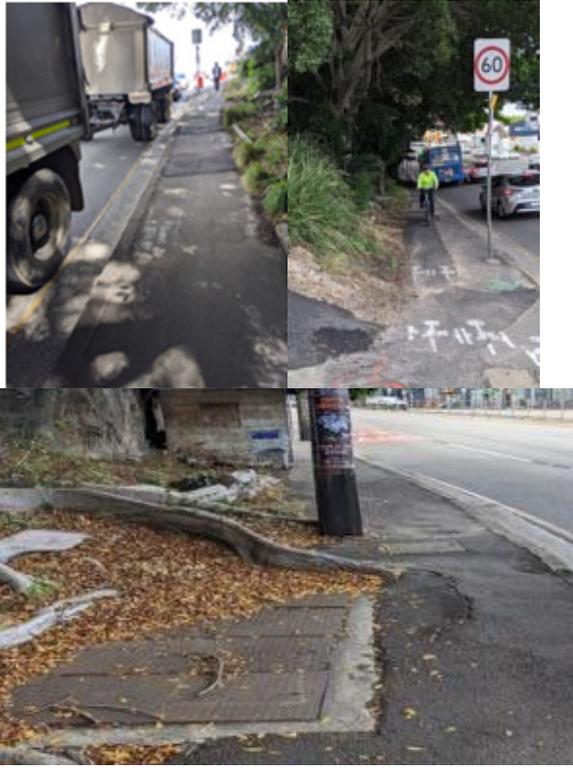
Item	Problem	Recommendation	Illustration
4	Narrow footpath adjacent to Victoria Rd from Quirk St to Maney St Rozelle is narrow and rough, not suitable for cycle use, danger of overbalancing onto busy Victoria Rd	Install No Bicycle Access signs alongside Victoria Rd between Quirk and Maney Sts to discourage cyclists from accessing this dangerous area.

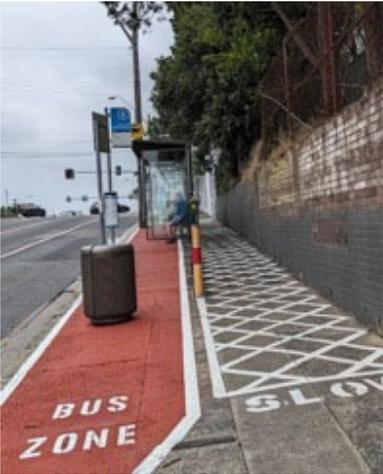
Item	Problem	Recommendation	Illustration
5	Victoria Rd shared path at Darling St Rozelle bus stop is still too narrow, only allowing one way cycle traffic	Widen easement for footpath and cycleway, as recommended in the Draft Victoria Rd Public Domain Masterplan.

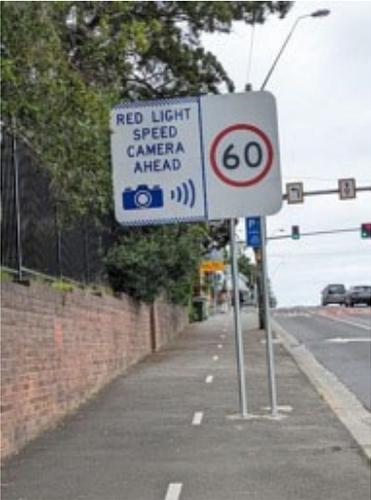
6	Victoria Rd shared path adjacent to Rozelle Public School has more road signs obstructing cycle and pedestrian movement	Remove obstructive signage on pathway and relocate by other means.

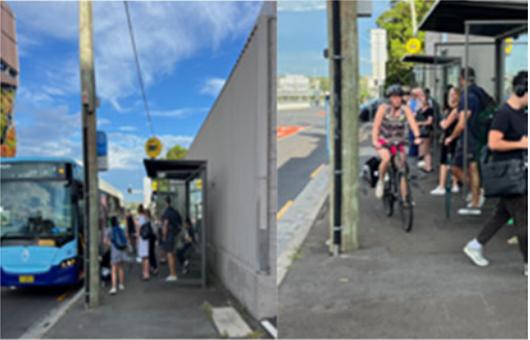
Item	Problem	Recommendation	Illustration
7	Victoria Road shared path east of Terry St still has inadequate room to accommodate cyclists and bus patrons	Widen easement for footpath and cycleway to allow cycle movement behind bus stop. Refer to Draft Victoria Rd Public Domain Master Plan showing re-allocation of lane space following opening of Iron Cove Link tunnel.

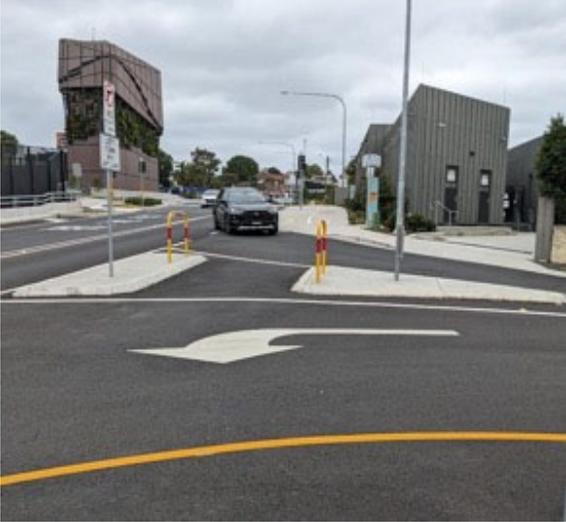
8	New slip lanes on south side of Victoria Rd at Springside and Callan St Rozelle cut straight across the shared path with no warning to motorists, dangerous to pedestrians and cyclists	Remove slip lane treatment favouring motor movement only. Erect warning signs to warn left turning motorists of cyclist presence/movements. Install raised priority crossing for cyclists and pedestrians.

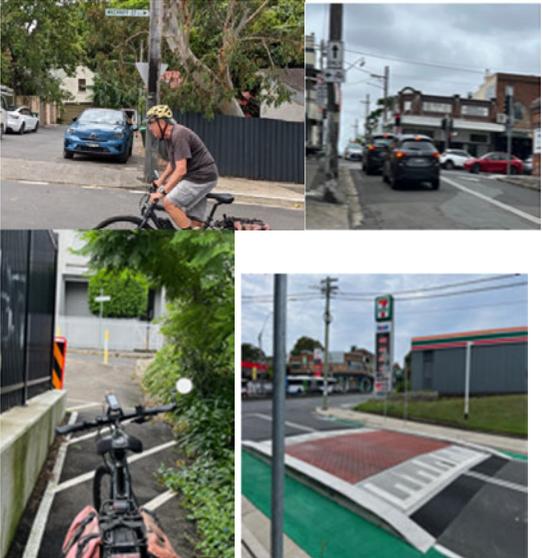
Item	Problem	Recommendation	Illustration
9	<p>The backstreet cycle route from Quirk St to Moodie street Rozelle is unacceptably hilly, awkward and unsafe. Grades for Kenniff and Waterloo are 14% and 10%, Austroads recommends 3-5%. Busy cross streets at Darling, Evans and Moodie have no warning to motorists of the cycle route. Moodie St cycle treatments poorly located. Cycle route is rarely used.</p>	<p>Provide adequately wide shared path on north side of Victoria Rd as recommended in the Draft Victoria Rd Public Domain Master Plan. South side access to north side of Victoria Rd can be from Gordon, Darling, Terry and Wellington St crossings.</p>

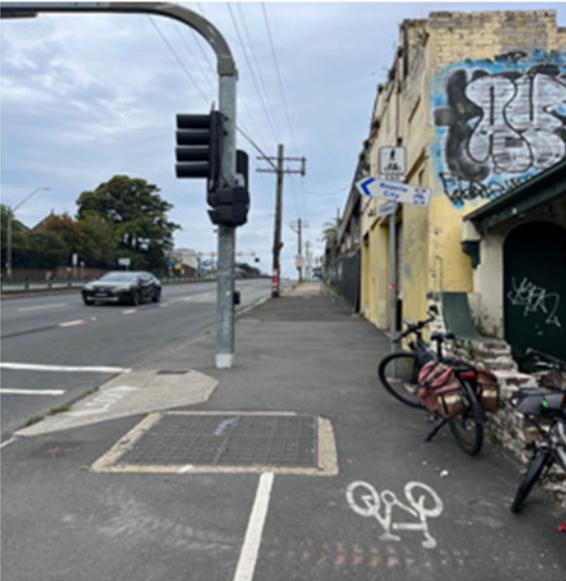
Item	Problem	Recommendation	Illustration
10	Shared path on south side of Victoria Rd between Moodie and Wellington Sts stops abruptly at Wellington St	Extend shared path eastwards to Darling St to facilitate north and south cycle movements at this key intersection.

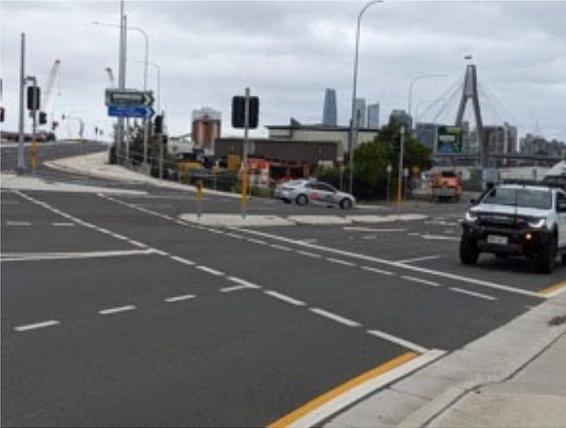
11	Cycle crossing of James Craig Rd slip lane requires difficult turn, encouraging cyclists to make unpredictable, unsafe movements across the following wide intersection	Reconfigure cycle route to provide clear logical and straighter line for cyclists to follow.

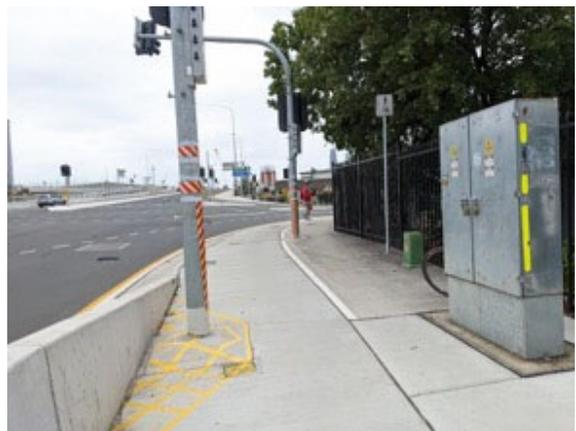
Item	Problem	Recommendation	Illustration
12	Poles and signal boxes on City West Link near James Craig Rd intersection obstruct the shared path, presenting a hazard to cyclists	Move the signal box back to the fence to allow more space for cycle movement.

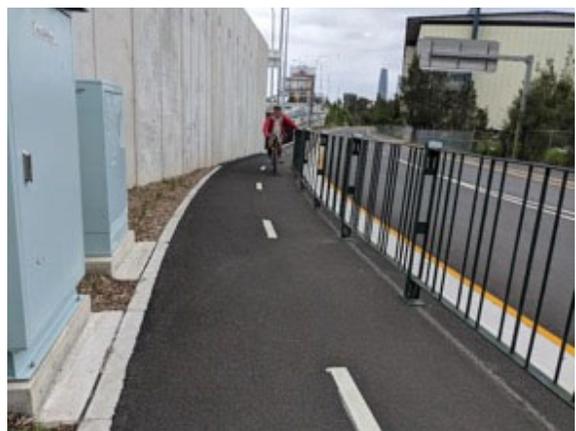
13	Newly constructed shared path adjacent to James Craig Rd is narrow, not complying with Austroads specifications. NB that the adjacent motor traffic lanes are 5m wide.	Improve width to standards,

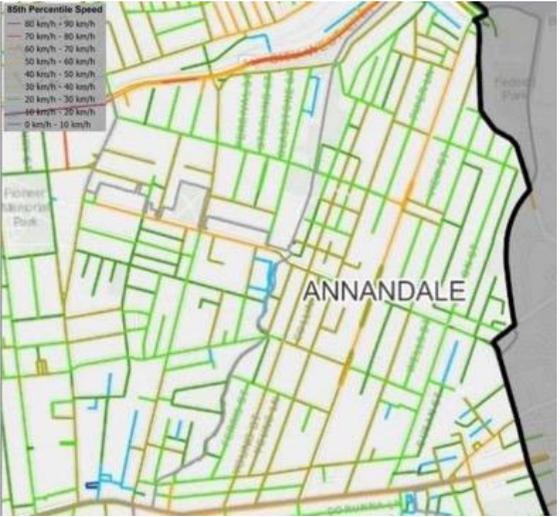
Item	Problem	Recommendation	Illustration
14	<p>Current 50km/h speed limits on streets adjacent to the Rozelle Parklands are too high, given the changed usage and character of the area</p>	<p>Lower speed ratings on Gordon St (from Victoria Rd to across Lilyfield Rd into Parklands), Brenan St and Railway Pde, and Lilyfield Rd from Victoria Rd to Ryan St. These could be candidates for Low Traffic Neighbourhoods and should be progressively lowered to 30 km/h.</p>

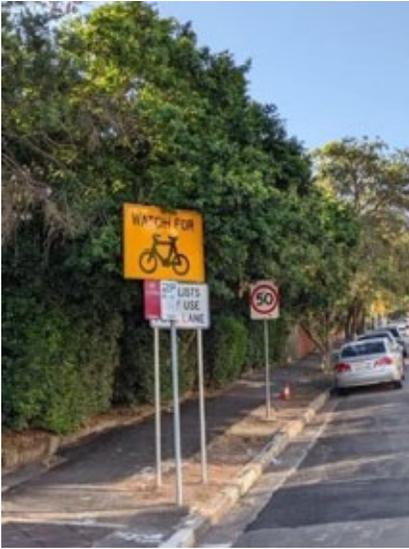
15	<p>Gordon St uphill cycle route is unsafe. Speed cushions are a hazard to cyclists, encouraging them to track too close to parked cars or too close to the centre of the road</p>	<p>Provide differential lane treatment on Gordon St northbound between Lilyfield Rd and Victoria Rd. Remove car parking on the west side and provide a clear delineated cycle lane. Consider a 30km/h speed limit for this congested street.</p>

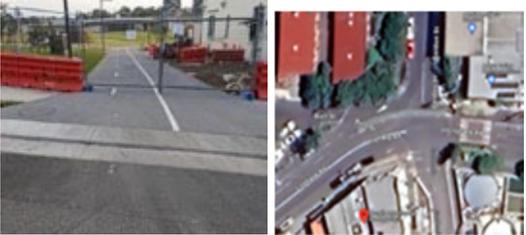
Item	Problem	Recommendation	Illustration
16	Gordon St entrance unsafe	<p>Redesign Gordon St/Lilyfield Rd intersection to cater for new usage. Move the raised section to the centre of the intersection. Remove northbound slip lane into Gordon St. Provide for right turn cycle movement off Lilyfield Rd into Parklands. Provide safe northbound exit of Parklands across Lilyfield Rd into Gordon St by cyclists. Remove dangerous lip on driveway into Parklands.</p>

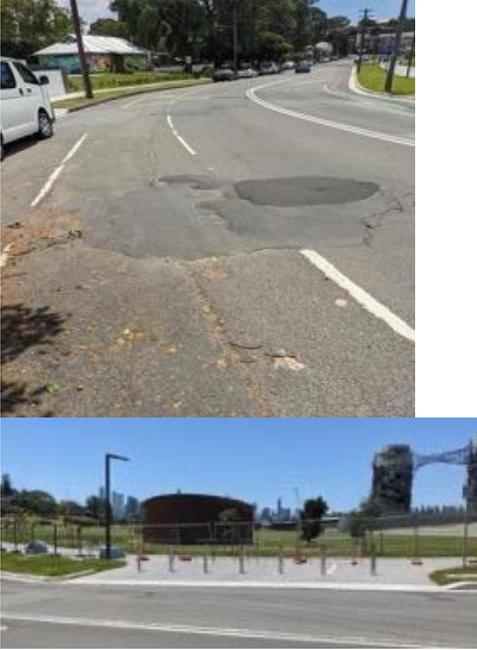
17	Easton Park entrance to Parklands has no safe crossing of Lilyfield Rd	<p>Provide a safe combined bicycle and pedestrian crossing approximately near the changing sheds in Easton Park that links to paths in Easton Park.</p>

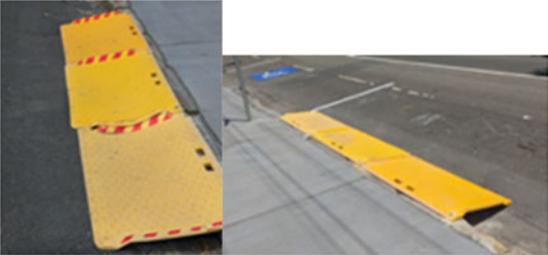
Item	Problem	Recommendation	Illustration
18	Ryan St/Lilyfield Rd access to Parklands is temporary and dangerous.	Provide a properly designed entrance that has good sight lines, adequate warning to motor traffic, a safe, combined bicycle and pedestrian crossing with smooth mesh ramping to cope for pedestrians, disabled users and cycle riders.

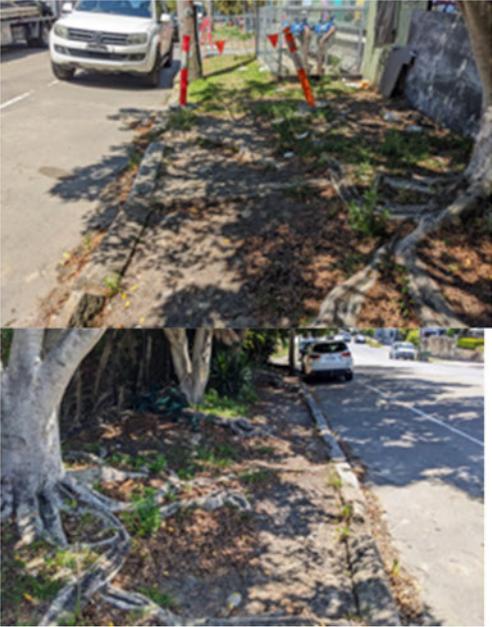
Item	Problem	Recommendation	Illustration
19	Lilyfield Rd footpath on south side of road from Ryan St to Catherine St has no paved path and has dangerous tree roots	Improve pedestrian access to Parklands to/from Lilyfield Light Rail stop by providing a paved footpath or boardwalk as appropriate.

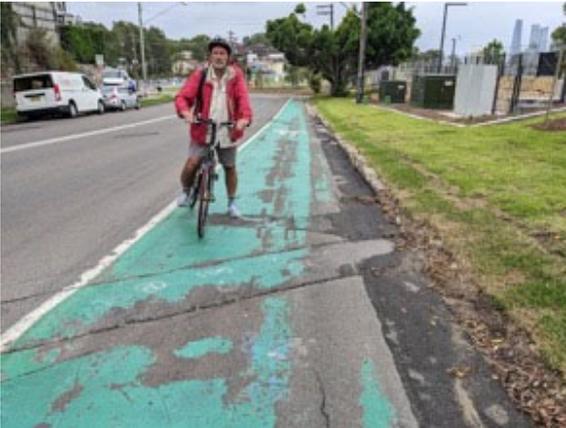
20	Poor quality of cycle lane pavement on Lilyfield Rd not remediated after construction	Remediate Lilyfield Rd pavement and restore cycle lane markings.

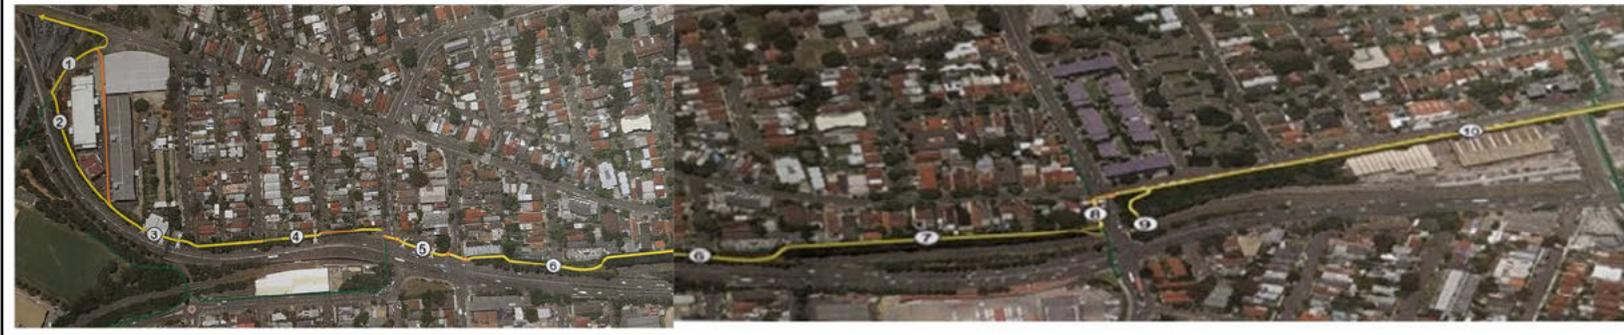
Item	Problem	Recommendation	Illustration
21	<p>Although the Parklands has two good north/south connections, western access beyond Ryan St is not considered. The Lilyfield Rd gradient between Hawthorne Canal and James St intersection presents a challenge for inexperienced cyclists</p>	<p>Investigate an off-road route between Hawthorne Canal and Balmain Rd intersection in a corridor between the City West Link sound wall and adjacent properties, offering a preferable gradient (<i>see B Ashley Plan - 2019 below</i>)</p>

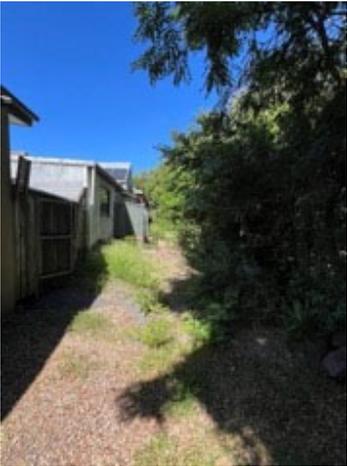
Item	Problem	Recommendation	Illustration
22	Lilyfield Rd between Derbyshire Rd and Balmain Rd has space limitations for a bi-directional cycleway due to potential loss of parking	Investigate a safer off-road route from Derbyshire Rd to the Balmain Rd intersection between the City West Link sound wall, the Light Rail corridor and adjacent properties.

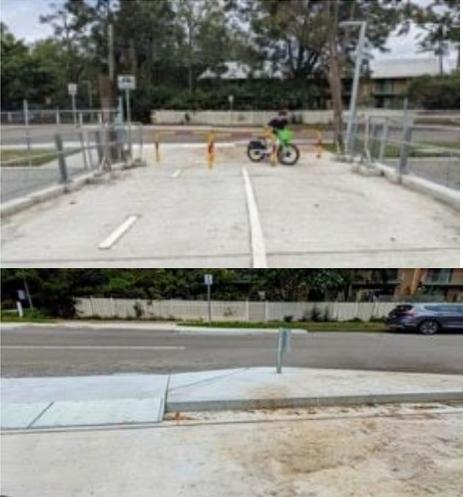
23	Parklands access at Brenan St Lilyfield is complicated and inadequate, with bollards presenting a cycle hazard, especially for larger 'cargo' bikes	Provide a safe combined bicycle and pedestrian crossing on Railway Pde that links Parklands to Whites Creek path, Brenan St and Railway Pde. Remove dangerous rails and bollards. Extend the grate to cover all of the gutter.

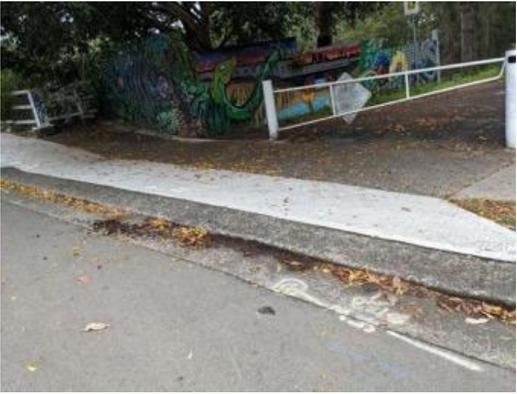
Item	Problem	Recommendation	Illustration
24	Entrance to Whites Creek path (south side of Brenan St) has a lip dangerous to cycle riders	Remove the lip to create a smooth entrance as in pram ramp treatments.

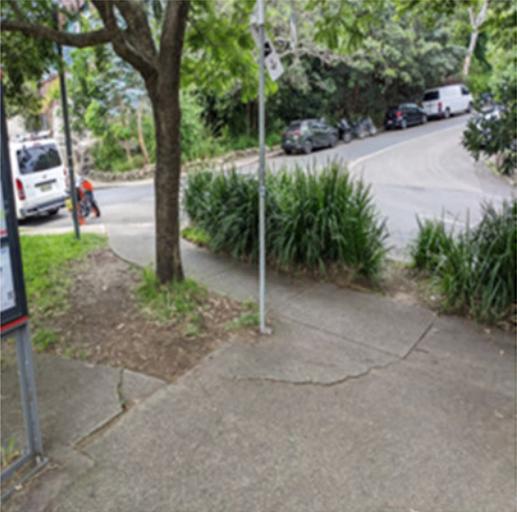
25	Path entrance to Rozelle Bay Light Rail station and Rozelle Bay shared user path from Bayview Cres is awkward and has poor sight lines	Reconfigure entrance to provide better space and safety for pedestrians and cycle users.

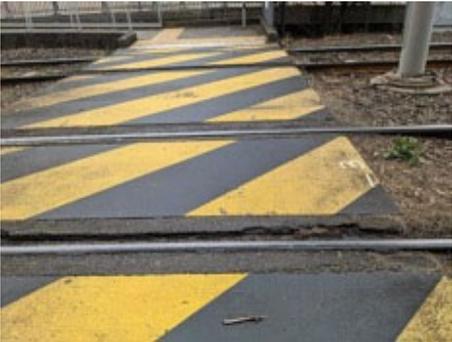
Item	Problem	Recommendation	Illustration
26	Gaps in Light Rail crossing of rails	Consider application of Strails (rubber inserts) currently being trialled by TNSW.

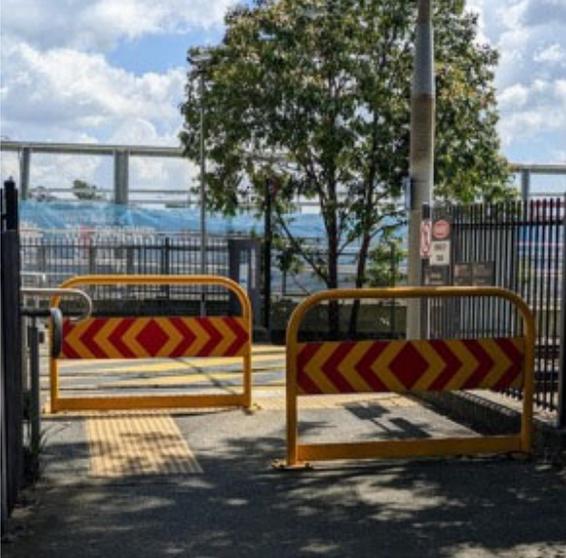
27	Dangerous chicanes at Rozelle Bay Light Rail entrance could cause congestion at peak times for patrons wishing to access the Green Link Bridge to Lilyfield from Annandale	Reconsider layout in the light of rail patrons and through traffic use of pedestrians and cyclists,

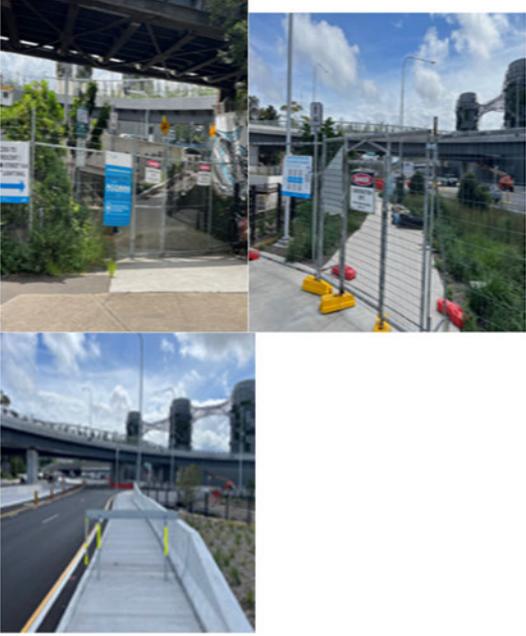
Item	Problem	Recommendation	Illustration
26	Underpass of Light Rail at Railway Pde remains closed stopping access to waterfront path	Open to allow movement of pedestrians and cyclists at grade access to Blackwattle Bay, Rozelle Bay path and James Craig Rd.

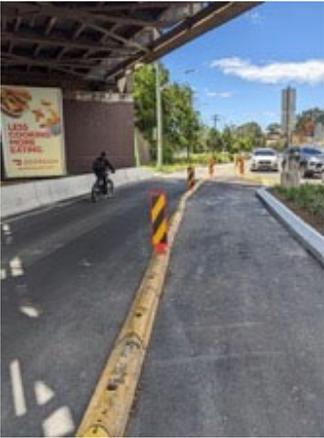
Item	Problem	Recommendation	Illustration
28	Southbound lane on The Crescent under the Light Rail bridge has no cycle lane, despite adequate space available	Provide a cycle lane for cyclists to allow safe south bound cycle movement along The Crescent towards Annandale, Glebe, Camperdown and Sydney University.

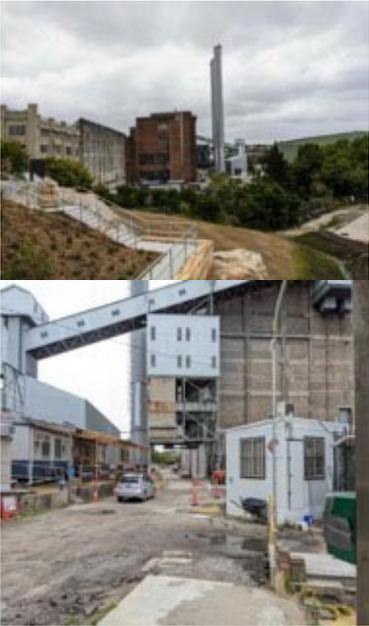
29	No direct access from Parklands to White Bay Power Station site	Provide a cycle /pedestrian link from the Anzac Bridge cycleway across to Roberts St via White Bay precinct. Would improve Balmain access to the Parklands. Could also be a very useful active transport link for upcoming and future Biennale exhibitions patrons.

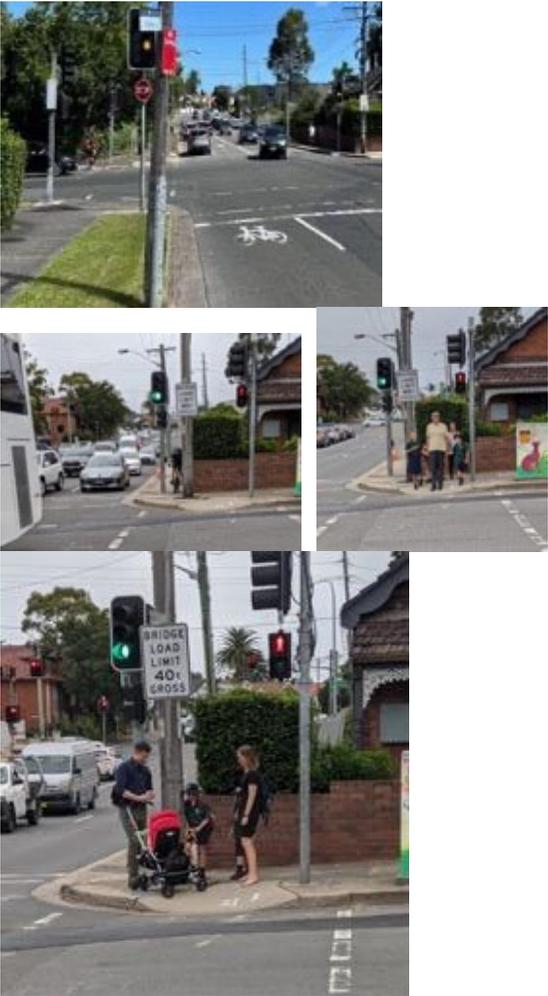
Item	Problem	Recommendation	Illustration
30	<p>Balmain Rd and City West Link intersection is relevant to Parklands and was caused by previous bad RTA practice from poor intersection design oblivious to pedestrian and cycle needs</p>	<p>Reconfigure lanes and unused footpath space on east side of rail bridge and CWL crossing to facilitate continuous north/south safe cycle movement on <u>both</u> sides of Balmain Rd.</p> <p>Remove power pole on corner of Balmain Rd and Lilyfield Rd to create waiting space for pedestrians and young cyclists attending Orange Grove School, Callan Park and Bay Run.</p>

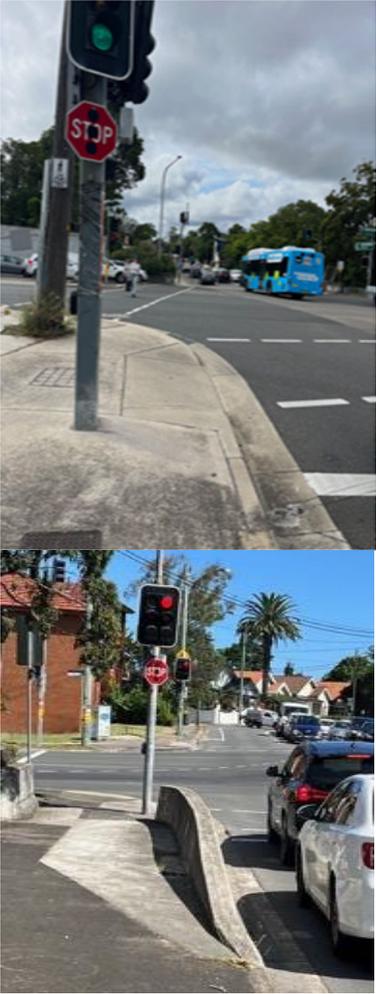
Item	Problem	Recommendation	Illustration
31	<p>Cycle lanes on Balmain Rd between City West Link and Lilyfield Rd are discontinuous, making this a barrier to safe cycle movement across this major intersection. TNSW and its forebears (RTA) caused this problem when the CWL was built.</p>	<p>Reconfigure lanes and unused footpath space on east side of rail bridge and CWL crossing to facilitate continuous north/south safe cycle movement on <u>both</u> sides of Balmain Rd.</p> <p>TNSW has the authority to fix this problem.</p>
