MINISTRY OF TRANSPORT

WATERFALL

31 January 2003

FINAL REPORT

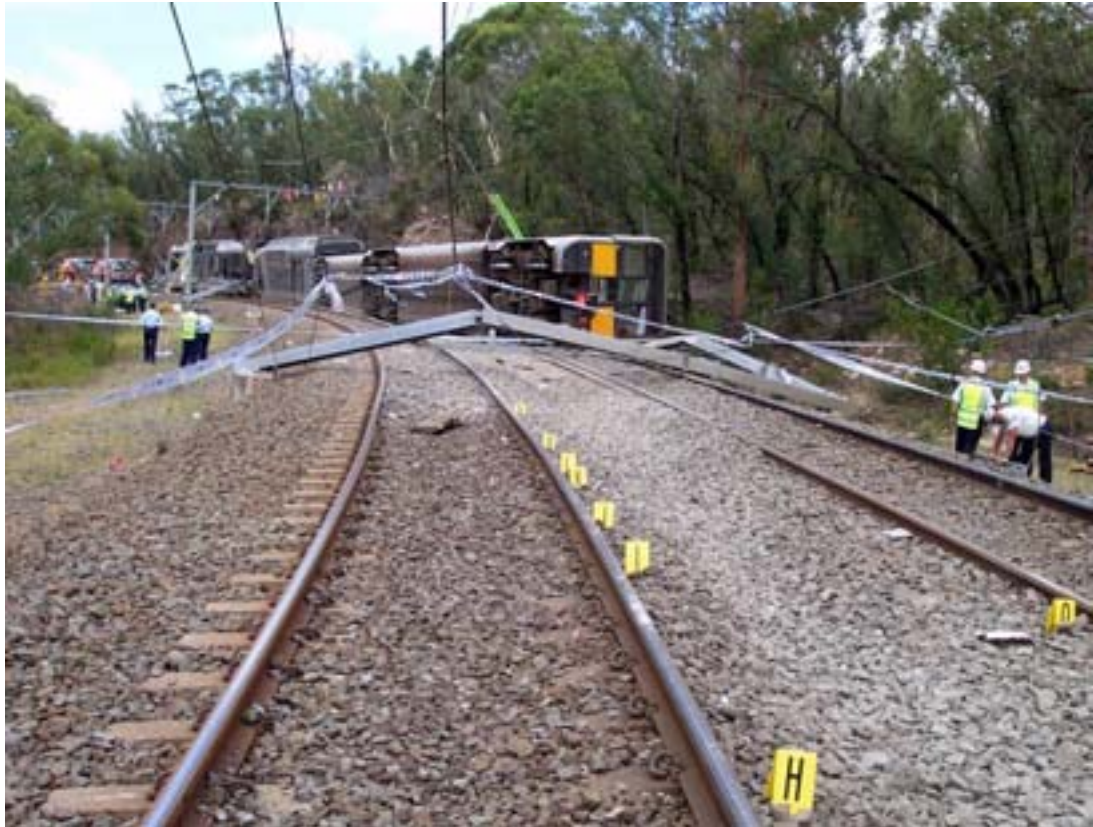
Picture 2: *View of accident site from where the train left the Down track.*

Independent simulations and analyses were carried out based on the observed status of the track and probable configuration of the train. These indicated that the train was travelling at a speed of approximately 117 km/h when the roll-over sequence began. Many of the passengers interviewed by police indicated that after Waterfall Station the train had travelled a lot faster than normal as it approached the left curve. Many passengers also

commented that there was no noticeable deceleration, or braking, before the train rolled over.

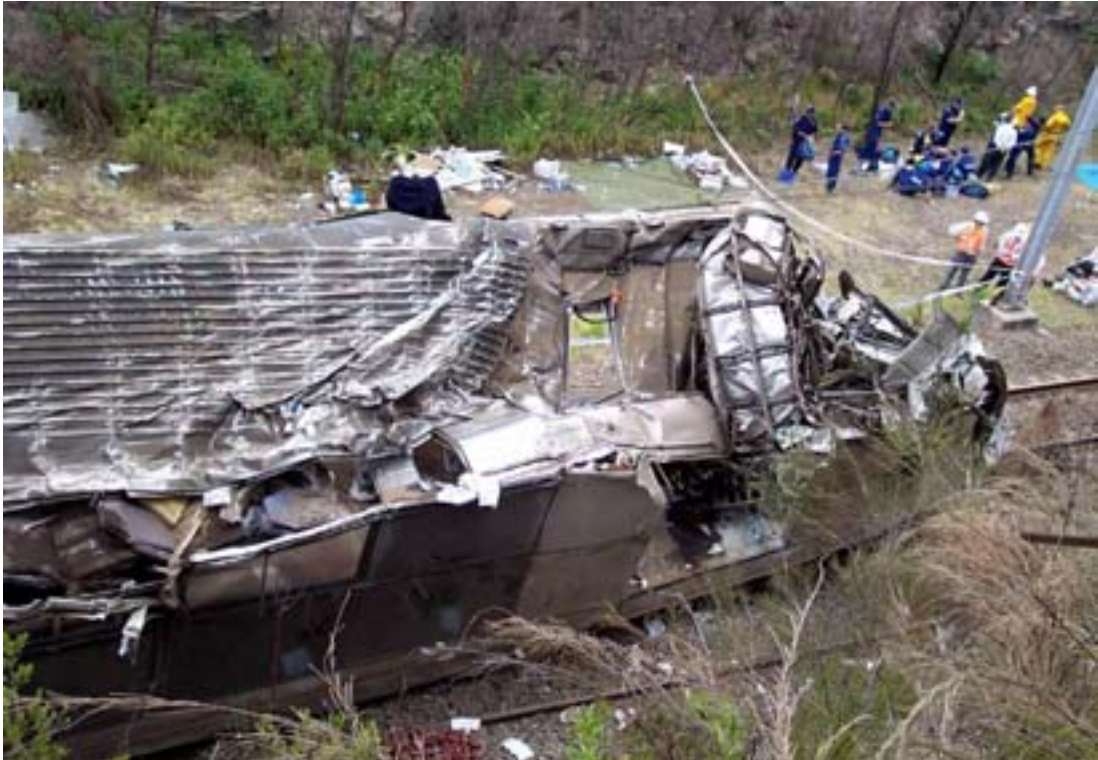
Picture 3: *Impact damage to the first carriage.*

Shortly after rolling over, the leading carriage hit stanchion SW40+805, which supported overhead wires. It then impacted the face of a rock cutting. The leading carriage separated from the train and was righted by the impact, coming to a stop on its wheels approximately 60 m beyond the stanchion footing.

The second carriage also impacted the rock cutting and was also righted onto its wheels. The third and fourth carriages remained on their side with the roof of the fourth carriage impacting and collapsing stanchion SW40+773.

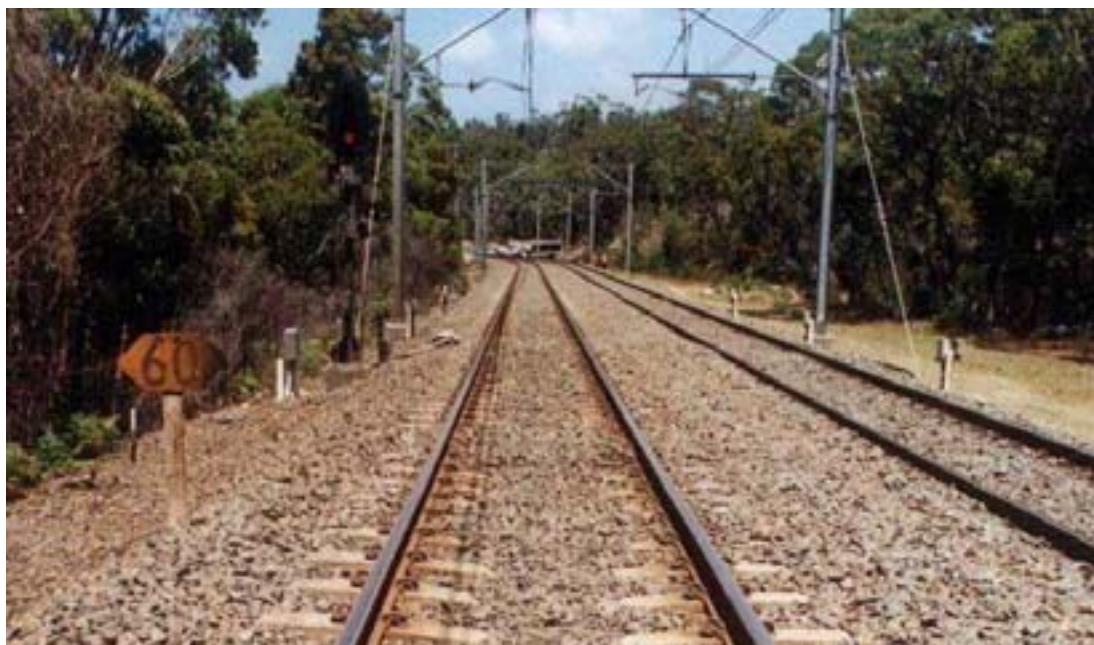
Picture 4: *Driver's view approaching the accident curve.*

The investigation examined the railway infrastructure in detail and found it did not contribute to the cause of the accident.

The investigation of infrastructure identified that the placement of speed boards and the associated construction of SRA timetables required further investigation. These issues are discussed in Section 11 of this report.

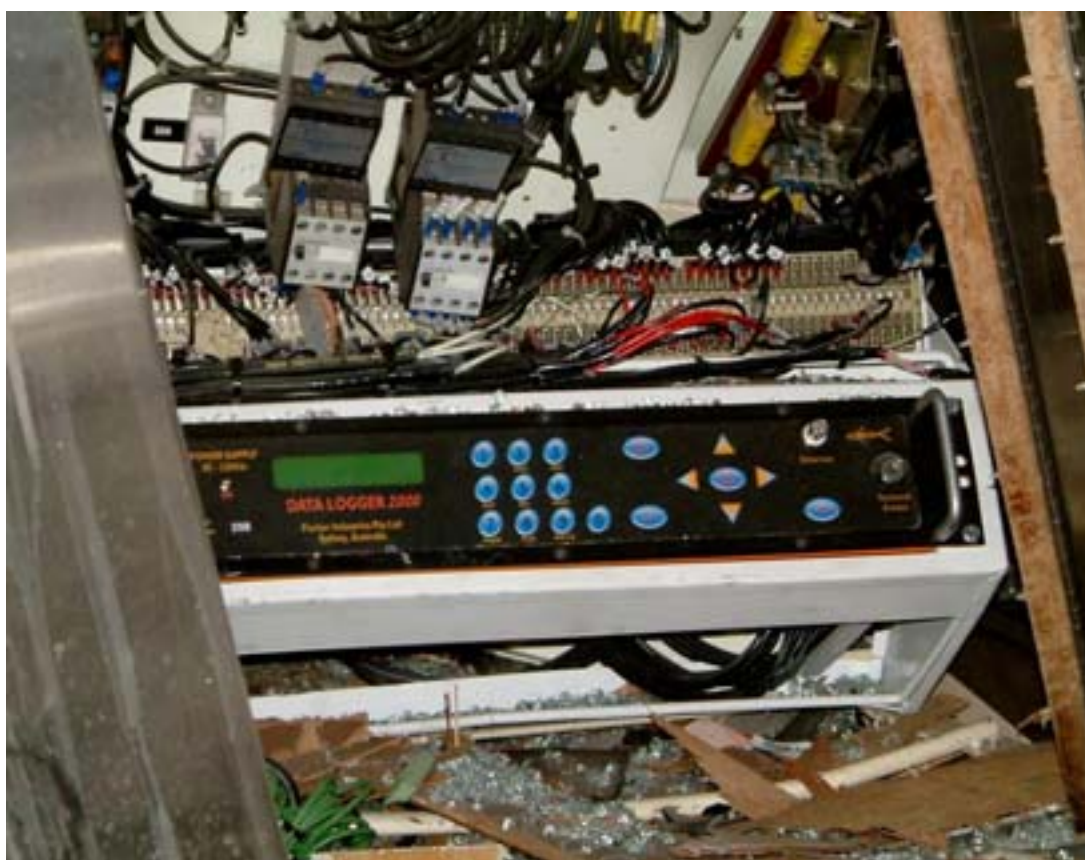
Two data loggers were installed in G7: one in each control trailer car (6831 and 6832). The data loggers were not switched on at the time of the accident. However, the supplier downloaded the devices to identify any data that may have been inadvertently recorded. This did not provide any fault conditions or information concerning the accident.

The data loggers were not switched on because the commissioning process had not been completed.

Picture 5: *Relatively undamaged data logger in the wreckage of car 6831.*

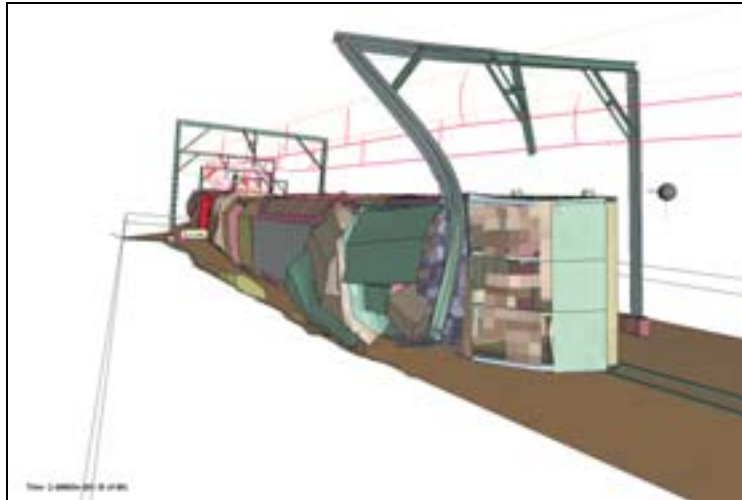
Figure 3: *View of FEA analysis showing concrete footing separating from Stanchion SW40+805 during the accident sequence.*

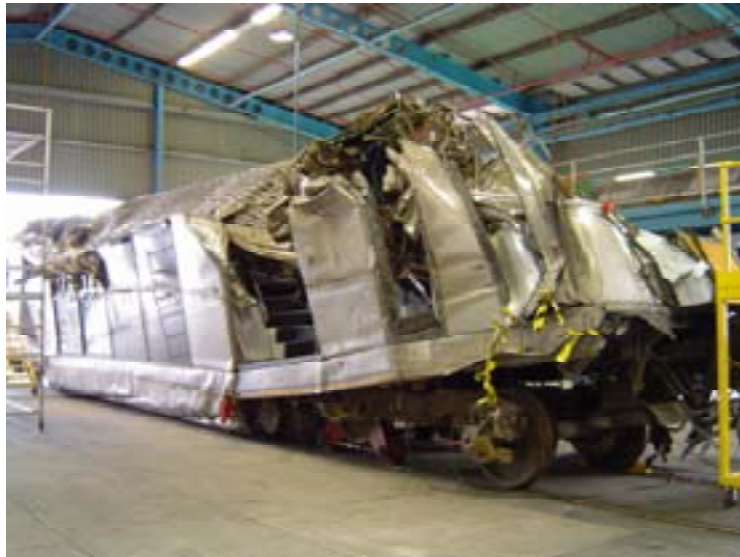
Picture 6 and Figure 4: *Demonstrate the correlation between the FEA analysis and the actual damage sustained.*

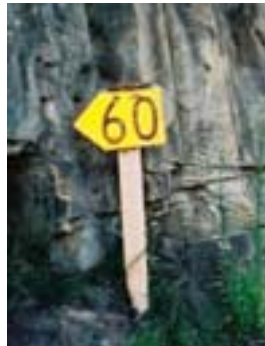
Picture 7: *A typical 60 km/h speed board.*

Some drivers gave evidence that, in general, they drove according to the weather and track conditions prevailing at the time, which may have resulted in them exceeding posted speed limits.

In the past, drivers had operated electric trains without speedometers and had developed the ability to drive at a safe speed based on the condition of the track and their estimation of speed. A number of other factors influenced drivers when deciding how fast to travel. These included unrealistic sectional running times, lack of supervision, errors in posted speed boards or doubts as to the appropriateness of posted speed boards. *See Section 11: Speed Boards and Timetabling.*

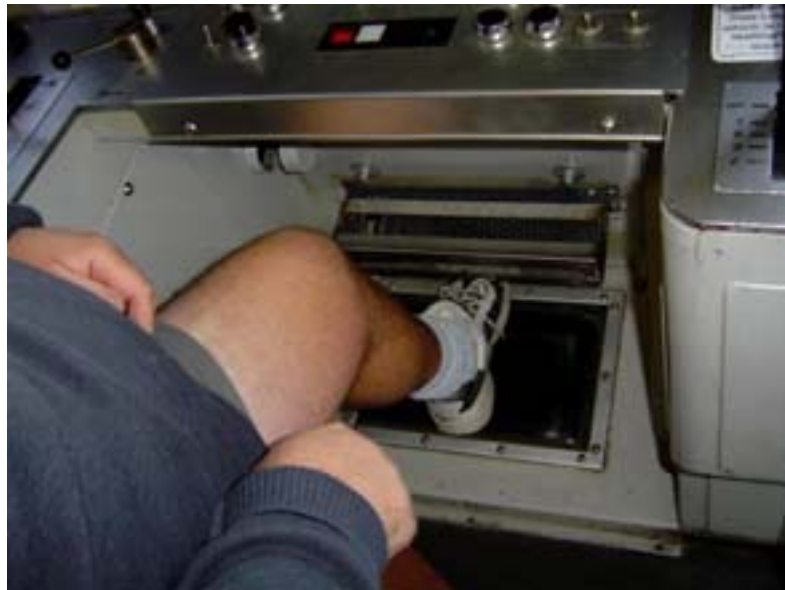
"I find that if I place my feet at the front of the plate, the weight of my legs will hold the deadman during motoring."

Picture 9: *View of deadman system being operated, without effort, by the weight of a seated driver's leg. Note: this train was under way at the time of the photo. Also note proximity of the heater to the top of the driver's foot.*

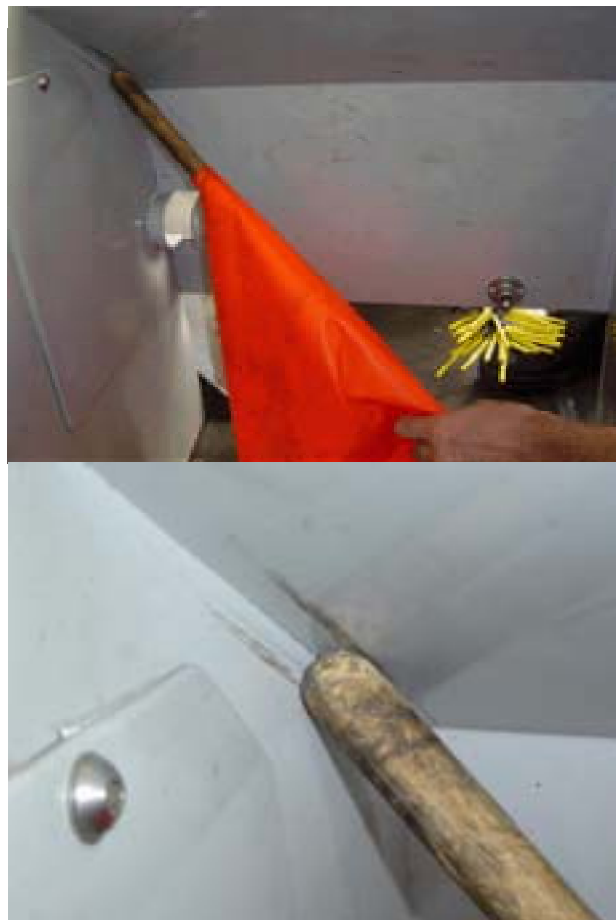
There was anecdotal evidence to suggest that some unofficial train maintenance practices may have utilised the flag or a similar device in a manner that would leave the observed witness marks under any of the driver's desks.

Pictures 10 and 11: Car 6832 foot well with flagstick.

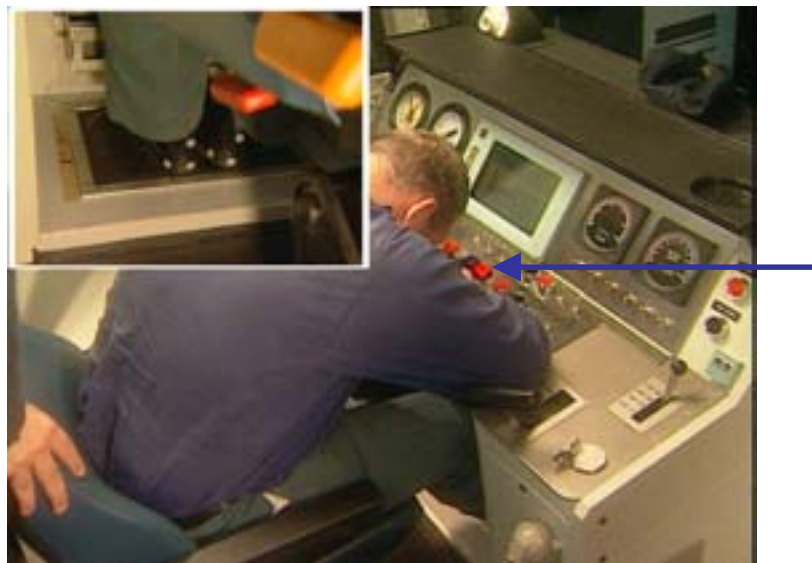
4. A driver with an equivalent body mass to the C311 driver was able to circumvent the deadman foot control involuntarily by wedging either one or both feet between the foot heater unit and the deadman pedal on the G7 set.

Picture 12: *Driver feigning incapacitation with both feet on the deadman pedal. Note arrowed light indicating that the deadman system was suppressed in these conditions.*

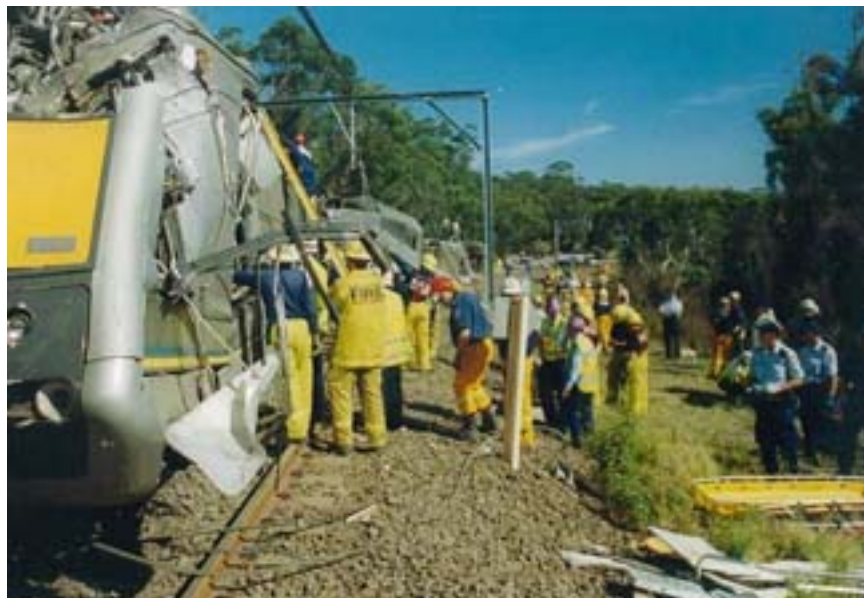
Picture 13: *Rescue operations taking place.*

The Regulator did not assume full control of the site at the transition from emergency response to investigation phase. Some evidence was not obtained from the accident site, which added to the cost and duration of the investigation.
