## FERRY SAFETY INVESTIGATION REPORT

# COLLISION OF THE MANLY FERRY *COLLARROY* NUMBER 3 WEST WHARF, CIRCULAR QUAY 4 MARCH 2005

**OTSI File Ref: 03545**

**25 November 2005**

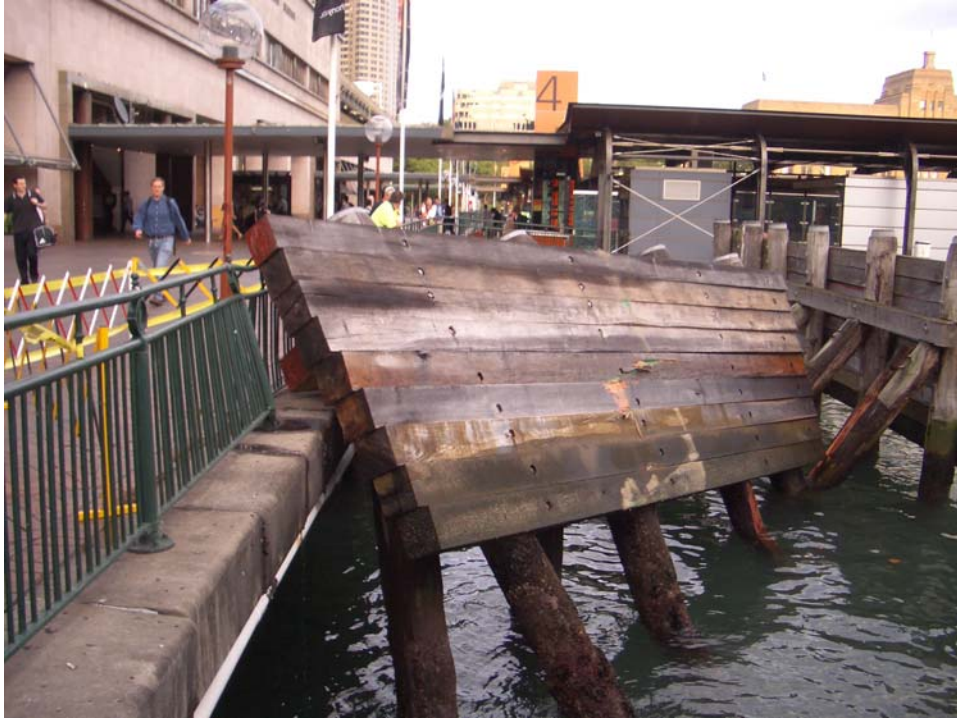
**Figure 2: Damage to the Backboard at No. 3 West Wharf**

- 2.3 The master reported that he was less than a vessel length (69.5 metres) from his intended berth when he noticed that *Collaroy's* speed was increasing, rather than decreasing, in response to his ordered control setting. He attempted to regain propulsion control by repeating the required setting several times, but the ferry did not respond and subsequently collided with the timber backboards or 'buffers' at the end of the berth. The backboards absorbed the force of the collision before collapsing against the promenade breastwork. Figure 2 shows the impact damage.
- 2.4 According to the master, the primary propulsion control system then spontaneously self-corrected, at which time he regained control and secured the ferry at its berth.

2.7 The *Collaroy* sustained minor scrapings to the above and underwater painted surfaces around its bow area and a zinc anode was torn off. Underwater divers confirmed that there was no visible distortion to the bow propeller or rudderstock. A section of the timber buffer was extensively damaged. Sydney Ferries' operations were affected by the *Collaroy's* withdrawal from service and the closure of No.3 West Wharf for one and three weeks respectively.

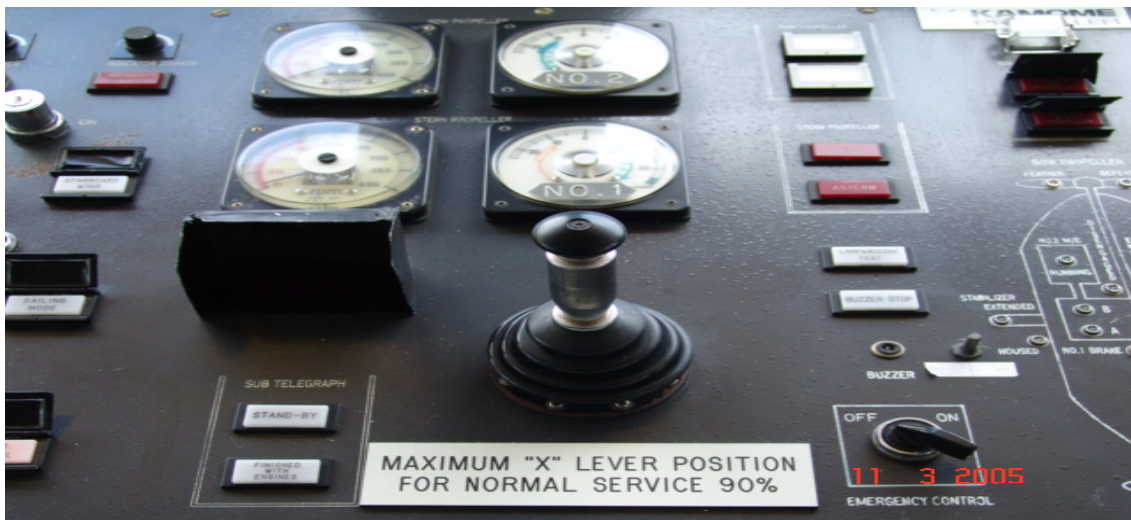
Figure 7: Showing the X-Y lever and Emergency Control Switch

3.1 Manly ferry masters navigate by eye and draw upon their experience, judgement and developed motor skills to manoeuvre their vessels into and out of wharves. The Freshwater class ferries have control systems and handling characteristics that are more complex than other vessels operated by Sydney Ferries. The master uses a control, known as the X-Y lever, to adjust the vessel's advance towards its position opposite the embarkation ramps at the dead-end berths. The X-Y lever is shown at Figure 7.

- 3.18 While the emergency mode comes on-line immediately a master switches the Emergency Control Switch to 'on', the initial effect of such an action is to bring the on-line propulsion engine up to 600 rpm very quickly. However, propeller pitch settings remain as they were immediately prior to the selection of Emergency Control. This option would have had to have been exercised by the master almost immediately after the onset of the failure to have had the desired effect

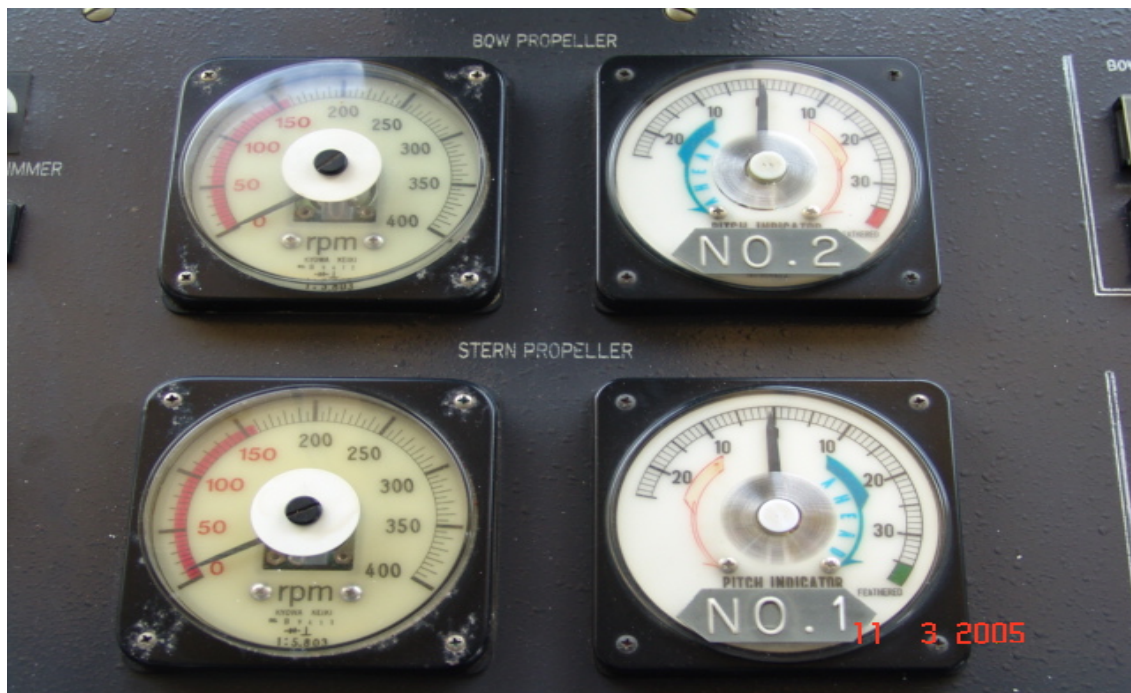
Figure 8: Gauges, available to a master, indicating pitch settings

- 3.3 The other aids to propulsion, steering and navigation available to the master of the *Collaroy* are radar and the bridge instrument console which houses the propulsion and steering control gauges that indicate each of the vessel's rudder and propeller pitch settings. There is no analogue or GPS speed indicator to confirm the master's visual estimation of his vessel's closing rate towards the berth. The pitch setting gauges are shown at Figure 8.

- 3.5 The key aspects of the master's description of events were corroborated by the information contained in the recordings of the *Collaroy's* data loggers. They show that during the final approach phase, the pitch setting of the bow propeller, known as No.1, did not respond to a series of commands from the master. Further, instead of slowing the vessel, the No.1 propeller set to a pitch that drove the vessel ahead. After a delay of 28 seconds, during which the master repeated his original command a number of times, the No.1 propeller began to provide the reverse braking thrust ordered by the master. A further 22 seconds elapsed before No.1 propeller assumed the 30-degree blade pitch setting needed for full reverse thrust. During this time the ferry struck the backboard.

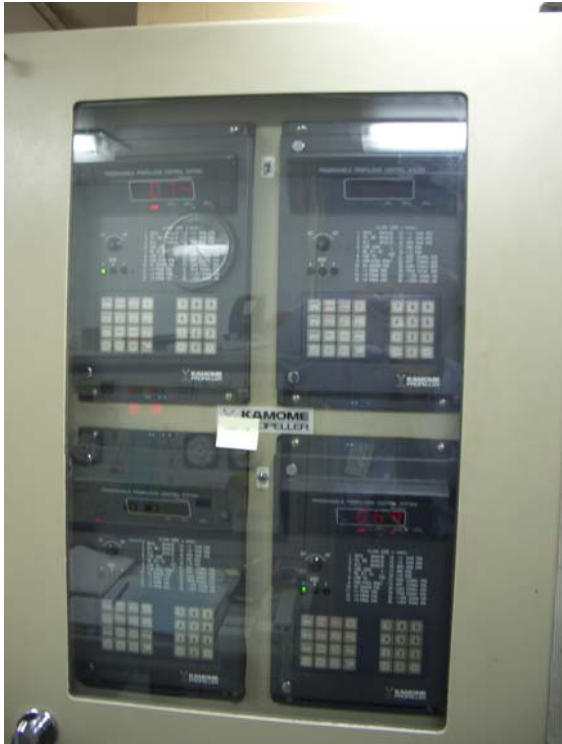
Figure 9: ProCon Cabinet

- 3.9 *Collaroy* is fitted with a “Kamome” propulsion control system and relies on four electronic logic units, known as Programmable Logic Controllers (ProCons). The units are designated 1A, 1B, 2A and 2B and are housed in a cabinet as shown in Figure 9 *overleaf*. Two ProCon units are assigned to each propeller, so that at any time the vessel is in operation, each propeller has one of these units on-line and the other in stand-by mode. Normally, ProCon units 1A and 2A are used as the on-line operating controllers and units 1B and 2B are in stand-by mode.

- 3.14 Eventually, a simulation which fed false inputs into the ProCon system, did replicate the 4 March failure and revealed that ProCon unit 1B had failed. The logic cards, in effect circuit boards, in the ProCon were subsequently replaced with new cards. *Collaroy* was then subjected to a series of sea trials which were completed without fault. Further analysis established that at the time of the malfunction, ProCon units 1B and 2A were being employed by the master, instead of the normally used 1A and 2A units. More significantly, it was also established that ProCon units 1A and 2B were not switched on. This meant that when unit 1B failed, there was no prospect of the master receiving an audible warning alarm, or of a back-up ProCon unit being automatically brought on-line.

3.15 Sydney Ferries advised OTSI that they had been experiencing thermally-induced faults in the ProCon's electronic logic-card circuitry over a period of several months and that Sydney Ferries' technical support staff were aware of the situation. The problem, believed to be caused by the ProCon units being subjected to repeated cycles of heating and cooling after being switched on and off on a daily basis, was usually only apparent during morning start-ups whilst the propulsion control system warmed-up. Loud warning alarms would sound in the vessel's MCR each time a unit malfunctioned. The problem would typically self-correct before vessels left the Balmain Yard. A senior engineer, on his own initiative, issued a Memo to guide fellow engineers in a modified start-up procedure which, amongst other things, was intended to compensate for the problems that were being experienced within the ProCon units during start-up. Part of the instructions read:

- iv. Require all propulsion control units to be tested on all vessels as part of start-up procedures.
- v. Act to reinforce CRM throughout its organisation and in particular require safety critical issues during start-up and emergency procedures to be the subject of specific communication between masters and engineers.

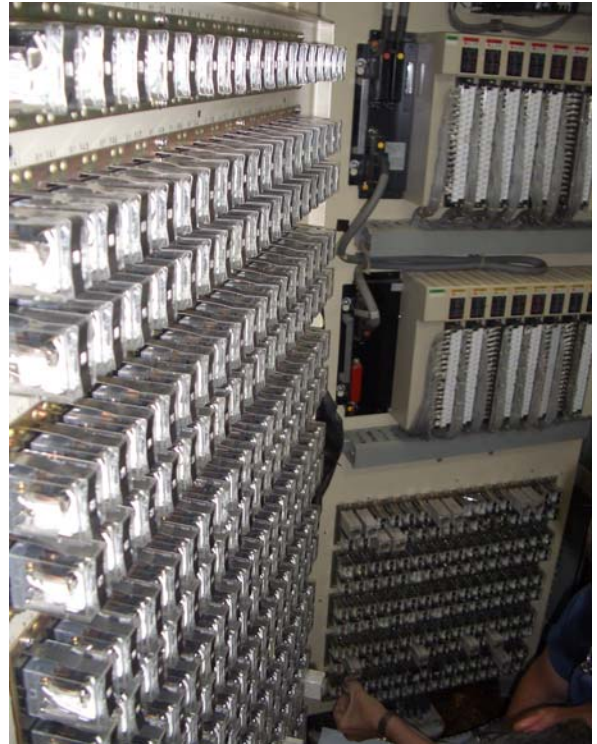
Figure 10: Part of the Kamome propulsion control circuitry

- 3.13 Initially, simulations and a sea trial failed to replicate a loss of control similar to that which occurred on 4 March 2005 and system engineers were subsequently forced to work their way through the entire Kamome system, using a process of elimination. Whilst a number of electrical control relays were found to have high resistances, none could be positively identified as initiating the failure. Detailed analysis of recordings on the data logger identified that the active propeller’s pitch gradually increased even though the X-Y lever remained at the zero position.
