RAIL SAFETY INVESTIGATION REPORT

**DERAILMENT OF CITYRAIL PASSENGER SERVICE
K496**

UNANDERRA

24 JANUARY 2009

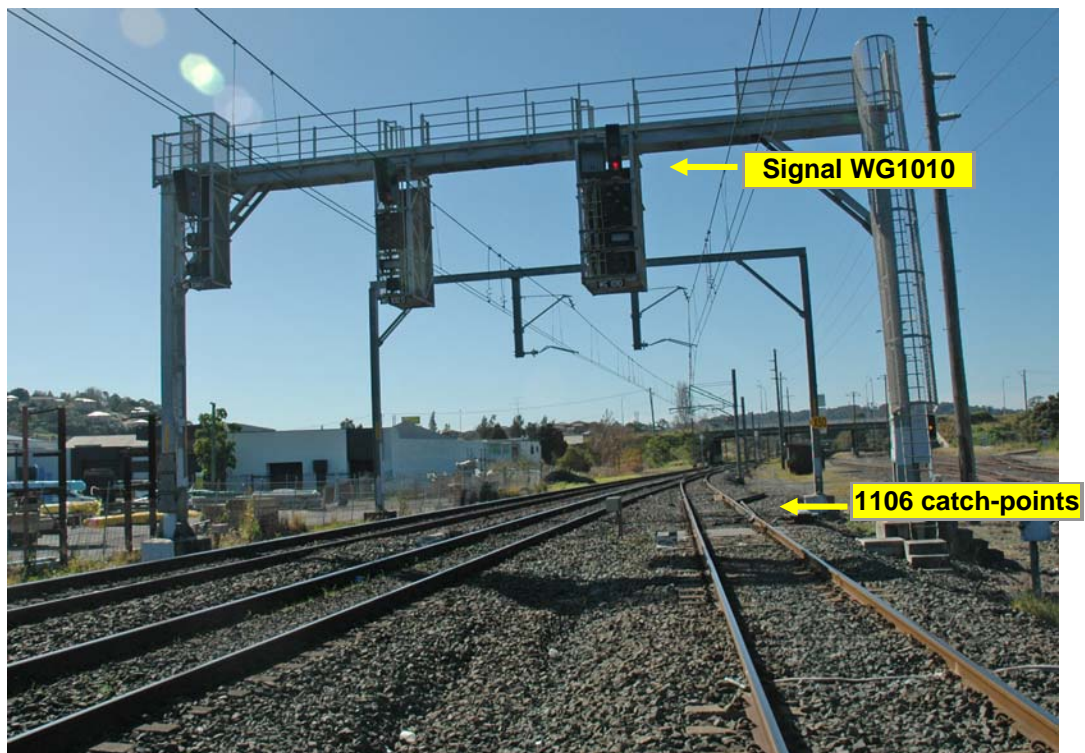
- 1.1 At approximately 2:35am¹ on 24 January 2009, a CityRail four-car Tangara passenger service designated K496, crewed by a Driver and Guard and en route from Kiama to Wollongong, was proceeding via Unanderra Station and Signal WG1010 which was at stop. The Driver heard a loud noise from a passenger disturbance which momentarily distracted him and, as a result, the train passed Signal WG1010 at stop without authority (SPAD). After passing the signal, the train derailed on the catch-points designated 1106 (see *Photo 1*).

Photo 1: Signal WG1010 and 1106 catch-points

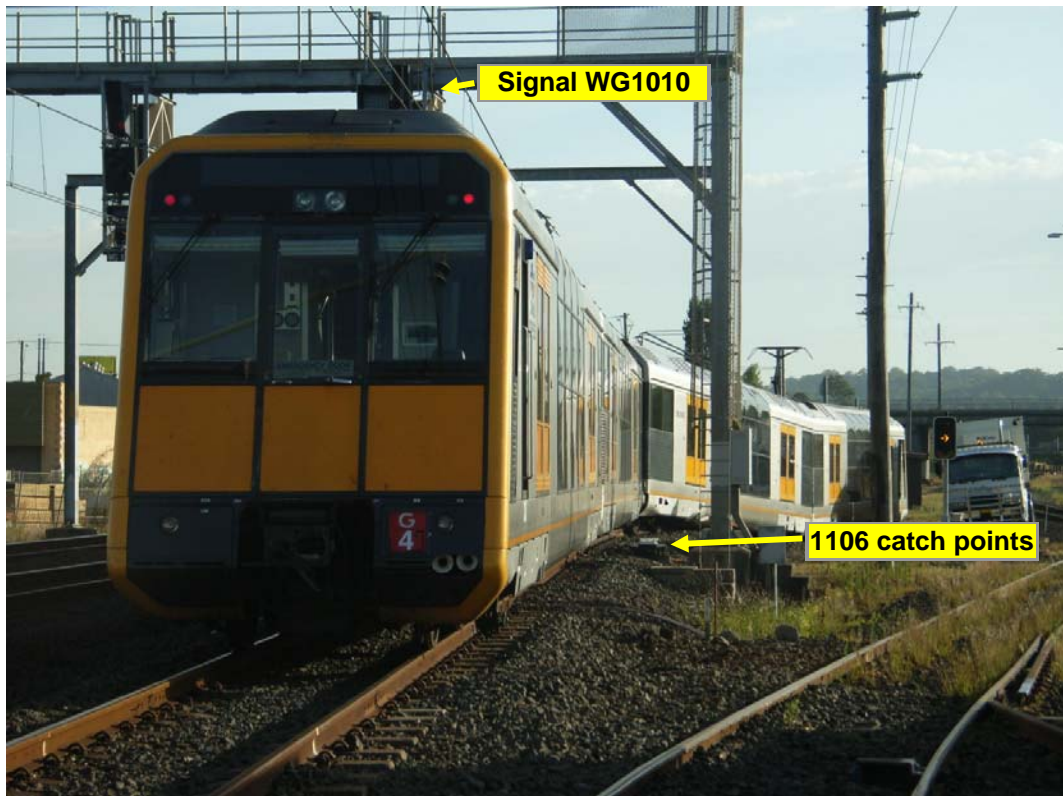
Photo 2: K496 showing front two cars derailed

- 1.2 The leading car of K496 came to rest at 87.880km² approximately 50 metres past the catch-points (see *Photo 2*). Consequently, the first two cars of the train derailed all wheels and the leading bogie of the third car also derailed, while the rear car remained on the track. As a result of the catch-points performing their intended function, a potential collision with an opposing freight service 8938, which was approaching on the 'Down Illawarra' line, was prevented.
- 1.3 There were no injuries to the crew or the four passengers on board, and only minor damage to the train and track.

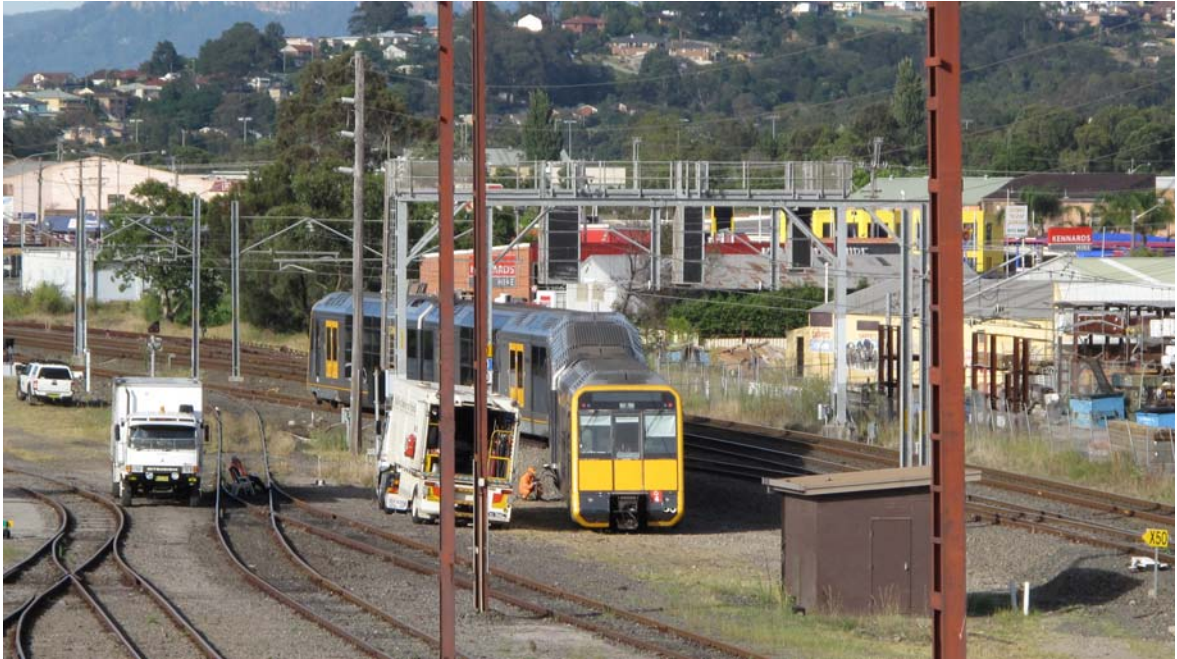
Photo 3: Final position of the derailed train

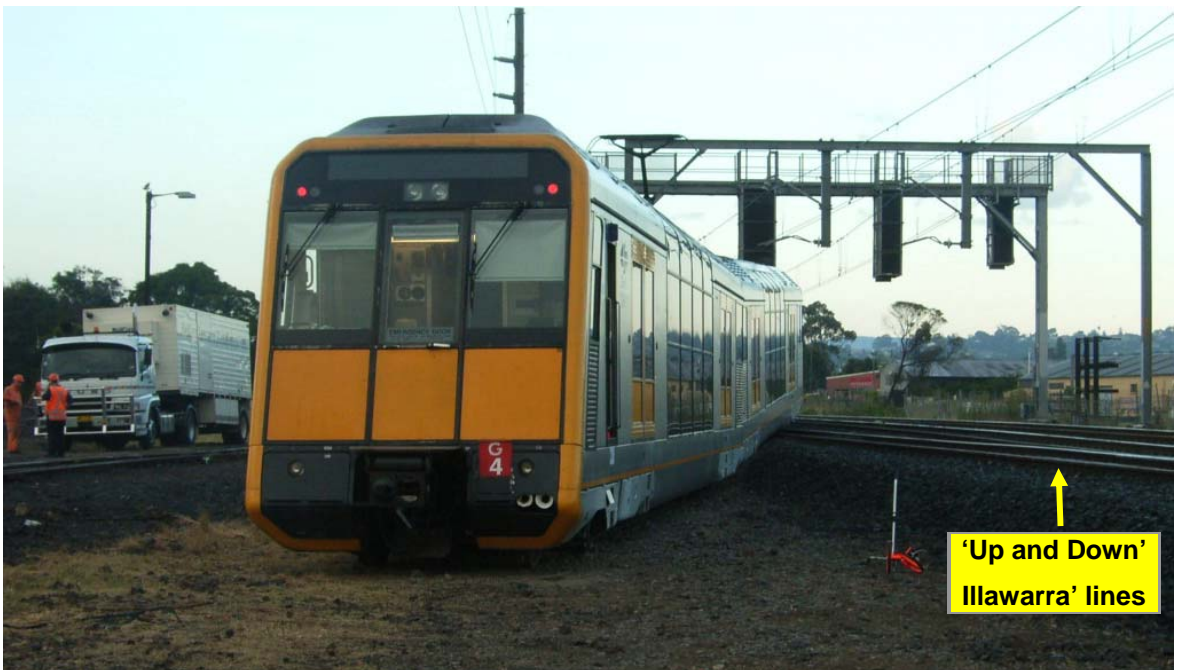
Photo 4: Final position of train relative to 'Up and Down Illawarra' lines

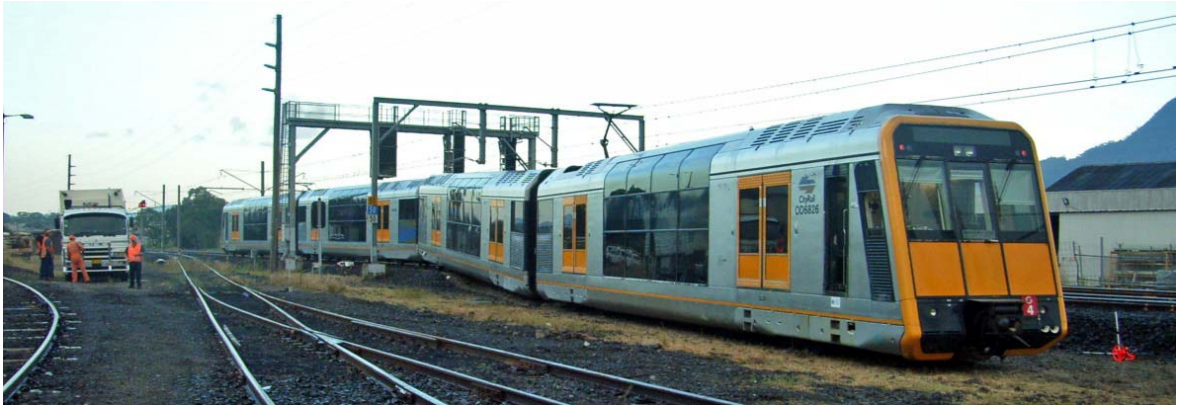
Photo 5: Side view of train

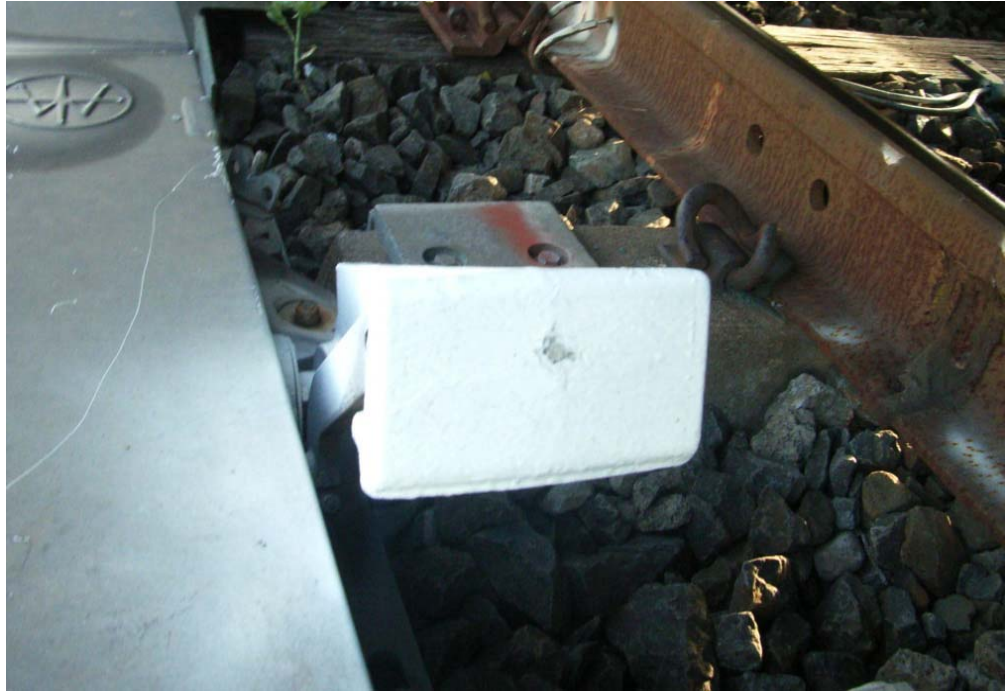
- 2.8 The Driver was looking towards the cabin door when he heard the brake pipe air releasing which was a sign that the train’s trip gear had been activated by the trip arm on Signal WG1010 (see *Photo 6*). Upon hearing the air release from the brake pipe, he immediately turned back around and made an emergency brake application, i.e., moved the brake handle forward from Notch 5 to the Emergency position. However, by this time, the train had already passed Signal WG1010 and was derailing on the catch-points.

Photo 6: Train stop arm at Signal WG1010 showing a fresh strike mark from the trip gear of K496

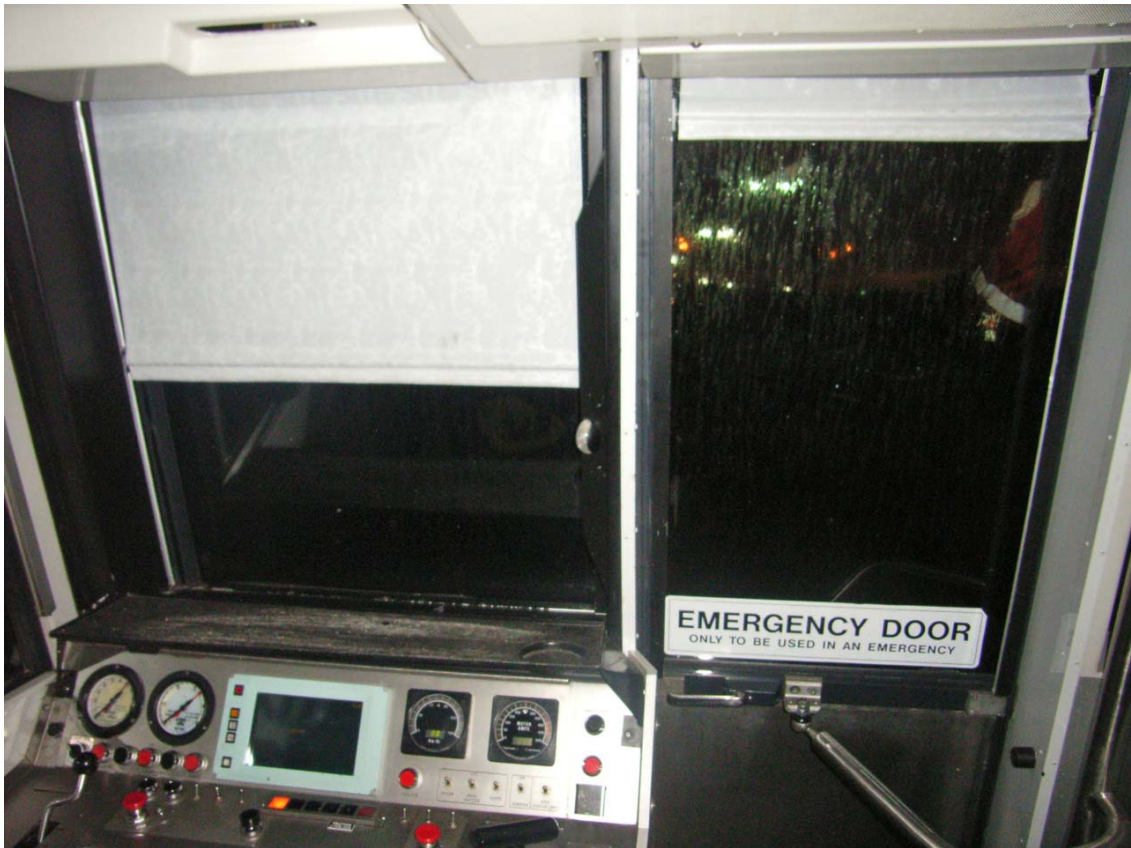
- 2.11 Blinds are provided for all windows in the crew cabs of the Tangara and are adjustable according to crew personal preference (see *Photos 7 and 8*). The Driver stated that the blind on the front window of K496 was drawn down to prevent glare from external light sources affecting his night vision such as street lighting, building lighting and motor vehicles. However, this has the potential to obscure a driver's view of signs, structures and gantry signals. Regardless of the intentions of the Driver, it is likely that, for some period on the approach to Signal WG1010, the blind obscured his view of the Signal.

Photo 7: Drivers blind position on the windscreen and the emergency door

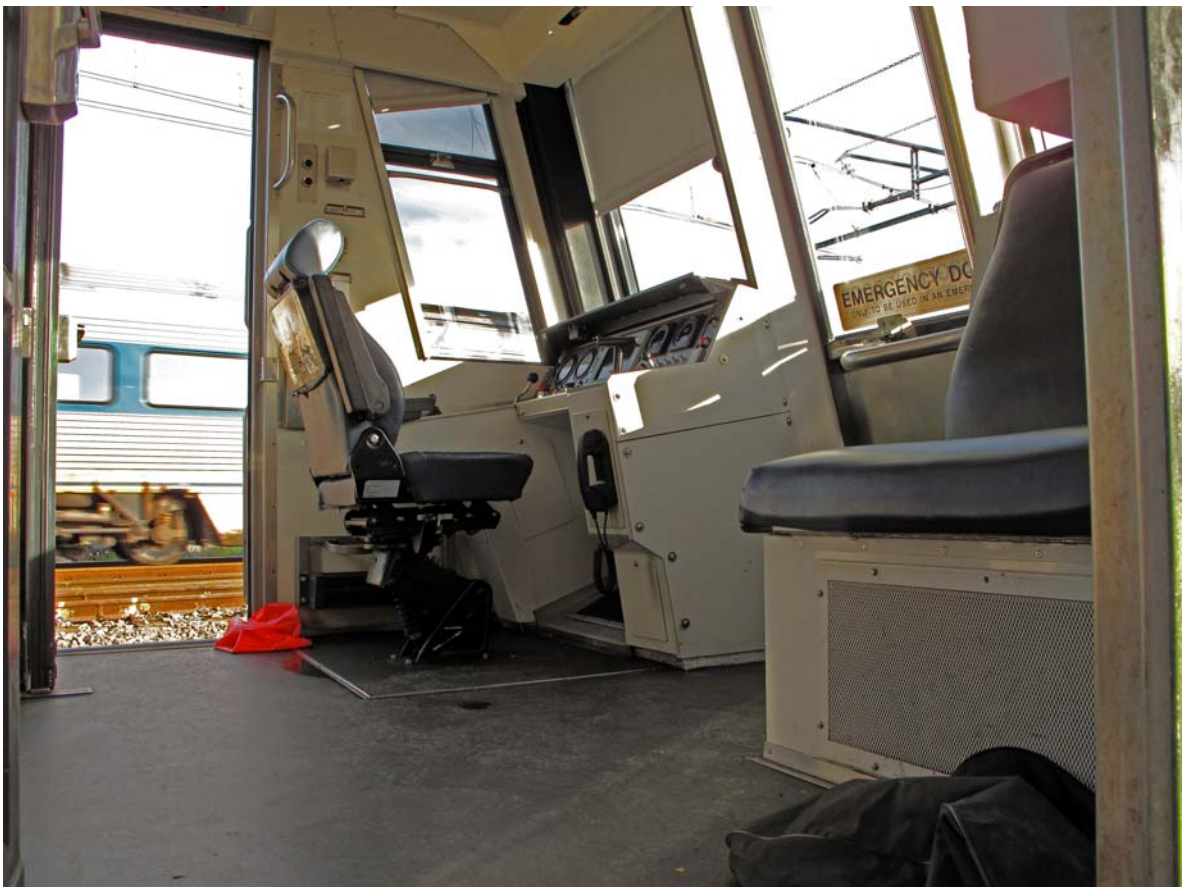
Photo 8: Drivers cab showing seating and blind positions

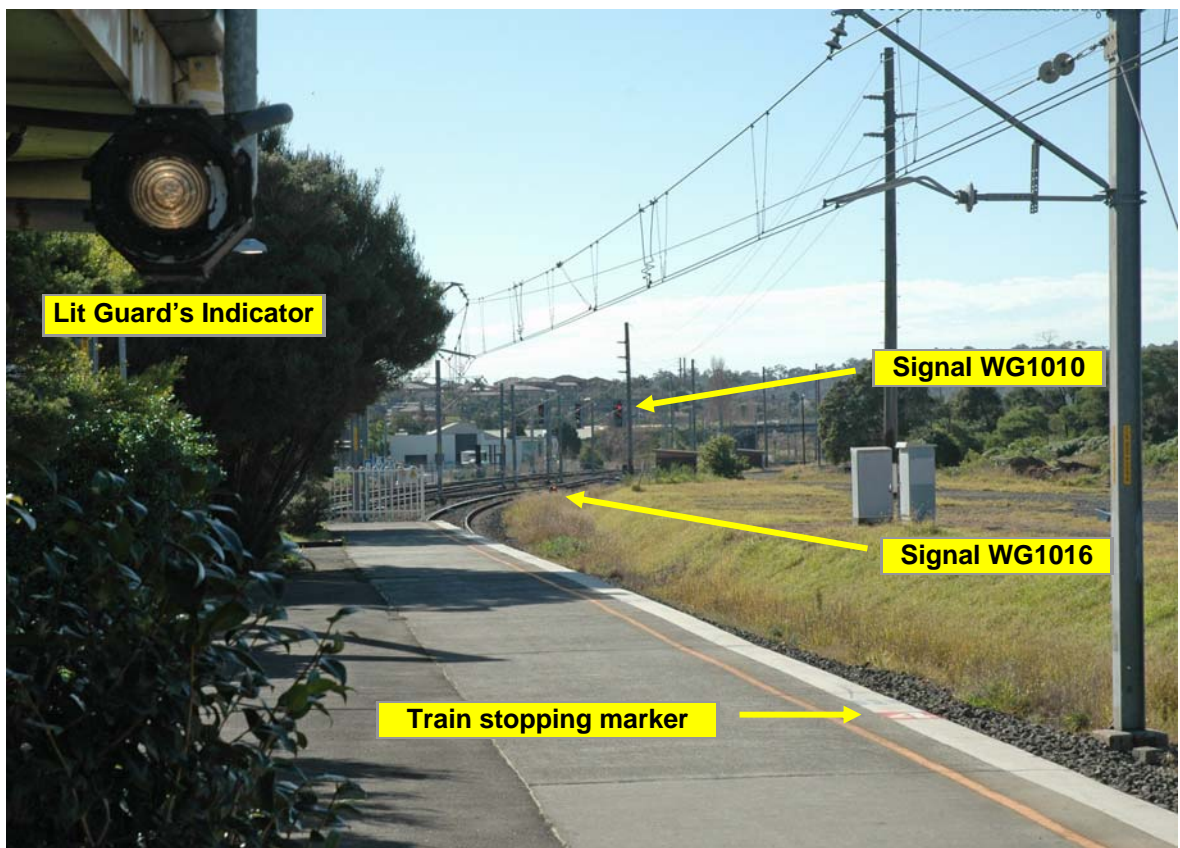
Photo 9: View of Guard's indicator (illuminated), stopping marker and signals visible from Unanderra platform

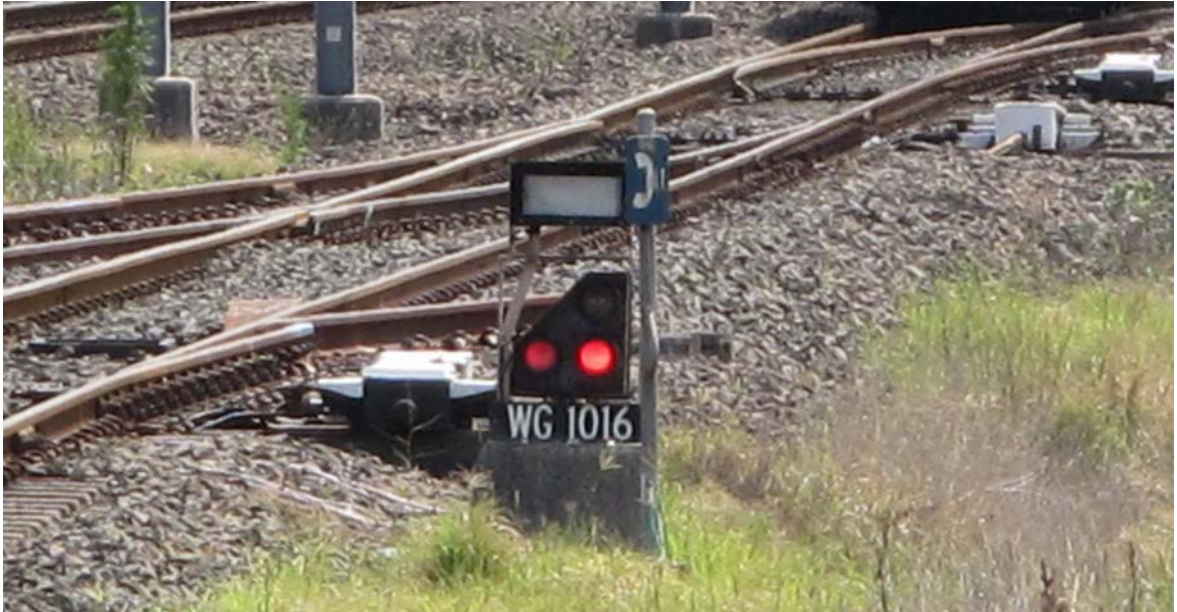
2.12 In contrast, Signal WG1016 is positioned low to the ground and may have remained longer in the Driver's line of sight from departure. (*Photos 10 to 12* depict relative positions and signal combinations.) The combination of the driver not recalling seeing Signal WG1010 upon departure from Unanderra, Signal WG1016 displaying a proceed indication and the blind obscuring Signal WG1010 may have contributed to the Driver being unprepared for the Signal WG1010 stop indication. This would have been reinforced if, as asserted by the Driver, Signal WG1010 was set at proceed on all his previous journeys along this route and so he had never been required to stop.

Photo 10: Close up of Signal WG1016 showing stop indication

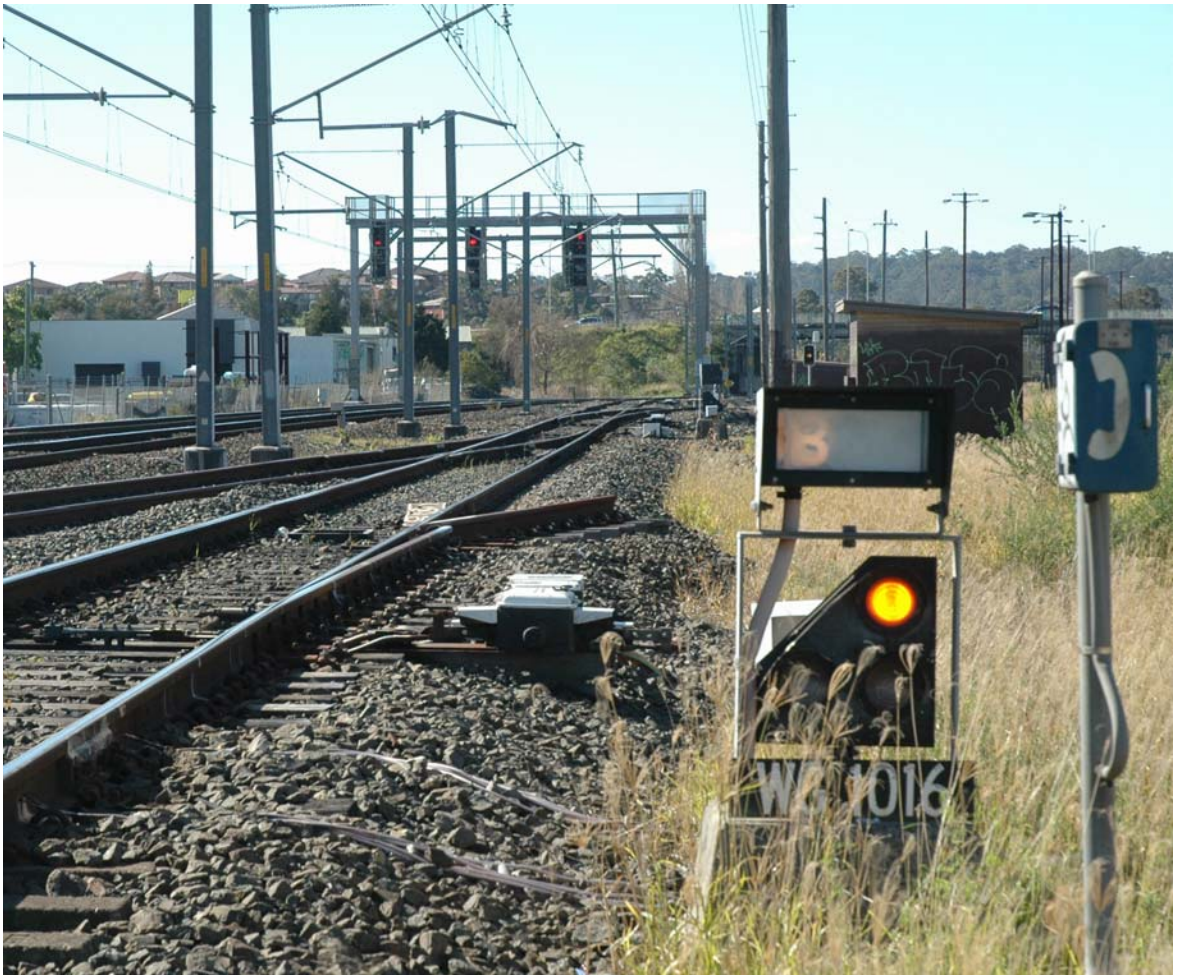
Photo 11: Signal WG1016 showing proceed indication in relation to signal WG1010 at stop

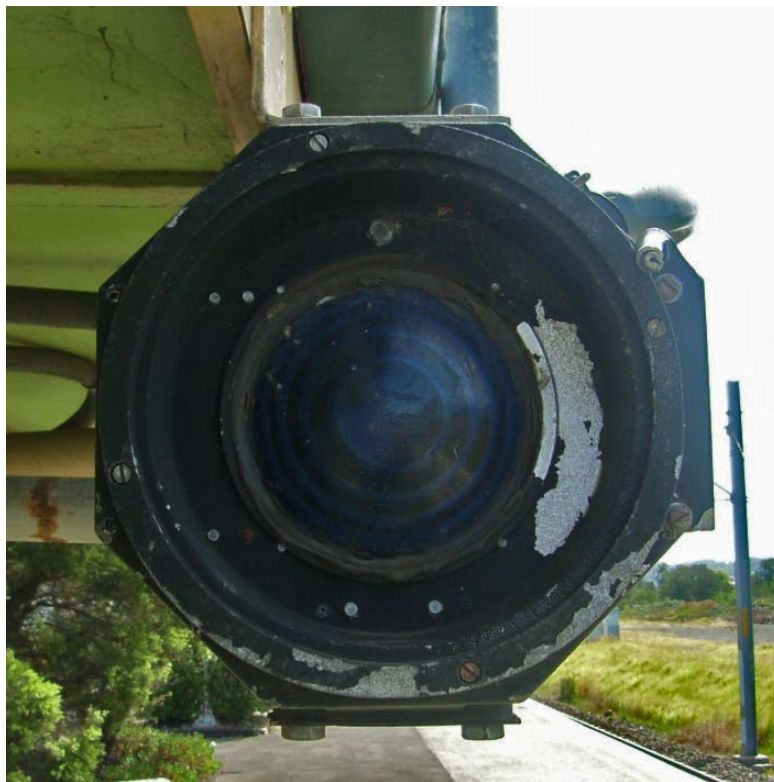
- 2.30 Without a view of the Guard's Indicator, the Guard instead looked up the line towards the next facing signal - shunting Signal WG1016 - and noticed it had a proceed indication. He assumed the Signal satisfied the need for a signalling authority to depart the platform then closed the doors, gave the Driver the proceed bell indication and went and sat down on the seat opposite the Driver. The Guard also failed to notice Signal WG1010.

Photo 12: Close up of unlit Guard's indicator at Unanderra Platform

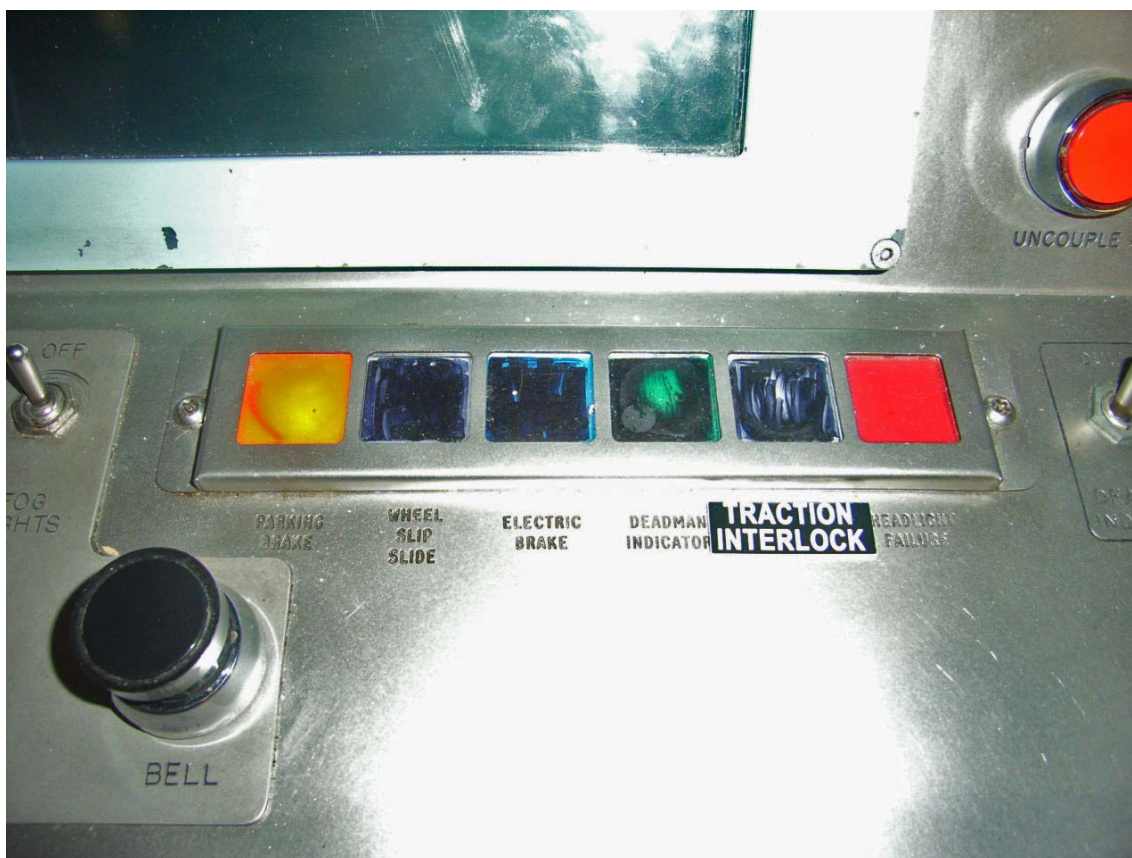
2.52 Evidence was found of lenses on the driver's console having been coloured with a dark marker to reduce the illumination and glare for the driver (see *Photos 13 and 14*).

Photo 13: Drivers console on K496 showing lenses coloured in

2.53 The Driver was unaware of who had darkened the lenses but acknowledged that it is a common occurrence. He stated that he had observed many trains that had similar darkening of the lenses and that he could recall seeing this on other Tangara trains. This practice is contrary to the requirements of TWP 100 which states that train crew must “.. *not intentionally override any of the train safety systems.*” However, it appears the action is being taken to reduce or remove an annoyance or distraction interfering with their driving duties.

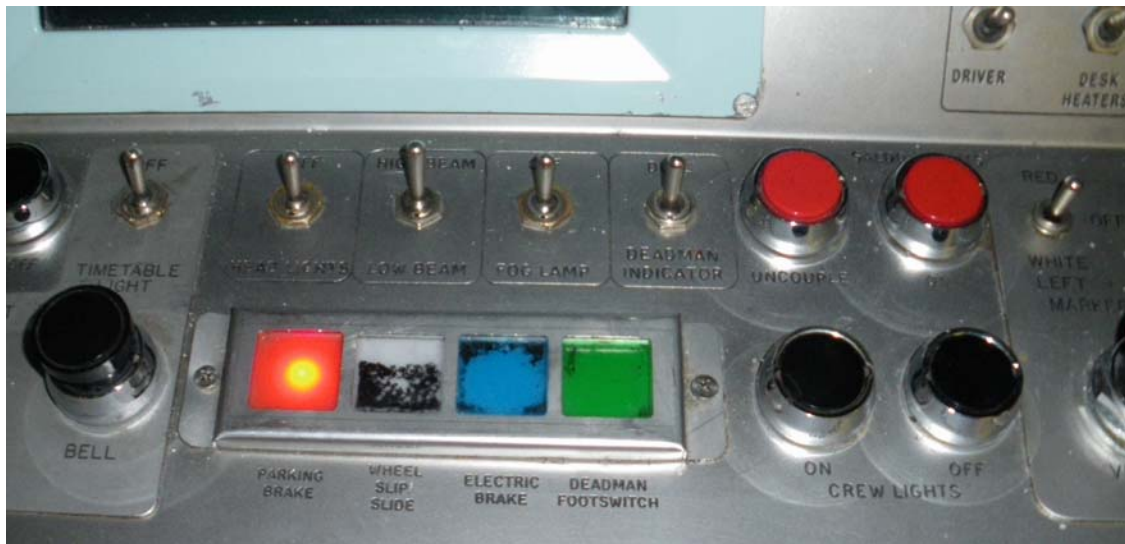
Photo 14: Drivers console on another Tangara service showing lenses coloured in
