# Rail Safety Investigation Report

## UNANDERRA

**Signal Passed at Danger resulting in derailment of Pacific National Service B9162.**

Issue Date: 28 July 2004

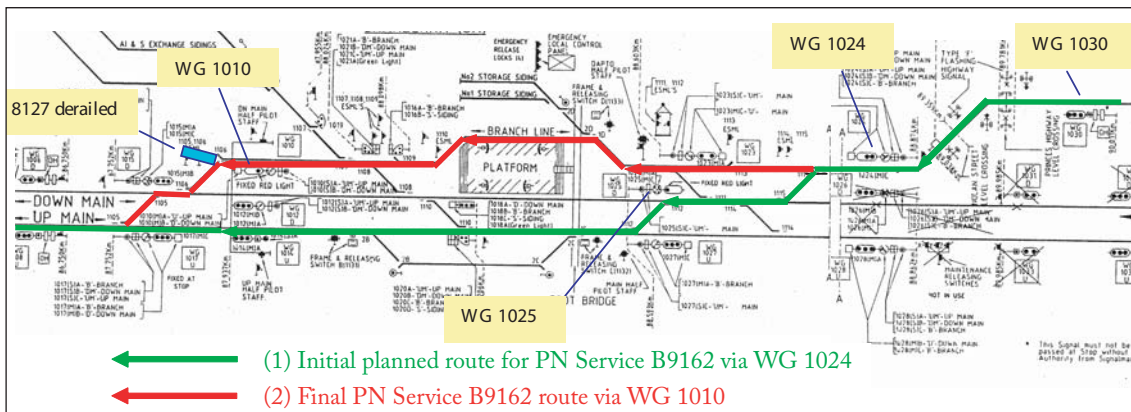
Figure 4.2 Change in Route Selection for B9162 through Unanderra Platform

Up Main crossover movement using Signal WG 1010. A pictorial representation of this change in route can be referenced in Figure 4.2.

The change in set up of these operational movements occurred approximately 4 minutes prior to the incident by the signaller controlling the South and Coast panels (Signaller 1)<sup>4</sup>. In resetting the crossover movement of B9162, Signal WG 1024 was initially set to Stop and then cleared. This signal manipulation resulted in Signal WG 1024 displaying a Caution indication. Signal WG 1010 was subsequently left at Stop and Signal WG 1030 would have then automatically displayed a Clear indication as Signal WG 1024 displayed the Caution indication. The event of Signal WG 1030 changing from a Caution indication to a Clear indication was witnessed by the train crew of B9162 as previously described.

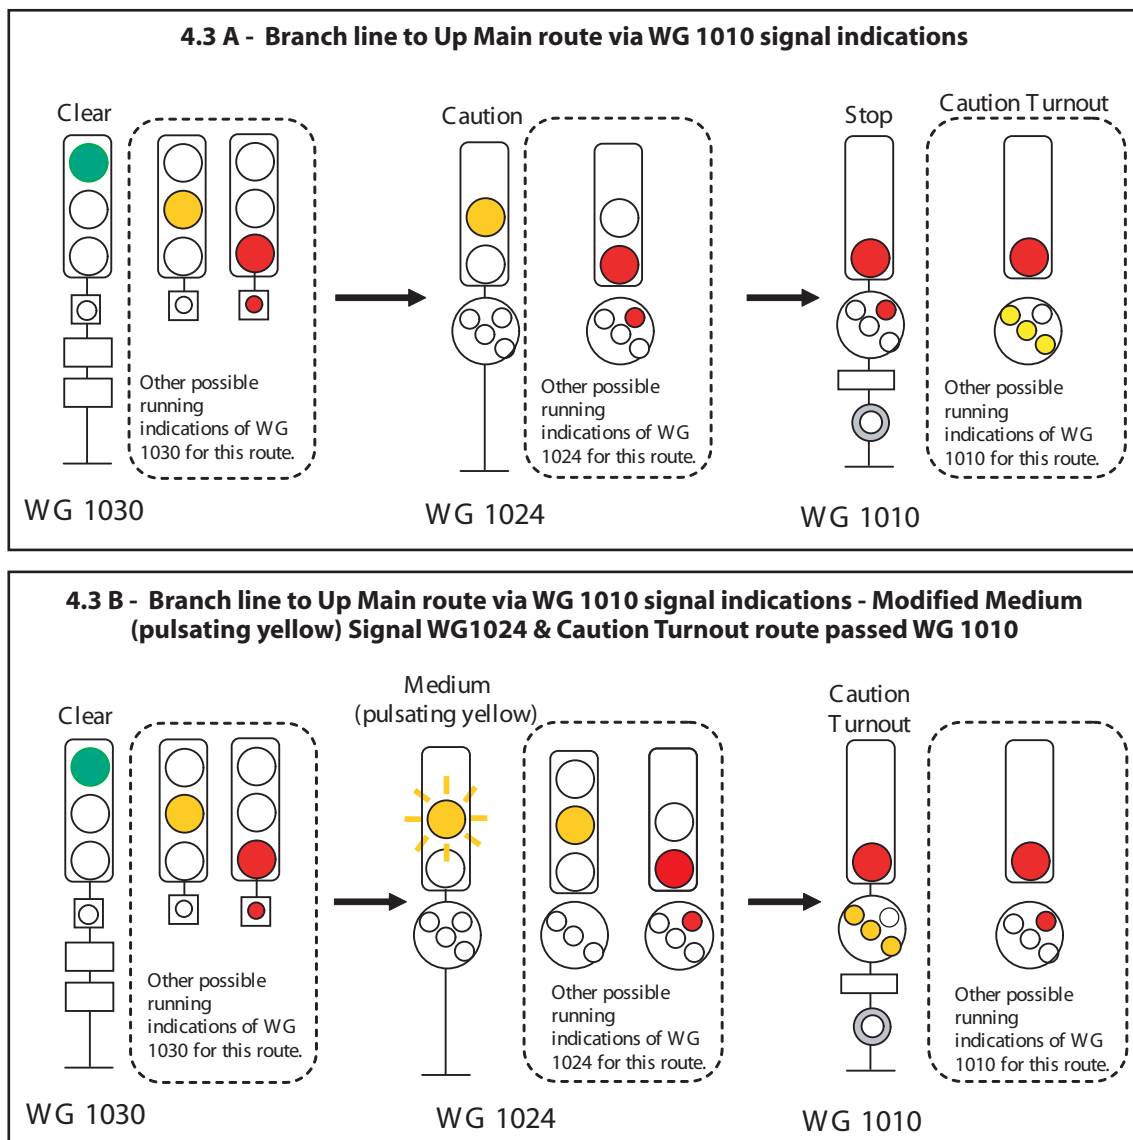
Figure 4.3 – Unanderra Branch Line Signals – Route Indications on 28 June 03 and other possible route indications leading to Signal WG 1010.

The main route signals leading up to and including Signal WG1010 are of the single head 3 light type. The signal indications that would have been displayed to the train crew of B9162 prior to the derailment are shown in Figure 4.3 A. In addition to these indications, Figure 4.3 A also depicts the remaining possible running indications of these signals.

Since the introduction of single head signals in the early 80's there have been further improvements in signalling indication control technology for these types of signals. The improvements have allowed the yellow signal to pulsate thereby representing a Medium indication as defined by the RIC Network Rules at NSG 606 (refer to Appendix 8.12). This Medium signal indication provides drivers with a definitive indication that the next main route signal will be set as a minimum at Caution. At least two signals controlled by the Wollongong Signal Complex have been modified to allow the yellow or yellow turnout signals to pulsate in this manner. If the current signalling design principles contained in RIC's standard SC 00 13 01 01 SP were applied to Signal WG 1024 as a new installation, the signal would be configured with a Medium aspect as shown in Figure 4.3B.

It is recommended that RailCorp conduct a human factors review of the potential risks associated with a driver's response to single head signal configurations that have a limited number of coloured light indications. Such a review is recommended to determine if the existing pulsating yellow Medium signal enhancement is considered an appropriate modification to address the human factor concerns of removing the predictive information associated with standard single head signals. The review is also recommended to assess the suitability of those locations on the NSW network in which the pulsating medium indication is currently implemented.

It is also recommended that RailCorp determine the suitability of Signal WG 1024's signalling configuration considering current medium signalling design principles and those other signals within the Unanderra junction configuration that have been modified to include a medium (pulsating yellow light) indication. Following from this review, RailCorp is recommended to correct the configuration of Signal WG 1024 where deemed necessary.

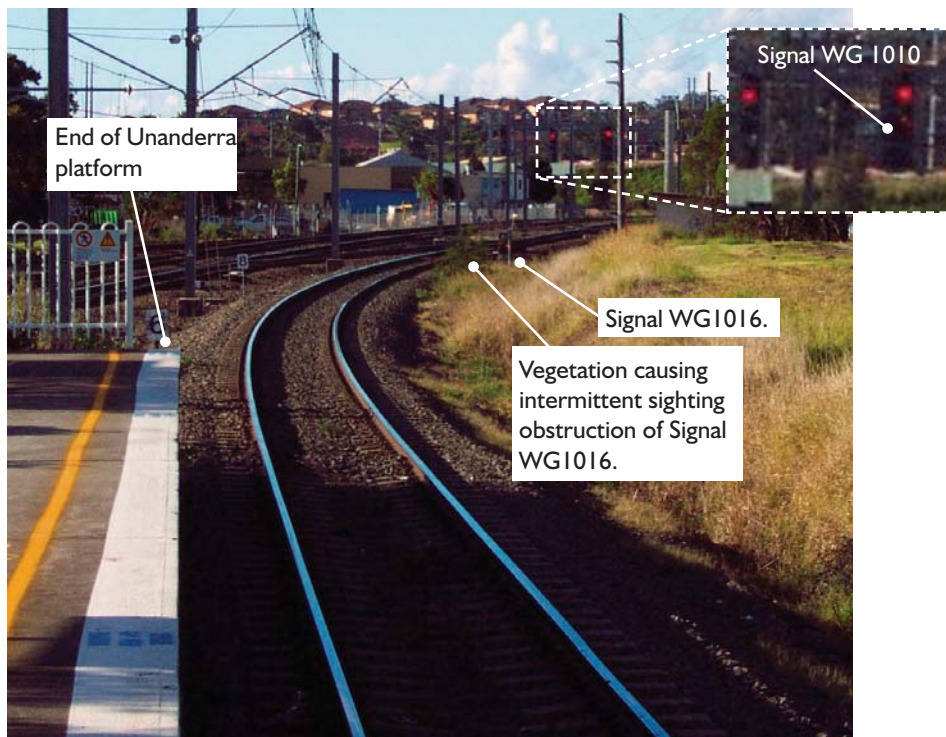
Figure 4.4 Signal Sighting of Signal WG 1010 at 88.244km.

There exists a number of intermittent signal sighting obstructions that obscure the aspect of Signal WG 1010 on approach of trains to this signal. At 88.244km there exists an unobstructed view of Signal WG 1010's red light indication as a train proceeds to the base of this signal. Overhead wiring structures do however intermittently obstruct one or more of the yellow turnout indicators of this signal. Any obstruction of this nature would place further emphasis on the Driver to closely monitor the turnout signal aspect. Refer to Figure 4.4 depicting the signal sighting view of Signal WG 1010.

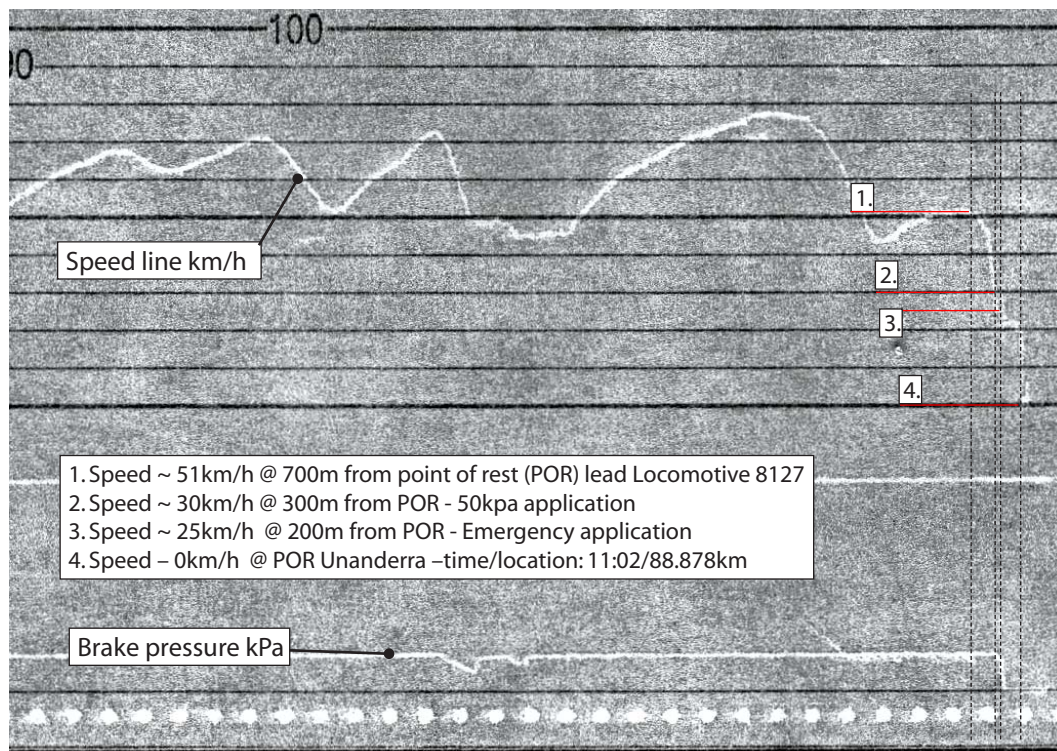
Figure 4.5 81 Class 8148 Hasler tape

The analysis information provided above has been transcribed onto the braking and speed diagram in Figure 4.1 and can also be referenced within Figure 4.5.

The Hasler tape retrieved from the lead locomotive 8127 was ripped and had not been recording for approximately 2 weeks prior to the incident date. Pacific National's Driver Locomotive preparation procedures requires a driver to check the Hasler operation and sign the Hasler tape in order to confirm that the Hasler has been inspected and found to be operational. An inspection of the Hasler tape revealed that there were no driver's initials marked at the signing location where the tape had stopped some two weeks prior to the incident.

It is recommended that Pacific National take action to ensure the certification and operational verification of Hasler speed recorders is undertaken by drivers prior to a train's departure. It is also recommended that Pacific National ensure adequate training and ongoing emphasis is provided to drivers in relation to the certification and verification of Hasler recording devices.

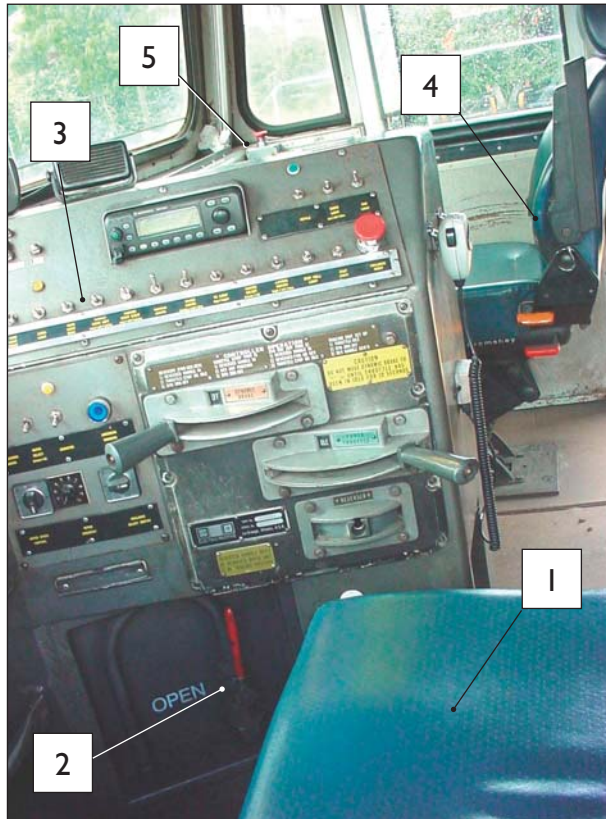
**81 Class Cab (ex National Rail 81 Class) – View from Driver 1's seat facing control stand and Driver 2's seat.**

81 class locomotives have a single brake emergency cock positioned in the Driver 1's control stand. The relative position of this brake cock to Driver 1 in the seated

position is adjacent to the driver's right foot. Should Driver 2 be required to apply the emergency brake cock he/she would have to leave their seated position and reach down between the control stand and the Driver 1's right leg. Refer to Figures 4.6 and 4.7 depicting the views of the emergency brake cock from both the Driver 1 and Driver 2 seats.

1. Driver 1's seat
2. Driver 1's Emergency cock (normal closed position)
3. Driver 1's control stand
4. Driver 2's seat
5. Driver 2's vigilance control (Removed on ex FreightCorp 81 Class Locomotives in 2002 and retained on ex National Rail 81 Class Locomotives)

It is recommended that Pacific National ensure the Driver 2 competency re-certification process covers an assessment of the driver's competency to apply emergency brake applications when required.

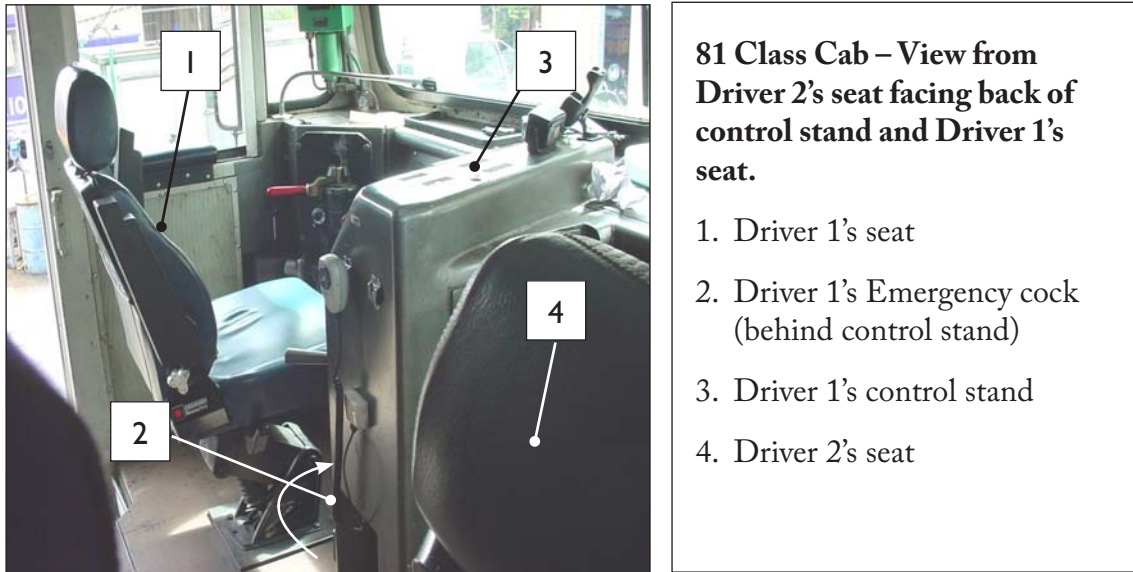
Figure 4.7 81 Class Cab – View from Driver 2’s seat facing back of control stand and Driver 1’s seat.

When 81 class locomotives were first manufactured they were configured with a vigilance control for the Driver 2. This vigilance control would enable Driver 2 to activate the emergency brake on depressing the vigilance button continuously. On a continuous application of the vigilance control the emergency brake would activate within a maximum period of 42 seconds. The vigilance controls within ex FreightCorp 81 class locomotives were disconnected in 2002 in response to actions undertaken to address the Beresfield collision recommendations<sup>11</sup>. At that time FreightCorp linked the brake and throttle applications to reset the vigilance system. This modification was designed to compensate for the change in vigilance control configuration.

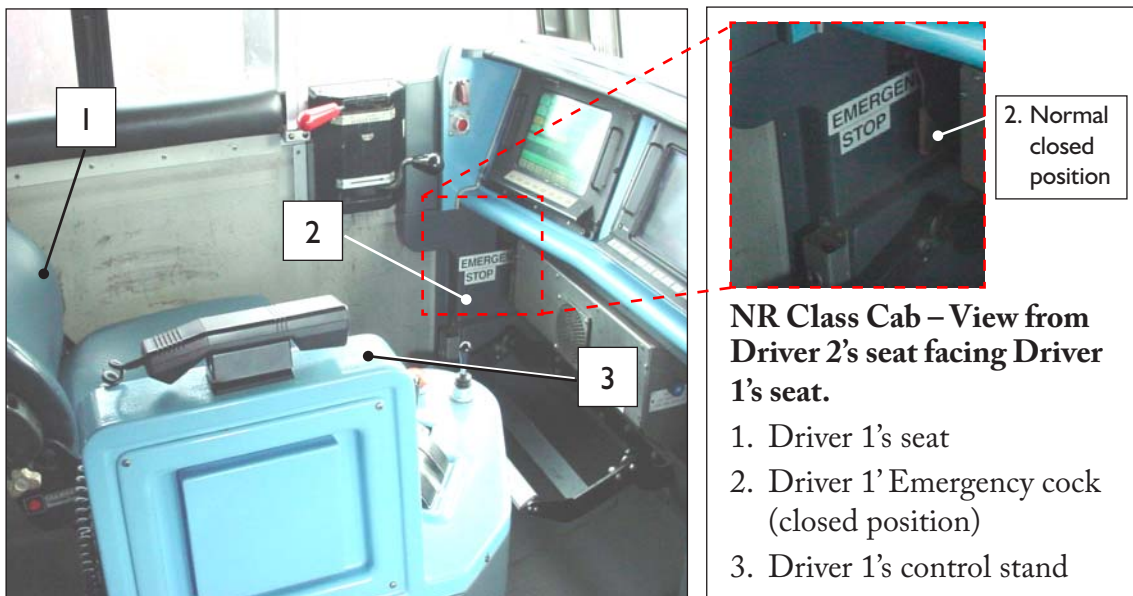
Figure 4.8 NR Class Cab – Driver 1’s Emergency Brake Cock - View from Driver 2’s seat facing control stand

NR class locomotives have two emergency brake cocks located within the driver’s cab. A number of other NSW locomotives also have two emergency brake cocks located within the driver’s cab. The locations of the emergency brake cocks within an NR class locomotive are depicted in Figure 4.8 and 4.9.

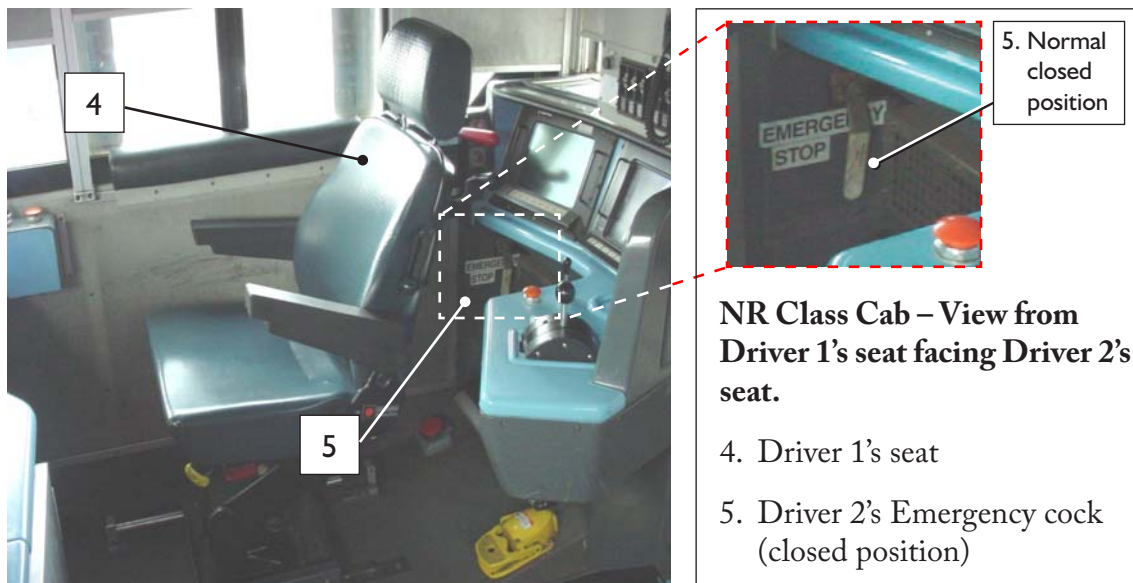
Figure 4.9 NR Class Cab – Driver 2's Emergency Brake Cock - View from Driver 1's seat facing Driver 2's seat

NR Class emergency brake cocks are placed primarily to cater for drivers operating the locomotive in either direction. The emergency brake cock located at the rear of Driver 2's seat is positioned for when a driver is operating the locomotive in the No. 2 end leading direction.

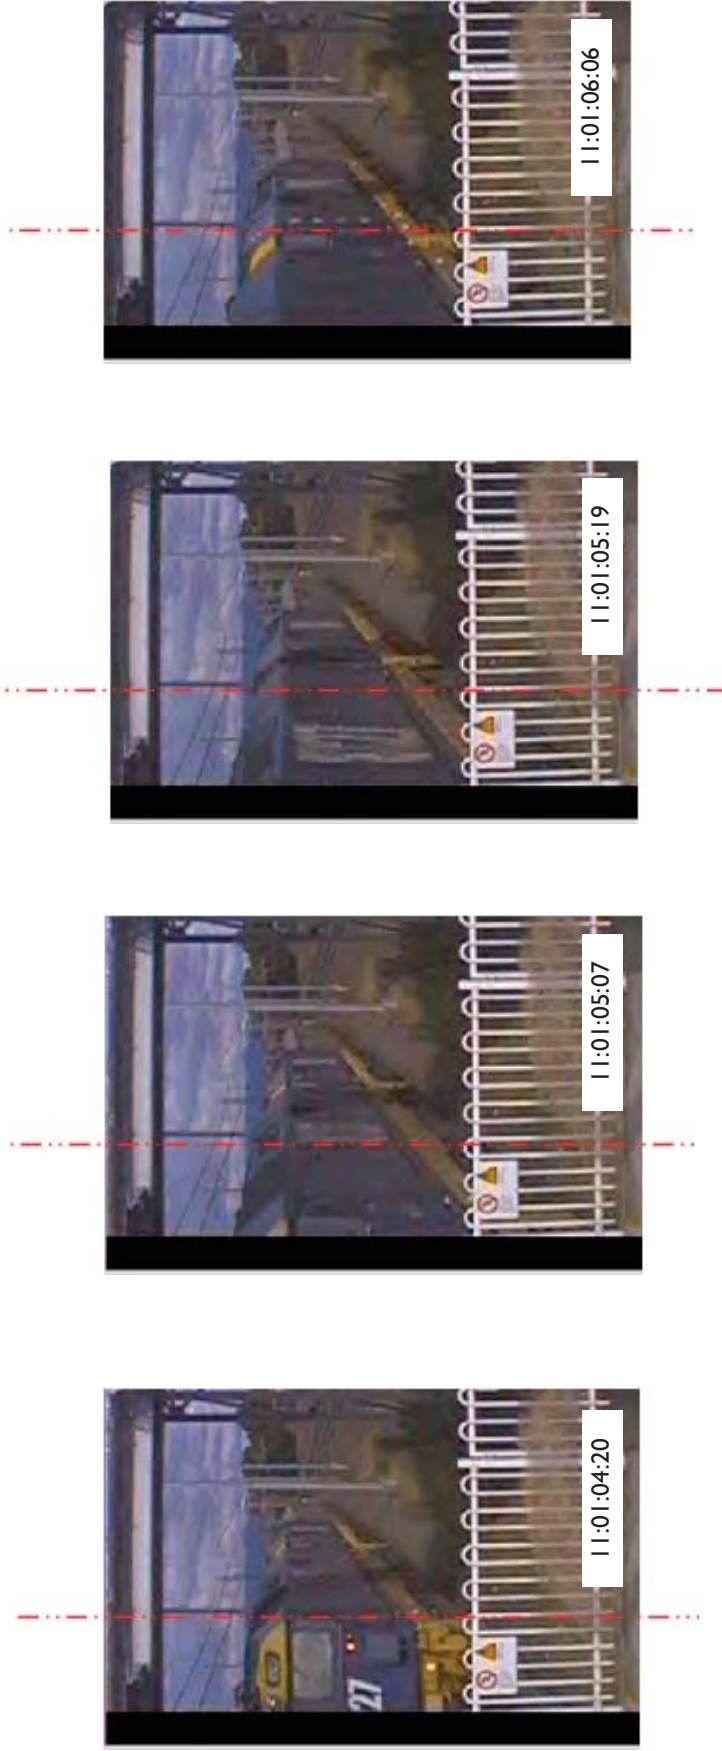
### 8.3 CCTV Speed check of B9162

Distance = Leading face of 8127 to leading face of 8148  
 = 21.156 metres

Time between CCTV frames = 1.86s

Approximate Speed =  $(21.156/1.86) * (3600/1000)$   
 ~ 41km/h – confirming those results extrapolated from the Hasler tape at the start of Unanderra Platform from the POR.

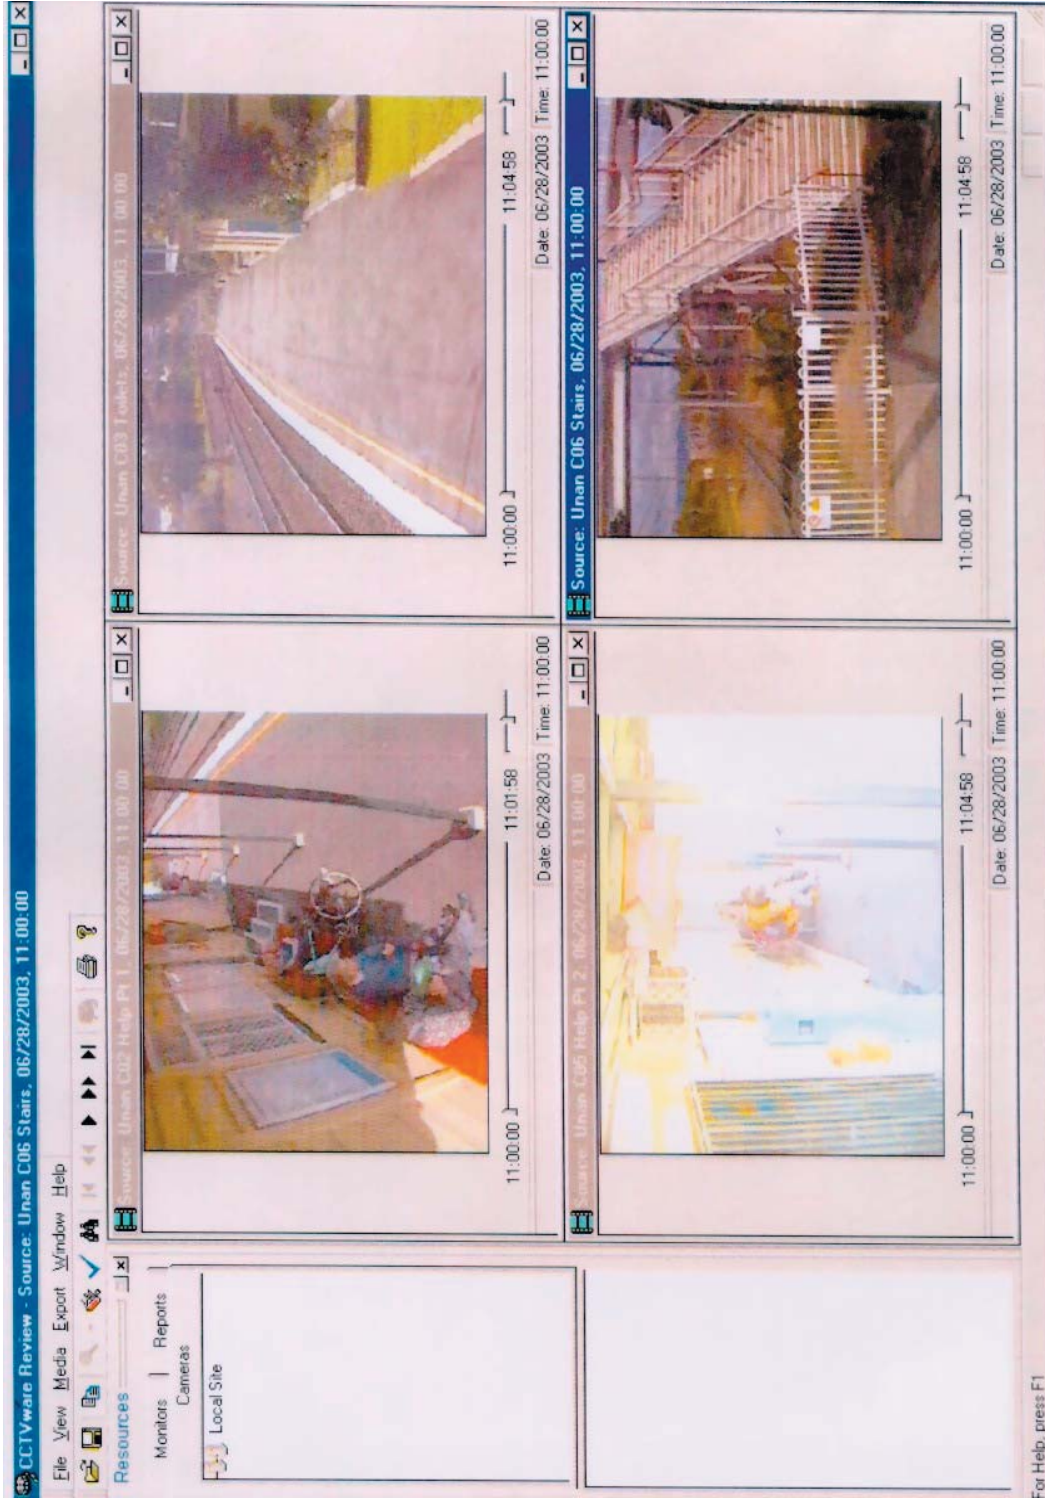
CCTV time references noting at 11.00am that both the City Rail passenger train K431 and B9162 were not visible from the Station CCTV cameras.

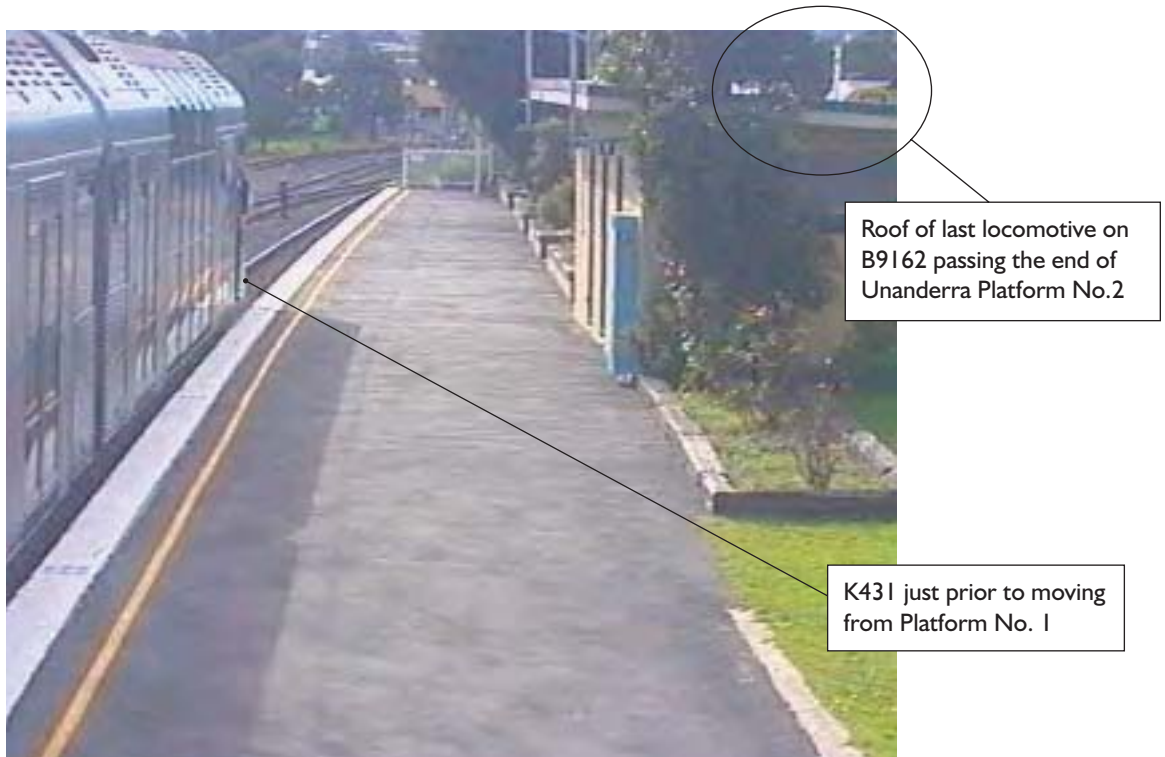
CCTV footage indicating that K431 had not departed Platform No.1 until both Locomotives on B9161 had passed the end of Platform No.2.
