RAIL SAFETY INVESTIGATION REPORT

RUNAWAY OF ROLLING STOCK

ENFIELD YARD

3 MAY 2011

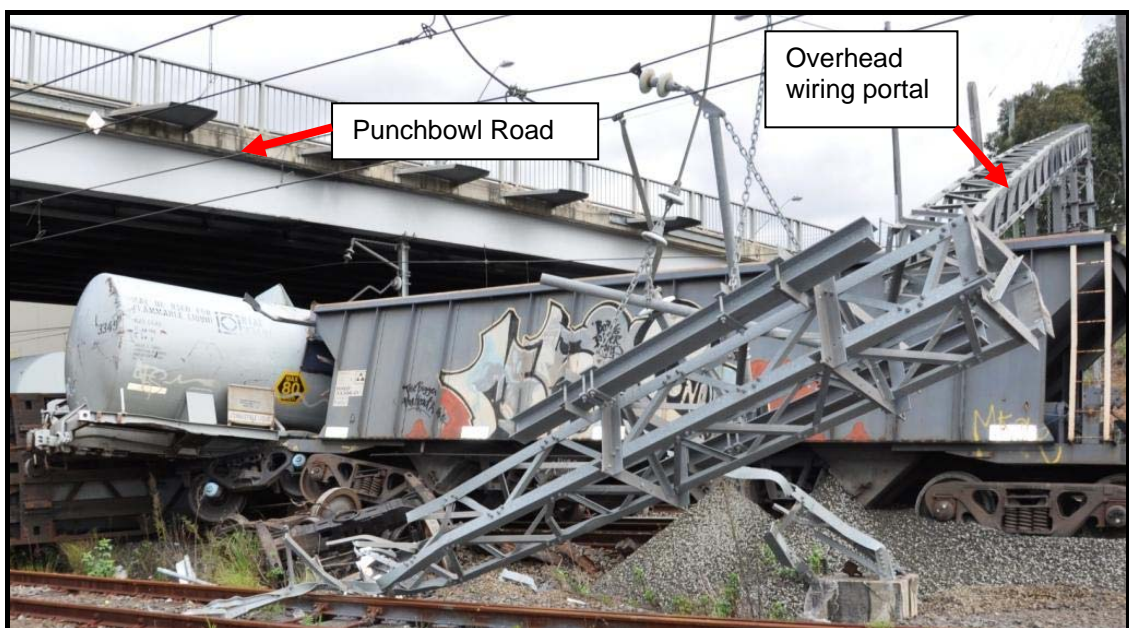
- 1.2 The two rakes continued with the derailed bogie travelling about 428 metres, before it struck No. 120 points. This caused the other bogie on that tanker and both bogies of the tanker immediately in advance to derail. The tankers slewed across the track carrying away two shunting signals and an overhead wiring portal stanchion before coming to rest approximately 460 metres from the point of collision. The slewed tankers were foul of the Up and Down Main lines. The rake of aggregate wagons ran away for a total of 1085 metres.

Photograph 1: View of runaway damage (part)

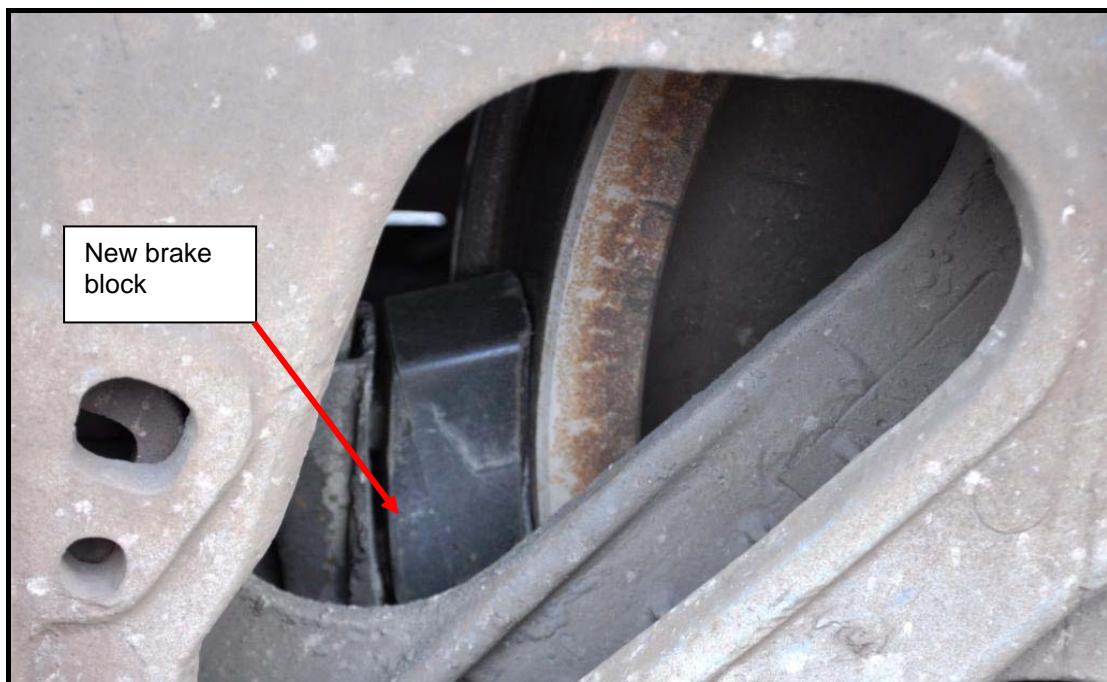
- 1.12 The same Terminal Operator carried out some routine maintenance activities on the rake between the time it was stabled and the time of the incident, fitting it in with other work. He began at the 'downslope' end and worked up the Eastern side of the rake. The Terminal Operator examined the brakes and replaced brake blocks as required (*Photo 3*). This included brake blocks on three of the wagons with handbrakes applied. In order to change these, the Terminal Operator had to release the hand brake, replace the brake block(s) and then re-apply the hand brake. No additional compensating handbrake was applied to another wagon prior to a handbrake being released.

Photograph 3: New brake block fitted on one of the NPZH wagons

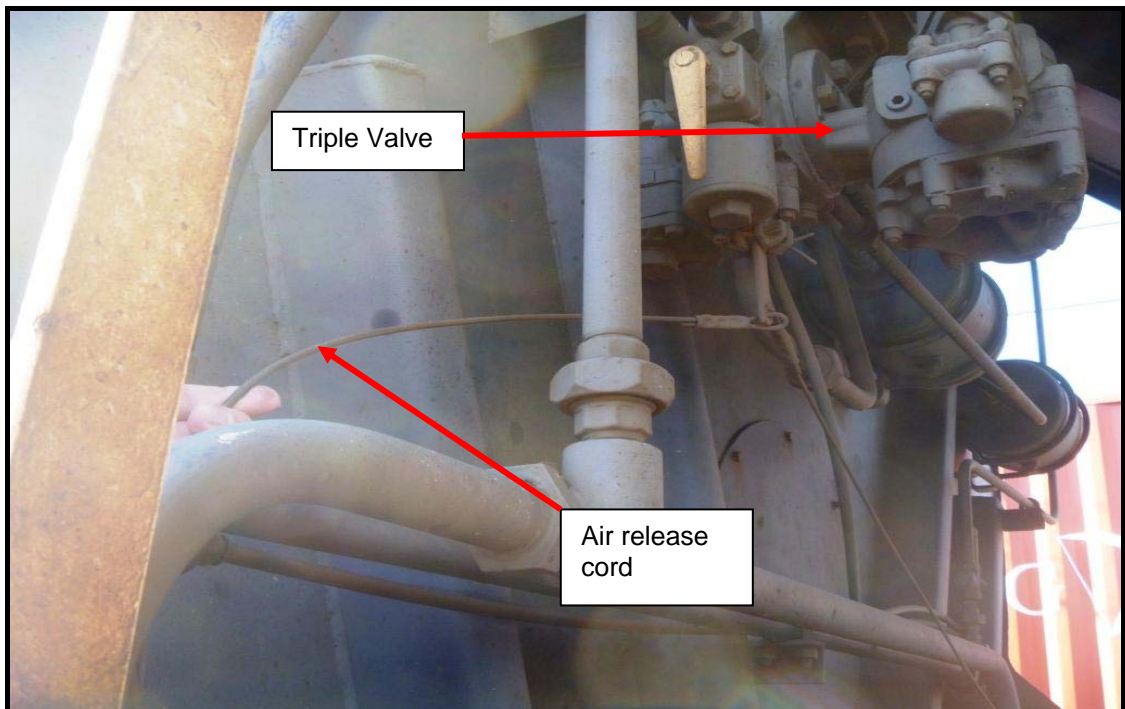
- 1.14 The Terminal Operator worked down the Western side of the rake replacing brake blocks as required (one brake block on each of four different wagons) until he came to wagon NPZH35652C just before 12:45pm. The Terminal Operator identified that the first wheel that he came to needed to have its brake block changed. He also noticed that the air brakes were still applied on this wagon as the brake cylinders were still charged with air.³
- 1.15 The Terminal Operator walked to the downslope end of the wagon and pulled the release cable attached to the triple valve to vent the air from the brake system (see *Photograph 4*).

Photograph 4: Auto valve and release cable

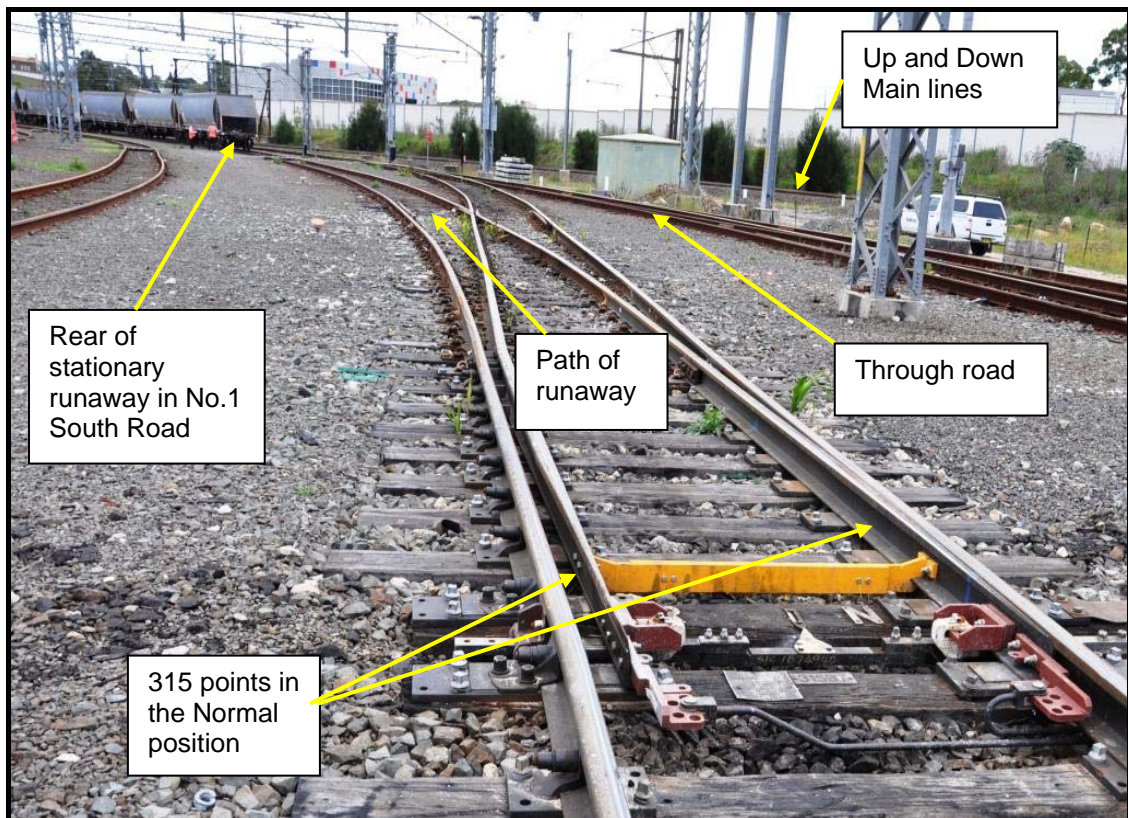
directed towards South Road No.1 in which a rake of 15 empty fuel tankers and three flatbed wagons was stabled (see *Photograph 5*).

Photograph 5: View looking South towards the runaway at 315 points

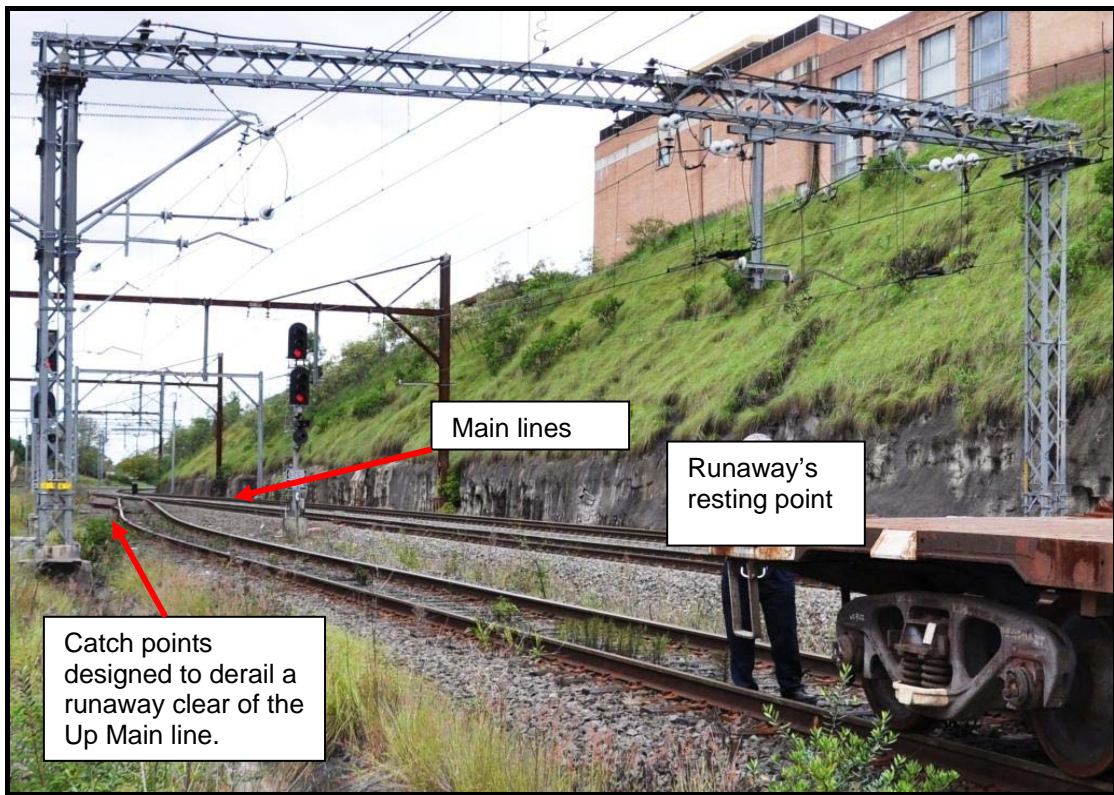
1.27 The rolling stock came to a stand with the leading flat bed at 14.080km (see *Photograph 6*). The runaway had travelled in excess of 1000 metres.

Photograph 6: Runaway came to rest towards the South end of the yard

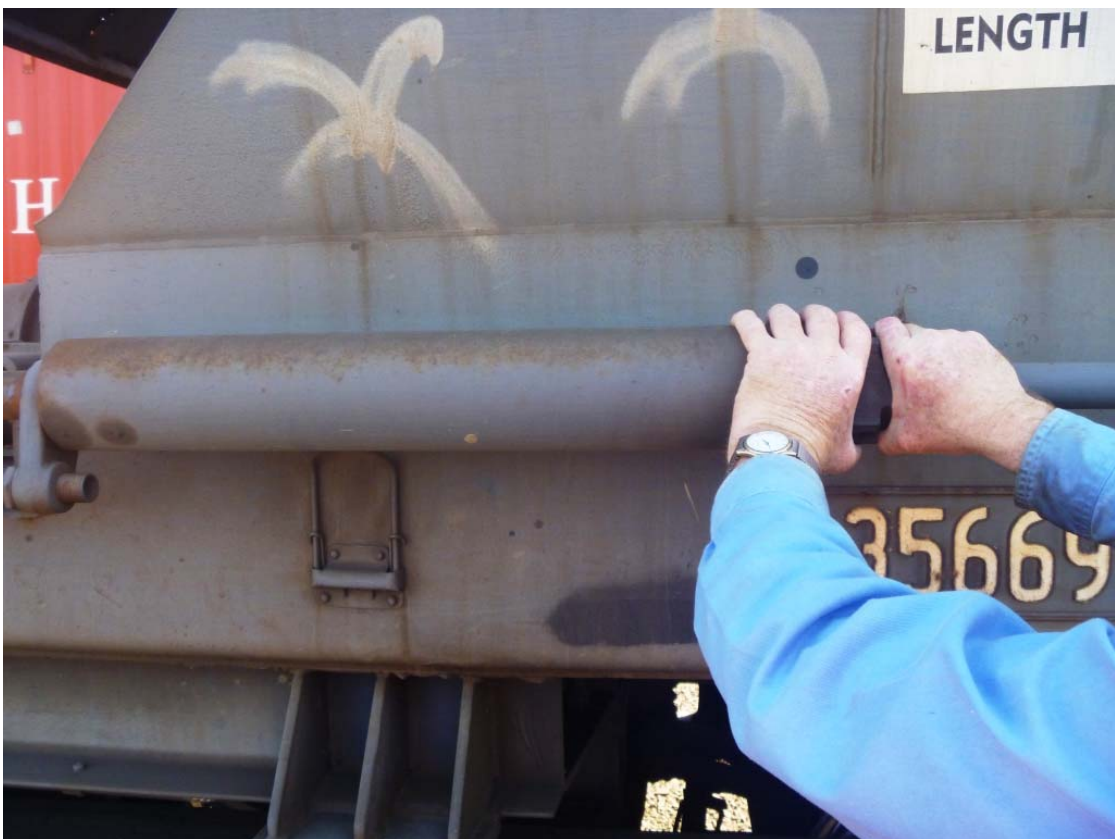
- 1.41 The rake of aggregate wagons was made up of 11 RHGF type and 17 NPZH wagons. It measured 490 metres in length with a total mass of 2576 tonnes. It was one of two rakes of wagons engaged in transporting aggregate from Dunmore Quarry to Botany via Enfield Yard. NPZH type wagons, in common with most current freight rolling stock, have slack adjusters which allow the brake rigging to be adjusted during brake block replacement (see *Photograph 9*).

Photograph 9: Brake slack adjuster on NPZH type wagon

- 1.42 However, RHGF type wagons do not have slack adjusters and the brakes require manual adjustment during brake block replacement. The RHGF type wagons were at the Southern (downslope) end of the rake and it was therefore a number of these wagons that had their handbrakes applied to hold the rake on the grade.

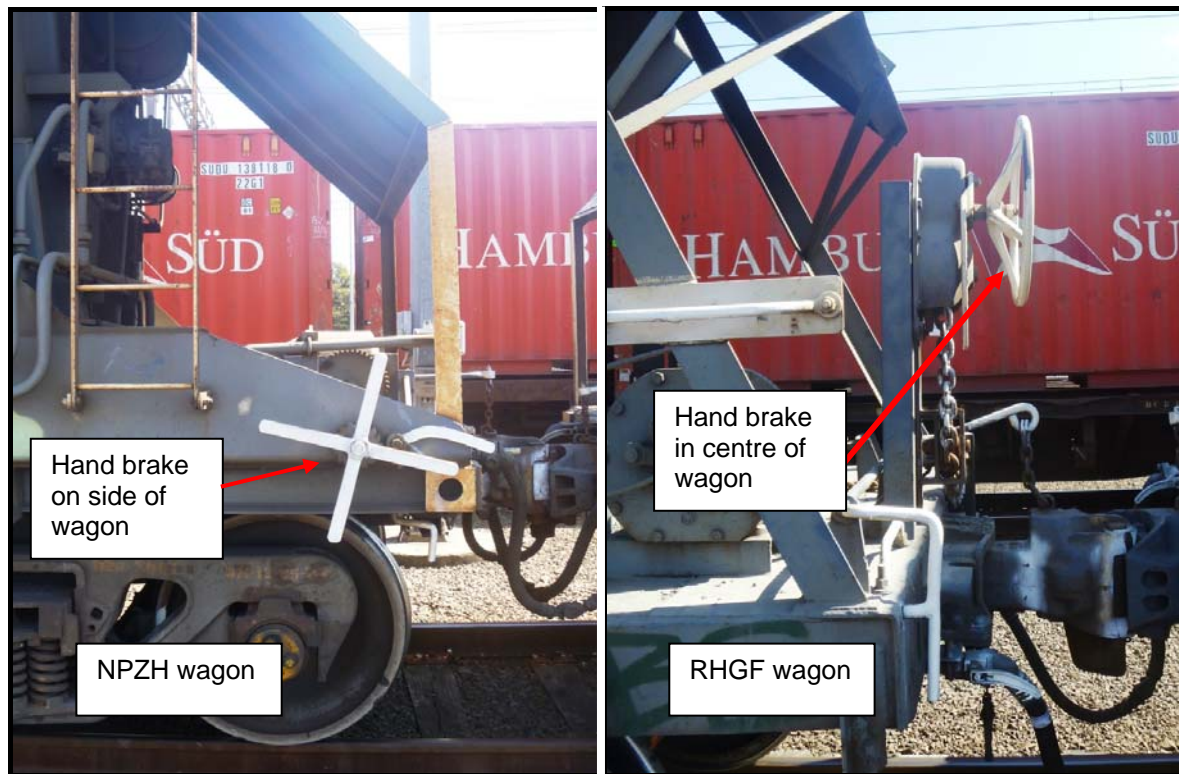
- 1.47 Another difference between the two wagon types, of relevance to this incident, was the location of the handbrake. The NPZH wagon's hand brakes are located on the side of the wagon and could therefore be accessed by the

Terminal Operator as the rake started to run away (see *Photograph 10*). In contrast, the handbrake wheel on the RHGF wagons can only be accessed by stepping between the wagons.

Photograph 10 : Hand brake locations
