**Office of Transport Safety Investigations**

## **LEVEL CROSSING COLLISION REPORT**

**PRIVATE LEVEL CROSSING at 594.680KMS**

**1 SEPTEMBER 2010**

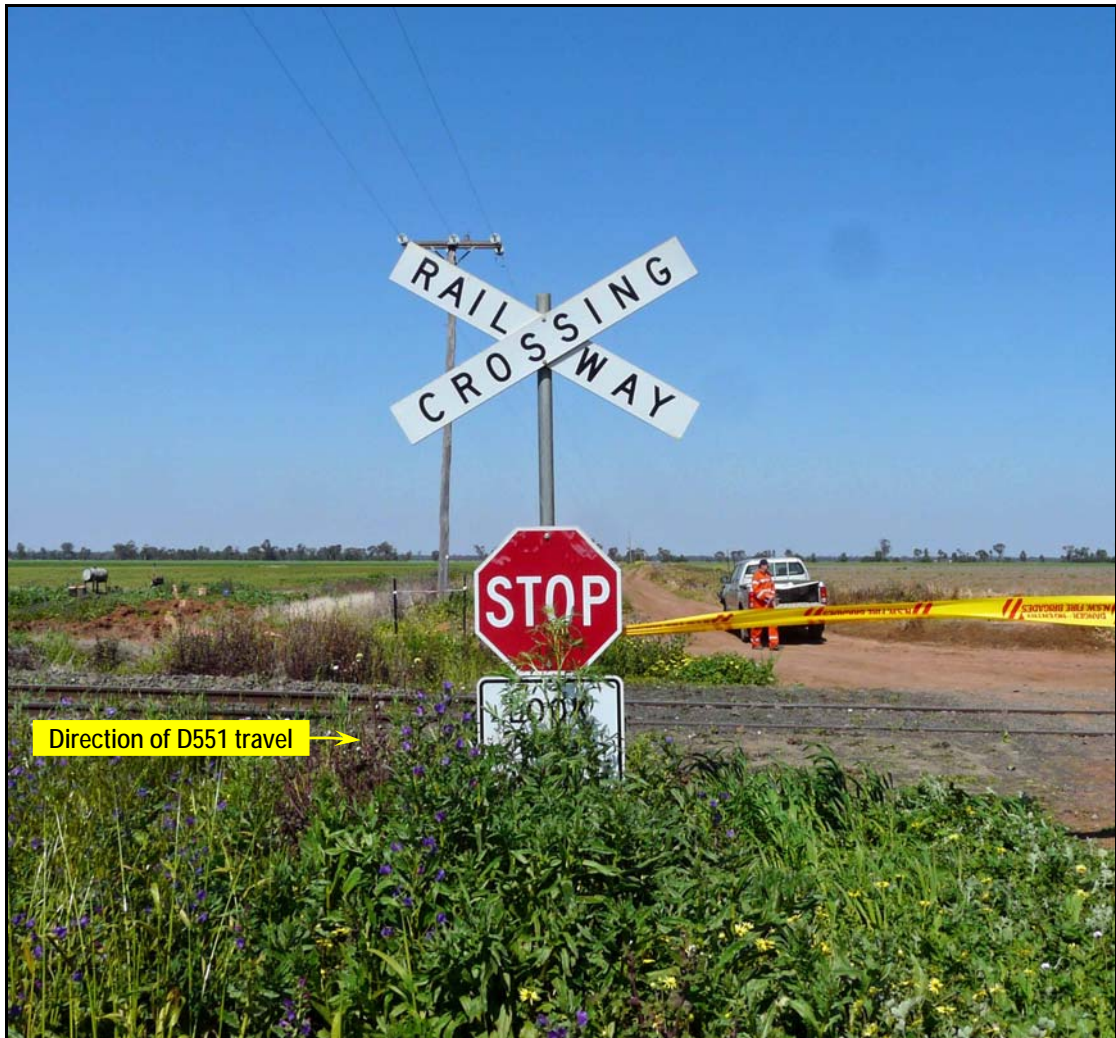
**Photograph 2: RX2 type warning sign assembly**

- 1.9 When inspected, both assemblies were in a clean and legible condition although both “LOOK FOR TRAINS” signs were partially obstructed by low

growing vegetation and did not meet the minimum height requirement of 1.5m from the ground to the underside of the lowest sign in the assembly.<sup>6</sup> These shortcomings were not considered as causal or contributing factors in the collision. There was no other form of warning signage on the approaches to the crossing.

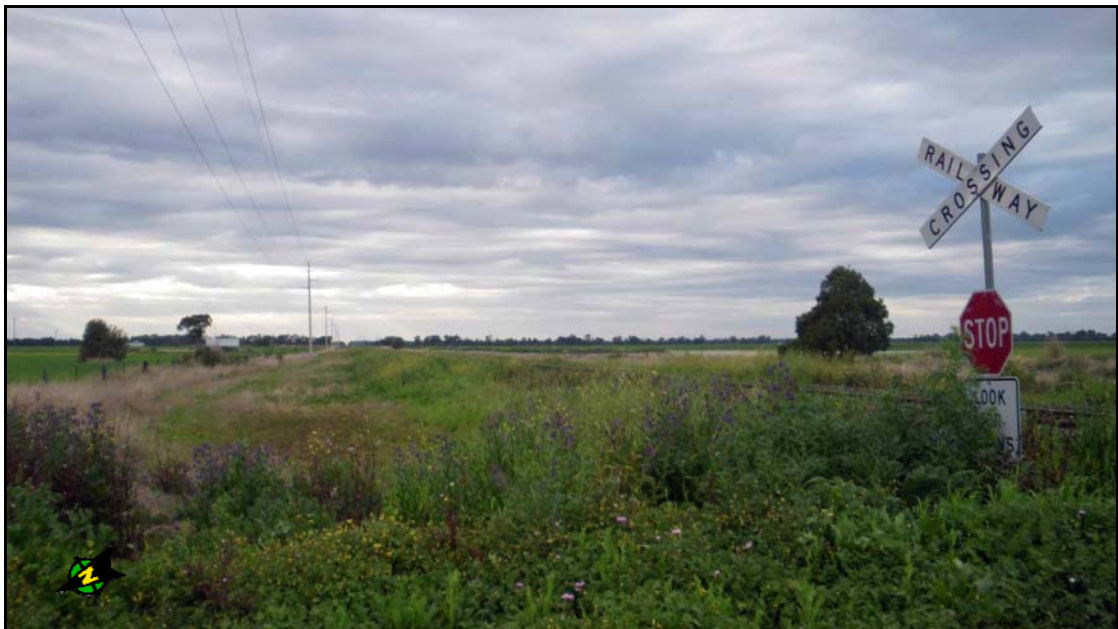
**Photograph 3: View of rail corridor in the direction of the approaching train**

- 1.12 The corridor is straight with the track elevated approximately 500mm above ground level. A 19m gap exists between the boundary fence and the track on the North-Eastern side of approach to the crossing. On the left side of the RMV approach, the corridor was clear of shrubs and trees for approximately 1.7kms (see *Photograph 3*). On the RMV's right side, the corridor was clear of shrubs and trees for approximately one kilometre. The paddocks adjoining the corridor were also clear of any vegetation that might obstruct the view.

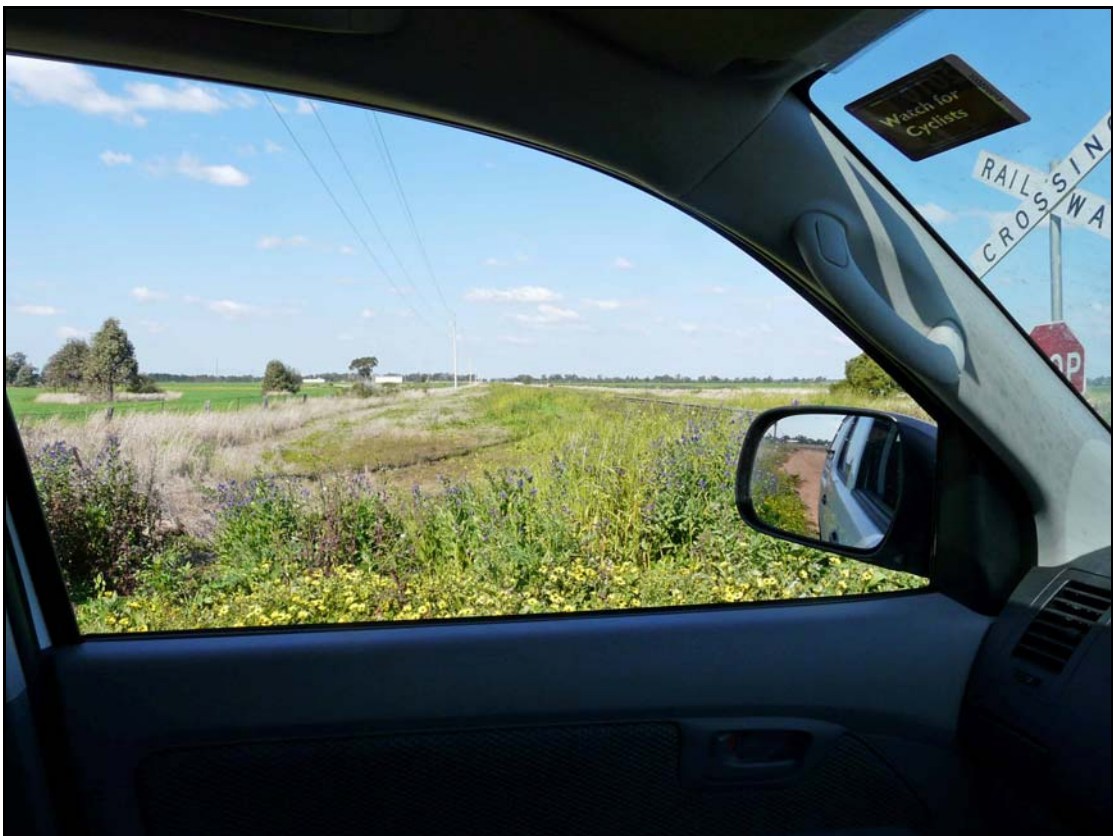
**Photograph 4: View of rail corridor from a RMV approaching the crossing**

- 1.13 Although clear of taller vegetation, there was heavy weed growth, e.g., oats, Patterson's Curse and canola, in the corridor and on the Eastern side of the road approach to the crossing. The height of this vegetation ranged up to approximately 900mm. However, none of this vegetation completely obstructed the view of an approaching train from a RMV which had stopped in accordance with the warning signage prior to traversing the crossing (see *Photograph 4*).

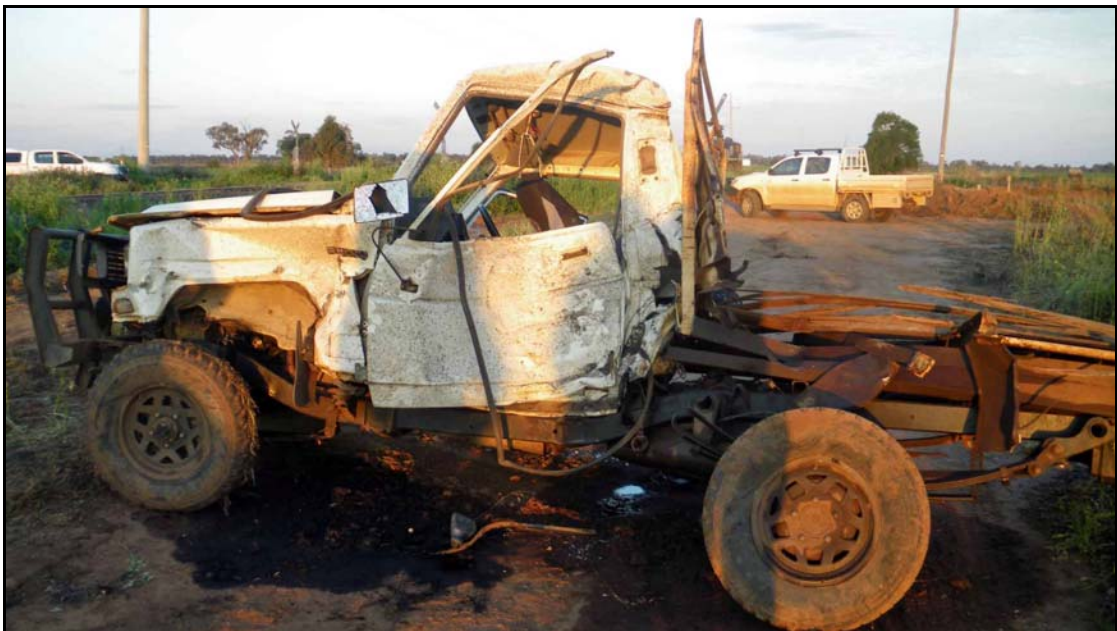
**Photograph 6: Damage to RMV**

- 1.23 D551 impacted the RMV on the passenger side in the area of the rear pillar of the cabin and tray section (see *Photograph 6*). The RMV was then propelled in an arc-like trajectory from the crossing and spun approximately 180°. It came to rest on the parallel access road at a point some 32m from the crossing and 14.4m from the track.

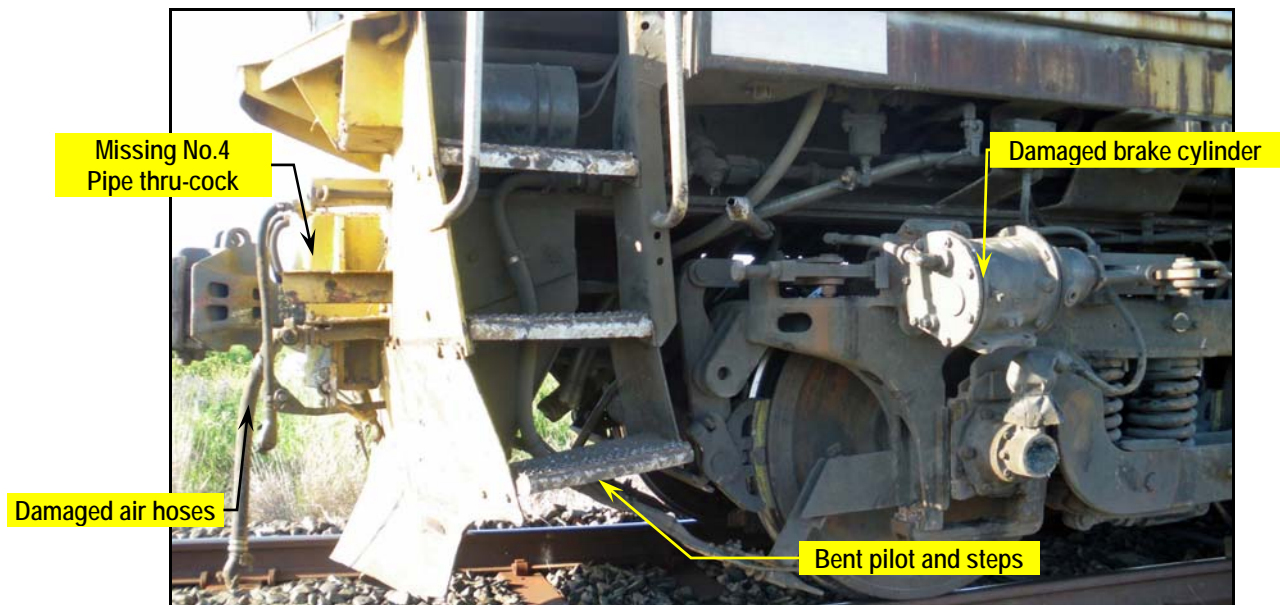
**Photograph 7: Damage to leading locomotive**

- The brakes on both locomotives were correctly regulated and within travel limits. The thickness of all brake blocks exceeded the allowable minimum of 16mm.
- Various impact marks and damage were apparent on the front coupling region, front left hand side of the headstock, and leading left hand side of the leading locomotive (4886). The damage included bent steps, a bent pilot, damaged thru-cocks and hoses on the air lines for the main reservoir, brake pipe and the No.3 pipe of the independent brake, a missing thru-cock and hose on the No.4 pipe of the independent brake, and a damaged brake cylinder casing on the left side of the leading bogie (see *Photograph 7*). The location of the damage was consistent with the RMV being struck as it exited the crossing.

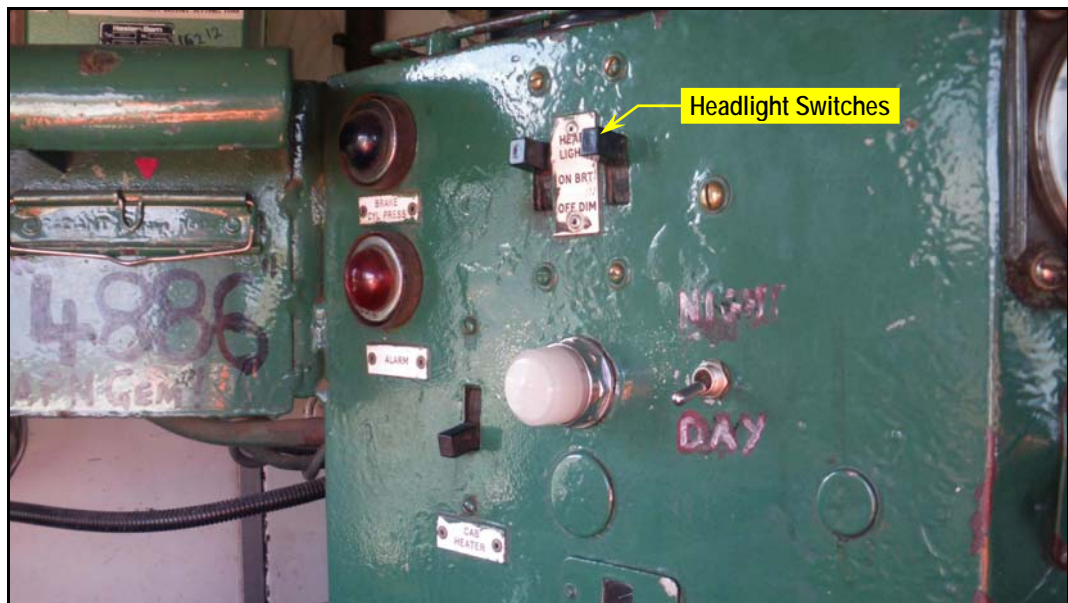
**Photograph 8: Headlight switches in “On” and “Bright” position**

- The whistle on 4886 was operable.
- The headlight switches on 4886 were in the “on” and “bright” positions (see *Photograph 8*) with both headlight globes illuminating when battery power was restored to the locomotives.<sup>8</sup> This indicated the headlights were being operated in accordance with ARTC Network Rule ANTR 406 *Using Train Lights* at the time of the collision.

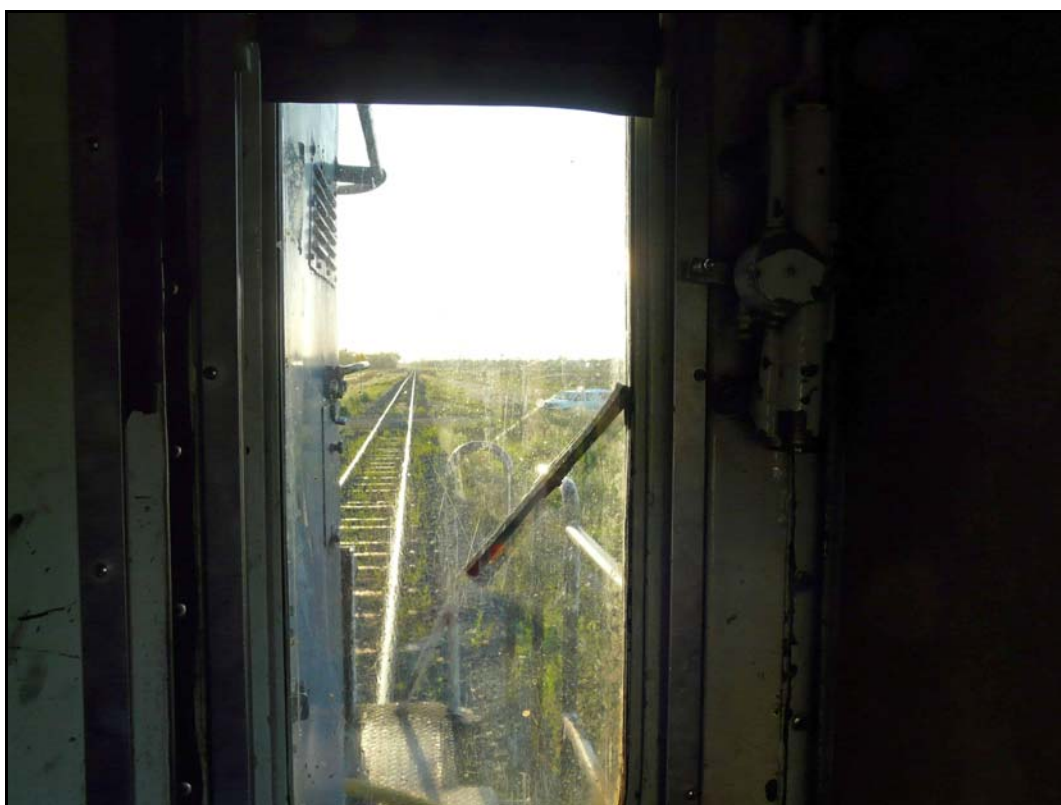
**Photograph 10: Assistant Driver's view of approach to crossing through scratched windscreen**

- Although not a contributing or causal factor, the windscreens on 4886 were scratched and dirty and provided less than optimal visibility.

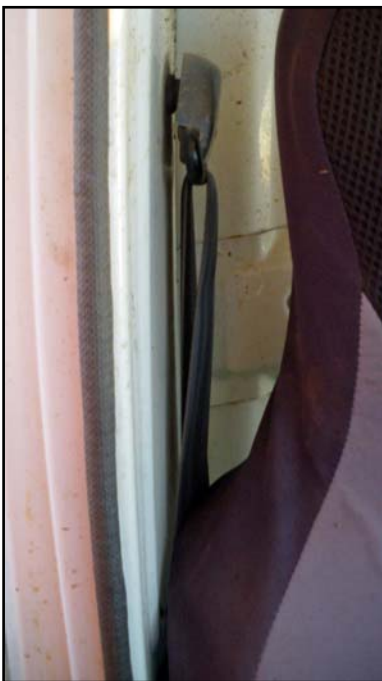
**Photograph 11: Seat belt retracted and jammed behind seat back**

- The RMV appeared to have been in a roadworthy condition prior to being struck.
- The driver's side seat belt was fully retracted and jammed against the rear pillar by the seat back indicating that the belt was not being worn at the time the RMV was struck (see *Photograph 11*). Further, the belt was not damaged; nor was there any damage on the buckle or clip to indicate that the buckle had disengaged during or after the impact (see *Photograph 12*).

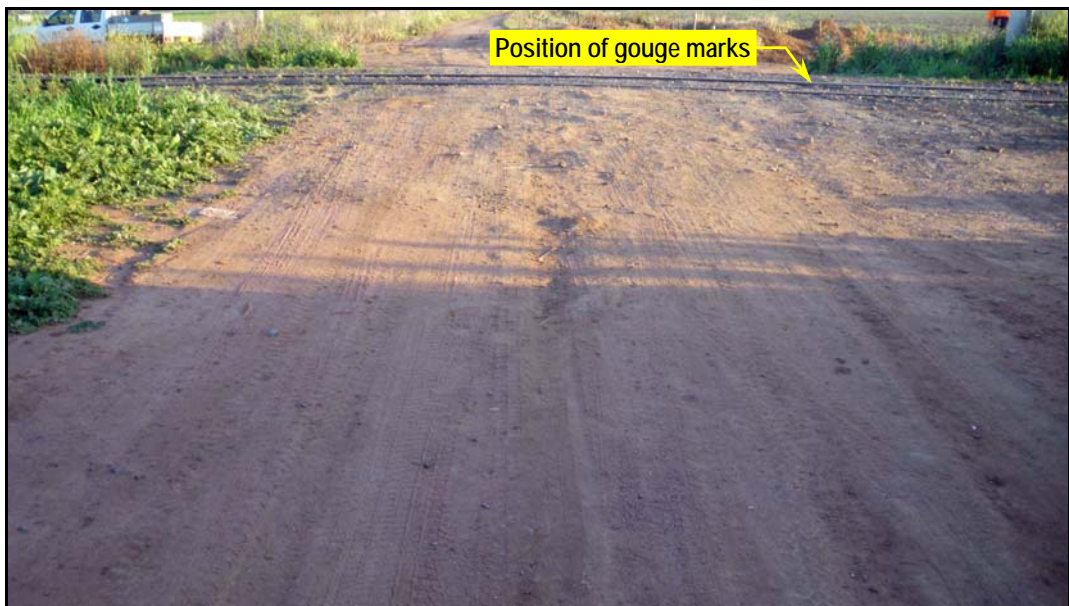
- The surface of the crossing was in a serviceable condition with minor tyre rutting evident from previous muddy conditions.
- There were no skid marks caused by the tyres of the RMV on the approach to or on the crossing to indicate that the deceased had braked at any time prior to being struck (see *Photograph 13*). The only marks that were found were gouge marks between the rails at the point where the RMV was struck.

**Photograph 13: Approach to crossing  
(Note no evidence of skid marks)**
