## **RAIL SAFETY INVESTIGATION REPORT**

**MONORAIL COLLISION**

**DARLING PARK**

**27 FEBRUARY 2010**

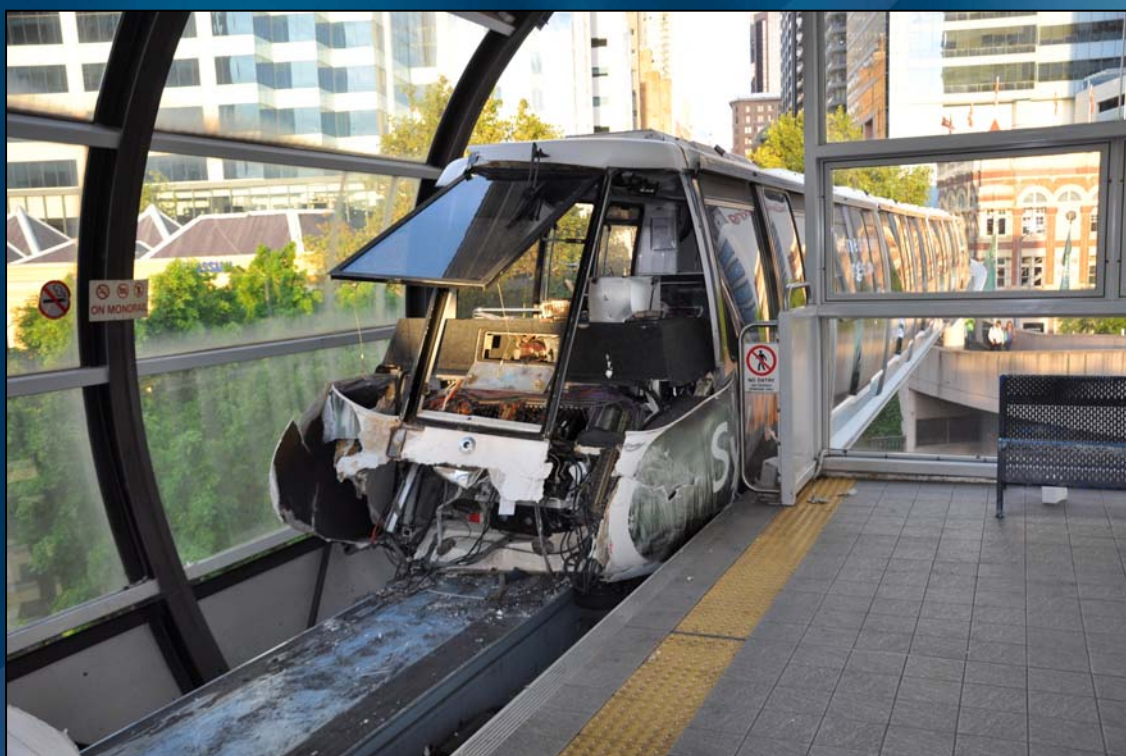
- 1.16 The collision caused significant damage to the front of Monorail 1 (see *Cover Photo*) and the rear of Monorail 4 (see *Photo 4*). Monorail 1 was damaged to the extent that it could not be moved under its own power. It was later towed back to the monorail maintenance facility by the maintenance vehicle.

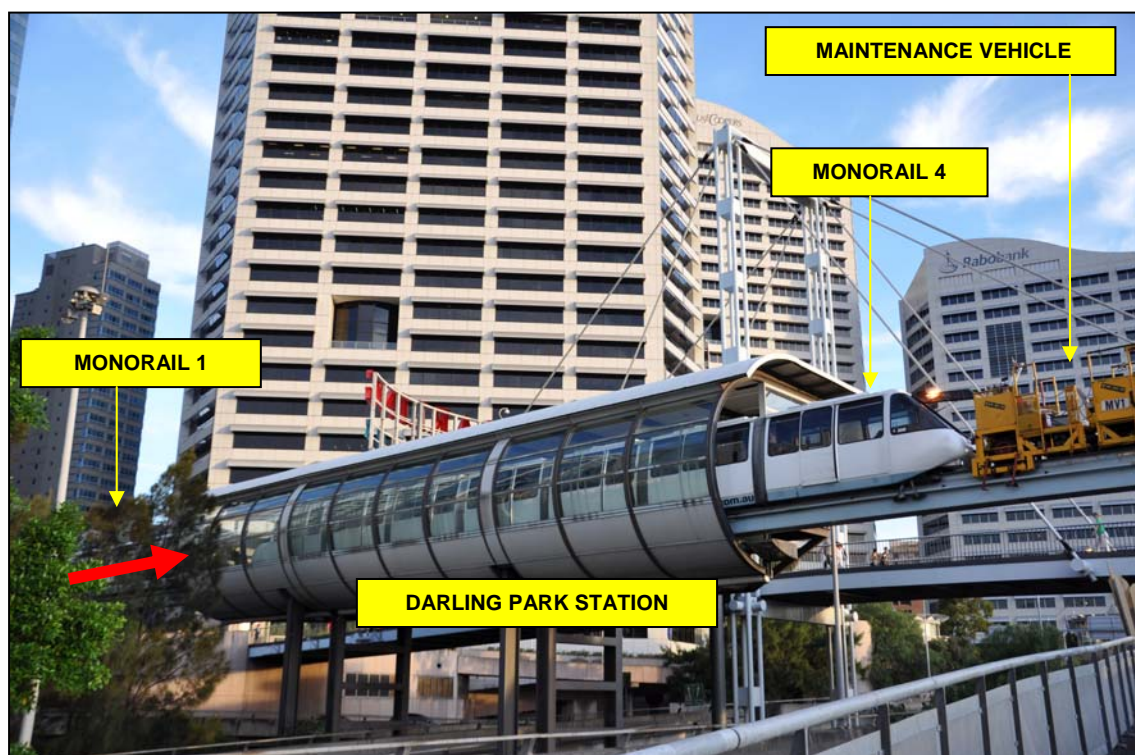
Photo 1: Darling Park Station after the collision

- 1.1 At about 4:00pm on Saturday 27 February 2010, a Veolia Monorail, Monorail 1, operating on the Sydney Metro Monorail system, collided with the rear of Monorail 4 which was stationary at Darling Park Station (see *Photo 1*). The doors on Monorail 4 had malfunctioned causing it to stand at the station for longer than its normal dwell time. As Monorail 1 approached Darling Park, it was travelling above the speed profile and the Driver, unaware that the monorail ahead had stopped, did not react quickly enough to brake his monorail before the backup Anti-Collision Emergency Stop (ACES) system activated. The ACES system on Monorail 1 was not effective in stopping the monorail before it impacted with Monorail 4. As a result of the collision three passengers from Monorail 1 were injured and transported to hospital and another passenger claimed to have sustained an arm injury. No one on Monorail 4 was injured.

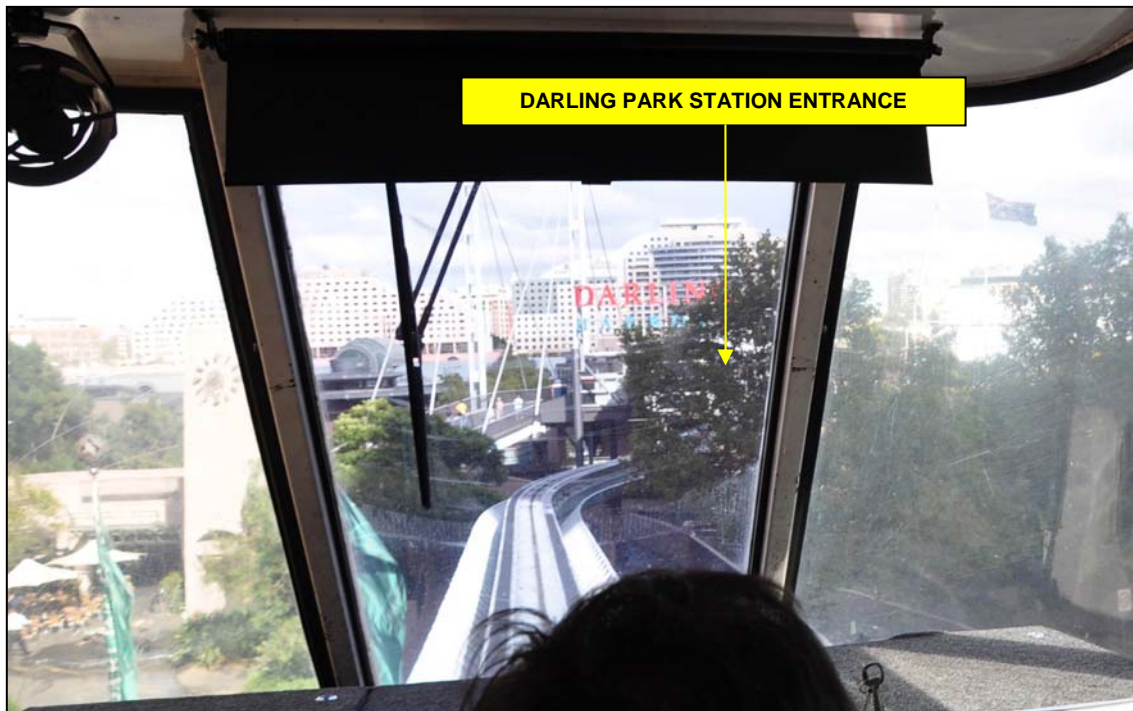
**Photo 2: View from monorail approaching Darling Park Station**

- 1.9 Had the Driver of Monorail 1 been able to see Darling Park Station as he approached it, he may have been able to initiate timely braking action. However, there is a large tree located approximately 40m before the entrance to Darling Park Station (see *Photo 2*). The Driver of Monorail 1 stated that until he drew alongside it, the tree obscured his visibility of the station. He stated that, when he passed the tree, he reacted by activating the emergency stop button and turning the monorail speed switch to zero. Both the Driver

and Relief Driver said that they felt no braking effect and that the monorail entered Darling Park Station at about 6m/s.

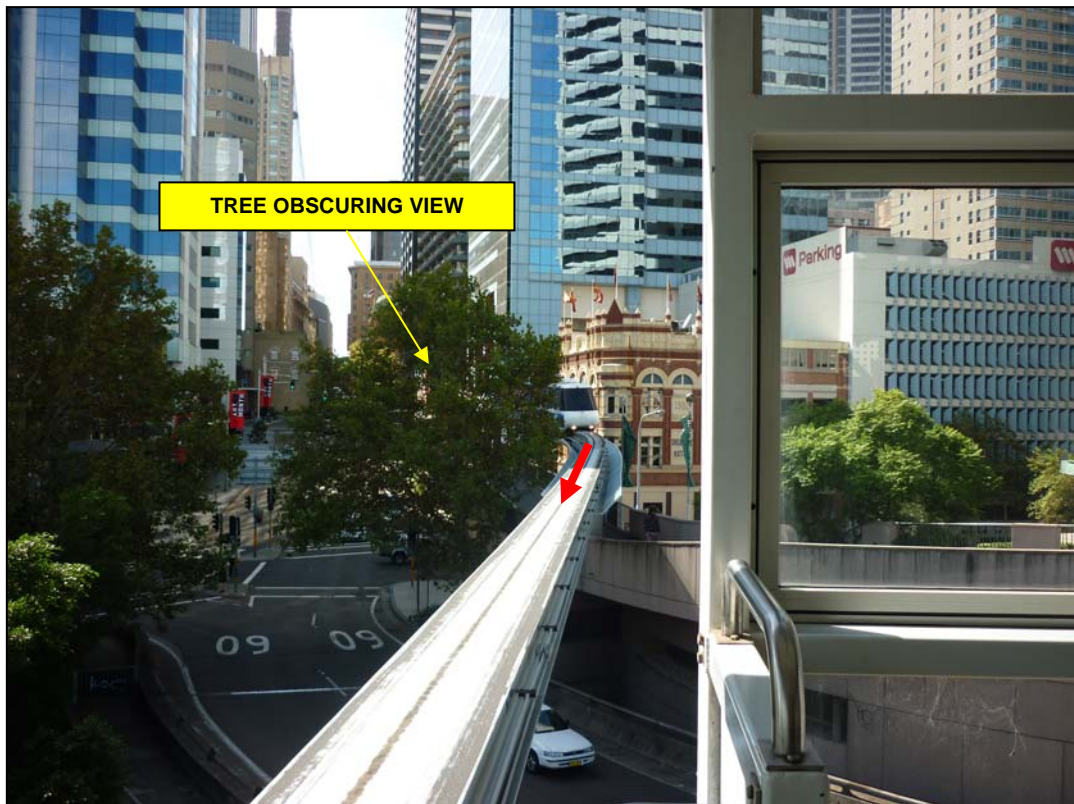
**Photo 8: View from Darling Park Station towards City Centre**

- 2.1 There are a number of locations where vegetation affects sighting distances for monorail drivers. In particular, a deciduous tree obscures the driver's view to the entrance of Darling Park Station for the majority of the way after departing City Centre Station (see *Photo 2*). This condition continues until approximately 40m from Darling Park Station where the view then becomes unobstructed. The station is also momentarily visible at a point approximately 220m away from the station, as the track crosses to the Southern side of Market Street. The Driver of Monorail 1 stated he did not see the stationary Monorail 4 until he had passed the tree.

- 2.2 The tree is growing on Market Street adjacent to the track (see *Photo 8*). The branches of the tree do not impinge on the track or the envelope of the monorail. Rather, it is the curvature of the track which causes the tree to block the view to the entrance of Darling Park Station. The issue of removal or lopping of the tree has been the subject of ongoing discussions between Veolia and the Sydney Harbour Foreshore Authority.

- 5.3 Verify that the new Anti-Collision Control system ensures sufficient separation between monorails and does so under all operating conditions.
- 5.4 Finalise arrangements with the responsible authorities for the pruning or removal of vegetation which obscures track visibility within the “rail corridor”, particularly the tree presently obscuring sighting of the entrance into Darling Park Station from the City Centre Station approach.

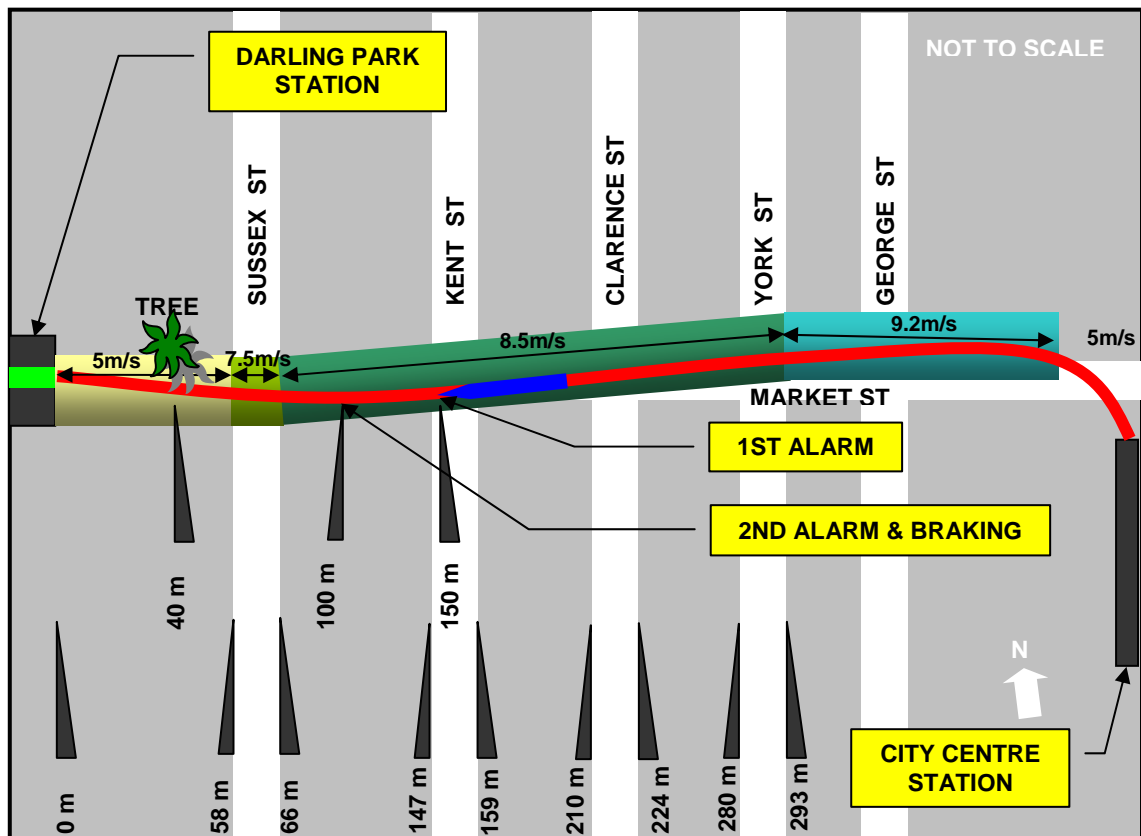
Figure 2: Speed profiles and distances to Darling Park Station entrance

- 2.11 The radio call from the Controller to the Driver came at a critical time. From the time the first alarm sounded, 150m from the monorail ahead, the Driver had 50m in which to take braking action before the 100m mark where any action to slow the monorail would be taken automatically by the ACES system. Travelling at the speed profile of 8.5m/s, or the estimated speed of 9.5m/s, the system provides for approximately five seconds to react (see Figure 2). Despite the distractions, the Driver had adequate time to react to the alarm and apply the brakes.

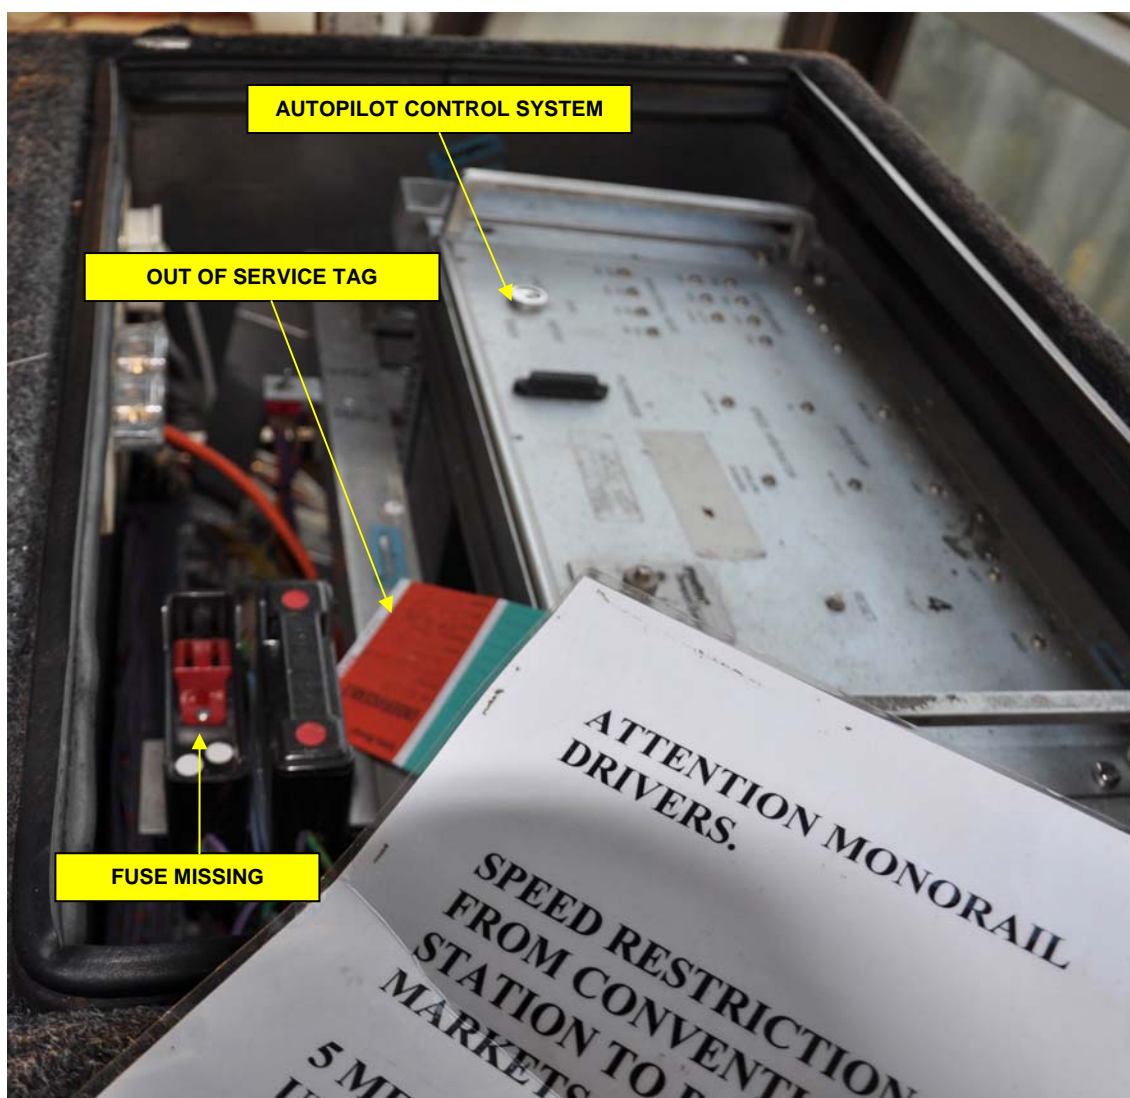
Photo 11: Autopilot Control System after collision

2.25 Autopilot 4 (AP4) was fitted to Monorail 1 at the time of the collision and an out-of-service tag (096-476) was attached to it (see *Photo 11*). According to the attached tag, dated 10 February 2010, AP4 was “*getting lost around the system*”. It should be noted that no subsequent fault was found with the AutoPilot and it is believed not to be a contributing factor to the collision. However, the job sheet relating to this tag was lost so any repairs conducted during the intervening time could not be determined. Maintenance records indicated that the Autopilot was reinstalled in Monorail 1 on 24 February 2010 stating that Monorail 1 “*Needs track testing*”. A Pre-service Inspection dated 25 February 2010 stated: “*AutoPilot Faulty, to be left in manual*”. The maintenance technician who reinstalled AP4 into Monorail 1 said:

*“I was concerned with the operation of AP4 due to it being on the bench and its previous problems.”*

- 2.30 **Fuse missing.** When originally inspected, one of two fuses in the power supply to the AutoPilot on Monorail 1 was found to be missing from its socket (see *Photo 11*). This was originally thought to be a contributory factor to the collision. However, a maintenance technician reported that it was found in the

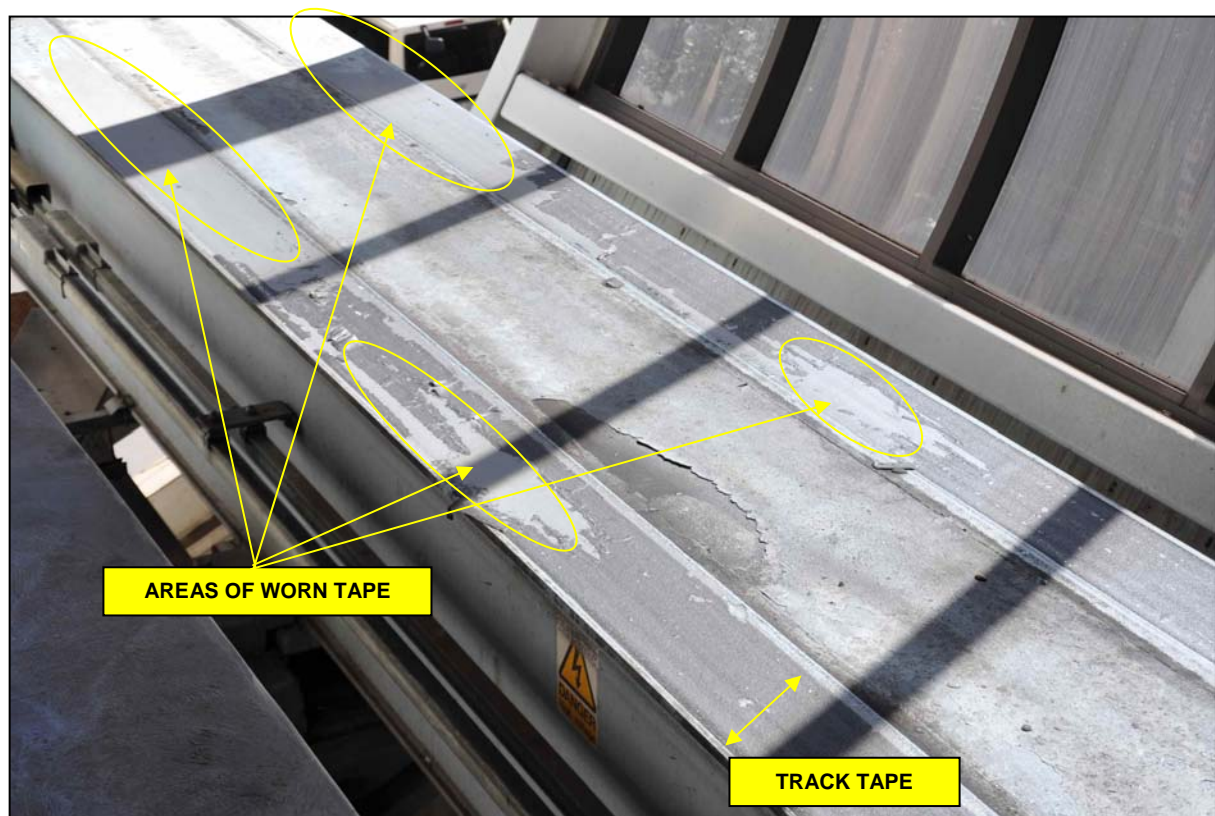
**Photo 13: Track tape at Galleries Victoria Station**

- 3.8 **Track Tape.** The track tape provides increased traction and adhesion between the wheels and the track. The condition of the tape on the approach to Darling Park Station appeared to be serviceable with approximately 80% track coverage. Maintenance records indicated that a significant amount of new track tape had been laid at various locations on 19 January 2010. However, an inspection of the track immediately following the collision showed that the tape was in a worn condition at many locations (see *Photo 13*).

- 4.5 Although in a satisfactory condition on the approach to Darling Park Station, track tape that provides increased adhesion for traction and braking was worn on many other parts of the track. The documentation for track tape inspections and maintenance was incomplete.
- 4.6 Maintenance history documentation, in particular Job Sheet 096-476, for the Autopilot in Monorail 1 at the time of the collision could not be located or provided.

- 5.6 Ensure its track tape maintenance schedule provides for the timely inspection and replacement for worn tape.
- 5.7 Upgrade the audio recording system used for voice recordings between train control and drivers to ensure ease of retrieval and clear, high fidelity replay.

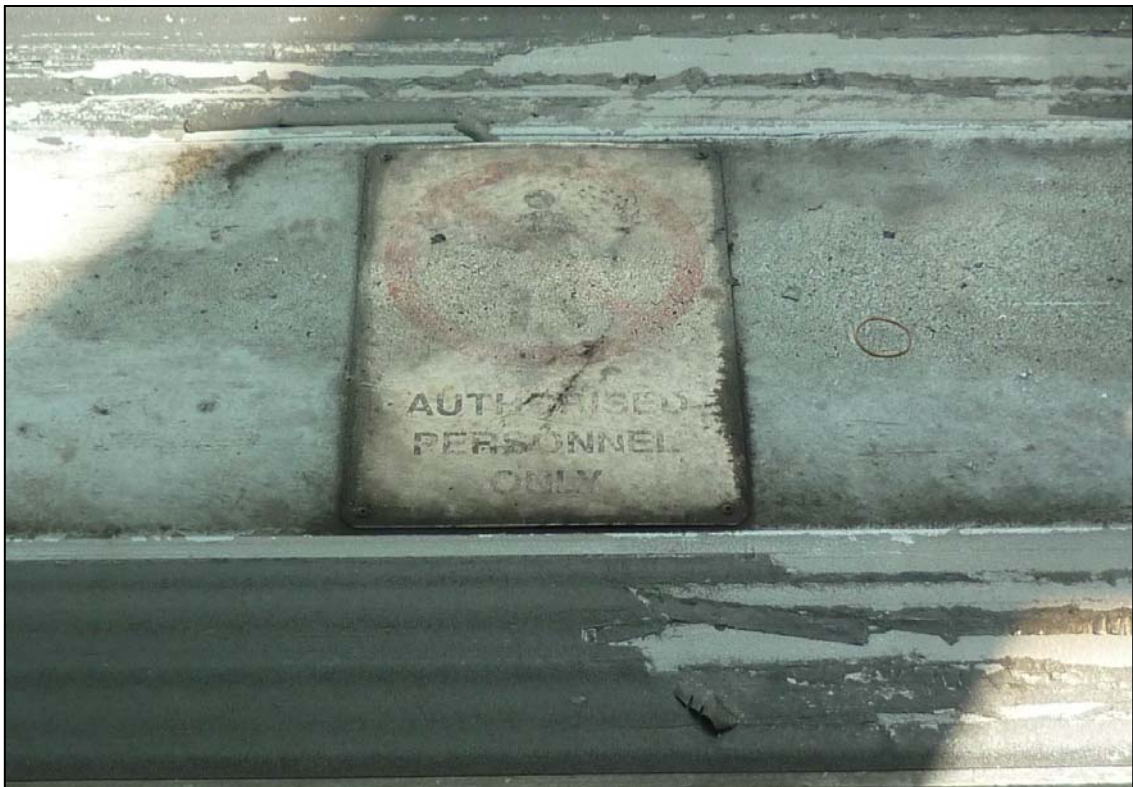
**Photo 14: Safety sign and track tape at Darling Park Station**

- 3.9 Veolia's Report<sup>10</sup> into the 2006 collision identified that a lack of track tape may have been a contributory factor to that collision and the recommendation that the tape be inspected and replaced where necessary was acted upon.
- 3.10 **Signage.** While inspecting the condition of the track tape, faded warning signage relating to "Authorised Personnel Only" was observed on the track near the point of the collision (see *Photo 14*). Although not a contributory factor in this collision, warning signage, where fitted, must be maintained in a legible condition.
