# FERRY SAFETY INVESTIGATION REPORT

**FERRY *PEMULWUY* LOSS OF CONTROL  
SYDNEY HARBOUR, NSW  
2 JULY & 23 NOVEMBER 2020**

**Released under the provisions of  
Section 45C (2) of the *Transport Administration Act 1988* and  
Section 46BBA of the *Passenger Transport Act 1990*  
*Investigation Reference 04821***

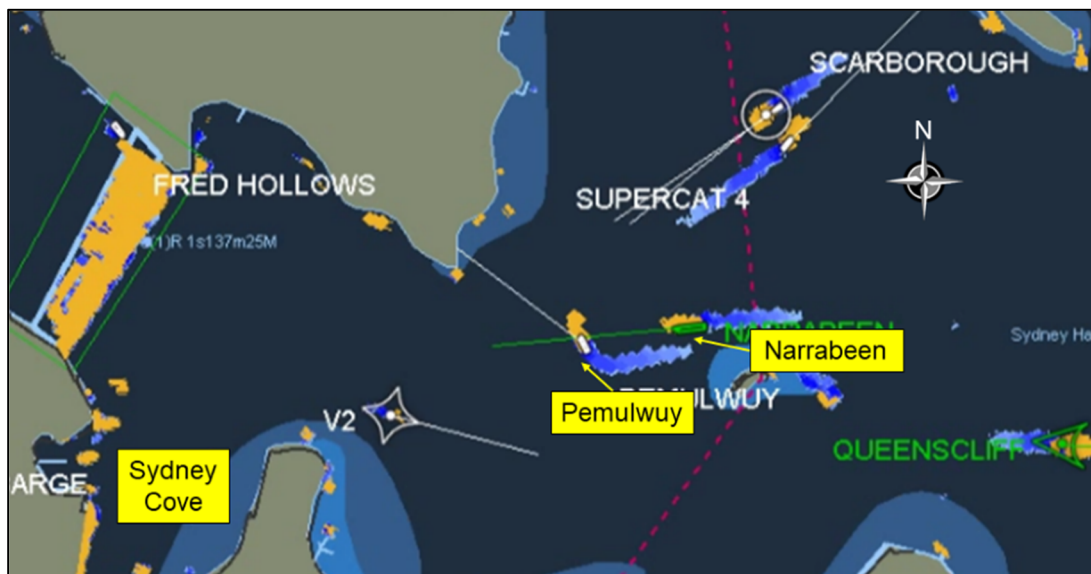
Figure 4: *Pemulwuy* crossing *Narrabeen*’s bow

- 1.9 Approximately 25 seconds after *Pemulwuy* passed Fort Denison, the steering stopped responding to the master’s input and both its rudders turned hard to starboard. This resulted in *Pemulwuy* performing an uncontrolled, sudden and unexpected turn to starboard before the master could slow the vessel and switch to back-up steering control.
- 1.10 The uncontrolled change of heading and subsequent reduction of headway placed *Pemulwuy* in the direct path of the ferry *Narrabeen* (see Figure 4). AIS data indicated that *Pemulwuy* slowed to approximately 10 knots, before accelerating to approximately 16 knots for a short distance. This acceleration resulted in *Pemulwuy* clearing *Narrabeen*’s intended path. During the turn to starboard, *Pemulwuy* changed course from approximately 260° to 359°.

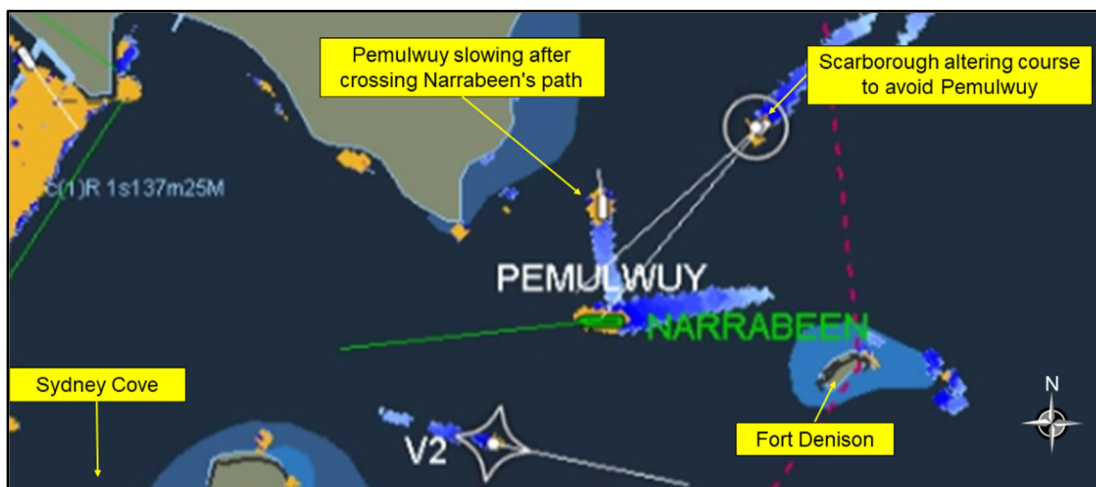
**Figure 5: Scarborough altering course to avoid the slowing Pemulwuy**

- 1.11 When *Pemulwuy*'s master realised the vessel was not responding to steering input, he slowed the vessel by reducing power on the throttles. The master then regained steering control by switching to back-up steering and increased power on the throttles, which allowed *Pemulwuy* to travel a short distance so as to clear *Narrabeen*'s path. The master then set the engine throttles to neutral and confirmed the back-up steering control was operational. This resulted in *Pemulwuy* drifting a short distance to the north of *Narrabeen*'s path and ahead of the ferry *Scarborough*, which was approaching from the northeast. *Scarborough*'s master seeing *Pemulwuy* in their intended path, altered course to pass down *Pemulwuy*'s starboard side at a safe distance (see *Figure 5*).

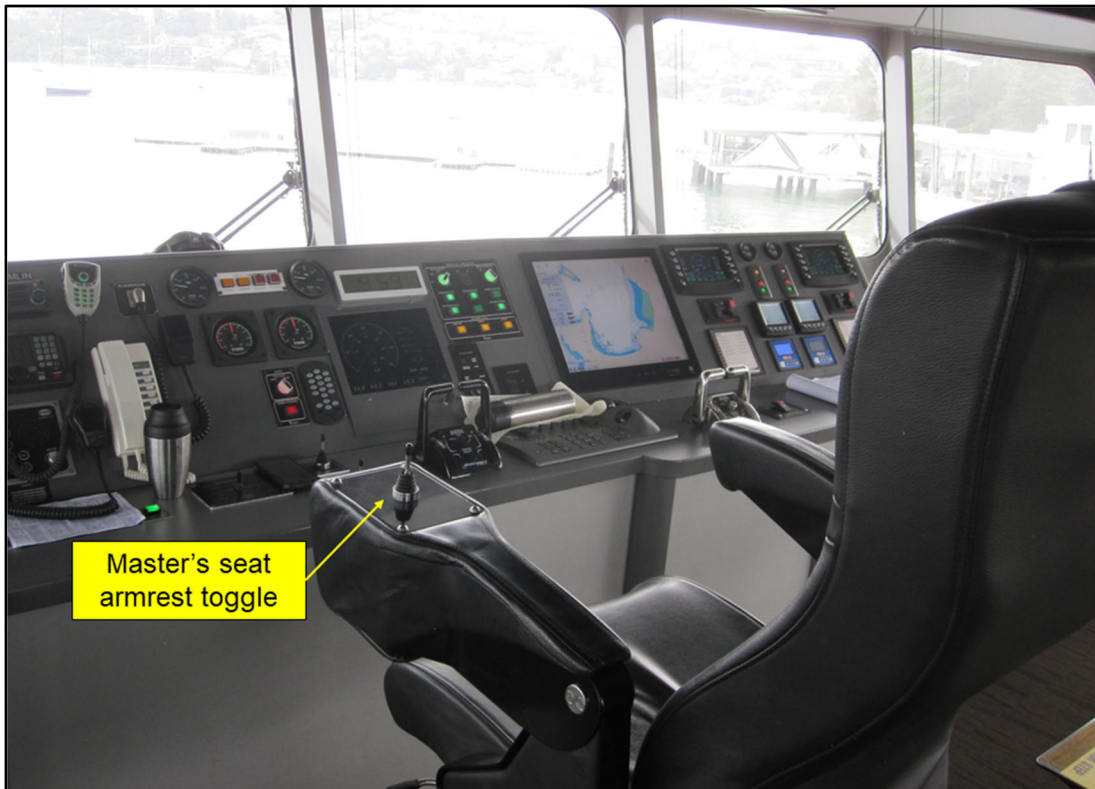
Figure 6: Master's seat and control toggle

- 1.12 *Narrabeen*'s master reported that when he noticed *Pemulwuy* turn across his bow, he reached for the controls to avoid a collision. However, before he could actually respond, *Pemulwuy* had reaccelerated and moved out of *Narrabeen*'s path.
- 1.13 *Pemulwuy*'s master ensured that the vessel was safe and then made a passenger announcement on the vessel's public address system. The general purpose hand (GPH), conducted a patrol of the vessel to reassure and check on the passengers' wellbeing.
- 1.14 The master and engineer then undertook a series of checks to identify and isolate the problem. They suspected that the steering toggle on the master's seat armrest was faulty (see *Figure 6*).

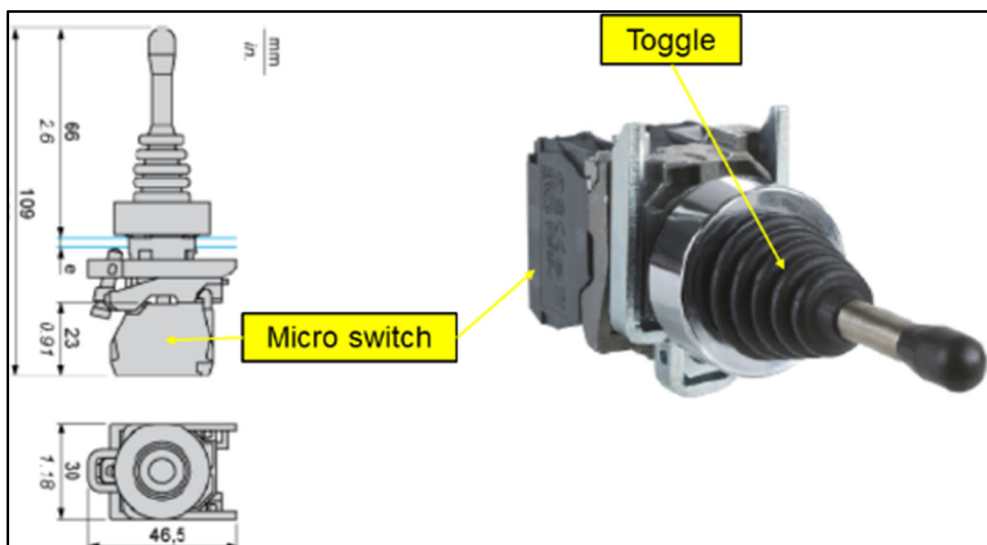
Figure 12: Steering toggles

1.32 Schneider Electric manufactured the steering toggles installed on the Emerald class ferries. The toggles were designated as XDPA22 Joystick Controllers (see Figure 12).

- 2.19 The investigation identified that the steering toggle (XDPA22 Joystick Controllers) micro switches, as installed from new, were not carrying 0.5 amps as assumed, but exposed to an electrical current of 1.2 amps. This current was at the upper limit of the carrying capacity of the switch and almost two and a half times over the stated manufacturer's durability rating. TSF contacted Schneider and reported the current that was measured during the investigation. Schneider estimated, that under those operating conditions, the durability rating would reduce by a factor of ten, to approximately 100,000 cycles.

- 2.12 As a result of the technical investigation, TSF replaced the toggles on all the Emerald class ferries with new toggles of the same type.
- 2.13 In October 2020, TSF commenced a trial of different toggles to identify if a more suitable make was available.

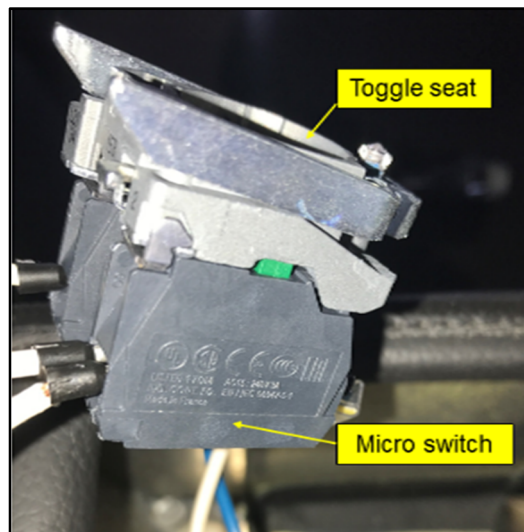
**Figure 13: Micro switch**

- 1.33 The product data sheet stated that the micro switches (see *Figure 13*) had a service life of 1,000,000 cycles on a 24-volt DC circuit, when operated with a 0.5 amp<sup>11</sup> current.

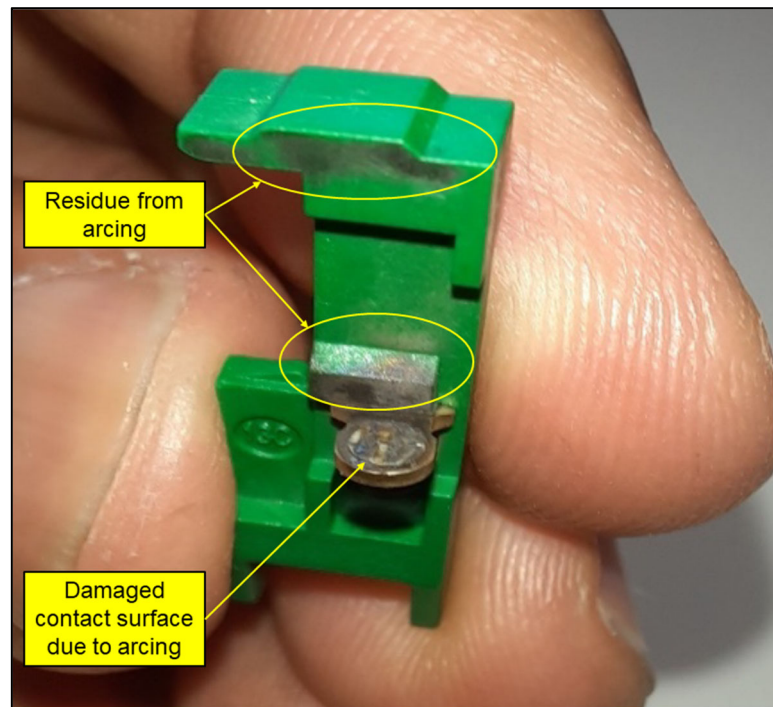
**Figure 15: Damaged micro switch surface**

- 2.21 Following the second incident, TSF conducted destructive testing of the micro switches removed from the Emerald class ferries. This testing found that the contact surfaces were pitted and charred (see *Figure 16*).

- 2.22 The investigation determined that the switches were operating at the upper limit of their current carrying capacity. This likely resulted in pitting and charring, caused by arcing between the contact surfaces on the micro switch. The damage to the contact surfaces likely resulted in both short and open circuit faults<sup>22</sup>.
- 2.23 TSF, in conjunction with Incat, installed solid-state relays to reduce the current passing through the micro switches to approximately 12 milliamps (0.012 amps). This current was well within the micro switch carrying capacity.
- 2.24 Following a successful trial of *Pemulwuy* in the new configuration, the relays were installed on all Emerald class ferries by 20 December 2020.
- 2.25 As a further precaution, TSF replaced all the micro switch blocks on the remaining Emerald class ferry steering toggles.

- 3.2 A failure in the master's seat steering toggle control caused the loss of control of the *Pemulwuy* on 2 July and 23 November 2020.
- 3.3 A 1.2 amp current passing through the steering toggles resulted in damage to the surface of the micro switch contacts. This resulted in a closed circuit, which sent an uncommanded signal to the rudder solenoid valve.

- 4.1 Review its investigation procedure to incorporate identification and rectification of critical failures before vessels are returned to service.
- 4.2 Review its fleet wide asset maintenance plan to include preventative maintenance of vessel safety critical systems.
- 4.3 Configure the VDRS to capture the recording of safety critical data related to vessel control.
- 4.4 Review its reporting systems and processes to enable accurate and prompt reporting of safety incidents and retention of relevant data.
