Office of
Transport Safety
Investigations

Safety Investigation Report

**Engine Bay Fire
Heatherbrae**

19 September 2019

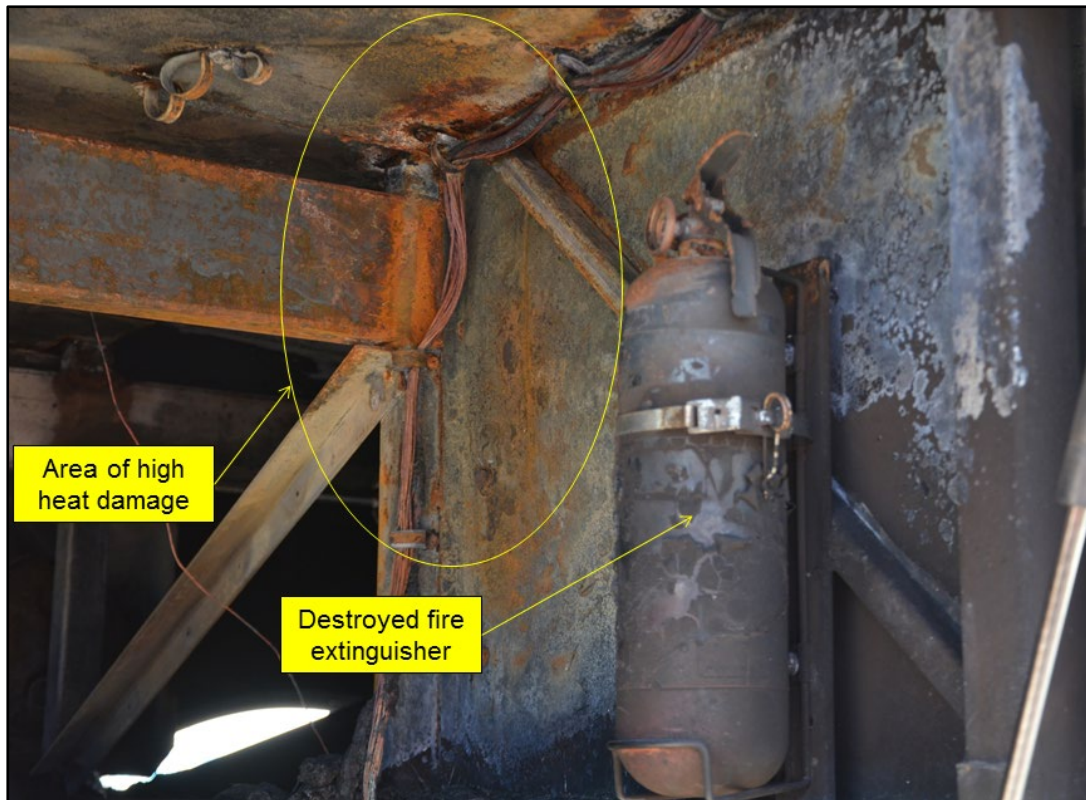
Figure 2: Fire damaged engine bay and extinguisher

- 1.5 Once the extinguisher was emptied the driver did not attempt to access the second fire extinguisher, located inside the engine bay, due to its proximity to the fire. The driver then used his mobile phone to call for emergency services assistance. NSW Police arrived at the scene and began to direct passing traffic safely past the burning coach.

- 1.7 The second fire extinguisher was destroyed by the fire (see *Figure 2*).

- 2.11 OTSI made recommendations that consideration be given to position the extinguishers in a readily accessible location in compliance with applicable standards, but not within the confines of the engine bay area.
- 2.12 The number of fires and thermal incidents initiating in the engine bay for the period 2013-2019 is shown below (*Figure 10*).

- 2.18 An additional 4kg fire extinguisher is now to be carried by buses fitted with a luggage compartment.
- 2.19 All buses in the fleet are to be fitted with an access portal in the engine bay hatches to allow the discharge of a fire extinguisher from outside the engine bay.

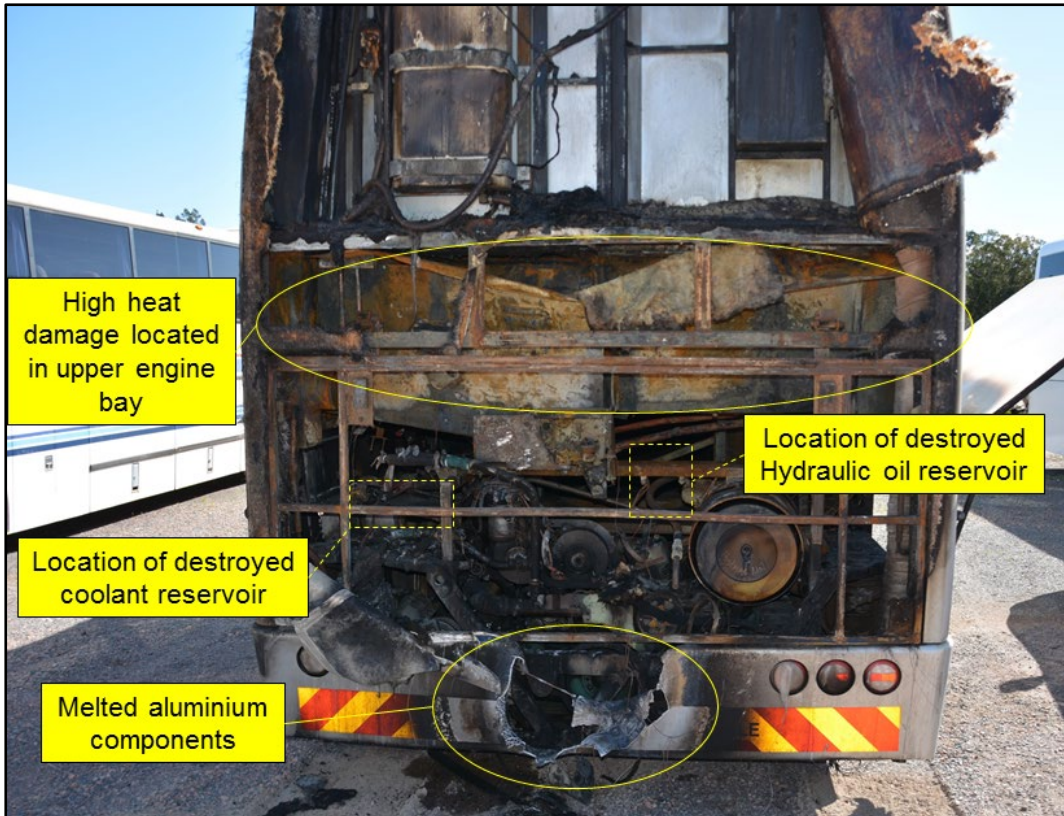
Figure 3: Damaged rear of TV9793

2.3 Externally, the coach body panels remained undamaged along the sides and front. The body panels in the immediate vicinity of the engine bay were damaged or destroyed by the fire. The aluminium rear engine bay hatch skin was almost totally destroyed, leaving only the hatch frame. The centre section of the rear bumper was heavily damaged, most likely due to burning fluids escaping from the melted plastic hydraulic oil and coolant reservoirs.

2.4 Inside the engine bay, most electrical wiring insulation, fuel lines and componentry above the engine were heavily damaged or destroyed. Evidence of intense heat was found in the upper side of the engine with far less damage evident in the lower engine bay (*see Figures 3 & 5*).

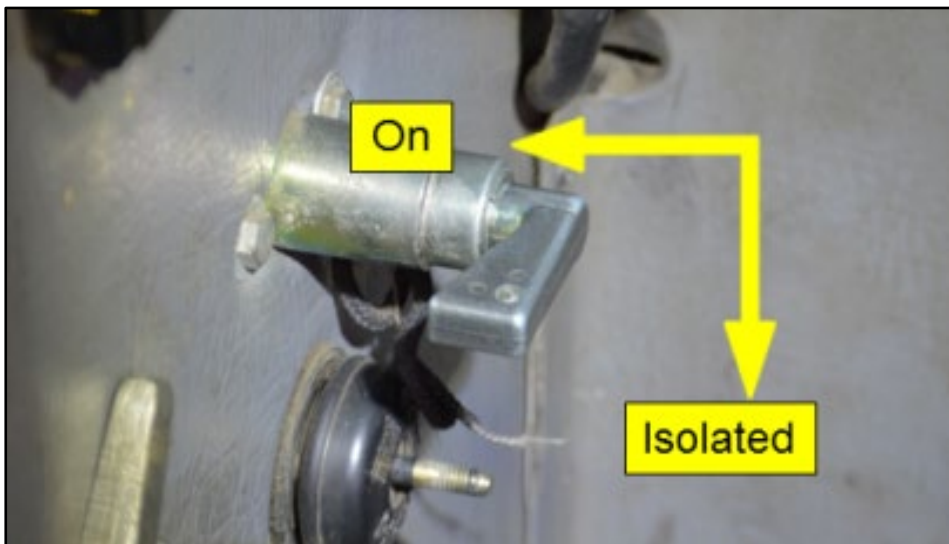
Figure 6: Under console battery isolation switch

2.6 The electrical and battery isolation switches in the driver's console area were found in the engaged position (see Figures 6 & 7). This created an unfused circuit from the batteries to the starter motor and alternators. Figure 8 shows evidence of electrical arcing of the B positive feed to the alternators due to short circuiting⁴. This cable is part of the unfused circuit.

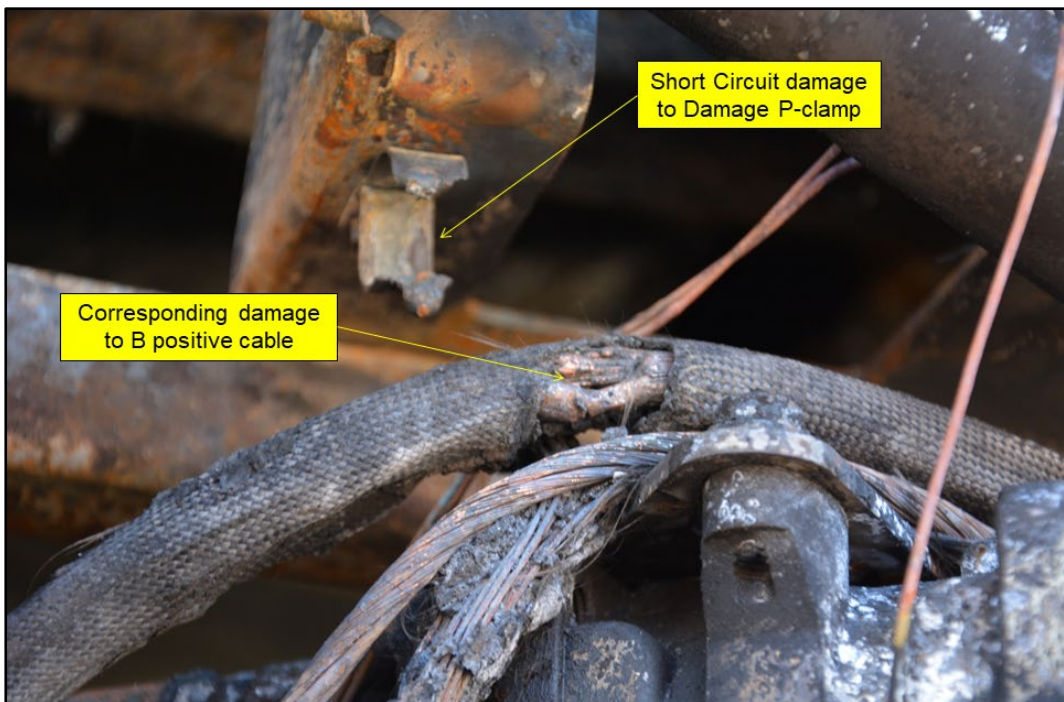
Figure 8: B positive cable damage from short circuit

- 2.7 Further investigation of the engine bay revealed damaged cabling from electrical arcing due to short circuits (see *Figure 8*). This likely indicates a continuous supply of power to this circuit during the fire.

3.1 The following are the two likely scenarios that contributed to the initiation of the fire. Firstly, that of diesel fuel escaping under pressure from the fuel return circuit. Fuel leaking from the return line likely contacted heated engine components, vaporising the fuel. Vaporised diesel fuel can appear as white smoke as identified by the driver. Vaporised fuel can ignite when exposed to ignition sources. Secondly, energised cables forming an unfused, high amperage electrical circuit, which short circuited igniting surrounding combustible materials.

- 4.1 Incorporate into their maintenance regime ongoing inspection of fuel lines and high amperage electrical circuits to reduce the risk of fire.
- 4.2 Review the placement of fire extinguishers within engine bays with a view to extinguishers being readily accessible during emergencies.
- 4.3 Incorporate into their maintenance regime the periodic cleaning of engine bays to reduce any potential build-up of combustible material.

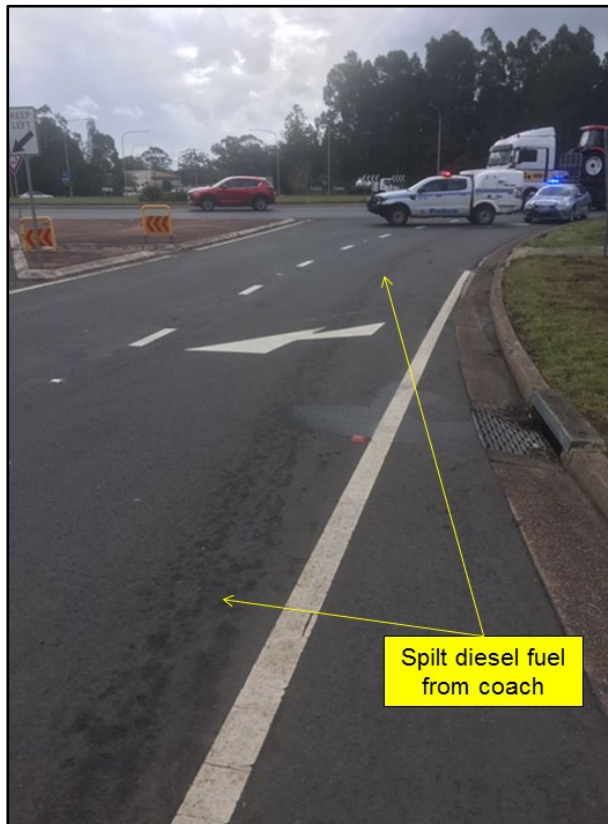
Figure 9: Diesel fuel leak leading to rear of coach

- 2.8 Photographs taken on the day of the incident show a trail of diesel fuel leading from the rear of the coach along the road (see *Figure 9*). The driver reported that, except for white smoke, the coach operated normally up to and including

when he stopped. This indicates that the fuel leak most likely originated in the return circuit of the fuel system.
