**Office of
Transport Safety
Investigations**

Safety Investigation Report

**Bus Fire MO5103
Campbelltown, NSW
16 August 2021**

Investigation Reference I02009

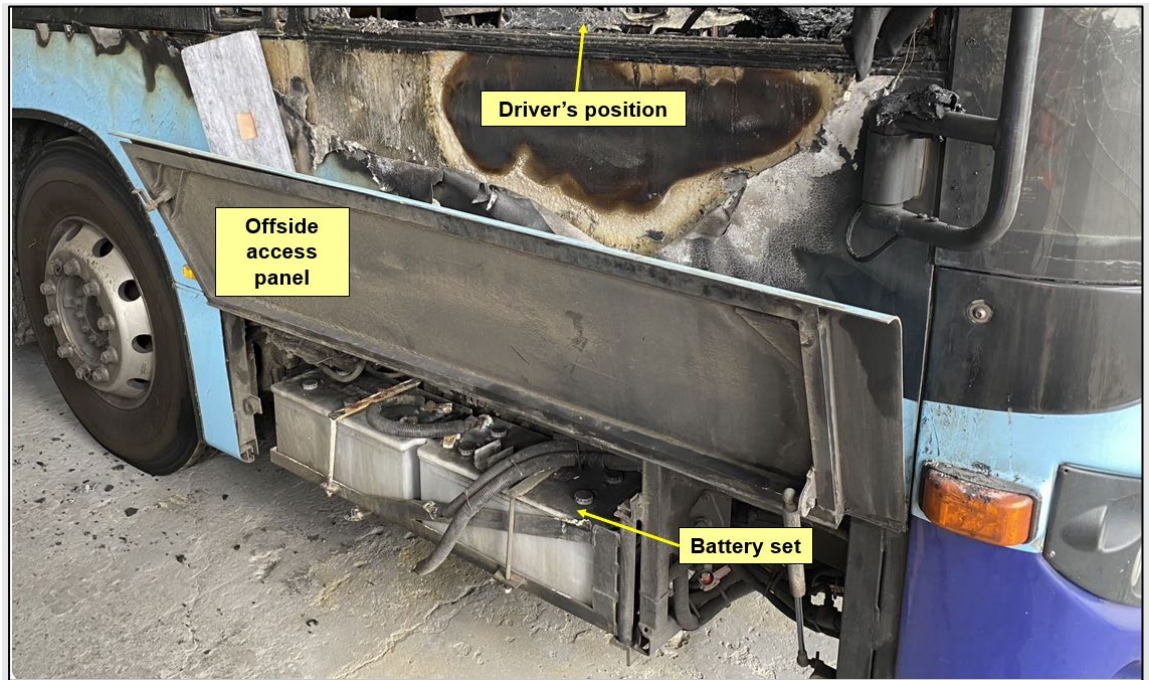
Figure 3: Bus battery set location (post fire image)

- 1.25 The bus battery isolation switch was located adjacent to the battery set on the front offside of the bus, under an external access panel (Figure 3).

- 1.26 The bus operator did not lock this access panel, nor require or train its drivers to isolate the bus battery in an emergency, due to assessed hazards and risks (see *Operator information*).

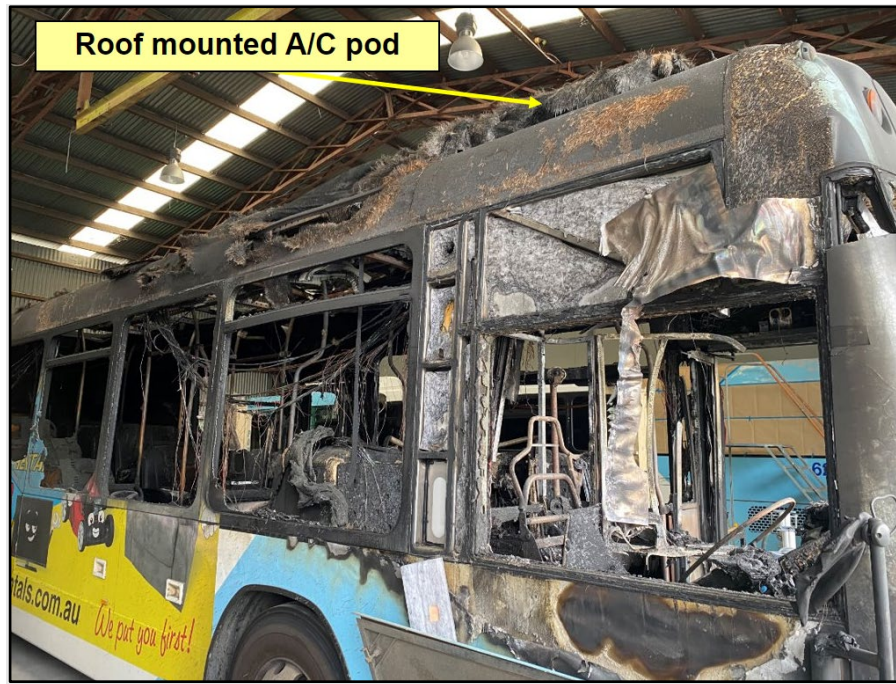
Figure 15: MO5103 fire damage on offside

- 2.3 The bus was destroyed as a result of intense fire and associated heat.
- 2.4 The Engine Bay Fire Suppression System (EBFSS) did not activate, as there was no thermal activity/fire in the engine bay.

Fire damaged the EBFSS wiring located within the interior A/C duct running down the offside of the bus, resulting in the driver's FSS alert activation due to both pressure switches in that system having lost electrical continuity.
- 2.5 Heat and fire signatures, both on the bus exterior (Figure 15) and inside the bus body, showed intense heat and fire damage in the area of the roof-mounted A/C pod, associated M2 node and wiring.

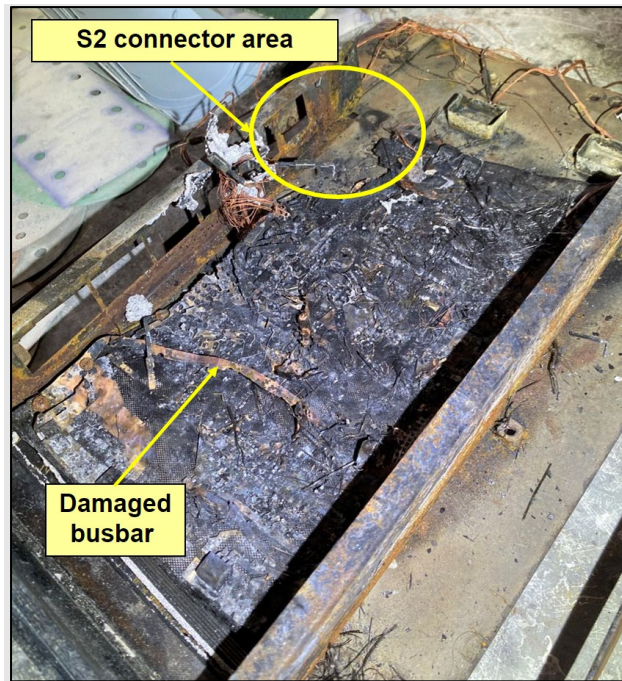
Figure 16: Fire damaged Thoreb M2 Node

- 2.6 While it could not be determined from the wreckage if the A/C system was on at the time of the incident, the 150A fuse, in the wiring connection from the A/C system M2 node S2 connector to the positive terminal block of the battery, had blown.⁸ There was no damage to the battery set.
- 2.7 The Thoreb M2 node and steel casing were located post-incident on the bus floor and had sustained extensive fire damage. The area of the S2 connector, and the metal casing covering that region, exhibited evidence of intense heat, with that corner of the node circuit board disintegrated through thermal decomposition (Figure 16) (see Figure 11 for an image of an undamaged M2 node circuit board).

- 3.1 Electrical arcing in the vicinity of the air conditioning system Thoreb M2 control node, specifically in the region of the main S2 connector block and its associated wiring harness, escalated to fire.

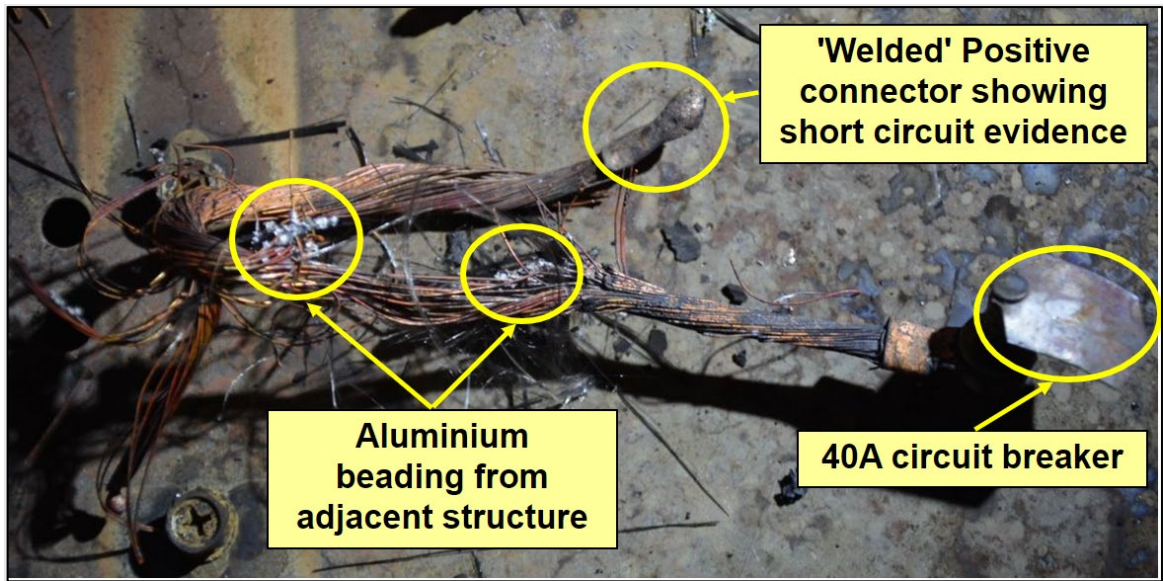
Figure 17: S2 connector wiring from M2 Node

- 2.8 The wiring between a positive connector into the S2 connector and a 40A 12V circuit breaker was identified in the debris. The connector was 'welded', showing evidence of a short circuit or high resistance connection (Figure 17). Evidence of aluminium beading from adjacent structures was also present. It was highly unlikely that this came from the steel casing as that was recovered intact. The aluminium cover and heat sinks of the M2 node were destroyed in the fire and only the steel case portions were recovered.

- contamination in the connector, such as dust or condensation
- sulphurisation of one of the silver-plated S2 connector tab posts
- the S2 connector was loose
- component deterioration.

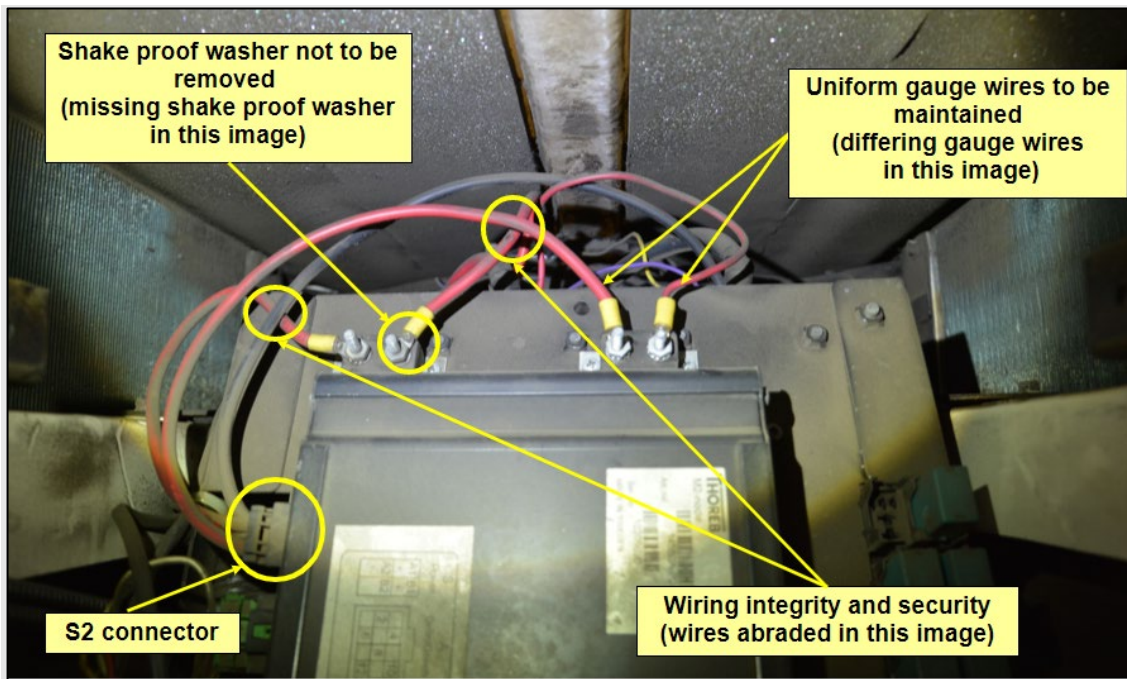
Figure 18: Wiring associated with M2 Node within the DENSO A/C system configuration on another bus

- 2.15 Post-incident inspections of other similarly configured buses within the operator's fleet identified issues with the wiring harness between the main A/C connector blocks, dust contamination, security of terminals and evidence of terminal discolouration within the main S2 connector block.

The M2 node in one inspected vehicle (bus body manufactured in 2012) exhibited several issues, including an incorrect gauge wire, missing shake proof washer, wiring abrasion and dust (Figure 18).

- 2.24 The post incident A/C system inspections, conducted on similarly configured buses, identified significant issues, including non-compliant gauge wiring, wiring abrasions, and missing fasteners, with some buses containing several issues.

- Inspect cabling associated with the Thoreb M2 node and ensure wiring is undamaged and secured correctly with adequate clearance of any possible points of contact.
- Inspect the S2 connector block terminals for discolouration, any evidence of heat damage and ingress of contaminants.
- Review maintenance regimes to ensure inspections adequately address and remedy any issues with wiring integrity (including checking shake proof washers have not been removed), security and overall cleanliness of the A/C system.
