# Derailment of freight train 4BM4

Nana Glen, New South Wales, on 25 February 2021

**ATSB Transport Safety Report**  
Rail Occurrence Investigation (Systemic)  
RO-2021-004  
Final – 6 June 2023

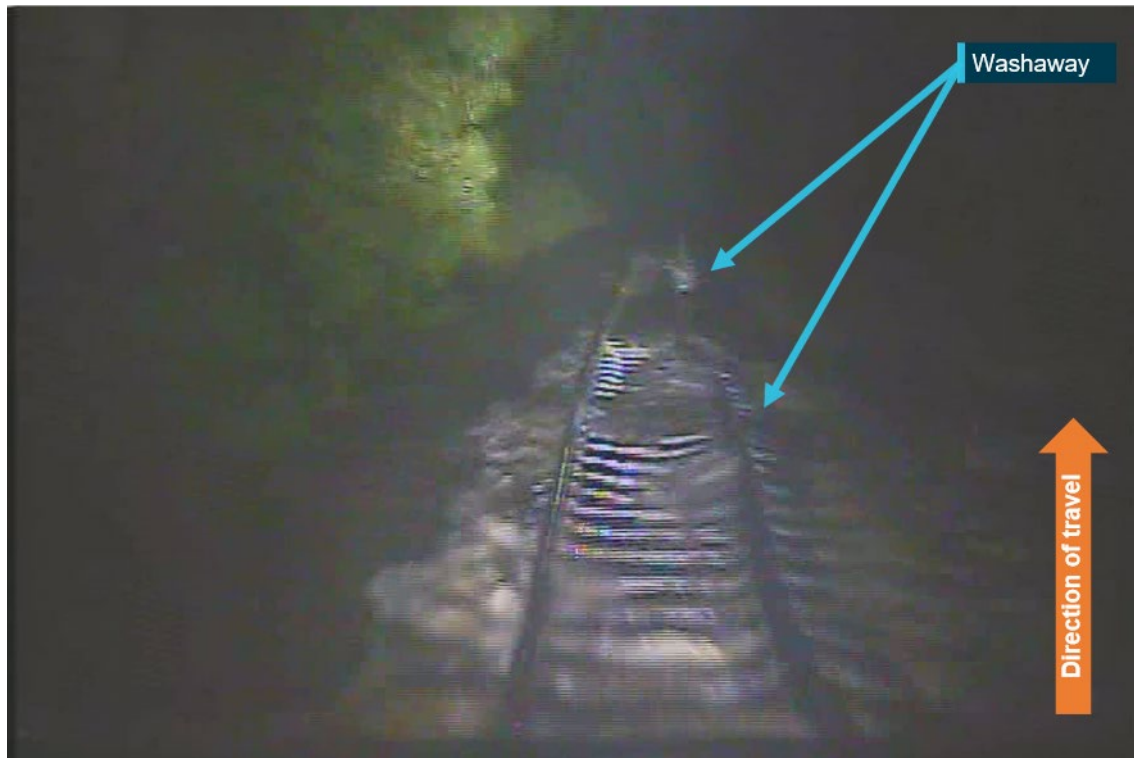
**Figure 5: Washaway**

*The image shows two sections washed away just prior to the train passing over. The floodwater was flowing from left to right.*  
Source: Pacific National, annotated by OTSI

At 0137 the train passed over the washaway while travelling at approximately 59 km/h. The lead locomotive dipped as it passed over the section of track and derailed, before bouncing out of the washaway and continuing. Both drivers reported they were thrown into the air when they passed over the washaway. Driver A was uninjured and driver B reported that at the time they felt some discomfort in their neck and shoulder.

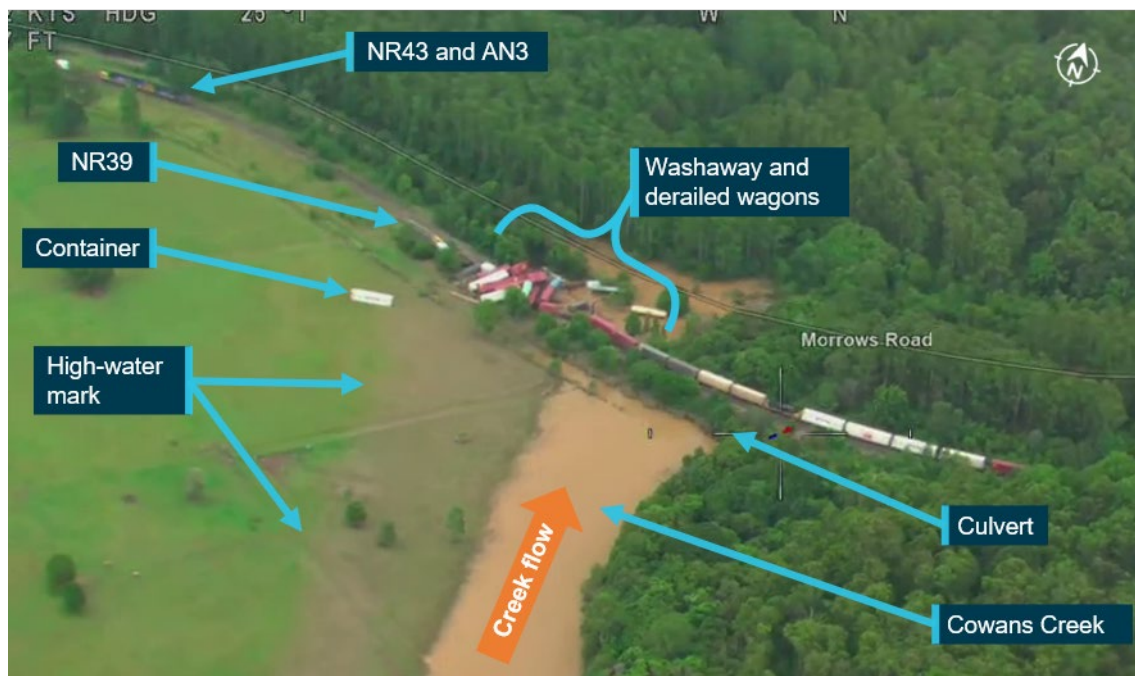
**Figure 6: Derailment site**

The first locomotive derailed the first and sixth axles and the second locomotive did not derail. Both locomotives remained upright and came to a stand approximately 360 m from the point of derailment (Figure 6). The train separated between the second and third locomotive with the third locomotive (NR39) coming to rest on its left-hand side in the direction of travel (Figure 7). The first 10 wagons in the consist derailed and concertinaed to the left and right of the rail line as the train came to a stand. A number of wagons entered the floodwaters on the Orara River (northern side) and one container came to a rest in the field on the southern side near the high-water mark (Figure 6).

The image was captured by a helicopter at 1528 on 25 February almost 14 hours after the derailment. At 1530 the river height at Glenreagh (6.48 km north west of the derailment site) was recorded at 10.02 m with water from the Orara River visible on the northern side of the derailment site. The location of the washaway and resting place of the locomotives and wagons are shown. Cowans Creek ran towards the Orara River and drained through a culvert at 643.849 km. The grass was stained with a high-water mark visible where the water had receded.

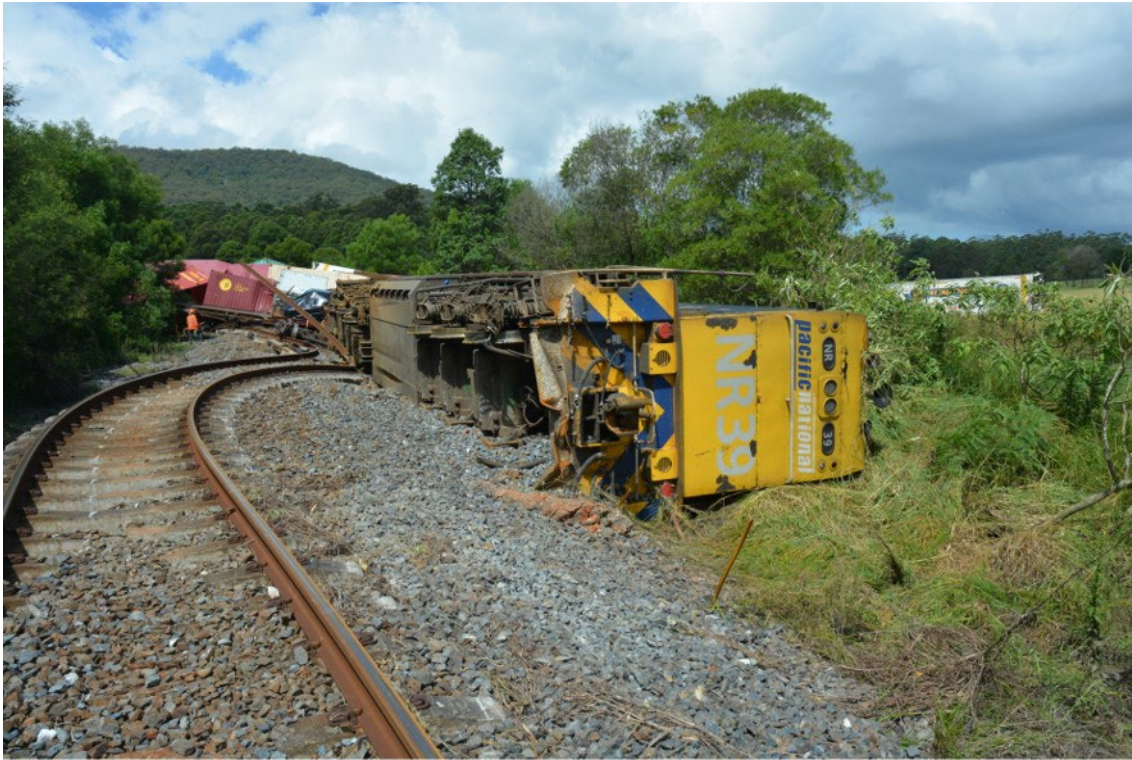
**Figure 7: Third locomotive NR39 derailed**

*NR39 shown laying on the side with wagons derailed behind. The topography of the area can be seen to rise behind the derailment site. Source: OTSI*

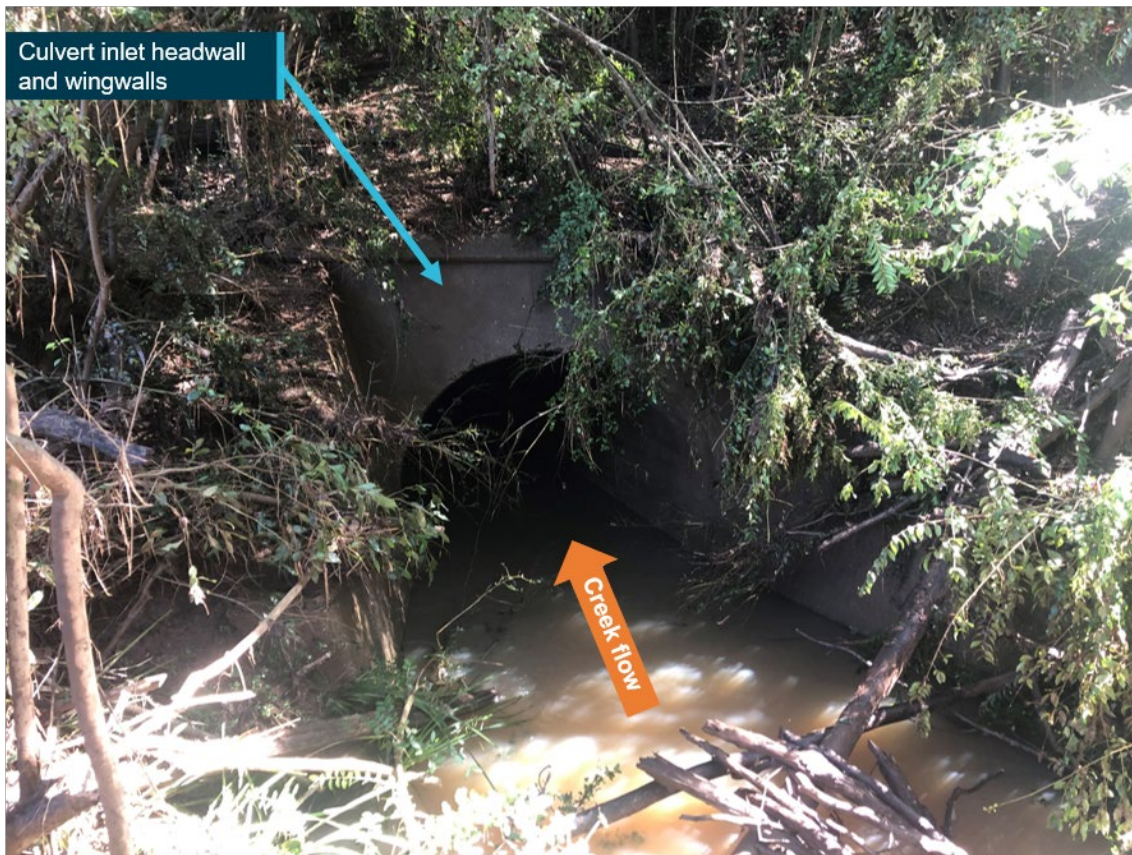
**Figure 18: Culvert inlet**

Photographs taken on 28 February and 1 March 2021 showed that some debris had collected around the inlet and some small branches were near the inlet. These photographs showed that the culvert about the water line was not blocked. Some of the debris would likely have moved as the water levels receded.

The inlet of the culvert at 643.849 km is shown with the headwall and wingwalls. Debris was present near the inlet with some small branches laying across the channel as well as collected above the culvert.  
Source: ARTC, modified and annotated by OTSI

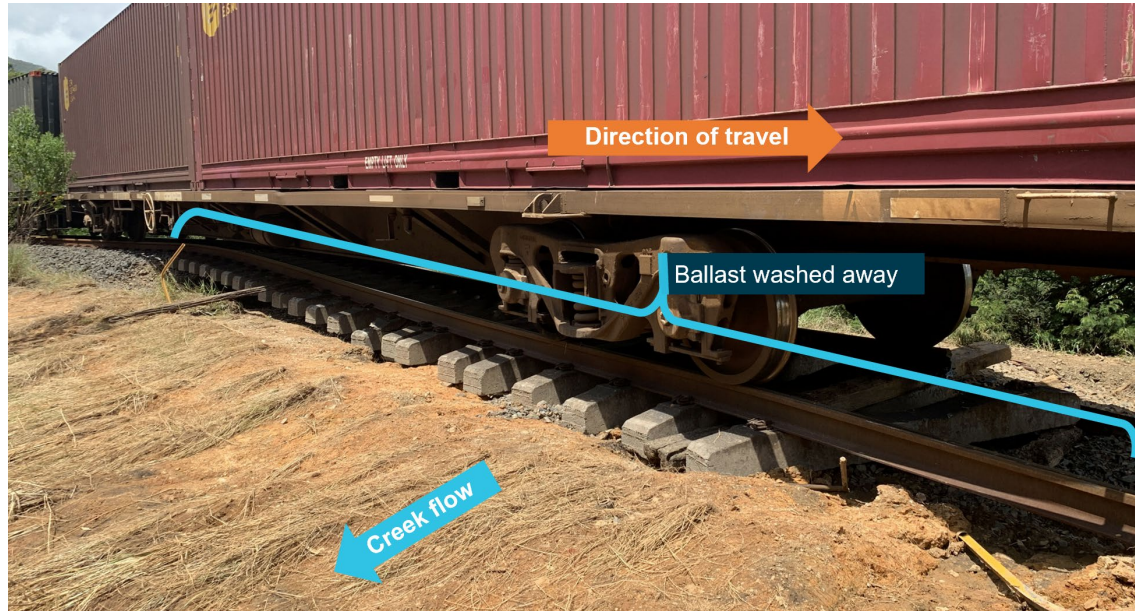
**Figure 24: Ballast washed away**

The image shows an area of the embankment where the ballast had washed away with the sleepers resting on the subgrade material. The vegetation can be seen to be lying flat due to the flow of water over the embankment.
