MOBILE SPEED CAMERA ENFORCEMENT PROGRAMS IN NSW

Speed Camera Inquiry – NSW

Individual Submission

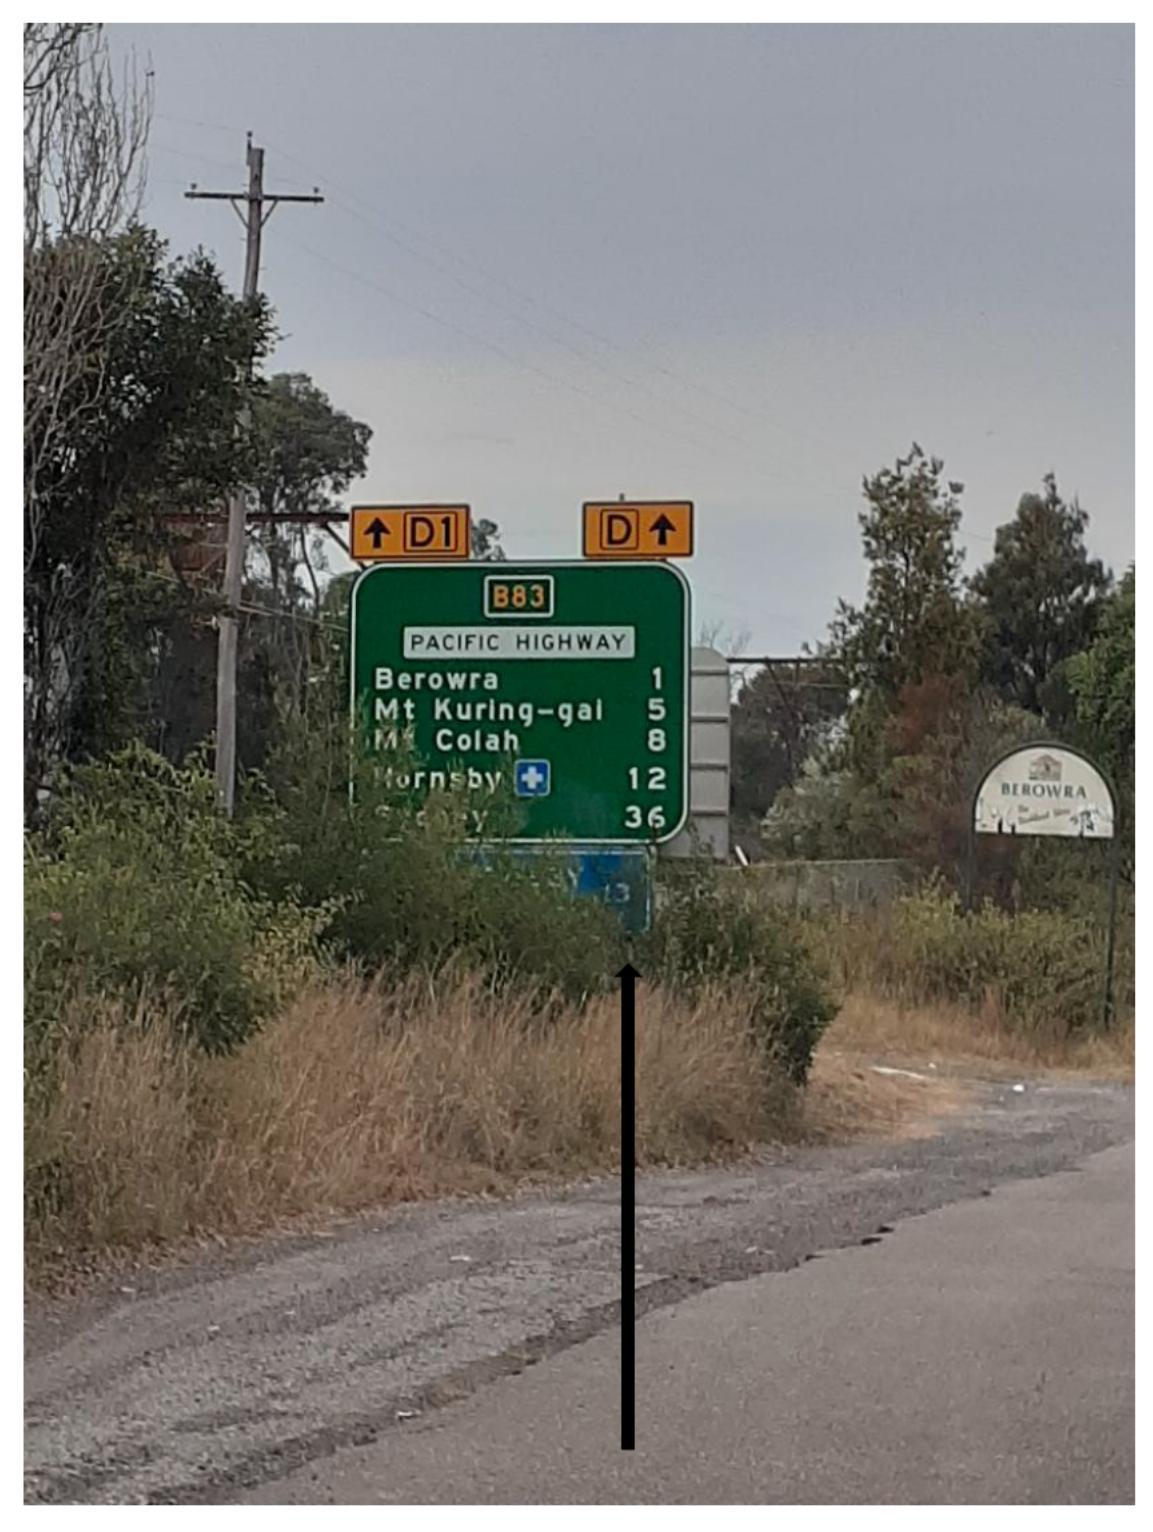
Sign indicating hospital cannot be seen by motorists. Location. Pacific Hwy, Berowra.

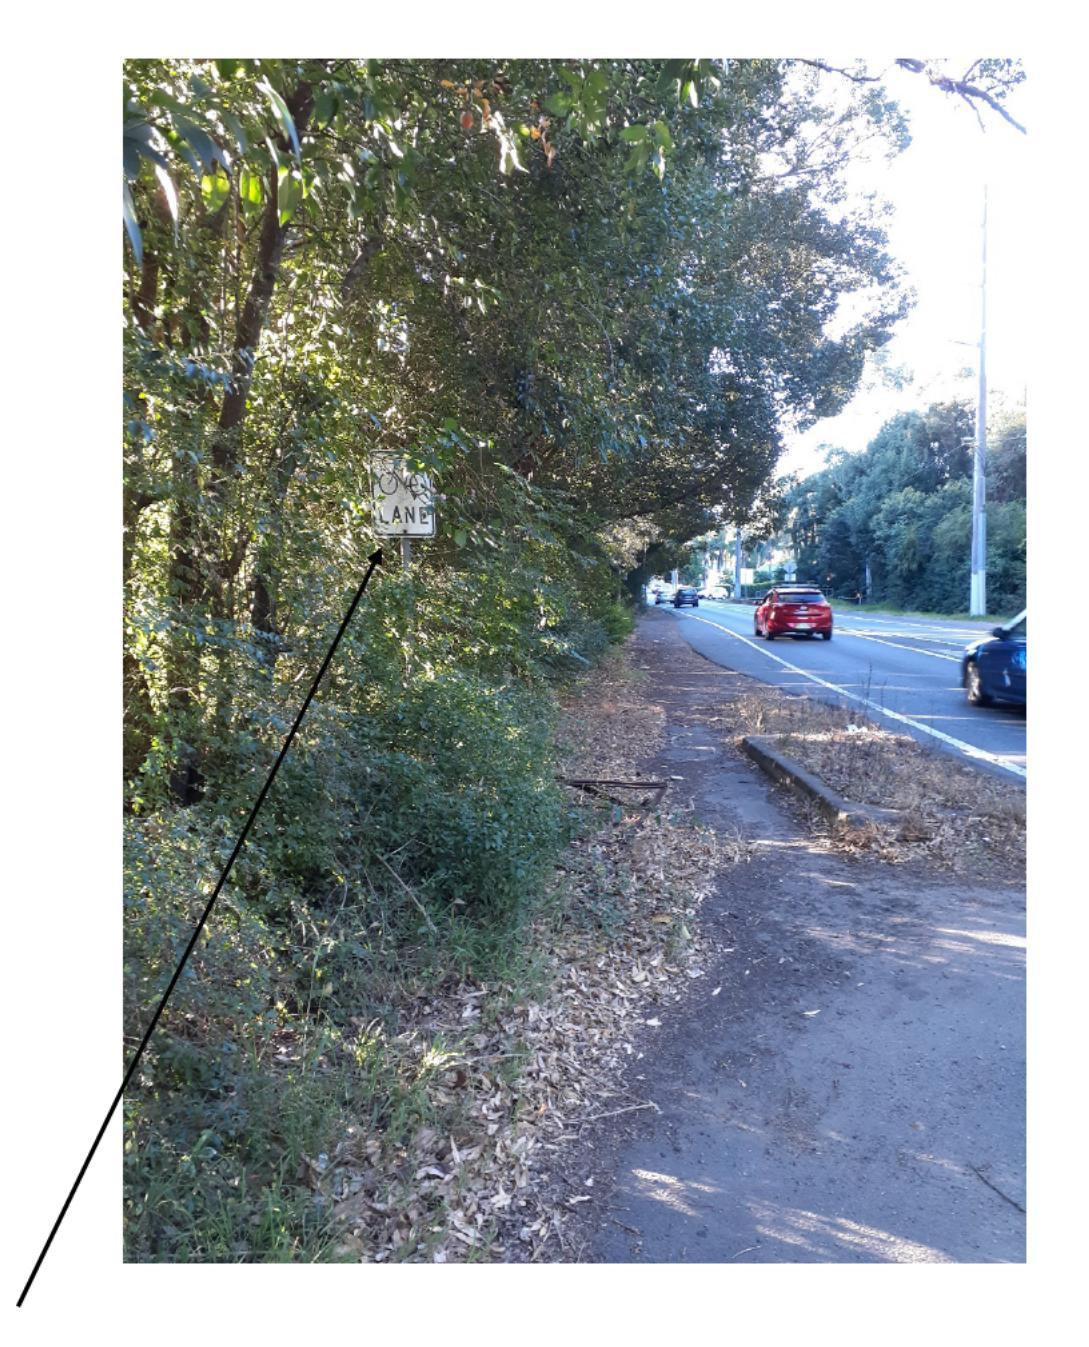
Poorly maintained cycleway indication sign for motorists to observe. Location. Manns Rd Narara.

Cannot be seen due to overgrown vegetation.

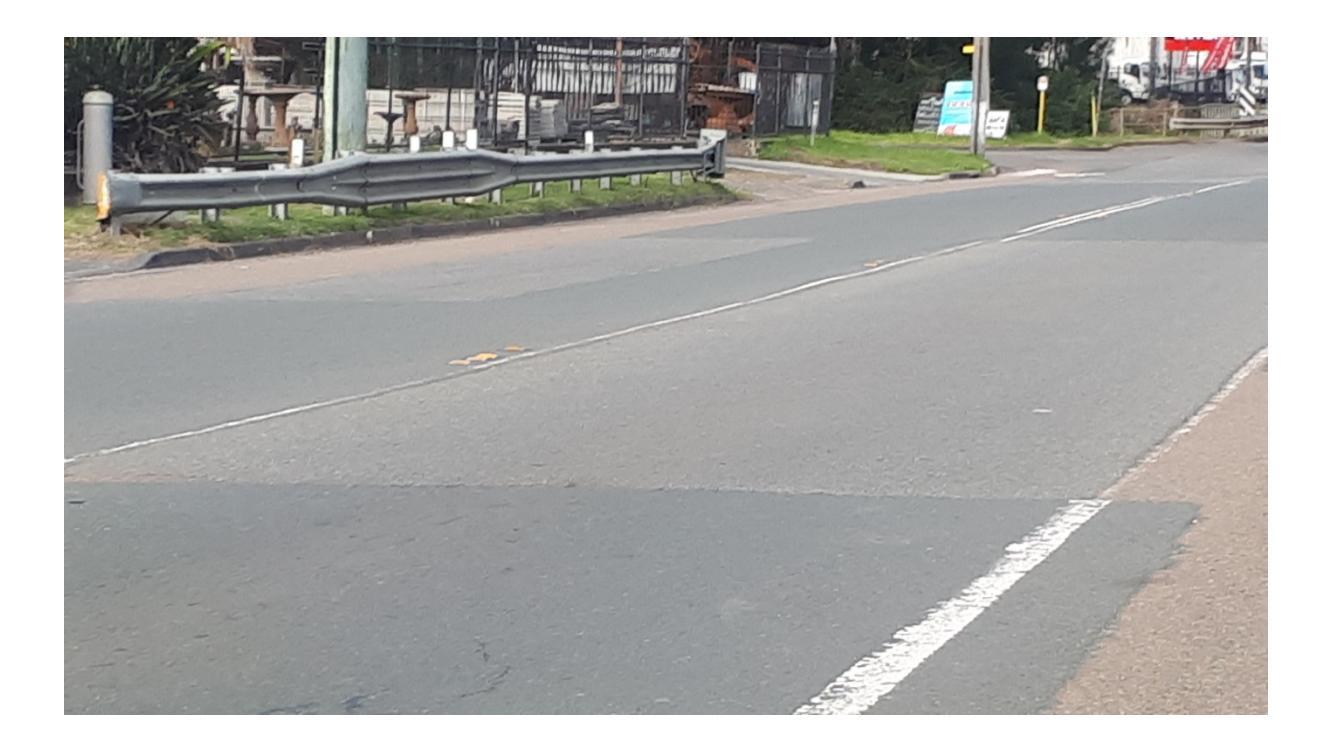
Invisible road safety markings. Location. Manns Rd West Gosford. Ironically this poor safety marking is located only 50 metres from a former fixed speed camera and only 900 from an ever present mobile speed camera further up on Manns Rd. And all revenue from mobile speed cameras is meant to be directed at road safety like this!!!

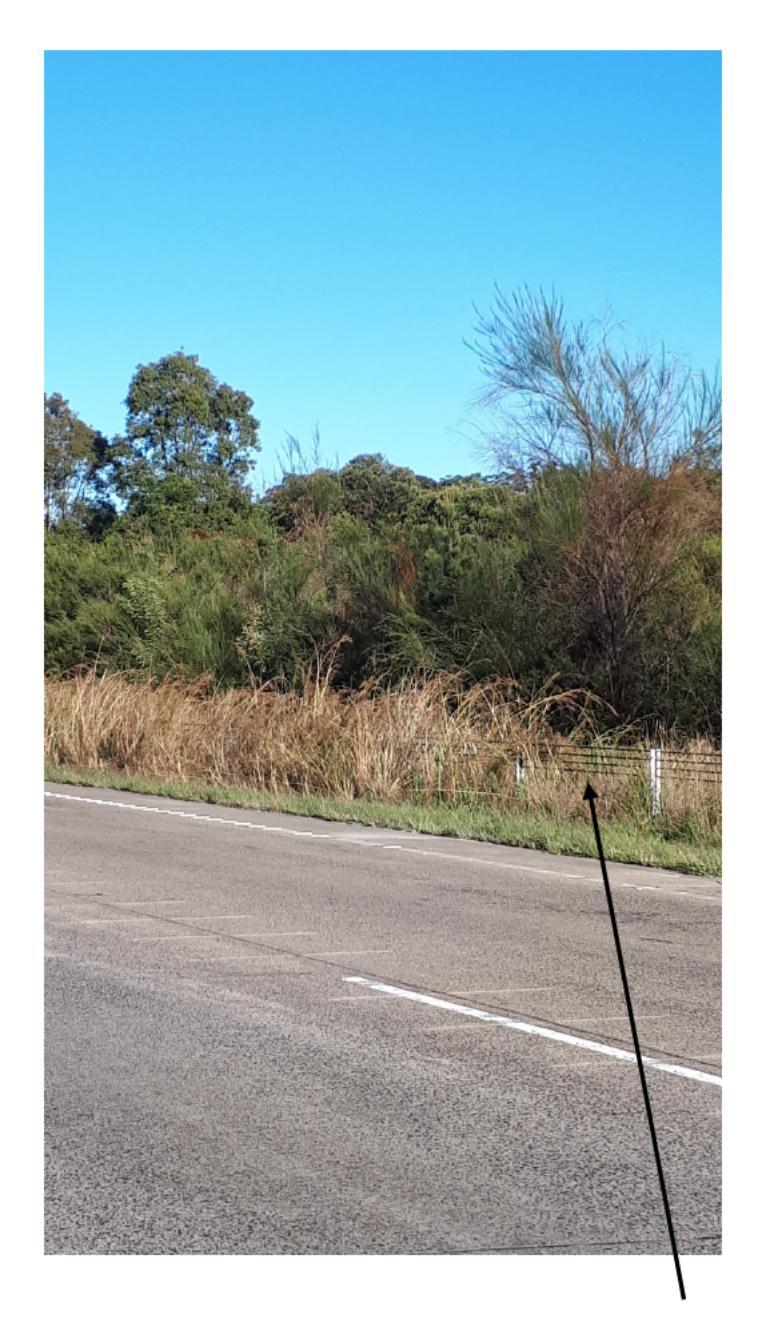
Location. M1 near Morisset

Poorly maintained road safety barriers in 110km/hr zone.

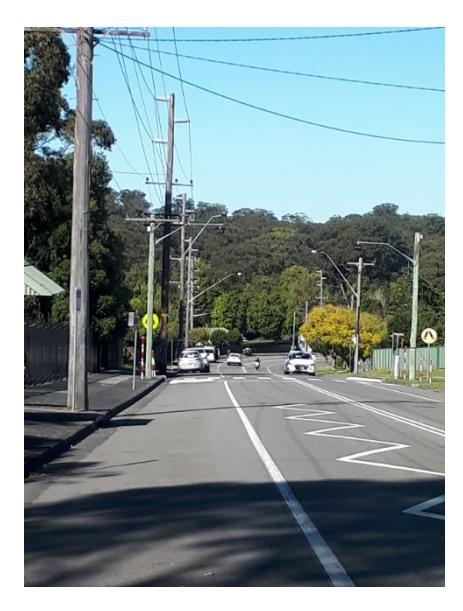
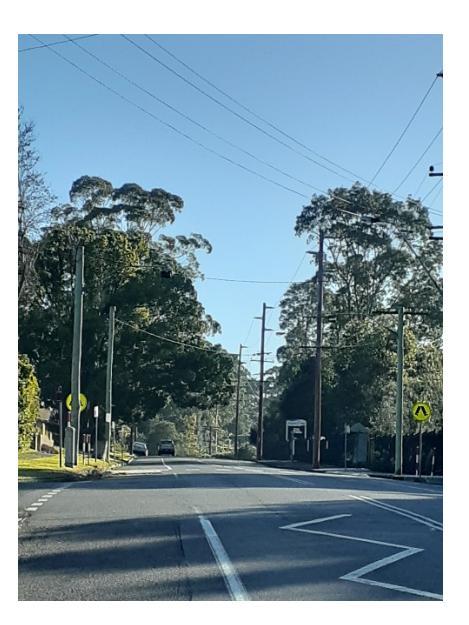
Safety pedestrian sign obscured southbound (L) outside Niagara Park PS! Sign opposite cannot be seen when heading north (R) in other direction due to positioning behind pole. Letters to Council have resulted in no action.

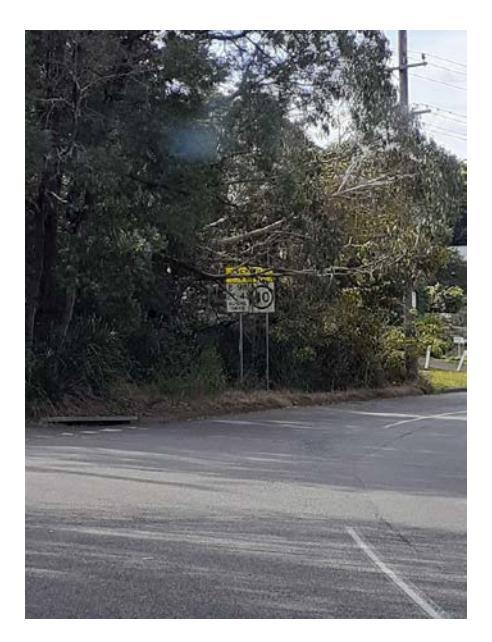
School speed variation sign near same location – Narara Valley Drive, Narara.

Vegetation and placement on a bend means it cannot be viewed by a motorist.

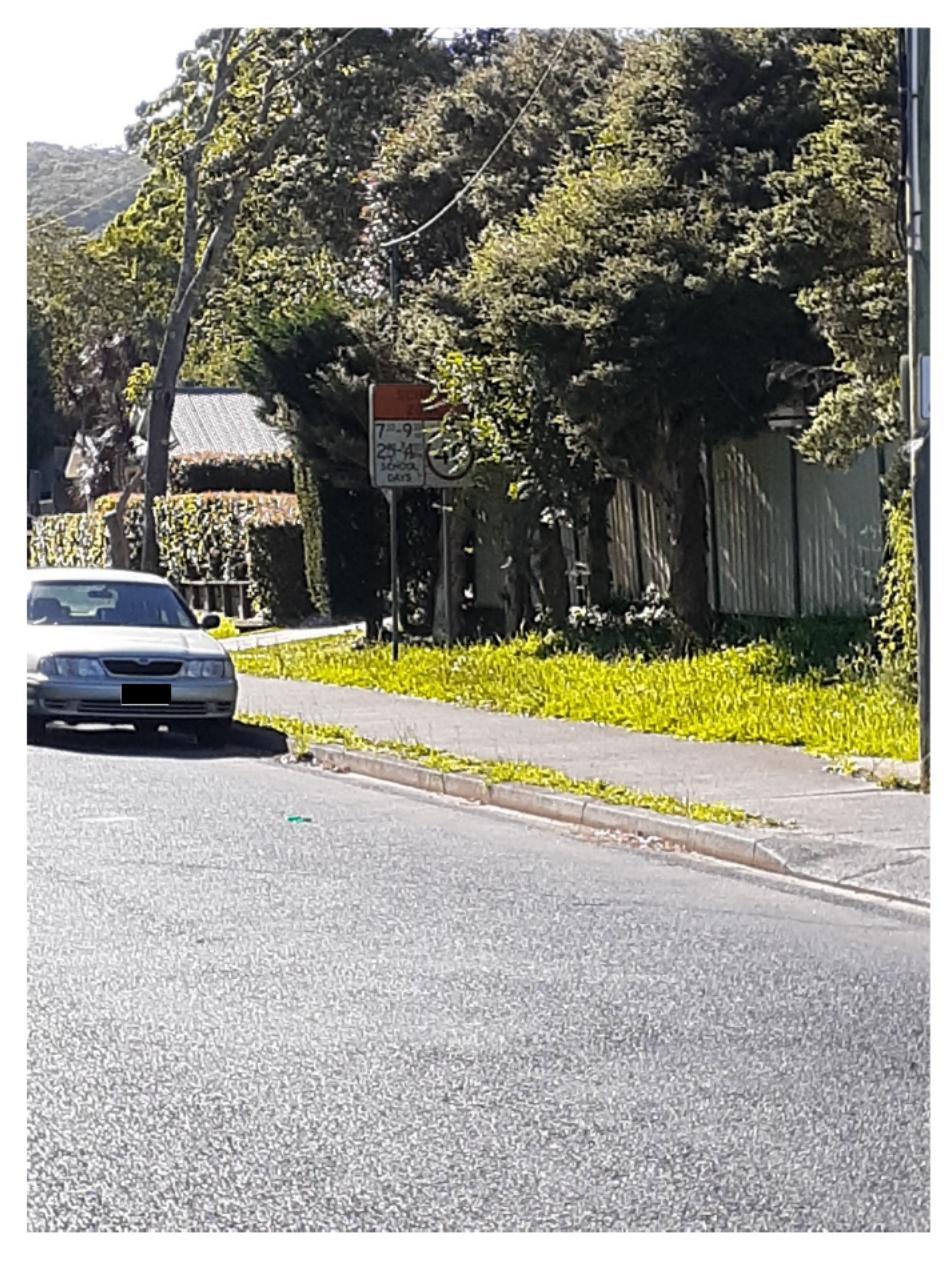
School speed variation sign opposite Narara Valley HS – Fountain Rd, Narara. Vegetation and graffitti means it cannot be viewed by a motorist.

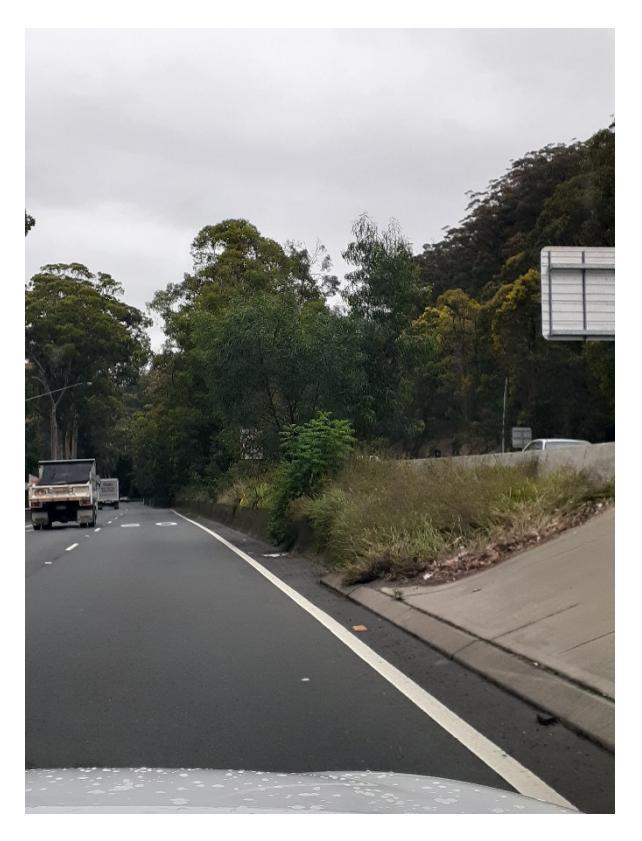
Location. Central Coast Hwy West Gosford

60 km/hr speed sign not visible. Citing poor/non-existent maintenance.

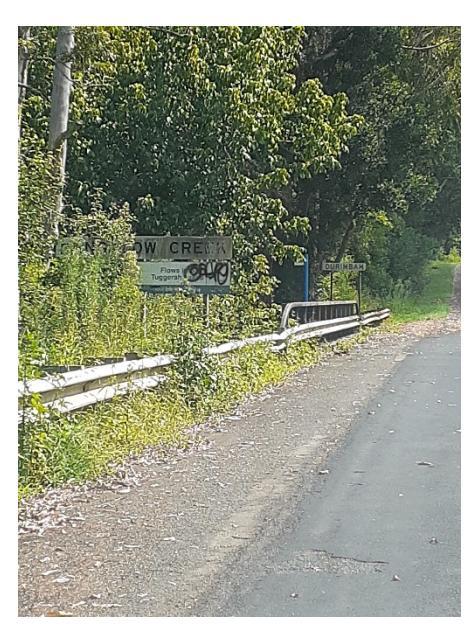
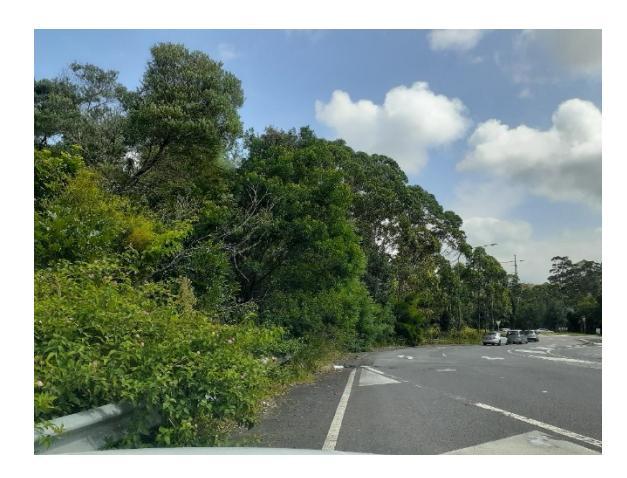
Location. Old Pacific Hwy Kangy Angy.

Hidden locality sign and guard/safety reflectors rail obscured by vegetation.

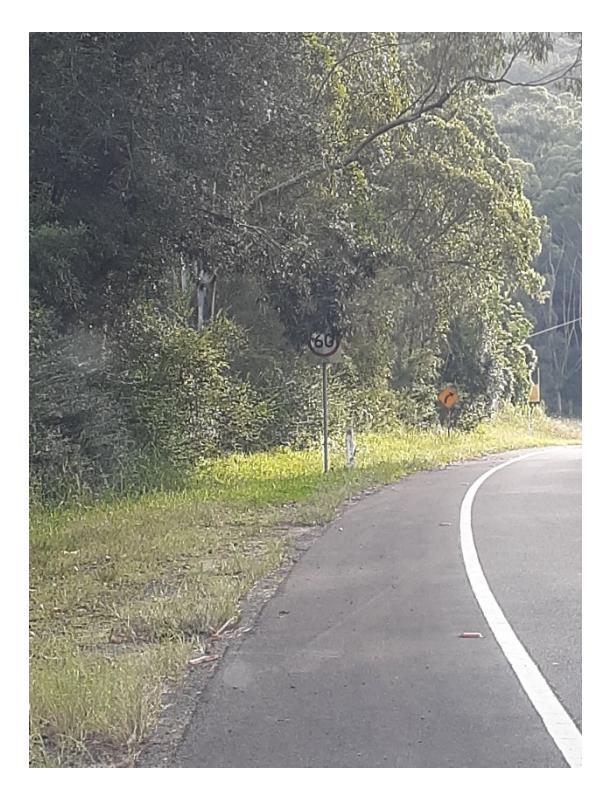
Same location and issue as above.

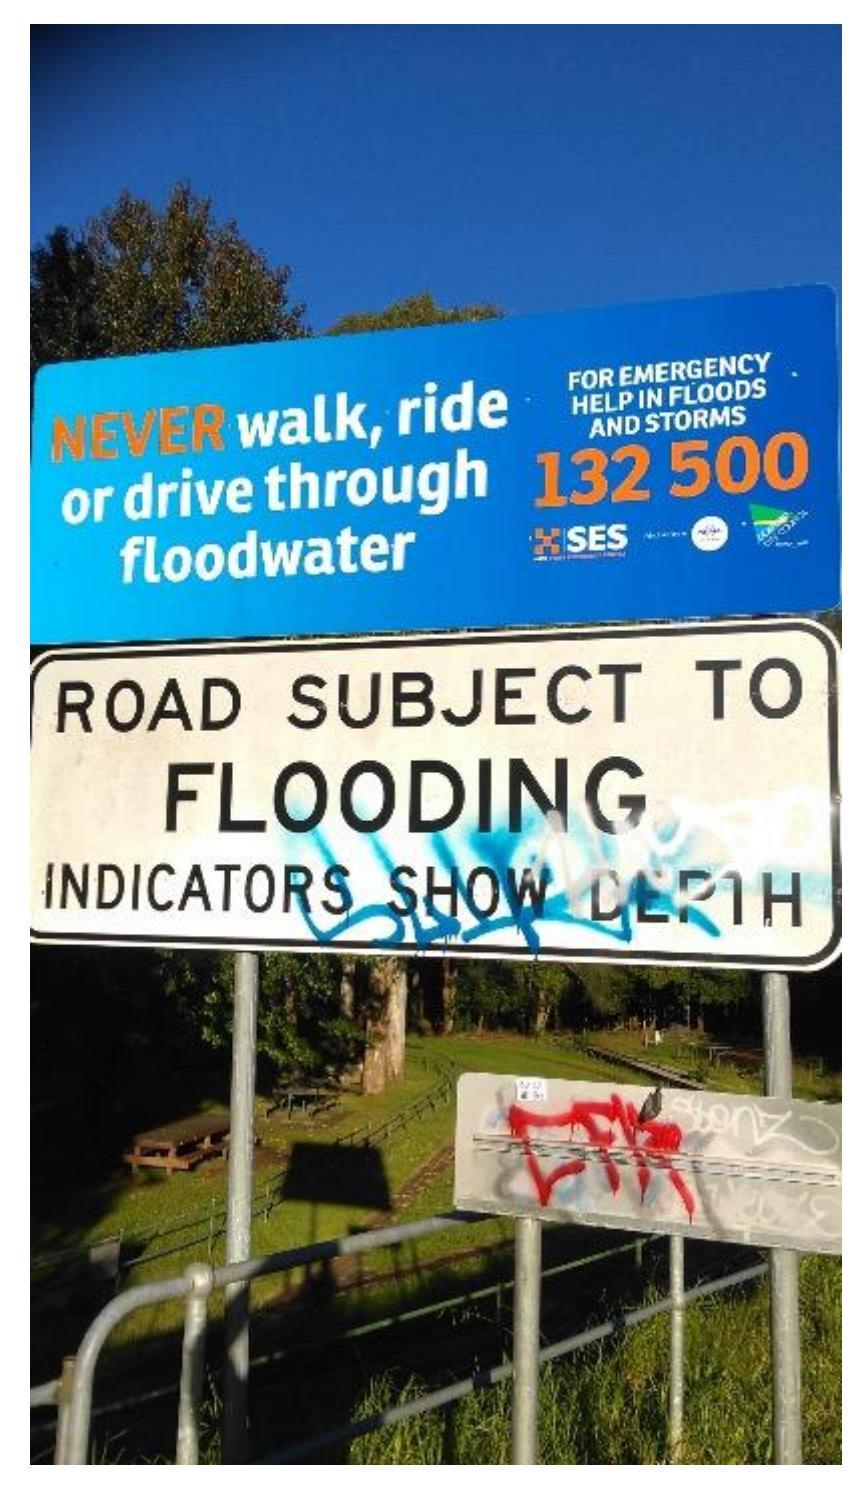
Vandalised/graffiti road safety sign. Location. Showground Rd, Narara NSW

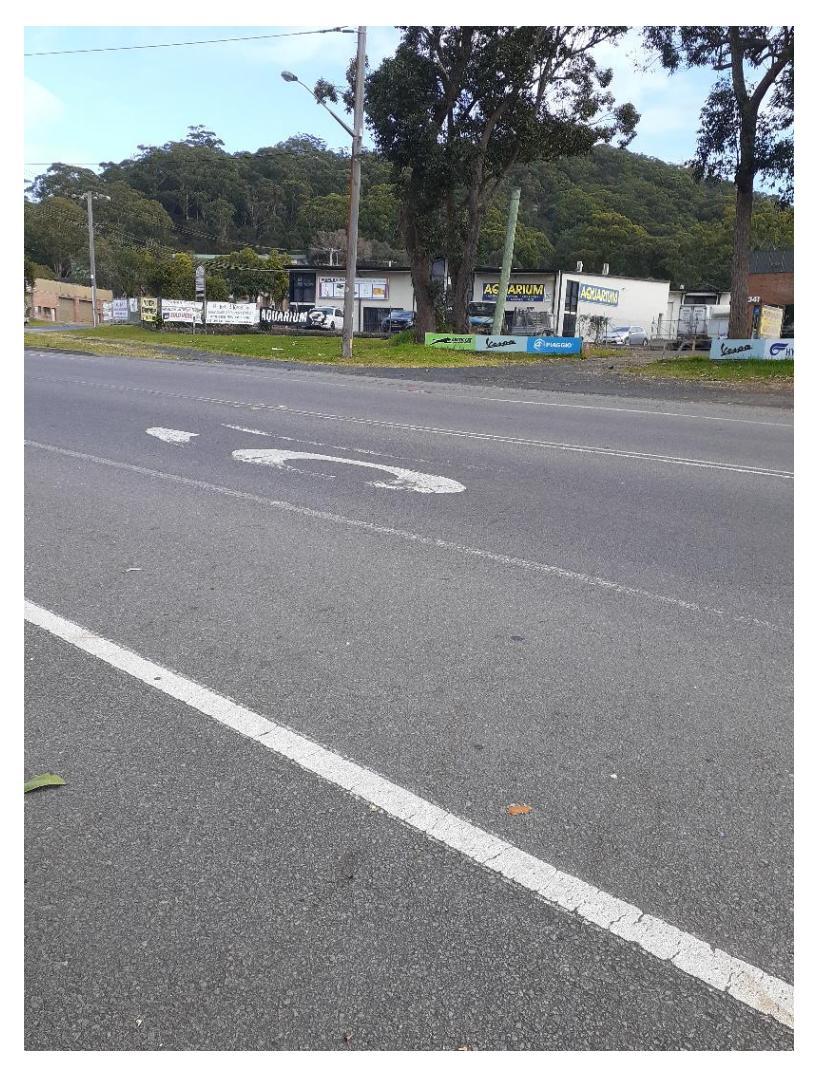
Near invisible speed road marking Manns Rd, West Gosford NSW (been like this or many years). Ironically this poor safety marking is located only 50 metres from a former fixed speed camera and only 900 from an ever present mobile speed camera further up on Manns Rd. And all revenue from mobile speed cameras is meant to be directed at road safety like this!!! (Question: Is this meant to say 80 or 60 km/hr speed marking?). Note also the faded/near invisible double yellow lines and shoulder line markings.

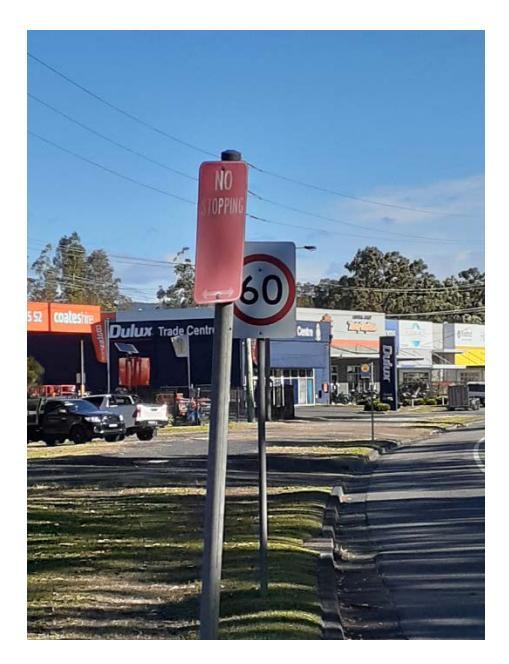
Faded road safety/rule sign opposite ever present mobile speed camera location at Manns Rd West Gosford (near intersection with Dell Rd).

60 km/hr sign can be obscured by this 'red' sign for oncoming motorists.

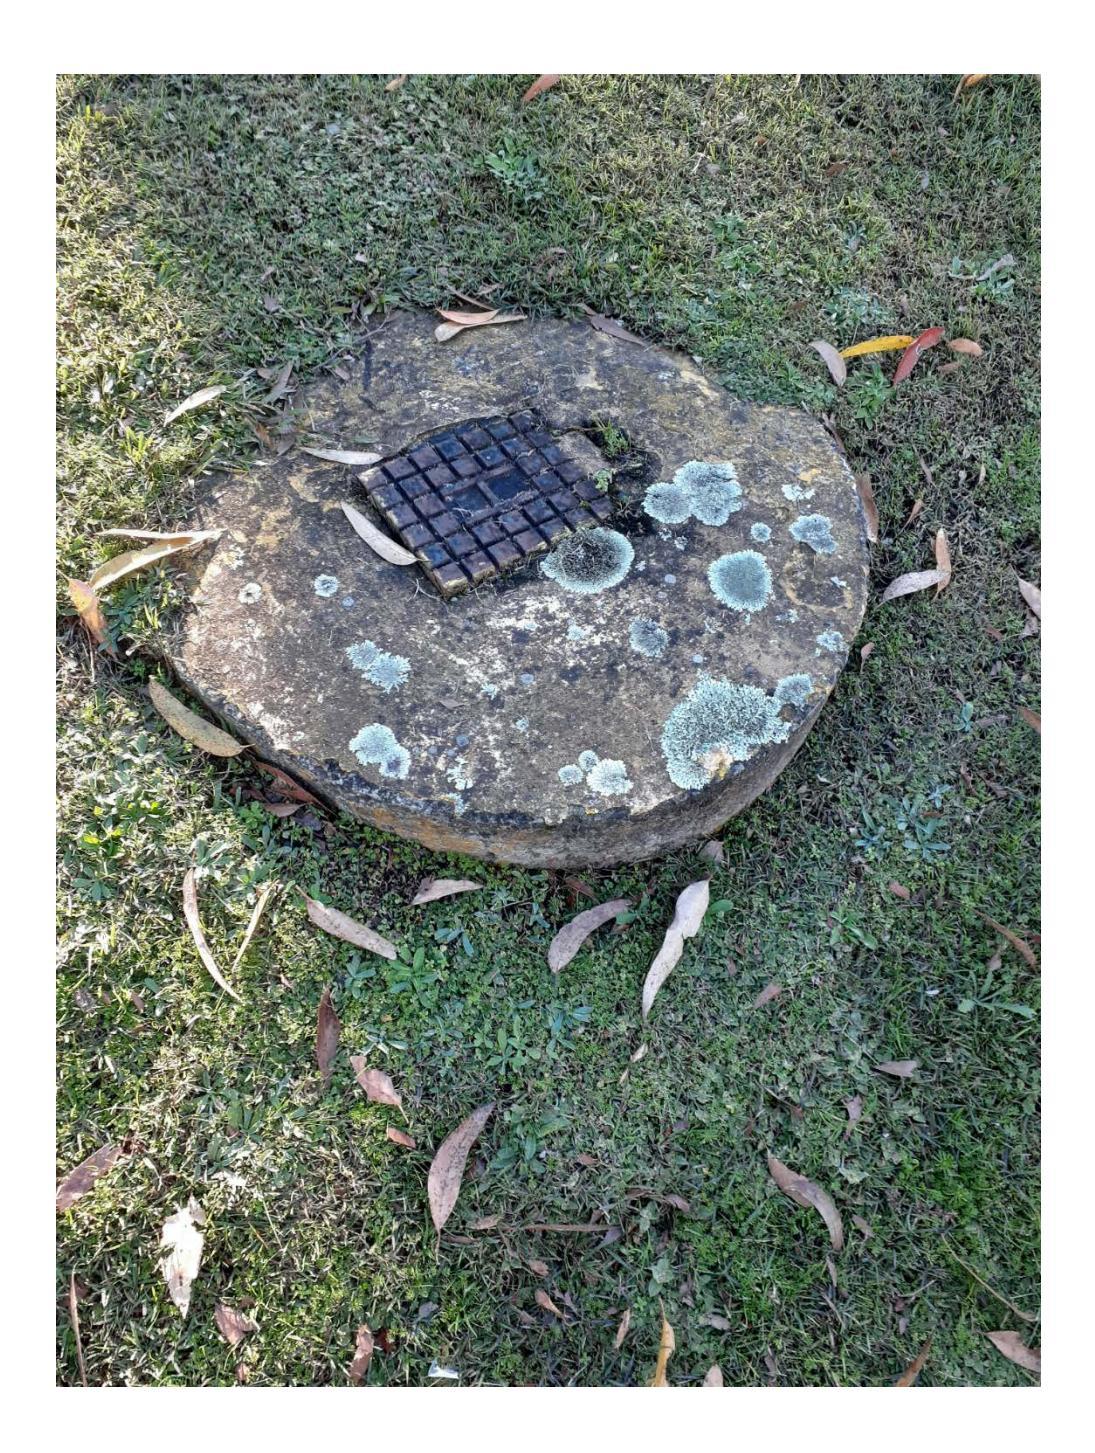
Obscured safety Fire Hydrant (HP – Hydrant on Path) with loss of safety yellow marking and covering in lichen. Opposite ever present mobile speed camera on Manns Rd West Gosford. Been in this condition like above for many years.
