Mr Greg Piper MP
Chair
Public Accounts Committee
Parliament of New South Wales
Macquarie Street
SYDNEY NSW 2000

Thank you for your letter of 5 August 2019 about the Auditor-General's report. The Department of Planning, Industry and Environment has been progressing implementation of the report's various recommendations.

MONTHLY BUSINESS ACTIVITIES REPORT

JUNE 2019

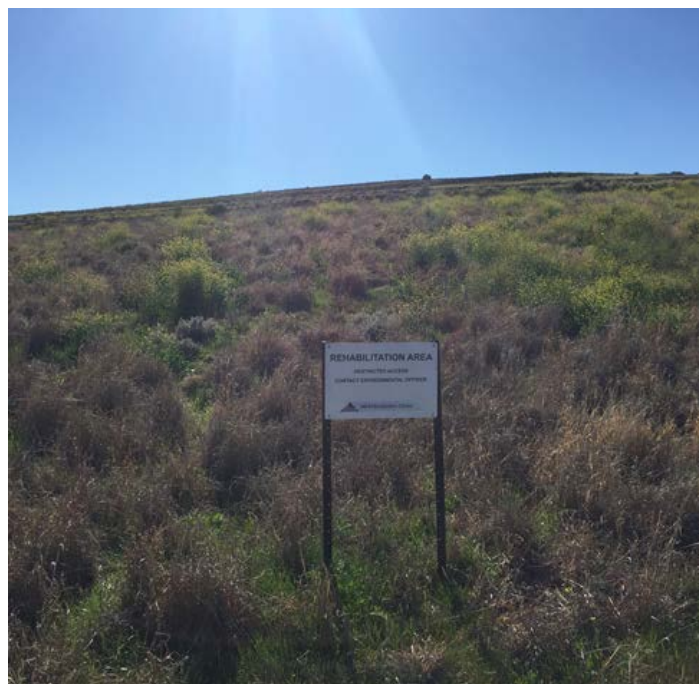
Figure 1 Tarrawonga Coal Mine's poorly wooded revegetation

Figure 1 shows poor revegetation at Tarrawonga. This area was shaped five to six years ago, with an open woodland rehabilitation objective.

This photograph shows no visible signs of established tree species. Rather, the rehabilitation area has a thick cover of exotic grasses and weed species. Under these circumstances, establishing a woodland area would be difficult and resource intensive.

The Regulator has issued statutory notices pursuant to section 240(1)(c) of the *Mining Act 1992* to Whitehaven Coal Mining Ltd requiring it to engage suitably qualified experts across its four operations (Tarrawonga, Rocglen, Sunnyside and Maules Creek) to:

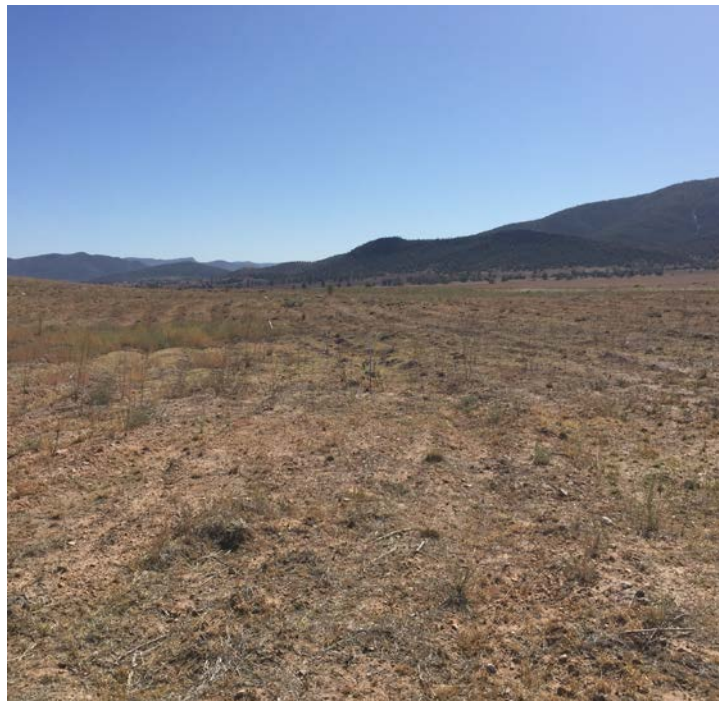
Figure 2 Woodland revegetation at Rocglen Mine

Figure 2 depicts the third attempt of woodland revegetation at the Rocglen Mine Northern Emplacement Area. Its target rehabilitation objective was open woodland. This area is three to five years old and is **not progressing well**. Tubestock has been planted in this area on three occasions without success.
