**Annexure I Road Safety Audit (Pedestrian and Cyclist
Detour Routes)**

VRE Pedestrian and Cyclist Routes Pre-Construction Strategic Design Road Safety Audit

Client: JHCPB

Date: 18 December 2019

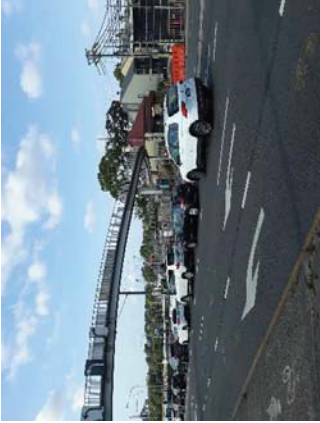
Item No.	Location / Time Period	Descriptions of Findings	Design/ Photo	Likelihood	Severity	Risk Rating	Designer Response
1.	Victoria Road south of Robert Street March 2020 – March 2023	Once the bridge is removed the cyclist desire line will still be to cross Victoria Road south of Robert Street. There is a risk of a cyclist being struck by a vehicle if they attempt to cross at this location due to the width of the road and traffic volumes. This would result in serious injuries to cyclists. The proposed detour route on Gordon Street has unfavourable gradient and additional delays crossing Victoria Road as well as the additional distance.

Occasional	Serious	High	Agreed. Temporary pedestrian fencing will be installed in those locations where existing fencing / barriers are not present to prevent any mid-block attempts for crossing Victoria Road
2	Shared path junction on western approach to Anzac Bridge August 2020 – March 2023	The raised garden bed may obstruct sight distance between cyclists and pedestrians approaching from the detour and the route parallel to the Anzac Bridge approach. The vegetation has died back at the moment but could grow to obstruct sight distance. The number of conflicting movements at this junction will increase significantly when detours are in place. This may lead to a collision between cyclists and pedestrians causing injury. As observed in the commuter peak periods, cyclists travel on Anzac Bridge with speed which heightens the severity of potential collisions when there is most pedestrian movement.

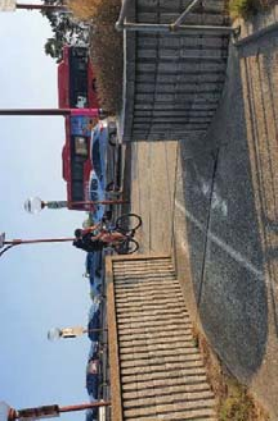
Item No.	Location / Time Period	Descriptions of Findings	Design/ Photo	Likelihood	Severity	Risk Rating	Designer Response
3	Shared path junction on western approach to Anzac Bridge. March 2020 – March 2023	The entrance of the shared path that leads under the bridge approach is narrow due to the garden bed encroaching on the path. There is a risk that with the higher cyclist traffic volumes using this path that there will be collisions between cyclists or pedestrians and cyclists. This may result in minor injury.

Occasional	Minor	Low	Agreed. The company will monitor this issue with feedback being sought from pedestrian and cyclist user group organisations.
4	Shared path beneath the western approach to Anzac Bridge. March 2020 – March 2023	A tight 'hairpin' bend on the shared path may result in collisions between cyclists or pedestrians and cyclists. The volume of cyclists using this path will increase significantly in the future, therefore, increasing the likelihood of a collision.

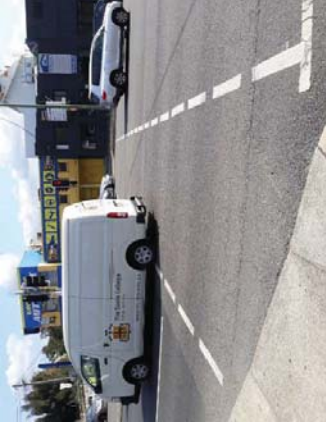
Item No.	Location / Time Period	Descriptions of Findings	Design/ Photo	Likelihood	Severity	Risk Rating	Designer Response
6	Pedestrian crossing of Victoria Road at Gordon Street August 2020 – March 2023	Existing pedestrian crossing is unsuitable for shared use of pedestrians and cyclists with narrow kerb ramps. There is a risk of pedestrians being struck by cyclists on the crossing. This may cause minor injury.

Improbable	Minor	Low	Noted. "Cyclists Dismount" signs to be installed at either side of the crossing to avoid pedestrian / cyclist conflict. The crossing has been measured in width to be 3.6m which is consistent with current signalised crossing standards.
7	Pedestrian crossing of Victoria Road at Gordon Street March 2020 – March 2023	During peak periods, the signal phasing favours the traffic flow on Victoria Road. Pedestrians may cross Victoria Road south of the relocated bus stop to avoid waiting at traffic signals. This may result in a pedestrian being struck by a vehicle and causing a severe injury.	-	Occasional	Major	High	Agreed. Temporary pedestrian fencing will be installed in those locations where existing fencing / barriers are not present to prevent any mid-block attempts for crossing Victoria Road

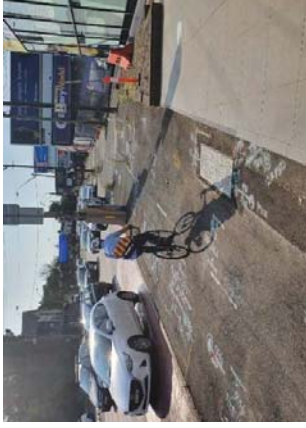
8	Relocated bus stop Victoria Road near Loughlin Street March 2020 – March 2023	Bus shelters will narrow the shared path at this location. Width of shared path likely to be reduced to 2.5m with increased pedestrian activity and cyclist activity due to the detours. There is an increased risk of pedestrians being struck by a cyclist near the proposed bus stop. This would probably result in minor injury.

Occasional	Minor	Low	Agreed. "Slow" zone cross hatched markings to be installed in both directions behind the newly installed bus shelter consistent with similar treatments at the Evans Street bus stop on the same corridor.
