Vales Point Power Station

Preliminary Environmental Site Assessment – Part 1

## Vales Point Power Station

Preliminary Environmental Site  
Assessment

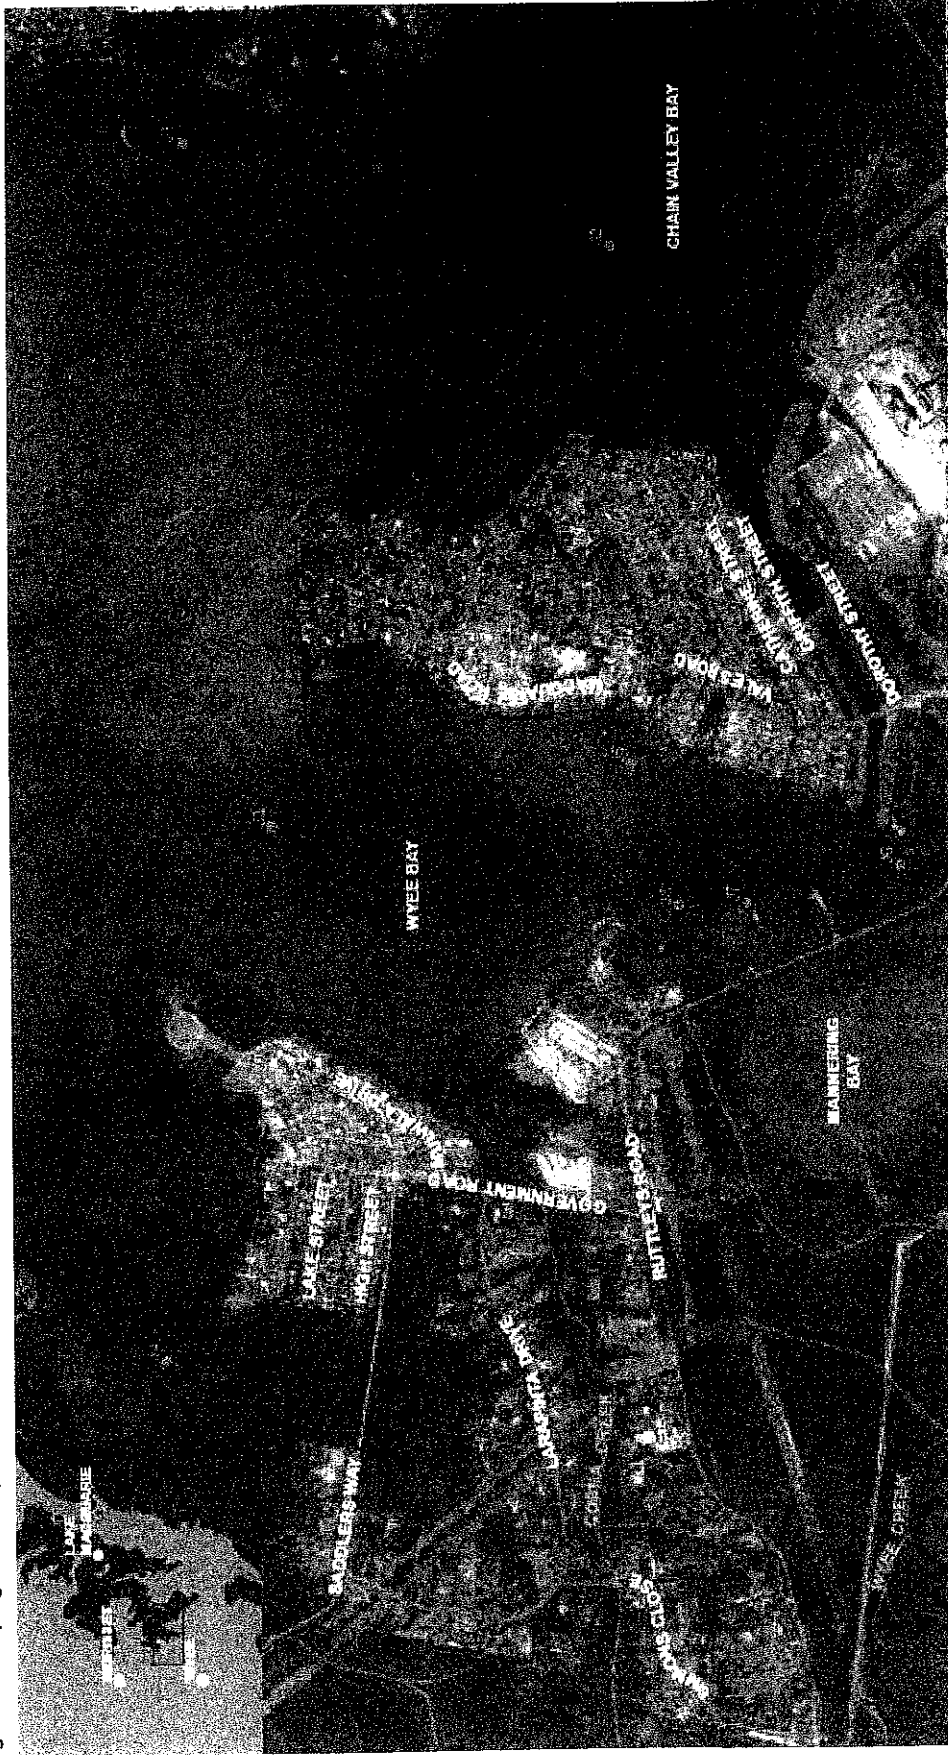
Figure 5.4: Sampling Locations (Jacobs, 2017)

Legend  
Sediment sample location

Figure 2 | Wye Bay sediment investigation

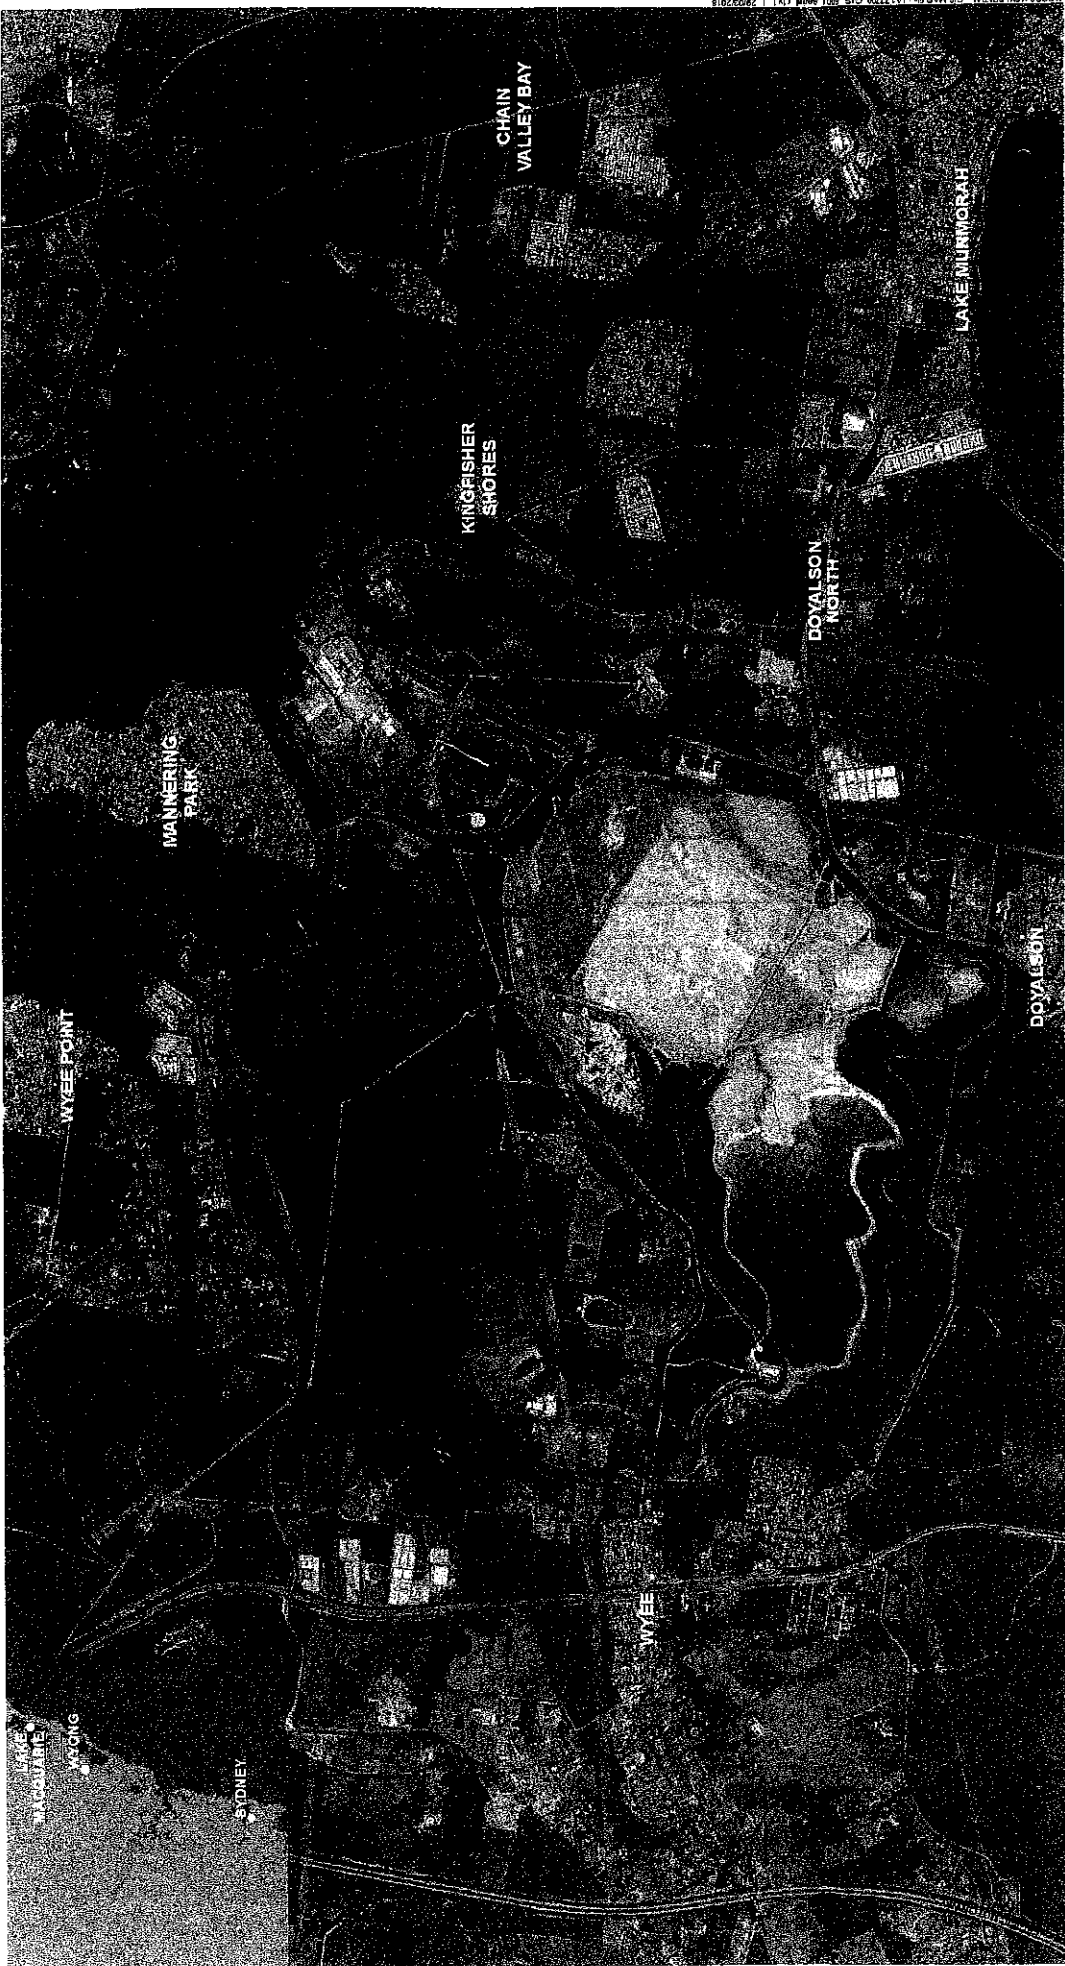
Figure 1 | Site location

Site boundary

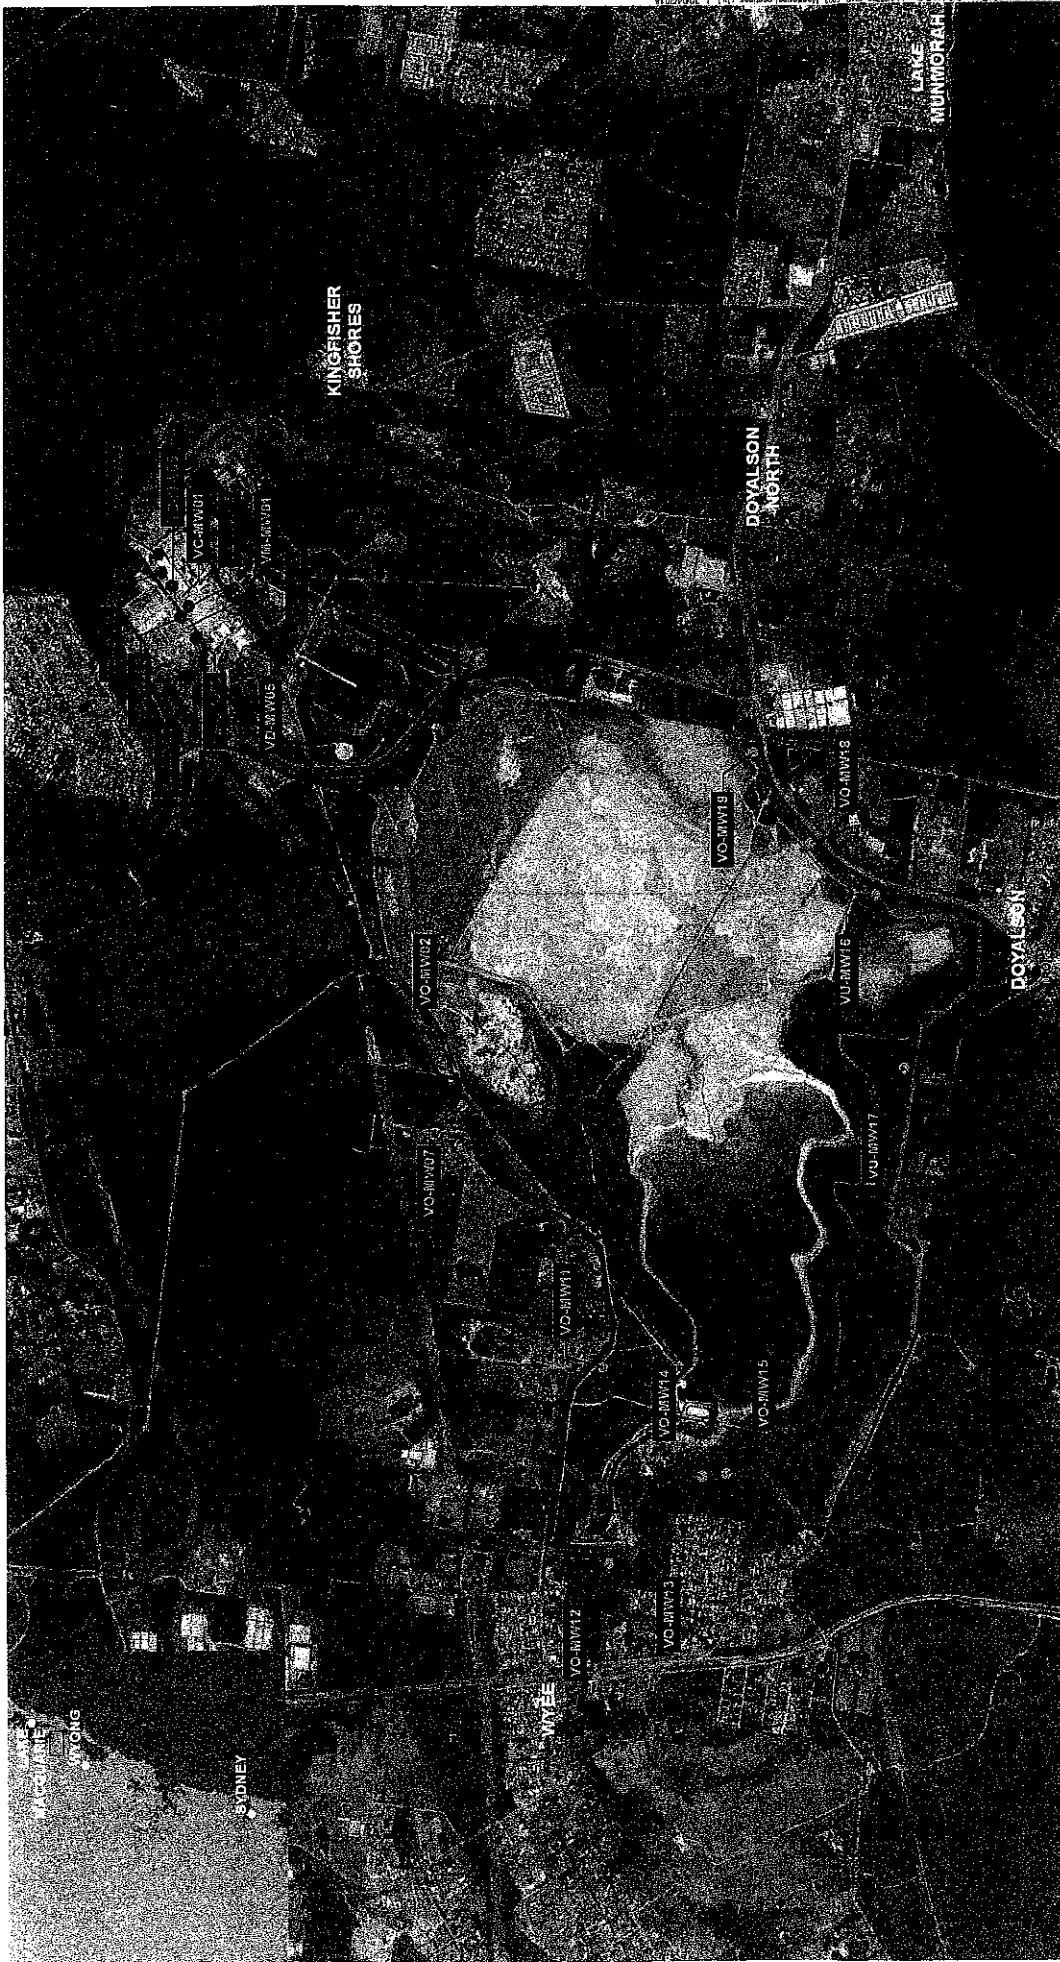
Figure 5b | Groundwater samples collected for PFAS analysis (Jacobs, 2018)

Site boundary
  PFAS concentrations in groundwater samples below LOR
  PFAS detected. Concentrations below protection of aquatic ecosystems guidelines (NEMP, 2018)

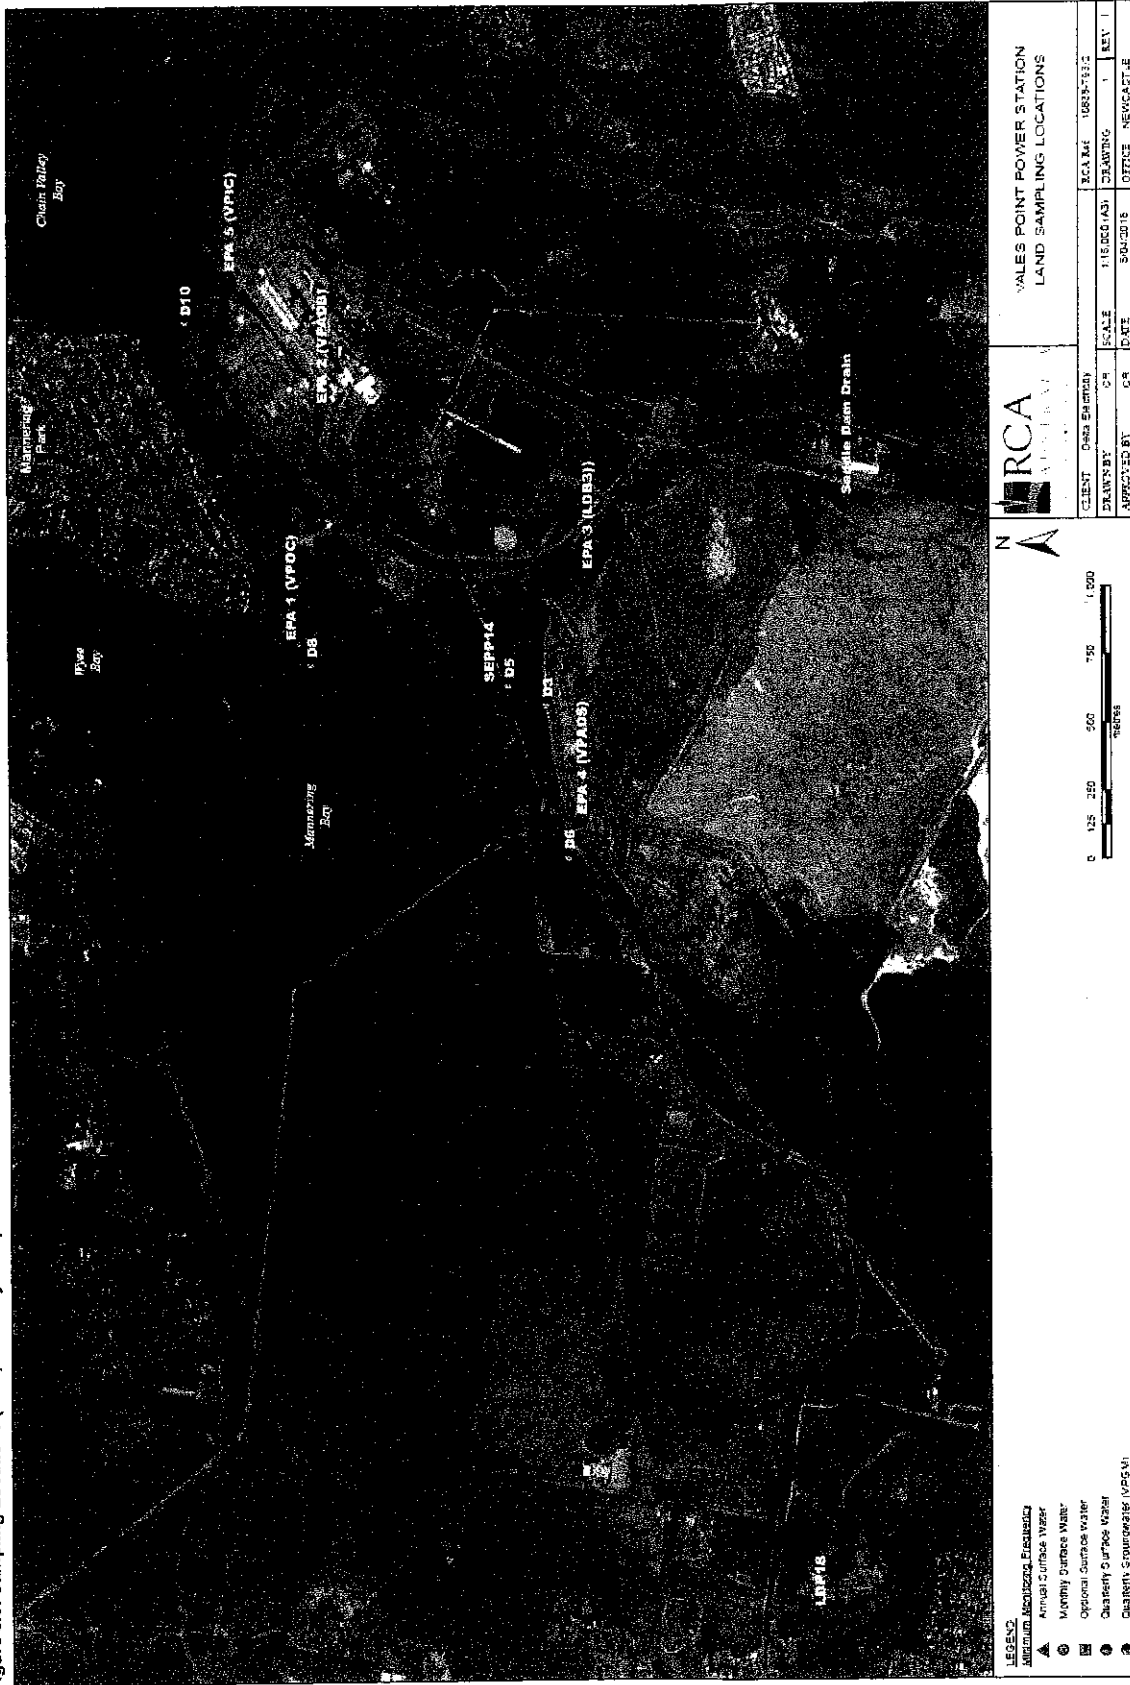
Figure 5.5: Sampling Locations (RCA, February 2018)

<b>LEGEND</b> Annual Groundwater Monthly Groundwater Optional Groundwater Quarterly Groundwater Quarterly Groundwater (VPGM)		<b>RCA</b> AUSTRALIA	<b>VALES POINT POWER STATION</b> <b>LAND SAMPLING LOCATIONS</b>	
CLIENT: ONS ENERGY DRAWN BY: CR APPROVED BY: CR	SCALE: 1:10,000 (AS) DATE: 30/03/18		RCA Ref: 10825/13.2 DRAWING: 1 REV: 1 OFFICE: NEWCASTLE

Concentrations of PFOS + PFHxS in samples collected from VC-MW02 and VC-MW05 (transformer area) exceeded the drinking water (VC-MW02 and VC-MW05) and recreational water use (VC-MW02 only) guideline
