## ANSWERS TO QUESTIONS ON NOTICE

# Site Investigation Report – Cammeray Golf Course (WP12)

Document No. SPA-JGA-REP-ENV-WP12-1-0007

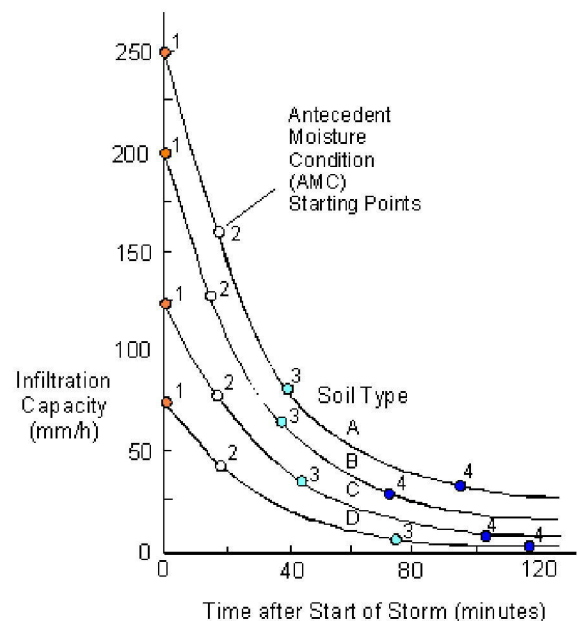
An AMC number corresponds to a starting point on an infiltration curve, as shown in the illustration. The curve defines the rate at which rainwater can penetrate into the soil. During a storm event, this will decrease, due to the soil becoming wetter, soil swelling and other effects. In research on DRAINS and related models, it has proved to be reasonably accurate to relate the AMC value of 1 to 4 to the rainfall in the previous 5 days.

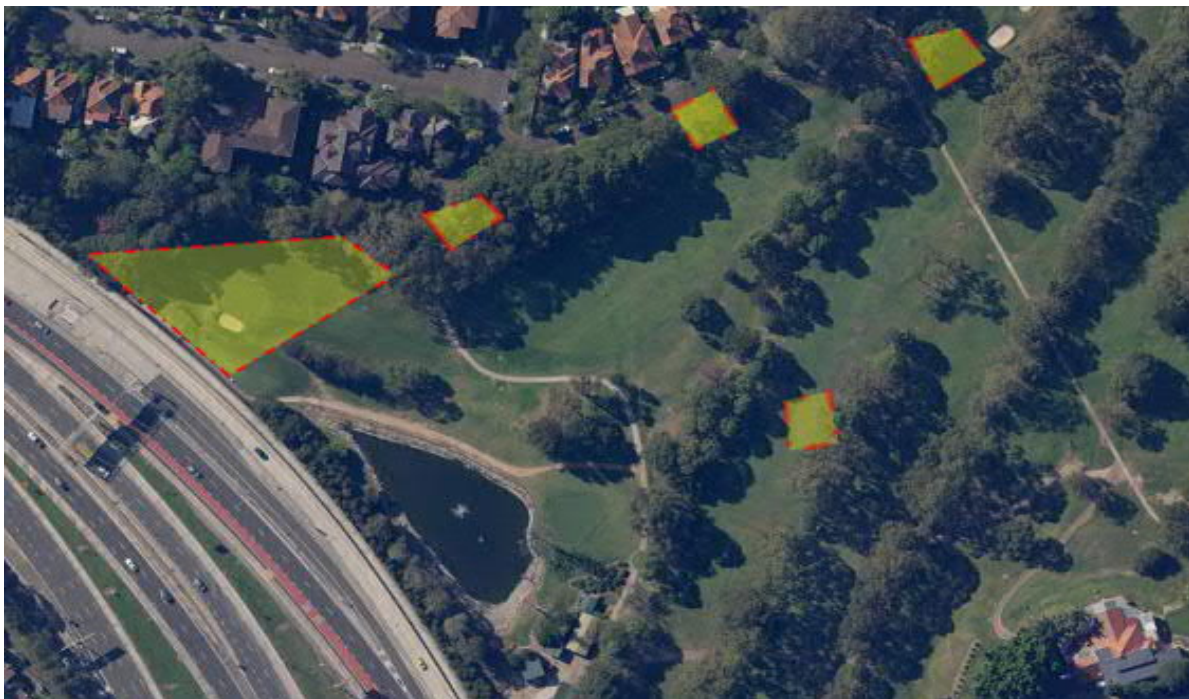
**Figure 1-1: Proposed construction support site extent (north western portion of CGC)**

The proposed extent of the six separate construction support areas is presented on **Figure 1-1** (north western portion of CGC) and **Figure 1-2** (south western portion of CGC).

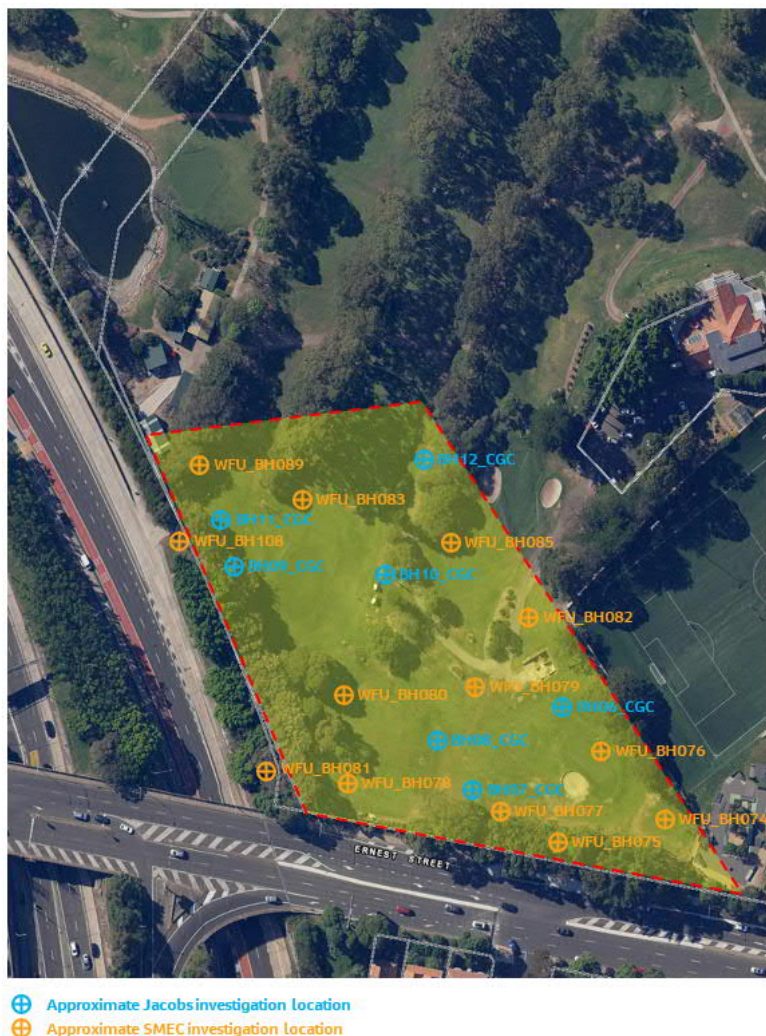
Figure 5-1: Approximate investigation locations (south western portion of CGC)

Selected soil samples were collected from the investigation locations at the surface (0.0 – 0.1 mbgl) and at depths of 0.25 mbgl, 0.5 mbgl, and 1.0 mbgl or at discreet sampling depths where potential contamination was observed.

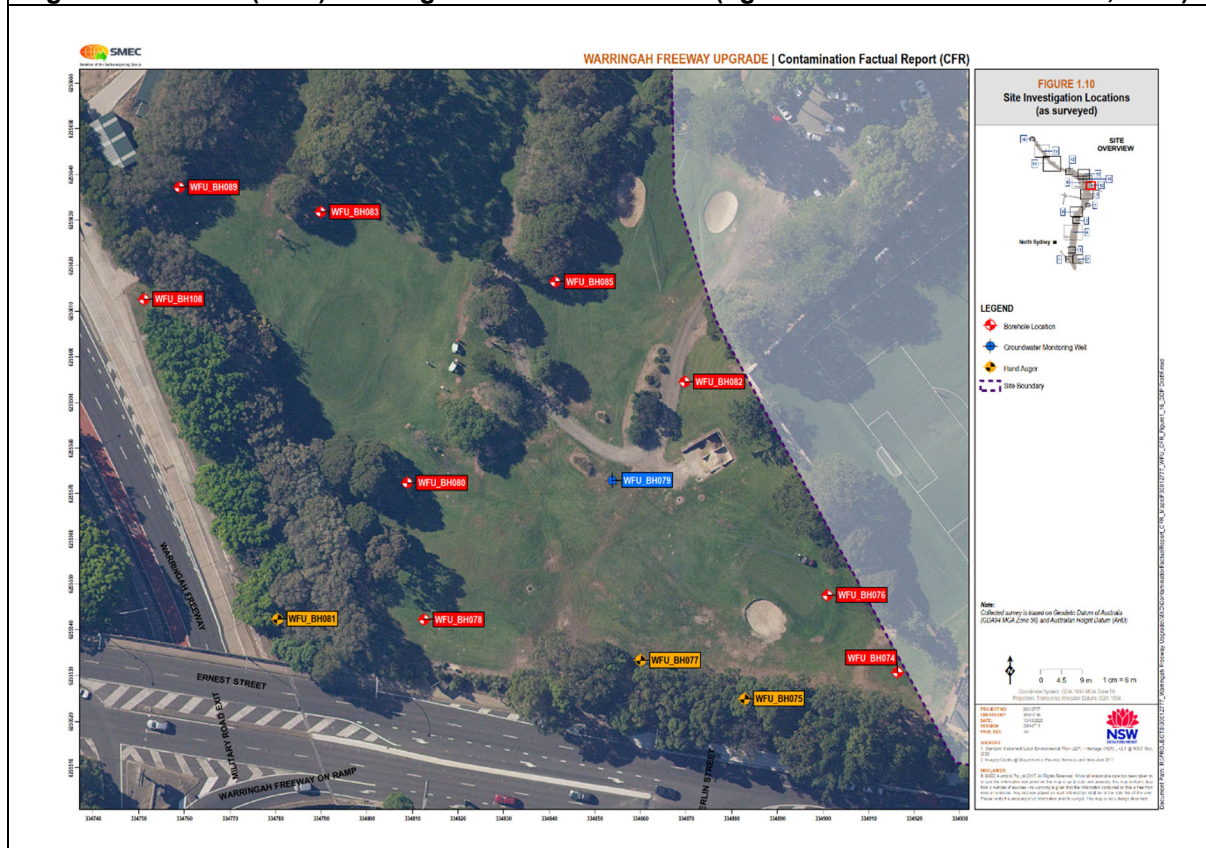
**Figure 4-3: SMEC (2020) investigation locations - CGC (figure sourced from the SMEC, 2020)**

Sample locations undertaken as part of the SMEC (2020) investigation are presented on **Figure 4-1**, **Figure 4-2** and **Figure 4-3**.
