# KOONDROOK-PERRICOOTA FOREST WETLAND “HOTSPOTS” ASSESSMENT

Prepared by Western Murray Land Improvement Group for Forestry Corporation of NSW

June 2021

Report Title: Koondrook-Perricoota Forest – Wetland Hotspot Assessment

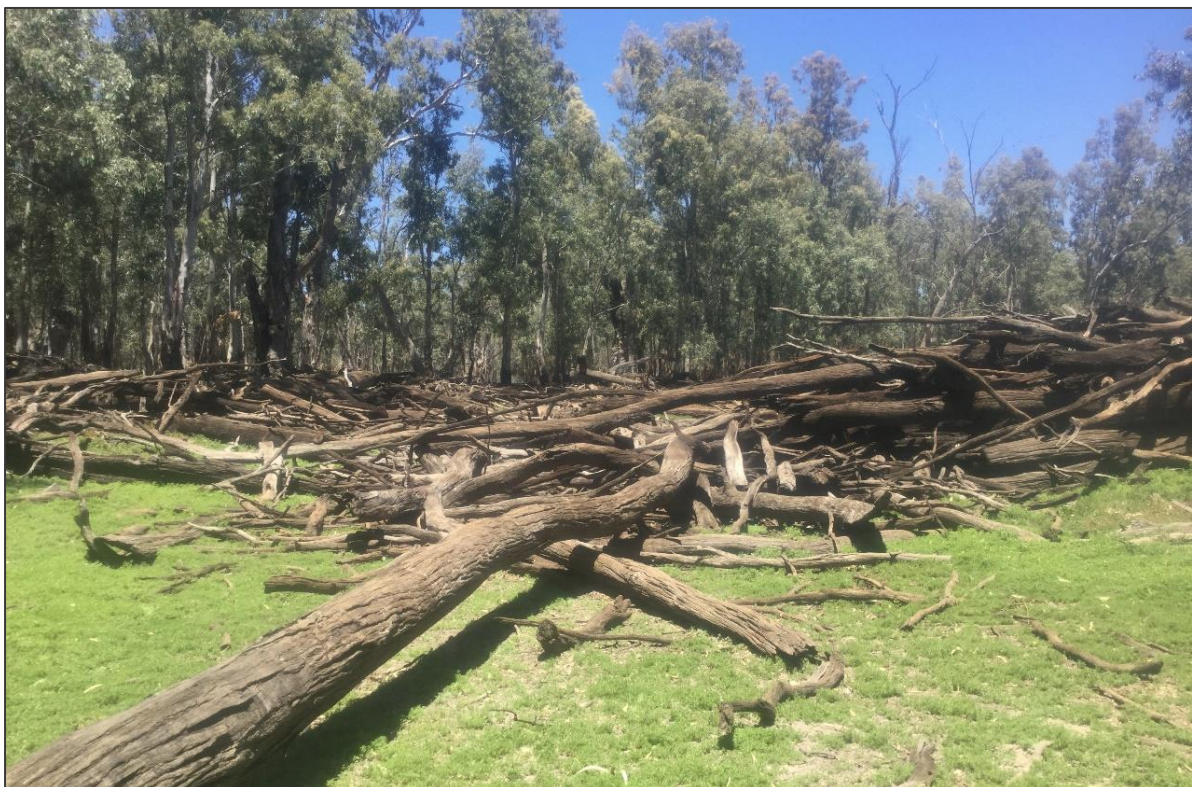
Site large enough to possibly support permanent water and populations of native fish. However, currently dry and lacking in any type of submerged or emergent vegetation to support fish populations. Excess of LWD that is causing hydrology problems. Higher up the system than other wetlands so possibility to water more frequently to maintain extent.

*Figure 2: one of the logjams within McMahoons Waterhole*

- Critical due to watering planned 2021
- Logjam and red gum sapling removal
- ACH site protection/rehabilitation
- Sediment depth tested
- Sediment cores for later analysis
- "Wetland Restoration" public signage.

- Wetland revegetation
- Pest animal & weed control.

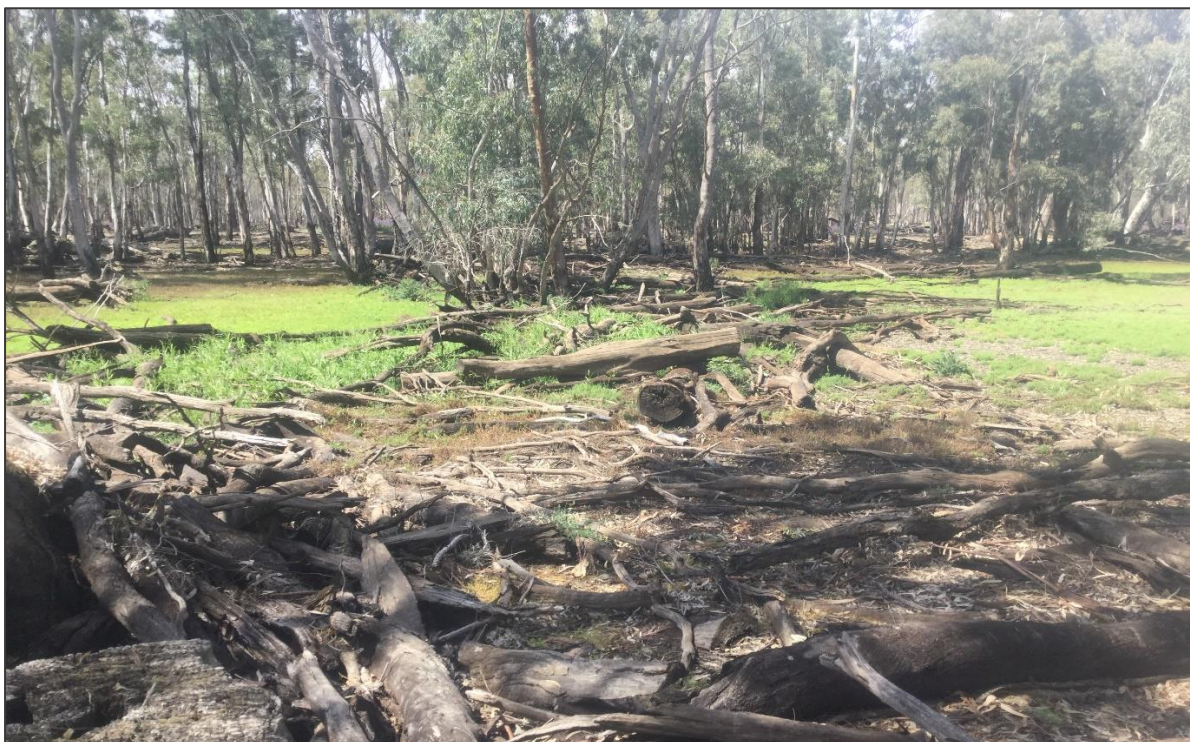
A large lagoon with a south and north lagoon which has good adequate size and depth to support native fish. However, it is currently dry and lacks any submerged or emergent vegetation. A small section of phragmites remains but is in poor condition. Woody debris is present in such abundance it is affecting hydrology and connection between the north and south reach as well as the exit. Sediment may be impacting the depths, but adequate depth is available for water retention over a 12-month period.

Figure 4: one on the logjams within Smokehouse Lagoon

- Not critical due to watering planned 2021
- Logjam and red gum sapling removal
- ACH site protection/rehabilitation
- Sediment depth tested
- Sediment cores for later analysis
- “Wetland Restoration” public signage.

- Wetland revegetation
- Pest animal & weed control.

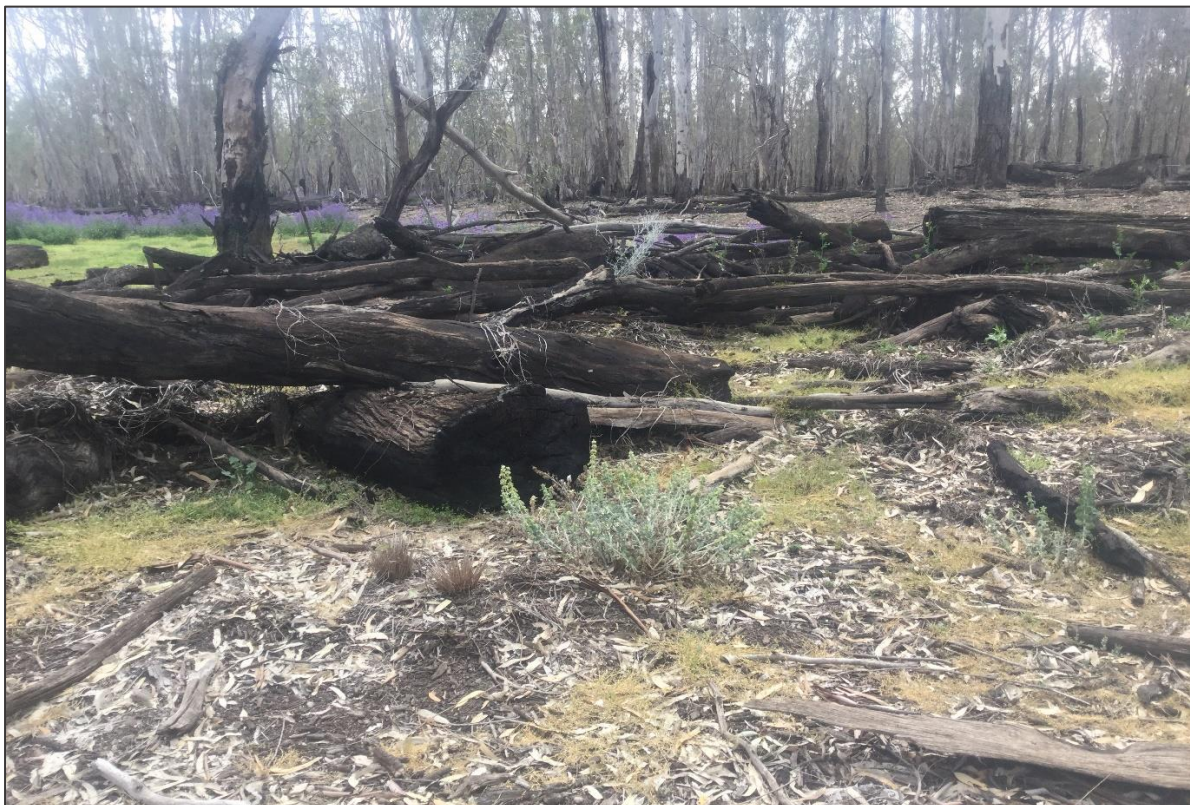
A long wide shallow lagoon with potential to support a permanent population of native fish. In centre of lagoon depth is adequate to maintain itself for over 12 months. However, currently dry and lacking in any submerged or emergent vegetation, except for one remnant patch of phragmites in poor condition. Depth may be impacted by sediment deposition. Infestation of redgum saplings in bed of lagoon.

*Figure 6: one of the logjams within Long Lagoon*

- Critical due to watering planned 2021
- Logjam and red gum sapling removal
- ACH site protection/rehabilitation
- Sediment depth tested
- Sediment cores for later analysis
- “Wetland Restoration” public signage.

- Wetland revegetation
- Pest animal & weed control.

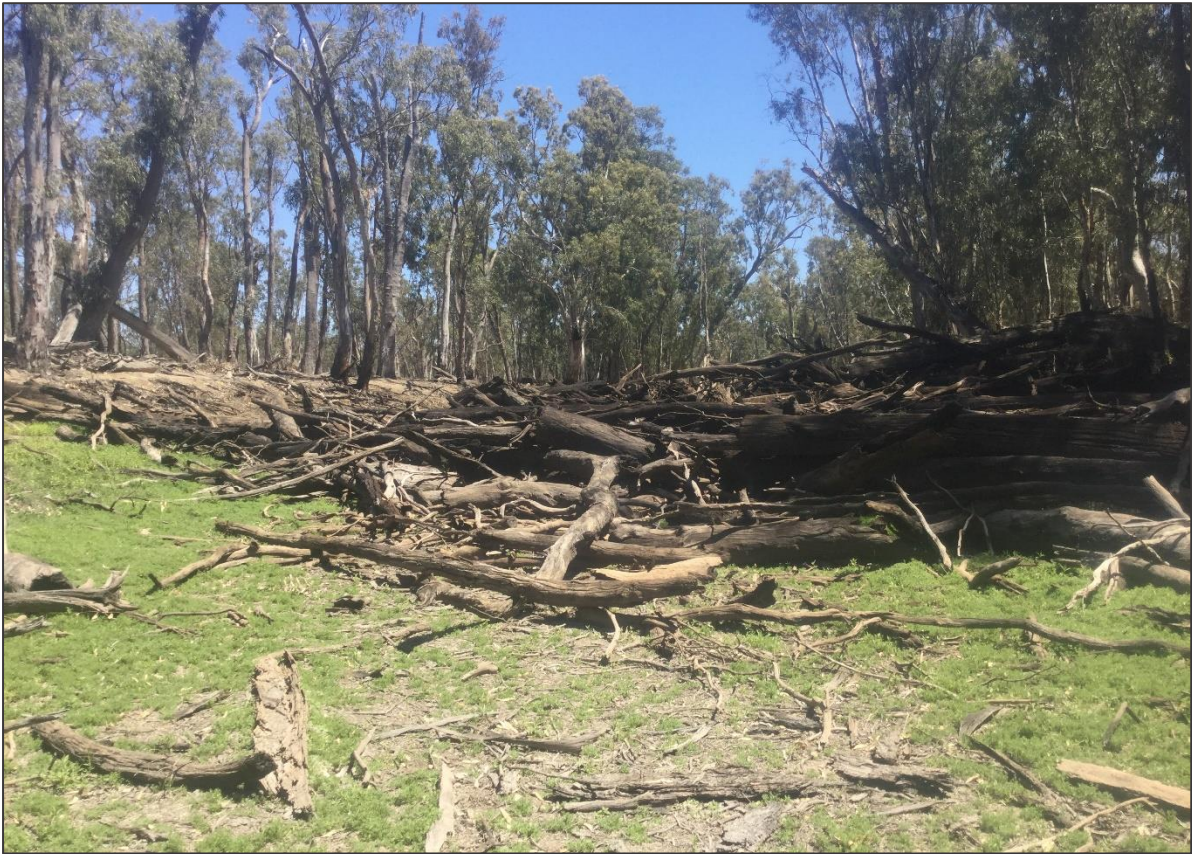
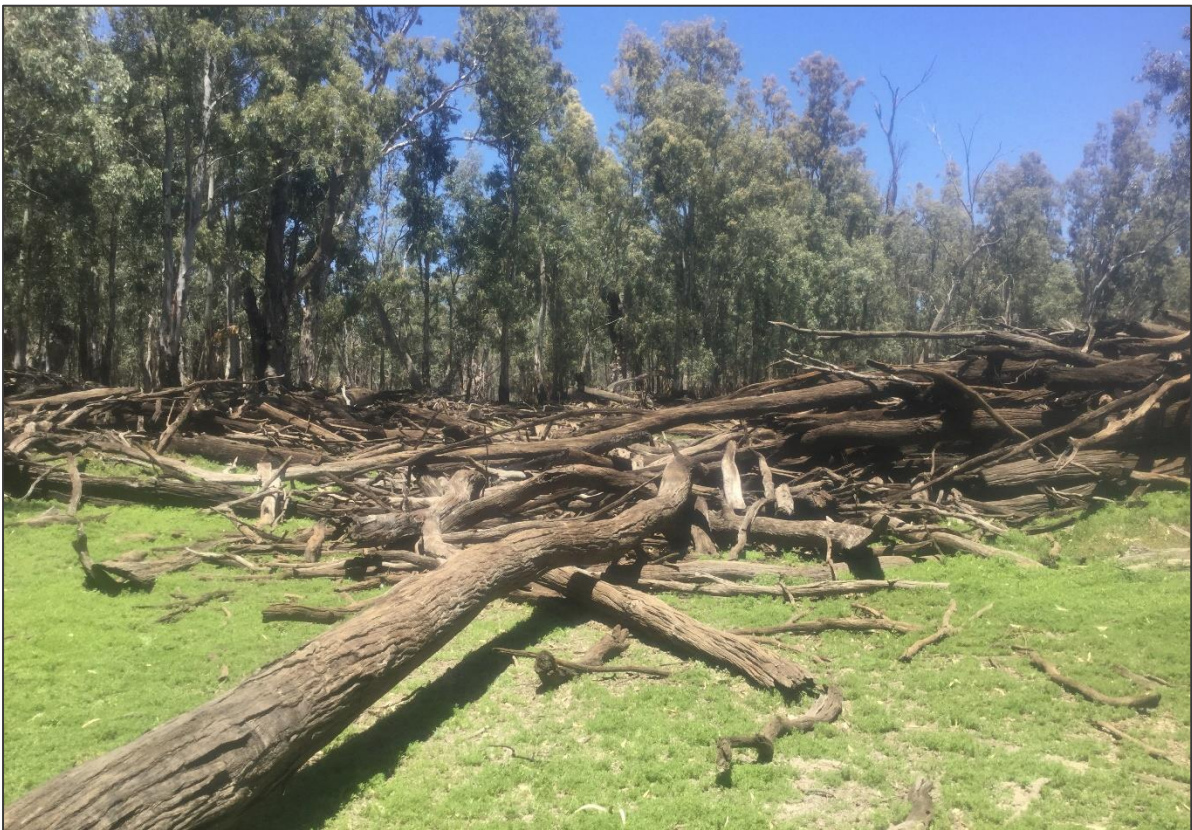
Other comments	Possible to water with smaller volumes as high in system								
	Old stands of phragmites exist but very poor condition

*McMahons Waterhole – photo 1*

*McMahons Waterhole – photo 2*

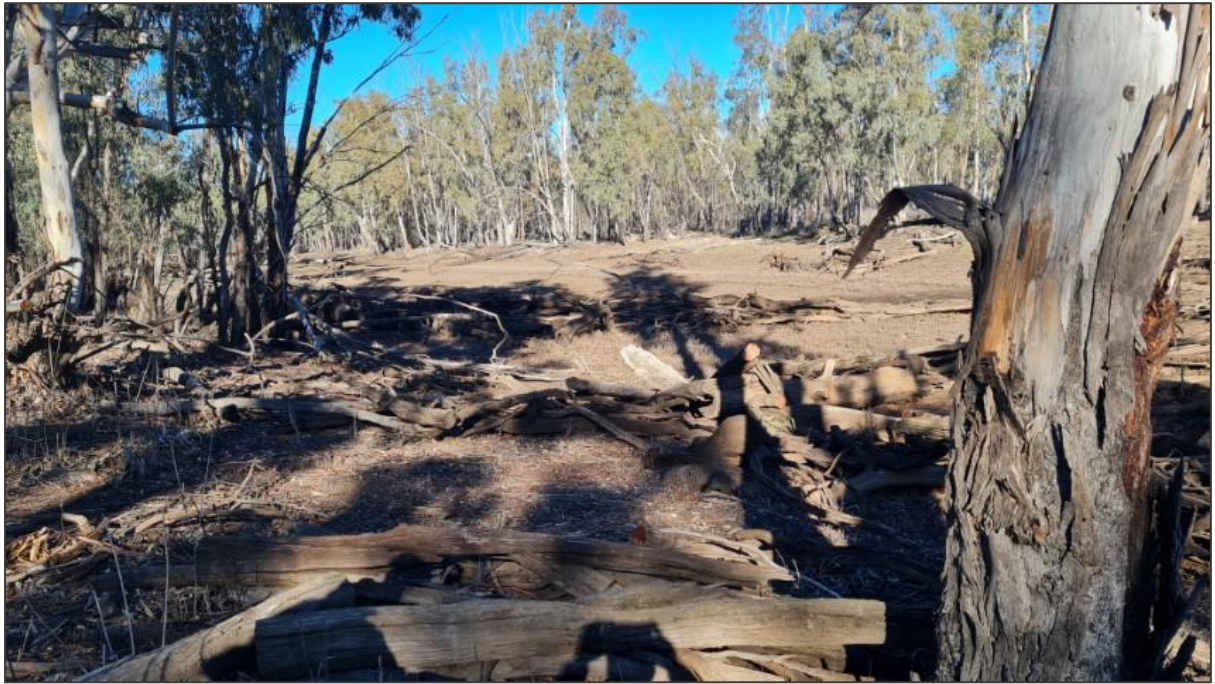
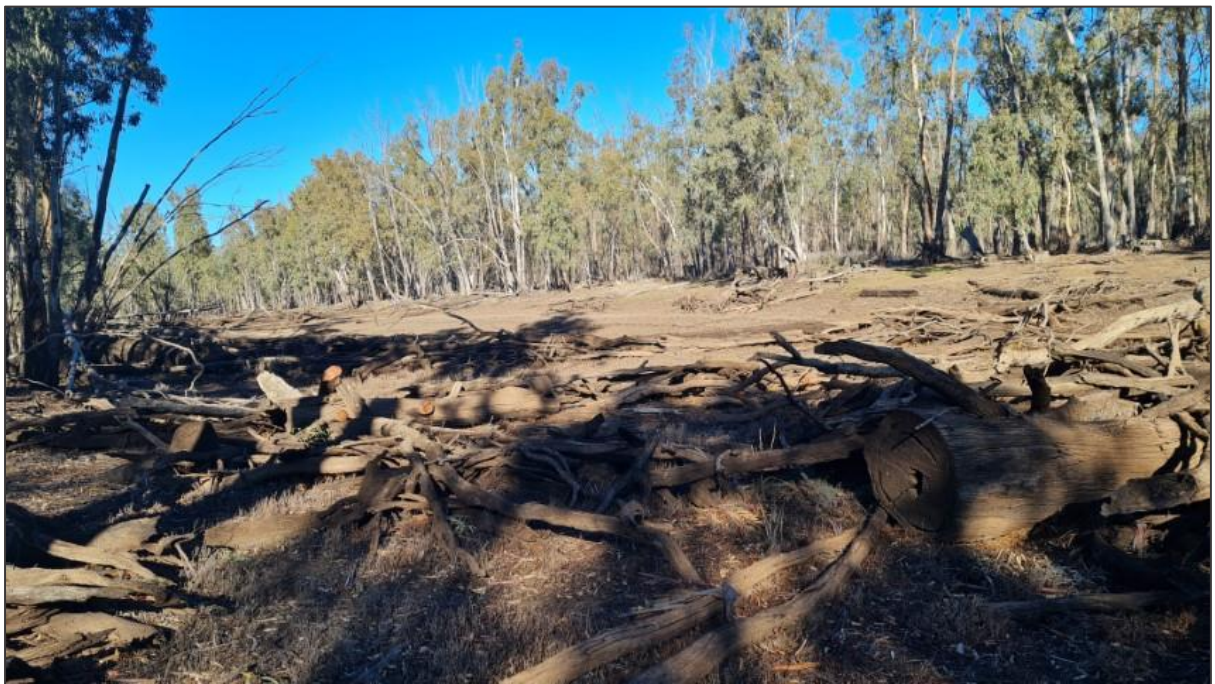
Other comments	A few instream red gums						
	Difficult to water with small volumes						
	Old stands of phragmites exist but very poor condition

*Smokehouse Lagoon – south Photo 1*

*Smokehouse Lagoon – south Photo 2*

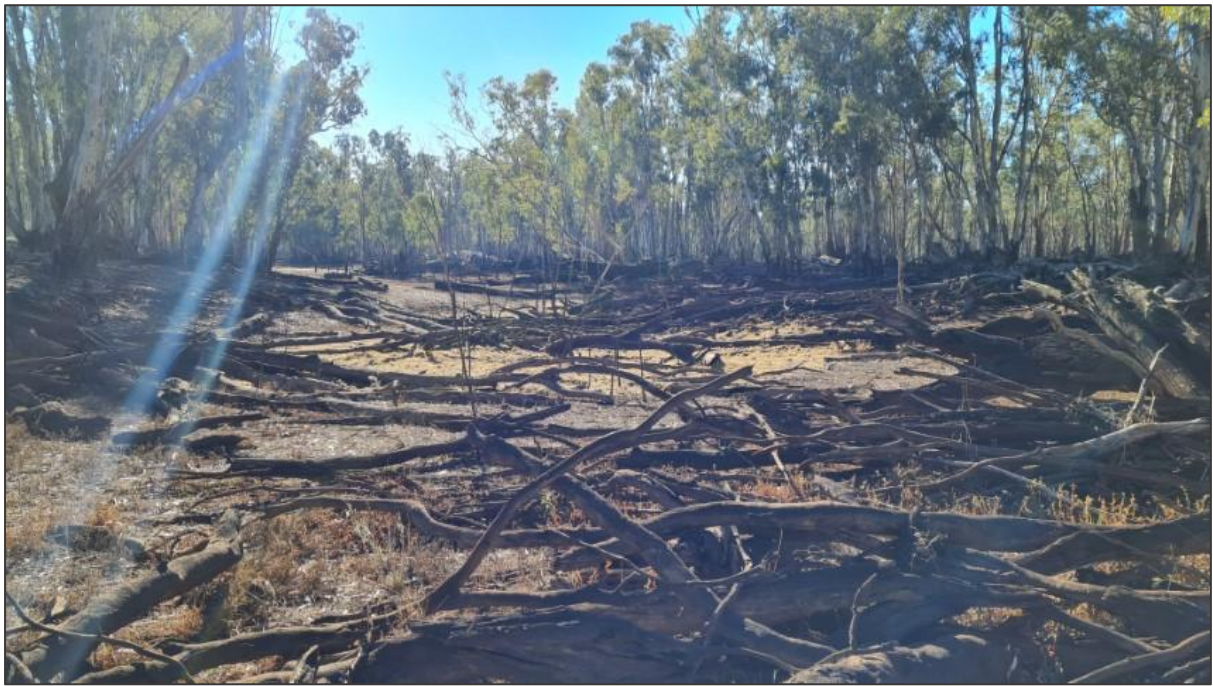
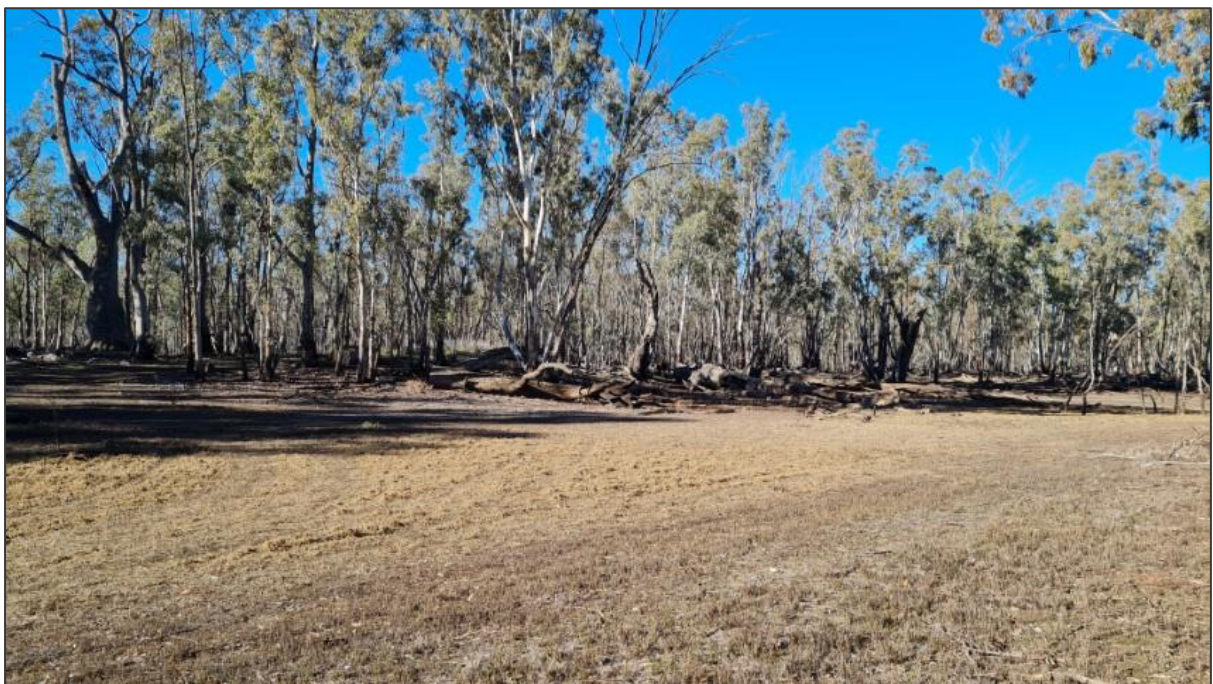
Water Quality									
Clarity	<del>Clear</del>	<del>Dark/Tannin</del>	<del>Turbid</del>	<del>Other</del>	Dry				
Pre-water - Significant Log jams at exit points need removal, red gum suckers									
Restoration Needs									
Post Water - Revegetation and pest animal monitoring									
Infested in stream with red gums, long way down from water entry point so									
Other comments									
difficult to water with small volumes									
Old stands of phragmites exist but very poor condition

*Smokehouse Lagoon – north photo 1*

*Smokehouse Lagoon – north photo 2*

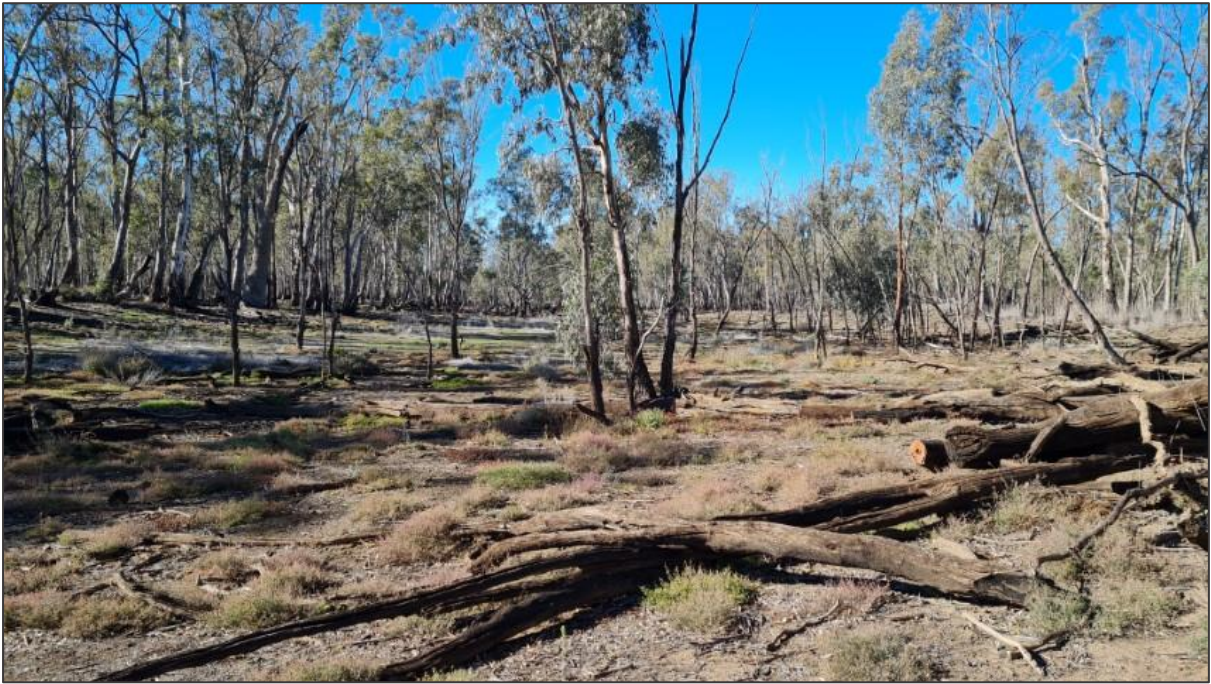
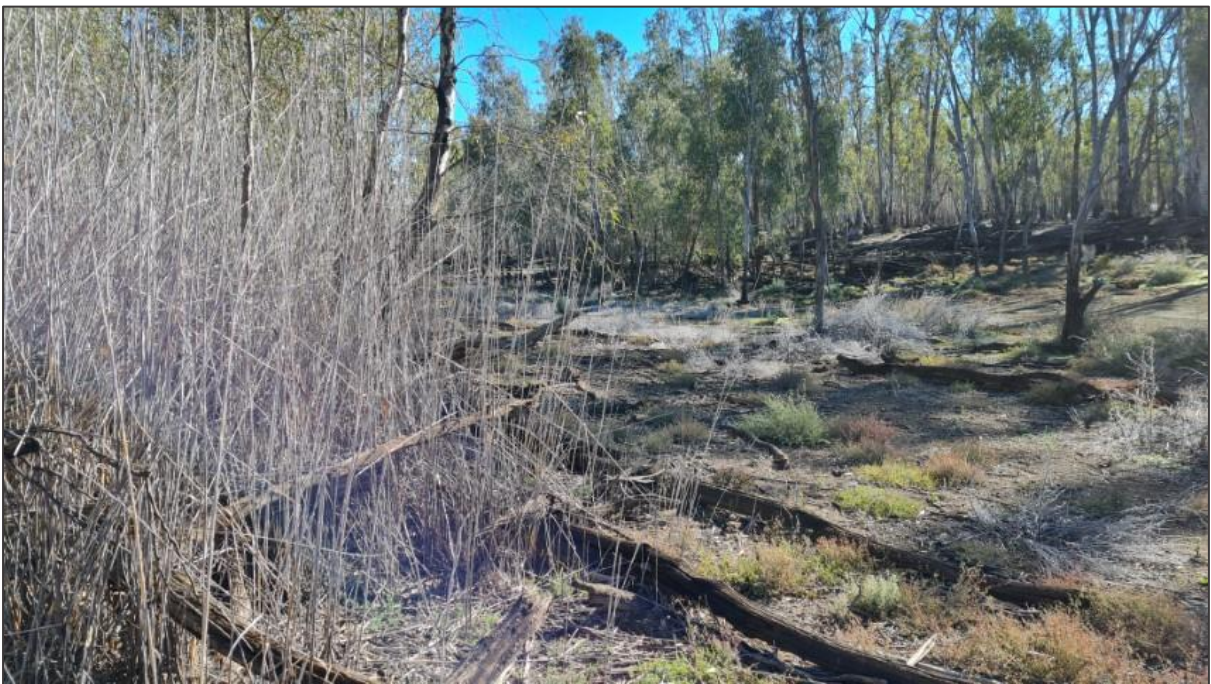
Type/Species									
Cover	None	1-25	25-50	50-75	75-100				
<i>Other Vegetation - Trees, acacias, salt bushes on banks</i>									
Type/Species	Redgums on banks, old man weed in bed								
Cover	None	1-25	25-50	50-75	75-100				
<i>Shading - How much of wetland shaded at midday</i>									
Cover	None	1-25	25-50	50-75	75-100				
<i>Instream Structure - LWD, undercut banks</i>									
Presence	<del>None</del>	in-channel	banks	submerged					
Exotics	No plants or animal damage visible								
Stock Access	Yes	<del>No</del>	Grazing lease is available but no sign of damage						
Ferals	Yes	<del>No</del>							
Type	Deer skat noticed								
Water Quality									
Clarity	<del>Clear</del>	Dark/Tannin	Turbid	Other	Dry				
Restoration Needs	Pre-water - Log jams at exit points need removal, red gum suckers Post Water - Revegetation and pest animal monitoring								
Other comments	Infested in stream with red gums, long way down from water entry point so difficult to water with small volumes Old stands of phragmites exist but very poor condition

*Long Lagoon – photo 1*

*Long Lagoon – photo 2*
