1. Introduction	4
2. Methodology	5
2.1 CO, CO ₂ , NO ₂ and Total VOCs	5
2.2 Particulate Matter PM _{2.5} and PM ₁₀	5
2.3 Temperature and Relative Humidity levels	5
2.4 Mycological (Mould).....	5
2.5 Site Details	5
3. Indoor Air Quality Results	22
4. Conclusion	25
5. References	28
6. Limitations	29
Appendix 1 – Reporting Criteria	30
Appendix 2 – Mould Sample Analysis Results	33

The aim of this assessment was to undertake a review of the sites IAQ conditions within the following Parliament House, Sydney locations:

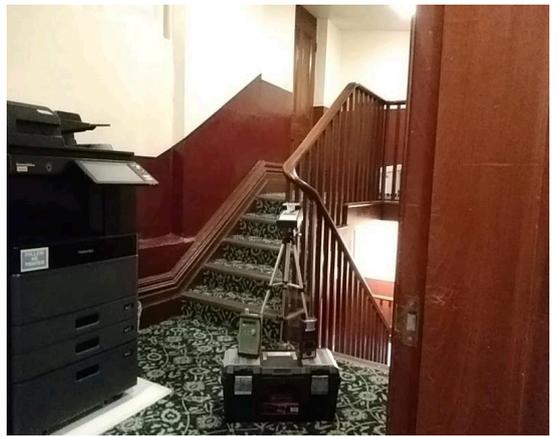
Location	Description	Image
Level 8: Exit opposite to 850	<p>Sample Type: airborne mould monitoring, dust, gas monitoring</p> <p>Notes and Observations:</p> <ul style="list-style-type: none"> • No organic odour detected • Mechanical airflow • Noticeable air movement • No visible mould detected • No visible water stain detected

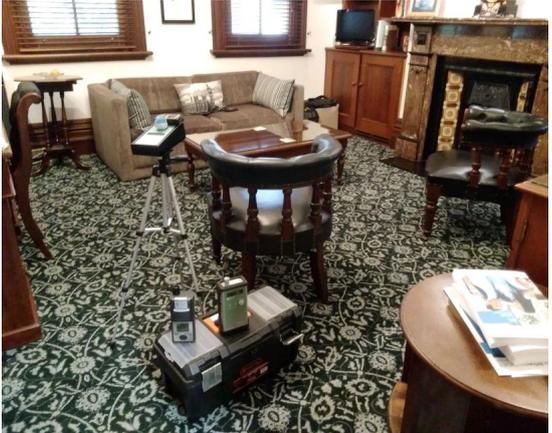
Location	Description	Image
Level 8: Room 850	<p>Sample Type: airborne mould monitoring, dust, gas monitoring</p> <p>Notes and Observations:</p> <ul style="list-style-type: none"> ● No organic odour detected ● Natural & mechanical airflow ● No visible mould detected ● No visible water strain detected

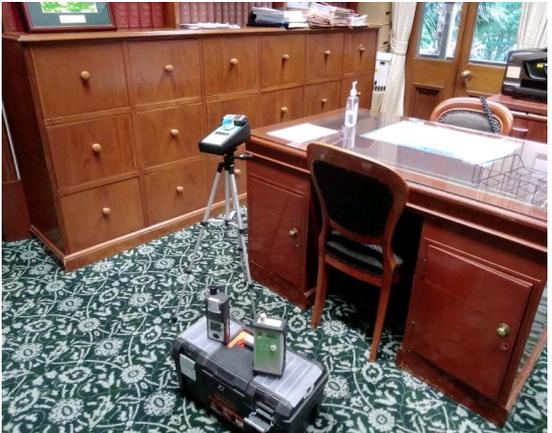
Level 8: Room 850A	<p>Sample Type: airborne mould monitoring, dust, gas monitoring</p> <p>Notes and Observations:</p> <ul style="list-style-type: none"> ● No organic odour detected ● Natural & Mechanical airflow ● No visible mould detected ● No visible water strain detected

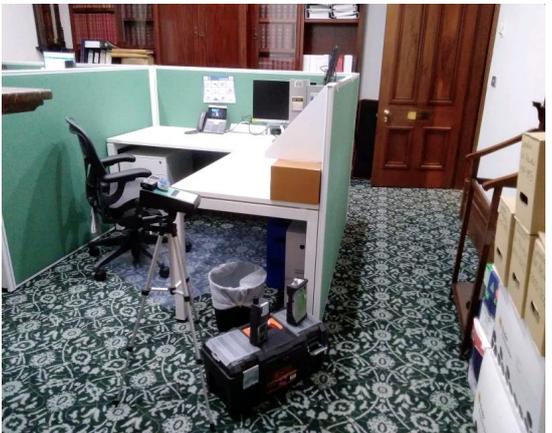
Level 8: Room 850B	<p>Sample Type: airborne mould monitoring, dust, gas monitoring</p> <p>Notes and Observations:</p> <ul style="list-style-type: none"> ● No organic odour detected ● Mechanical airflow ● No visible mould detected ● No visible water strain detected

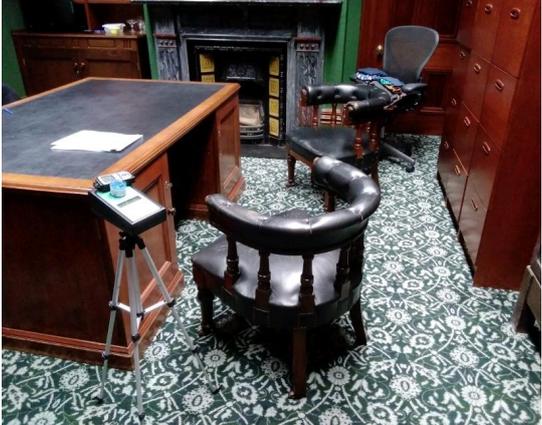
Location	Description	Image
Level 8: Room 851	<p>Sample Type: airborne mould monitoring</p> <p>Notes and Observations:</p> <ul style="list-style-type: none"> ● No organic odour detected ● Mechanical airflow ● No visible mould detected ● No visible water strain detected

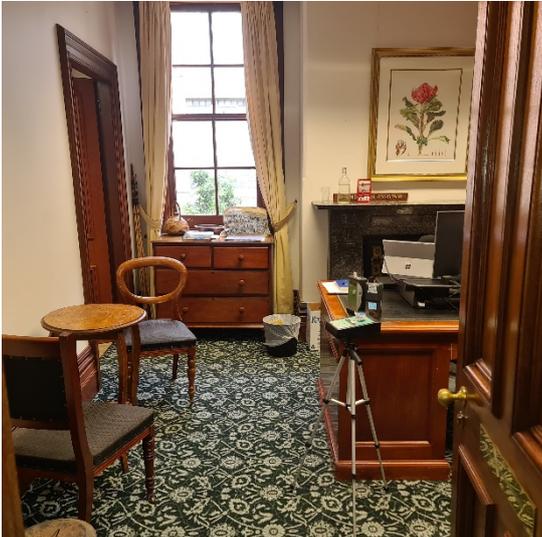
Level 8: Room 853	<p>Sample Type: airborne mould monitoring, dust, gas monitoring</p> <p>Notes and Observations:</p> <ul style="list-style-type: none"> ● No organic odour detected ● Mechanical airflow ● No visible mould detected ● No visible water strain detected

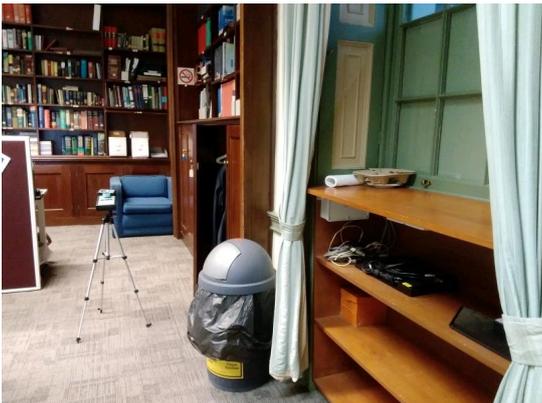
Level 8: Room 848C	<p>Sample Type: airborne mould monitoring</p> <p>Notes and Observations:</p> <ul style="list-style-type: none"> ● No organic odour detected ● Mechanical airflow ● No visible mould detected ● No visible water strain detected

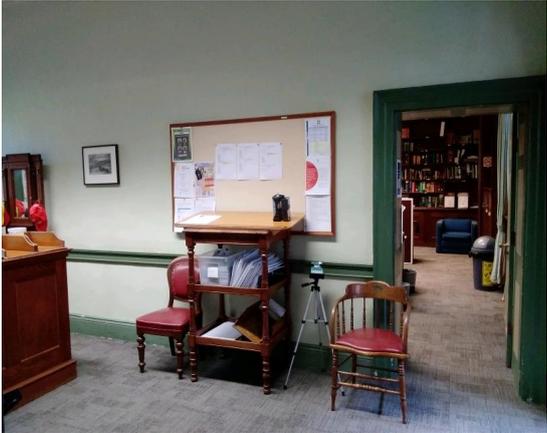
Location	Description	Image
Level 8: Room 848F	<p>Sample Type: airborne mould monitoring, dust, gas monitoring</p> <p>Notes and Observations:</p> <ul style="list-style-type: none"> ● No organic odour detected ● Mechanical airflow ● No visible mould detected ● No visible water strain detected

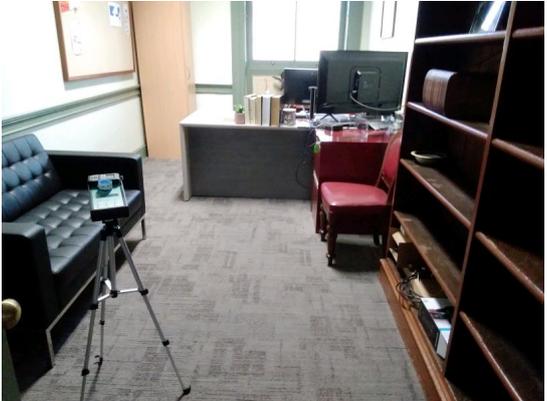
Level 8: Room 848E	<p>Sample Type: airborne mould monitoring</p> <p>Notes and Observations:</p> <ul style="list-style-type: none"> ● No organic odour detected ● Mechanical airflow ● No visible mould detected ● No visible water strain detected

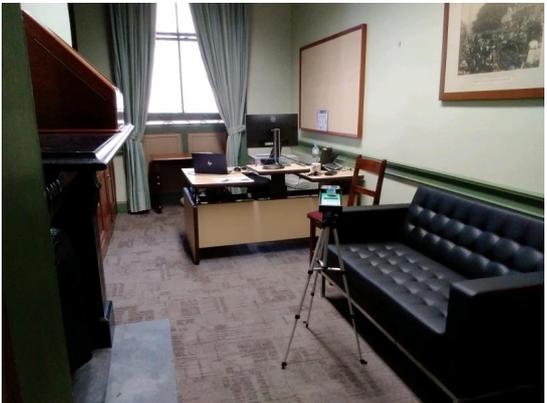
Level 8: Room 848D	<p>Sample Type: airborne mould monitoring</p> <p>Notes and Observations:</p> <ul style="list-style-type: none"> ● No organic odour detected ● Mechanical airflow ● No visible mould detected ● No visible water strain detected

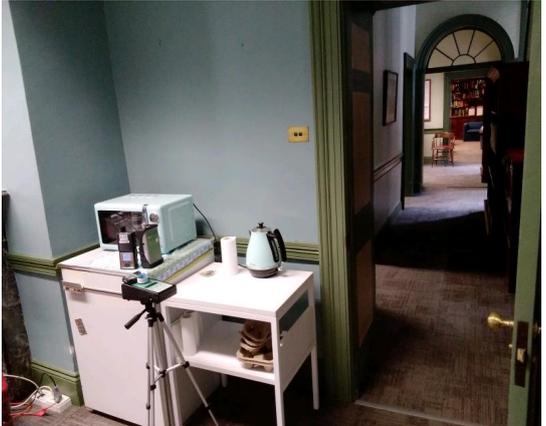
Location	Description	Image
Level 8: Room 848B	<p>Sample Type: airborne mould monitoring, dust, gas monitoring</p> <p>Notes and Observations:</p> <ul style="list-style-type: none"> ● No organic odour detected ● Mechanical airflow ● Visible mould detected to windowsills (sample: 005TL) and curtain (sample: 006TL) ● No visible water strain detected

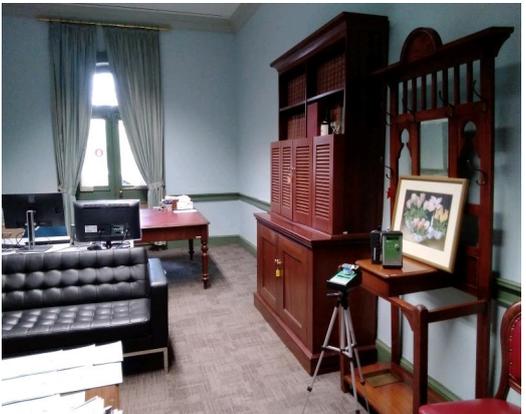
Level 8: Room 848A	<p>Sample Type: airborne mould monitoring, dust, gas monitoring</p> <p>Notes and Observations:</p> <ul style="list-style-type: none"> ● No organic odour detected ● Mechanical airflow ● No visible mould detected ● No visible water strain detected

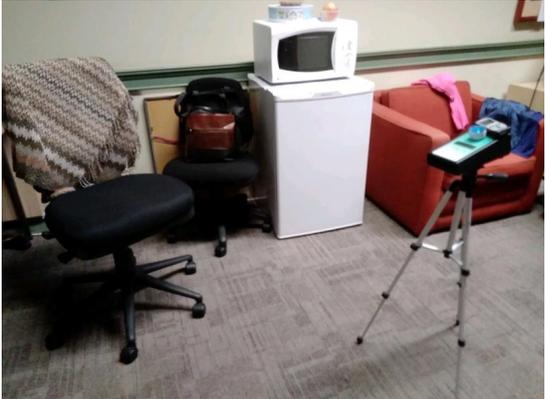
Level 8: Room 847	<p>Sample Type: airborne mould monitoring</p> <p>Notes and Observations:</p> <ul style="list-style-type: none"> ● No organic odour detected ● Mechanical airflow ● No visible mould detected ● No visible water strain detected

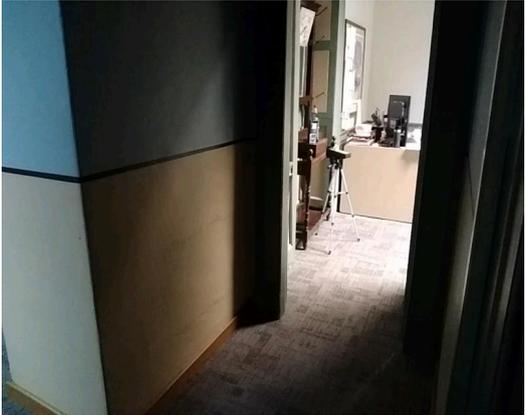
Location	Description	Image
Level 8: Room 846	<p>Sample Type: airborne mould monitoring, dust, gas monitoring</p> <p>Notes and Observations:</p> <ul style="list-style-type: none"> • No organic odour detected • Mechanical airflow • No visible mould detected • No visible water strain detected

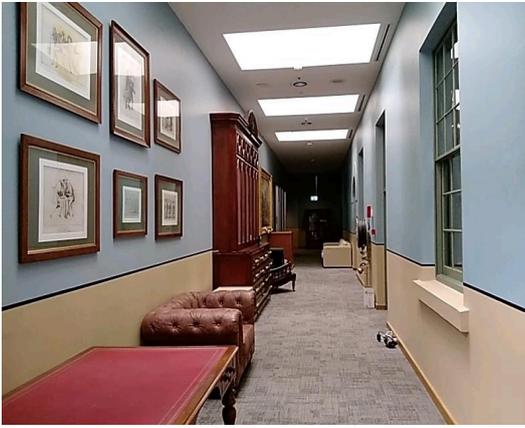
Level 8: Room 838	<p>Sample Type: airborne mould monitoring, dust, gas monitoring</p> <p>Notes and Observations:</p> <ul style="list-style-type: none"> • No organic odour detected • Mechanical airflow • Visible mould detected to picture frames & cupboard (sample: 001TL, 002TL, 003TL & 004TL) • Visible water strain detected (on southern concrete wall north end)

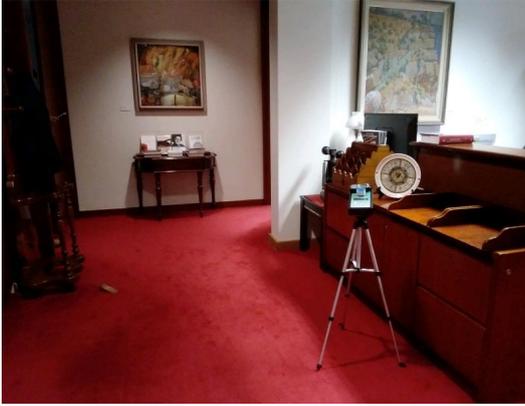
Level 8: Room 840	<p>Sample Type: airborne mould monitoring, dust, gas monitoring</p> <p>Notes and Observations:</p> <ul style="list-style-type: none"> • No organic odour detected • Mechanical airflow • No visible mould detected • No visible water strain detected

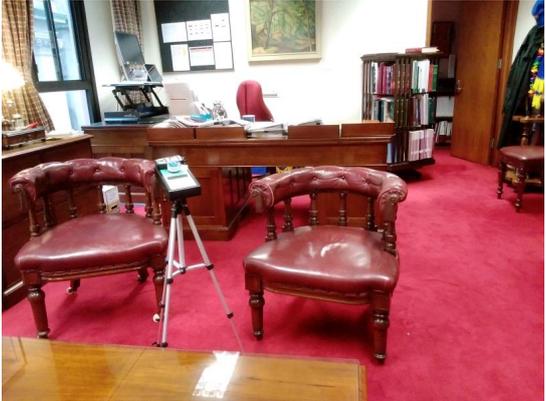
Location	Description	Image
Level 8: Room 841	<p>Sample Type: airborne mould monitoring</p> <p>Notes and Observations:</p> <ul style="list-style-type: none"> ● No organic odour detected ● Mechanical airflow ● No visible mould detected ● No visible water strain detected

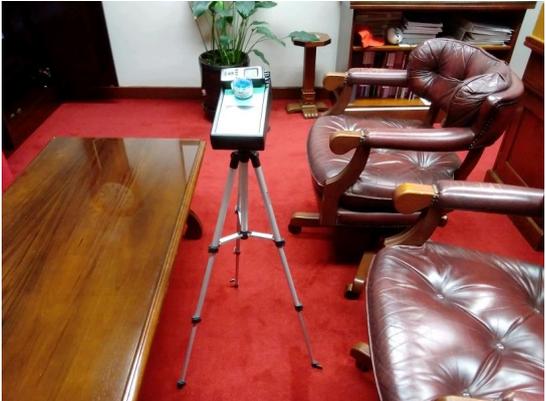
Level 8: Room 839	<p>Sample Type: airborne mould monitoring</p> <p>Notes and Observations:</p> <ul style="list-style-type: none"> ● No organic odour detected ● Mechanical airflow ● No visible mould detected ● No visible water strain detected

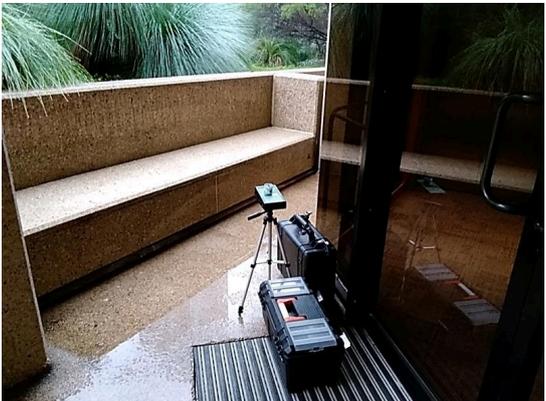
Level 9: Outdoor	<p>Sample Type: airborne mould monitoring, dust, gas monitoring</p> <p>Notes and Observations:</p> <ul style="list-style-type: none"> ● No organic odour detected ● Natural airflow ● Well maintain vegetation ● Pools of water detected

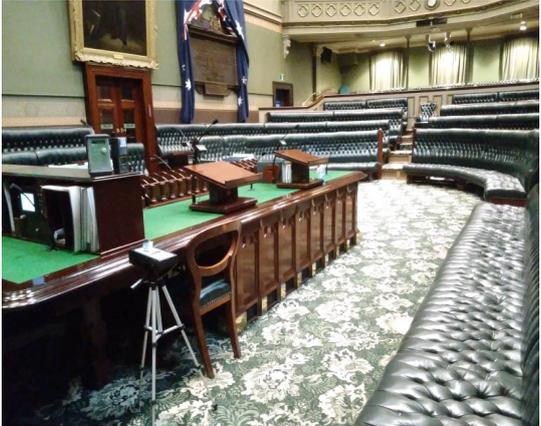
Location	Description	Image
Level 7: Room 748	<p>Sample Type: airborne mould monitoring, dust, gas monitoring</p> <p>Notes and Observations:</p> <ul style="list-style-type: none"> ● Mild organic odour detected ● Mechanical airflow ● No visible mould detected ● No visible water strain detected

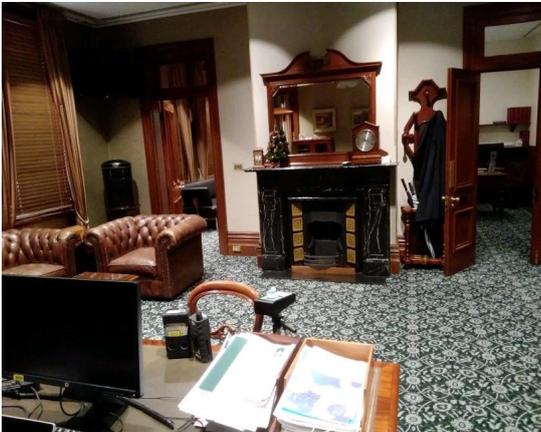
Level 7: Room 746	<p>Sample Type: airborne mould monitoring, dust, gas monitoring</p> <p>Notes and Observations:</p> <ul style="list-style-type: none"> ● No organic odour detected ● Mechanical airflow ● No visible mould detected ● No visible water strain detected

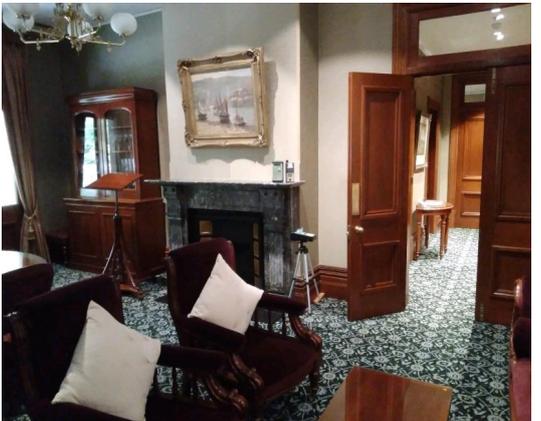
Level 7: Room 746E & F	<p>Sample Type: airborne mould monitoring, dust, gas monitoring</p> <p>Notes and Observations:</p> <ul style="list-style-type: none"> ● No organic odour detected ● Mechanical airflow ● No visible mould detected ● No visible water strain detected

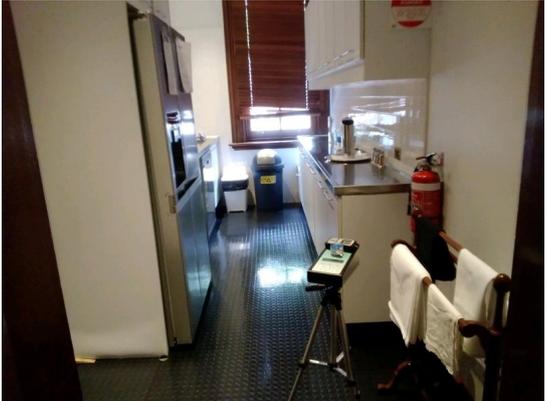
Location	Description	Image
Level 7: Room 746G	<p>Sample Type: airborne mould monitoring</p> <p>Notes and Observations:</p> <ul style="list-style-type: none"> ● No organic odour detected ● Mechanical airflow ● No visible mould detected ● No visible water strain detected

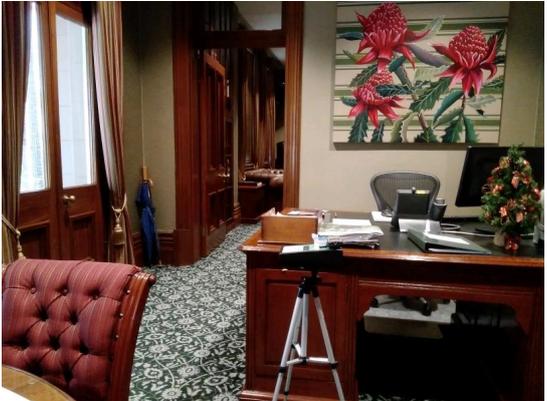
Level 7: Room 746D	<p>Sample Type: airborne mould monitoring</p> <p>Notes and Observations:</p> <ul style="list-style-type: none"> ● No organic odour detected ● Mechanical airflow ● No visible mould detected ● No visible water strain detected

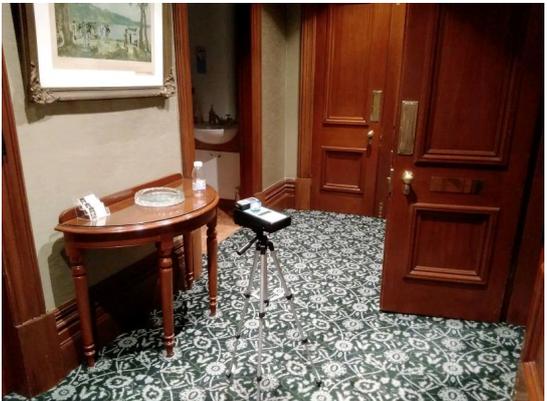
Level 7: Room 746C	<p>Sample Type: airborne mould monitoring</p> <p>Notes and Observations:</p> <ul style="list-style-type: none"> ● No organic odour detected ● Mechanical airflow ● No visible mould detected ● No visible water strain detected

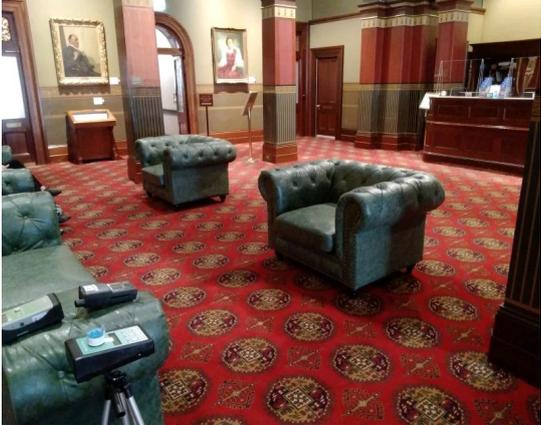
Location	Description	Image
Level 7: Room 766A	<p>Sample Type: airborne mould monitoring, dust, gas monitoring</p> <p>Notes and Observations:</p> <ul style="list-style-type: none"> ● No organic odour detected ● Mechanical airflow ● No visible mould detected ● No visible water strain detected

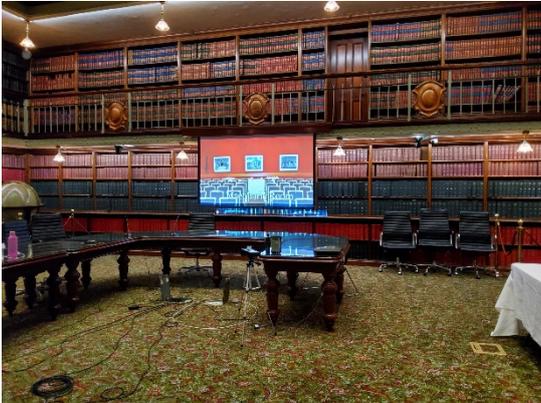
Level 7: Room 766	<p>Sample Type: airborne mould monitoring, dust, gas monitoring</p> <p>Notes and Observations:</p> <ul style="list-style-type: none"> ● No organic odour detected ● Mechanical airflow ● No visible mould detected ● No visible water strain detected

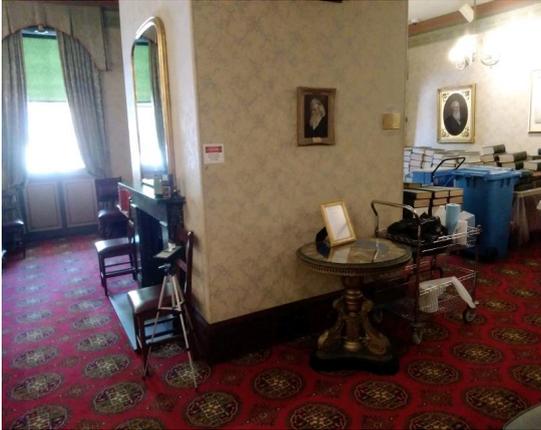
Level 7: Room 739	<p>Sample Type: airborne mould monitoring, dust, gas monitoring</p> <p>Notes and Observations:</p> <ul style="list-style-type: none"> ● Noticeable organic odour detected ● Mechanical airflow ● Visible mould detected on organic surface (edge of books, curtain) (sample: 09TL) ● No visible water strain detected

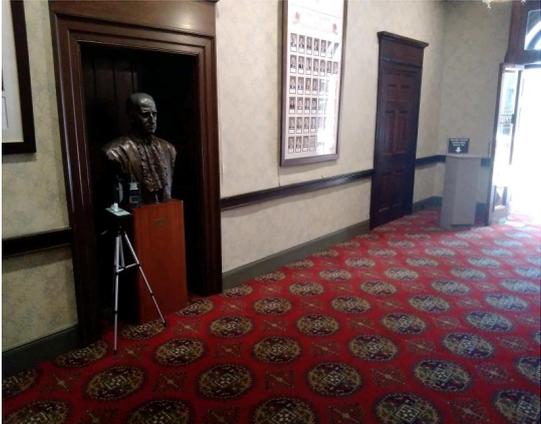
Location	Description	Image
Level 7: Room 738	<p>Sample Type: airborne mould monitoring, dust, gas monitoring</p> <p>Notes and Observations:</p> <ul style="list-style-type: none"> ● No organic odour detected ● Natural airflow ● No visible mould detected ● No visible water strain detected

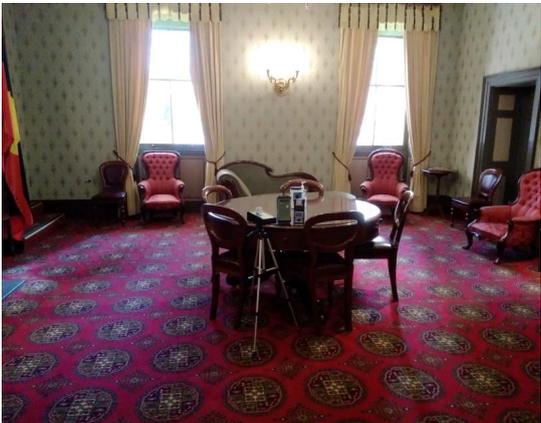
Level 7: Room 737	<p>Sample Type: airborne mould monitoring, dust, gas monitoring</p> <p>Notes and Observations:</p> <ul style="list-style-type: none"> ● Mild organic odour detected ● Mechanical airflow ● No visible mould detected ● No visible water strain detected

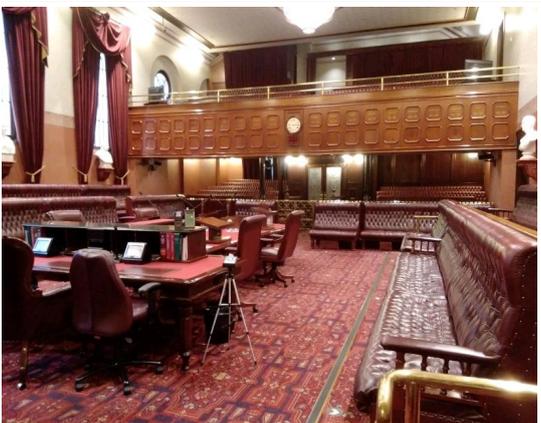
Level 7: Room 735	<p>Sample Type: airborne mould monitoring, dust, gas monitoring</p> <p>Notes and Observations:</p> <ul style="list-style-type: none"> ● Mild organic odour detected ● Mechanical airflow ● No visible mould detected ● No visible water strain detected

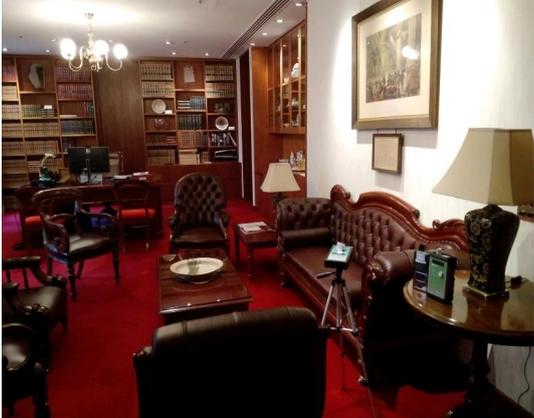
Location	Description	Image
Level 7: Room 734 & D	<p>Sample Type: airborne mould monitoring, dust, gas monitoring</p> <p>Notes and Observations:</p> <ul style="list-style-type: none"> ● No organic odour detected ● Mechanical airflow ● No visible mould detected ● No visible water strain detected

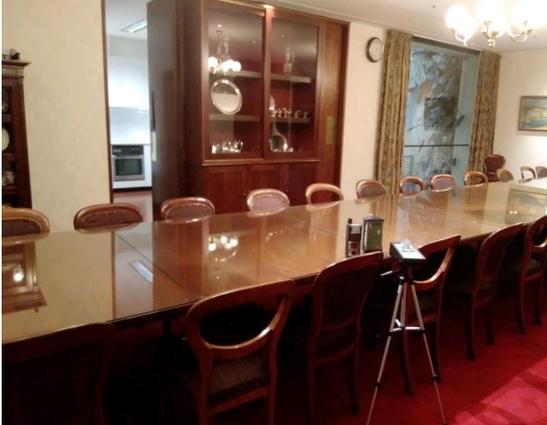
Level 7: Room 734E	<p>Sample Type: airborne mould monitoring, dust, gas monitoring</p> <p>Notes and Observations:</p> <ul style="list-style-type: none"> ● No organic odour detected ● Mechanical airflow ● No visible mould detected ● No visible water strain detected

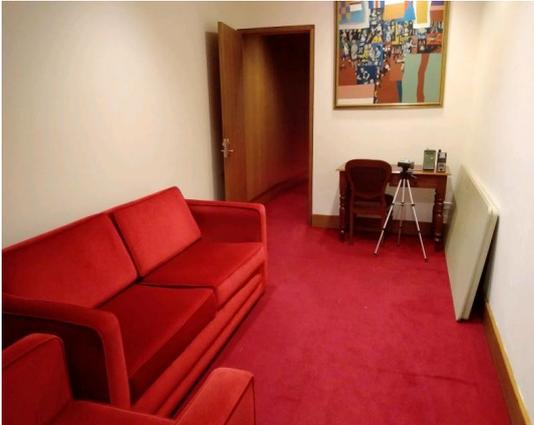
Level 7: Room 734C	<p>Sample Type: airborne mould monitoring, dust, gas monitoring</p> <p>Notes and Observations:</p> <ul style="list-style-type: none"> ● No organic odour detected ● Mechanical airflow ● No visible mould detected ● No visible water strain detected

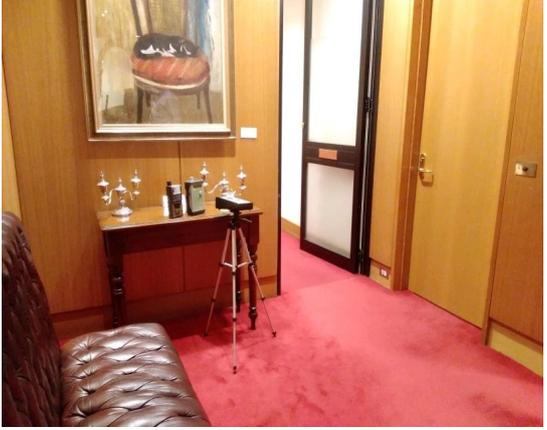
Location	Description	Image
Level 7: Room 734F	<p>Sample Type: airborne mould monitoring, dust, gas monitoring</p> <p>Notes and Observations:</p> <ul style="list-style-type: none"> ● No organic odour detected ● Mechanical airflow ● No visible mould detected ● No visible water strain detected

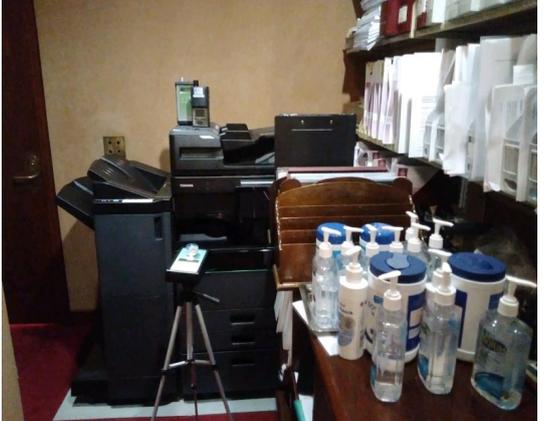
Level 7: Room 735A	<p>Sample Type: airborne mould monitoring, dust, gas monitoring</p> <p>Notes and Observations:</p> <ul style="list-style-type: none"> ● No organic odour detected ● Mechanical airflow ● No visible mould detected ● No visible water strain detected

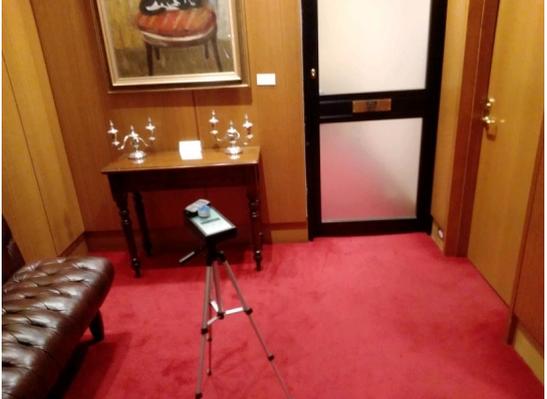
Level 7: Room 735F	<p>Sample Type: airborne mould monitoring, dust, gas monitoring</p> <p>Notes and Observations:</p> <ul style="list-style-type: none"> ● No organic odour detected ● Mechanical airflow ● No visible mould detected ● No visible water strain detected

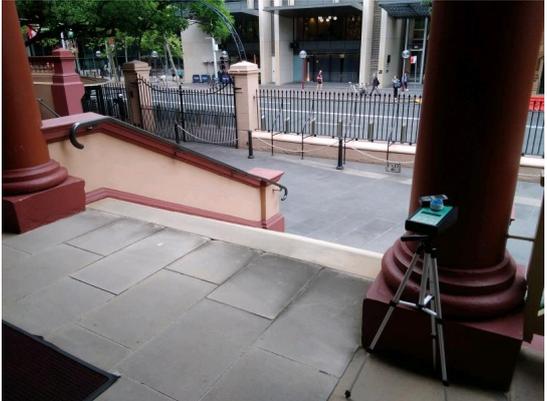
Location	Description	Image
Level 7: Outdoor	<p>Sample Type: airborne mould monitoring, dust, gas monitoring</p> <p>Notes and Observations:</p> <ul style="list-style-type: none"> ● No organic odour detected ● Mechanical airflow ● No visible mould detected ● No visible water strain detected

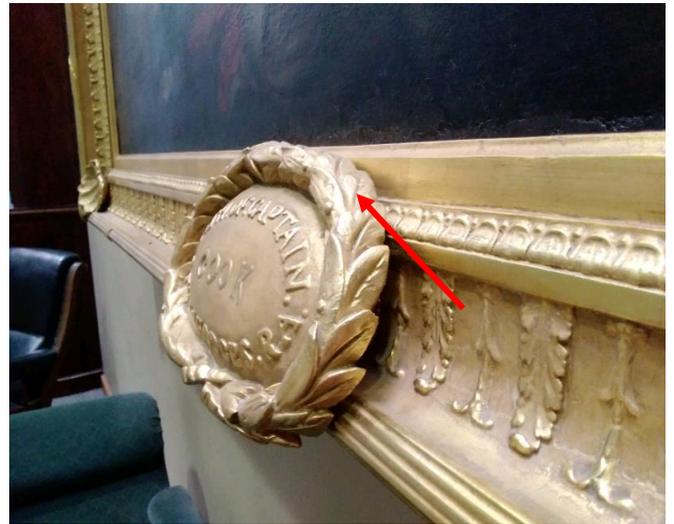
Photo No: 211110-115248
Sample ID: 002TL
Building: Parliament House
Room: Level 8
Location: Area: 838 - hard surface to photo frame

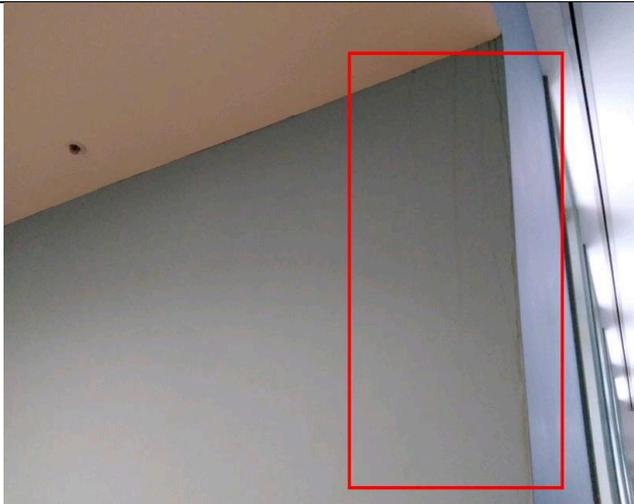
Photo No: 211110-115816
Sample ID: 003TL
Building: Parliament House
Room: Level 8
Location: Area: 838 - hard surface to water staining on southern walls

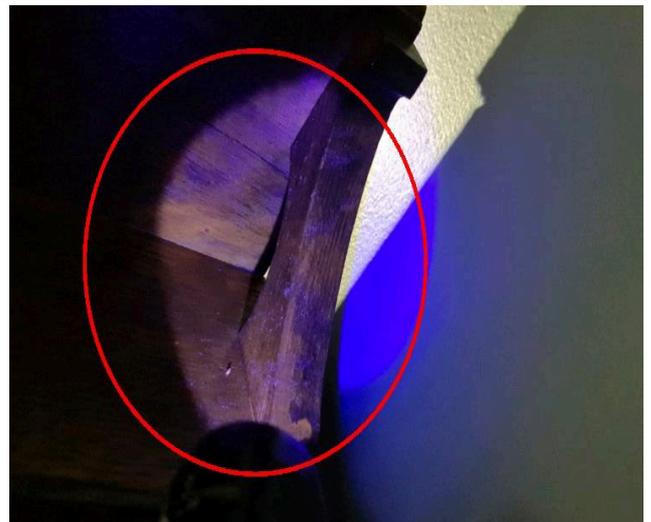
Photo No: 211110-152140
Sample ID: 004TL
Building: Parliament House
Room: Level 8
Location: Area: 838 - hard surface to the top of cupboard

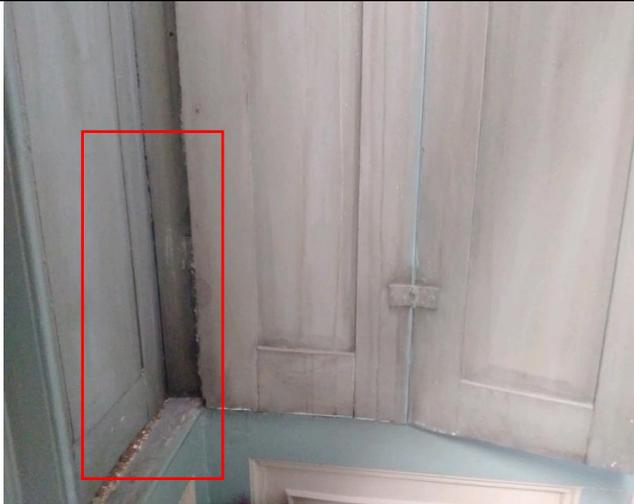
Photo No: 211206-095723
Sample ID: 005TL
Building: Parliament House
Room: Level 8
Location: Area:848B - hard surface to water staining and debris on window frames, western elevation

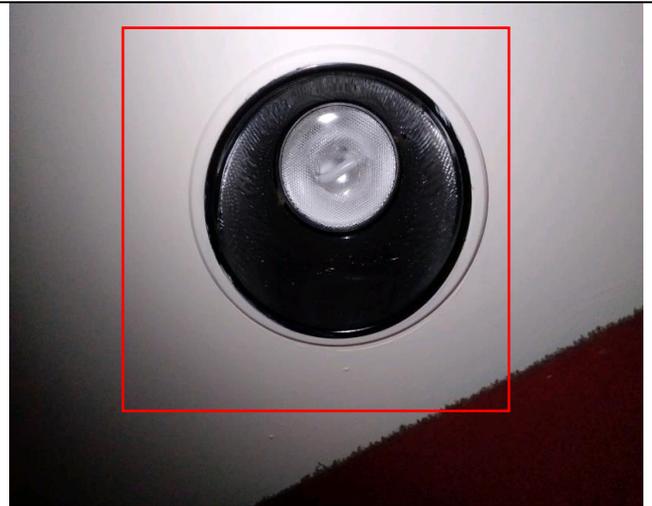
Photo No: 211206-143241
Sample ID: 010TL
Building: Parliament House Level 7
Room: Next to president's office
Location: Hard surface to the light fitting

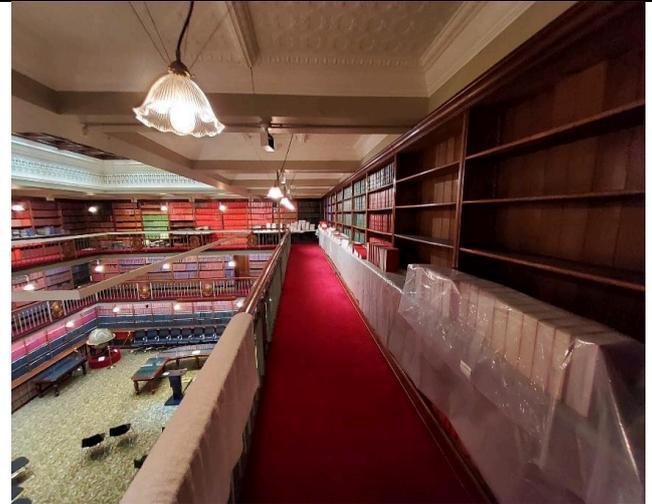
Photo No: 220322-111826
Building: Parliament House
Room: Jubilee room 3F
Elevation: Southern elevation east facing
Description: Overview of remediation items

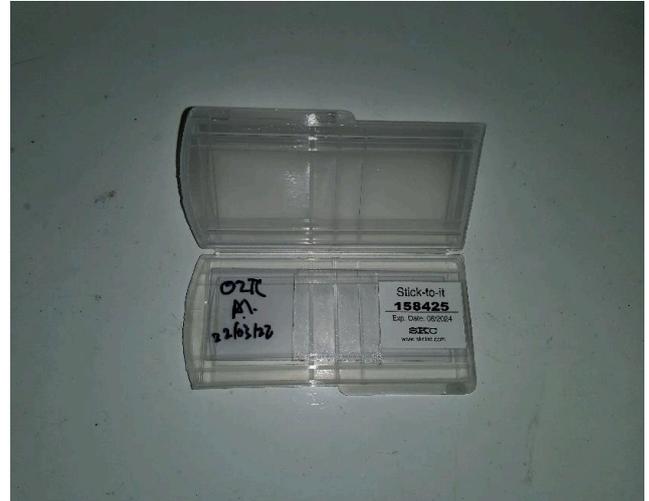
Photo No: 220322-112732
Sample ID: 02TL
Building: Field Blank
Room:
Location:
Result m²: Below Detection Limit
