# 2013 Audit of the Sydney Drinking Water Catchment Volume 3 - Appendix I

November 2013

This Section provides summaries of the 28 sub-catchments, which comprise the Sydney Drinking Water Catchment. The summaries provide a useful snapshot of the pressures and state (conditions) of each sub-catchment; and responses by the SCA and other major stakeholders (i.e. environmental monitoring and management actions).

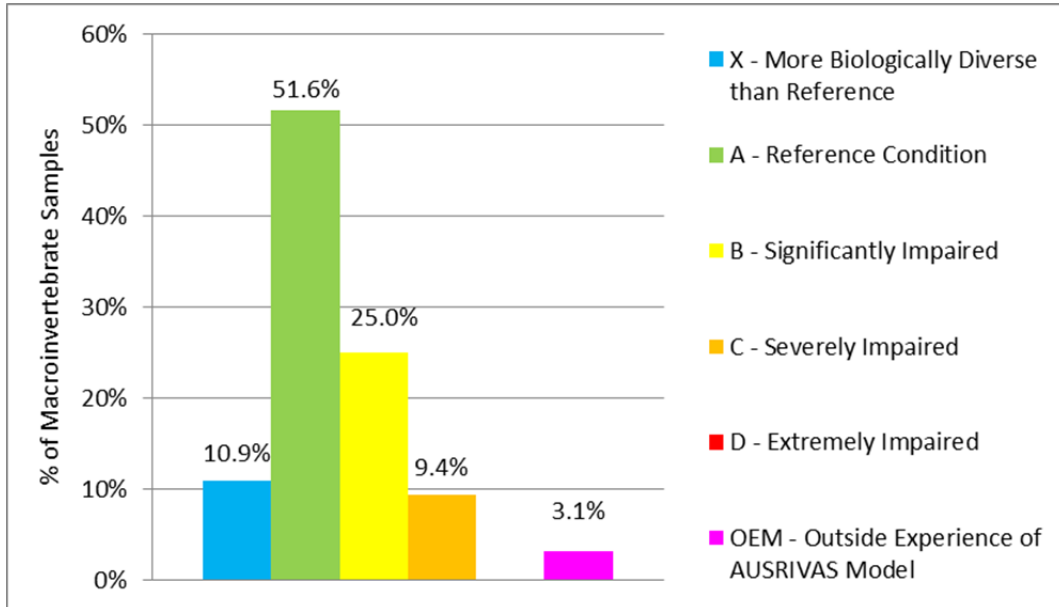
Figure I 1-11 Distribution of AUSRIVAS results for all macroinvertebrate sample data provided for the Lower Coxs River sub-catchment

The majority (51.6%) of these samples were rated by AUSRIVAS as reference condition (band A) with the remaining samples rated as significantly impaired (band B) (25.0%), more biologically diverse than reference (band X) (10.9%) or severely impaired (band C) (9.4%), with only a few samples (3.1%) falling outside the experience of the AUSRIVAS model.

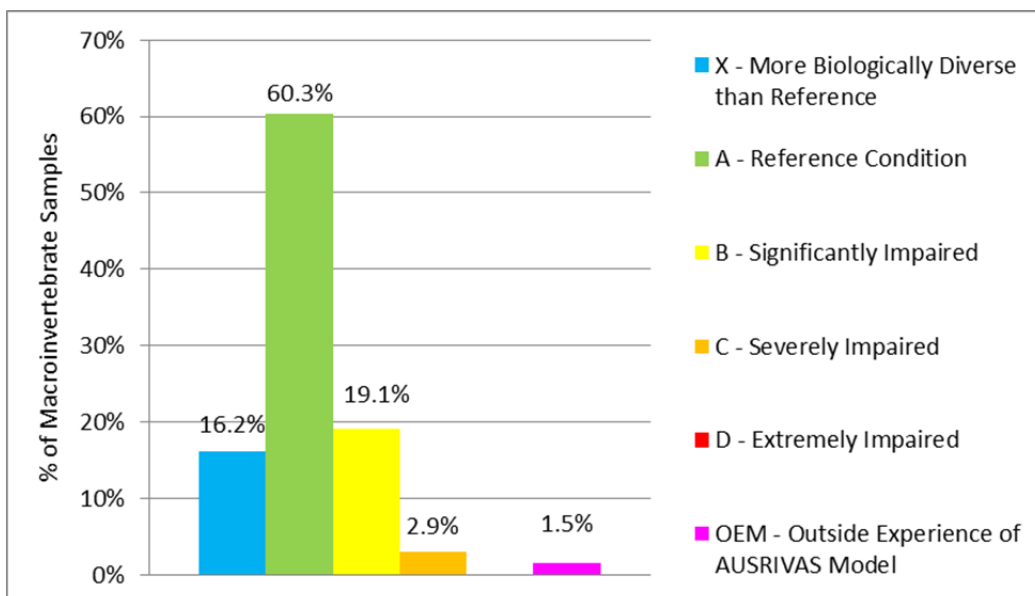
Figure I 1-20 Distribution of AUSRIVAS results for all macroinvertebrate sample data provided for the Kowmung River sub-catchment

The majority (60.3%) of these samples received an AUSRIVAS assessment of reference condition (band A) with the remaining samples rated as significantly impaired (band B) (19.1%), more biologically diverse than reference (band X) (16.2%) or severely impaired (band C) (2.9%), with only one sample (1.5%) falling outside the experience of the AUSRIVAS model.
