Peer reviewed paper

Managing the suspension bridge in Kangaroo Valley (Hampden Bridge)

Henry Fok, Bridge Inspection Engineer, Transport for NSW

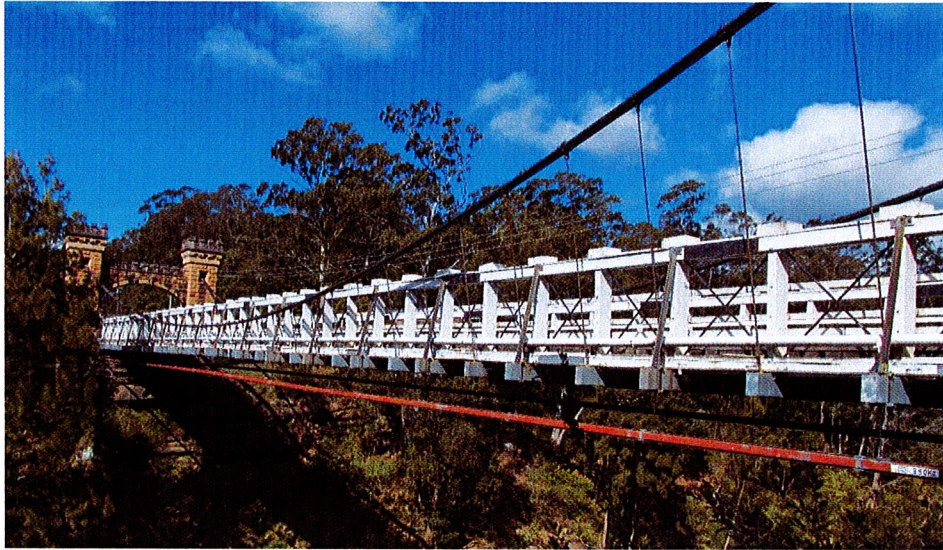
Elevation of bridge

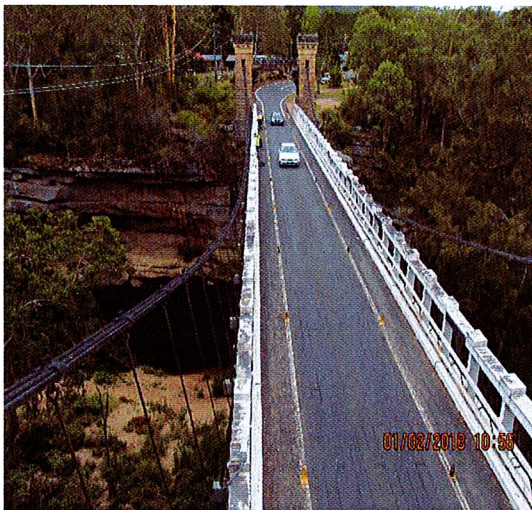
An above view of bridge

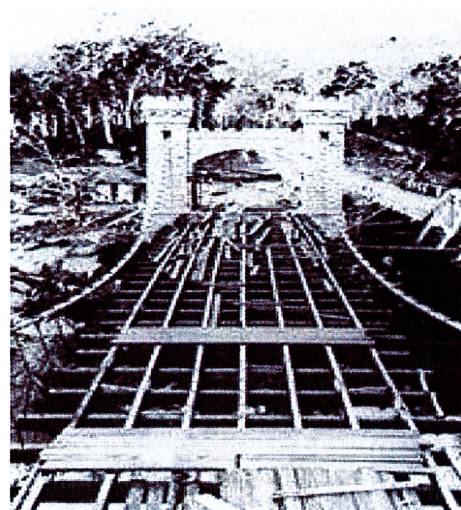
During construction

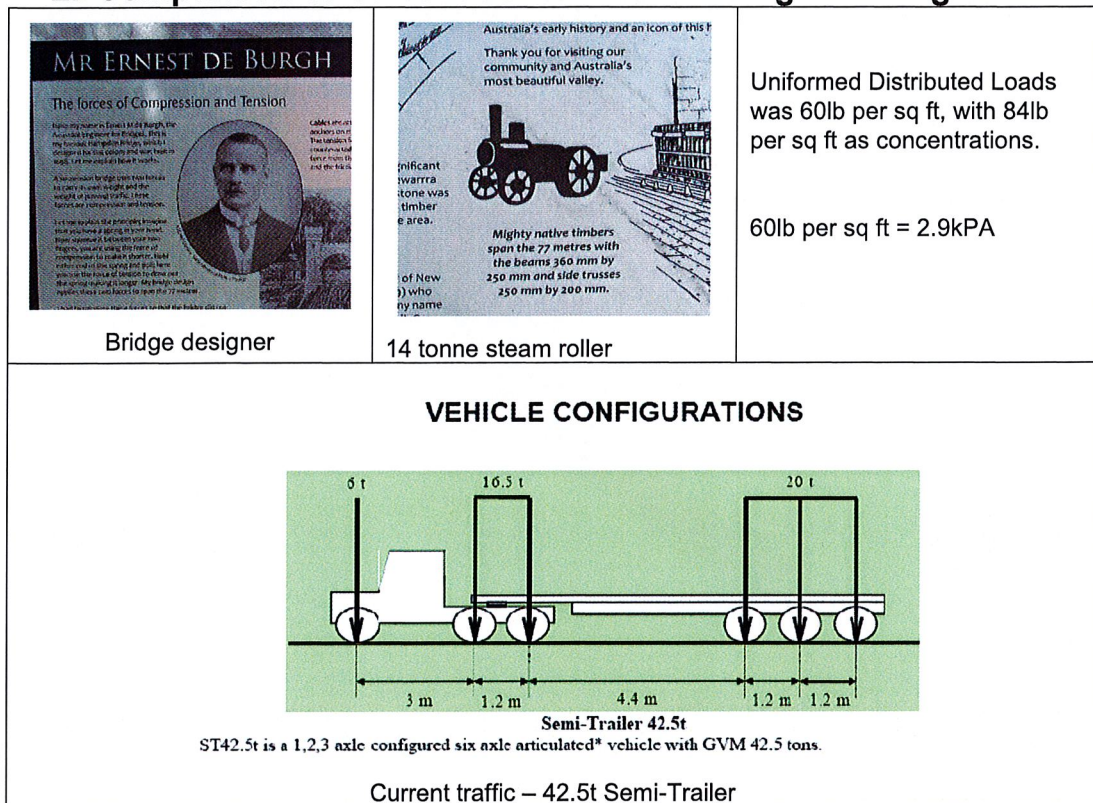
2. Comparison of Current traffic loads vs Original design loads

The original design loads were only one 14t steam roller and an UDL of only 60lb per sq ft (i.e. 2.9 kPa). Design loads were significantly less than current traffic 42.5t. In 1968, a load limit of 20t was considered but this was not feasible due to traffic demands. Hence, the bridge had been carrying loads exceeding its design loads.

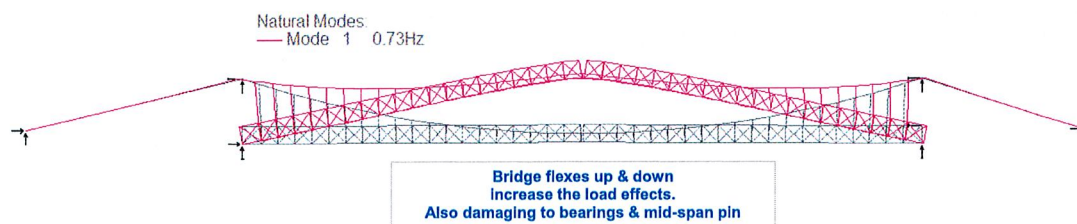
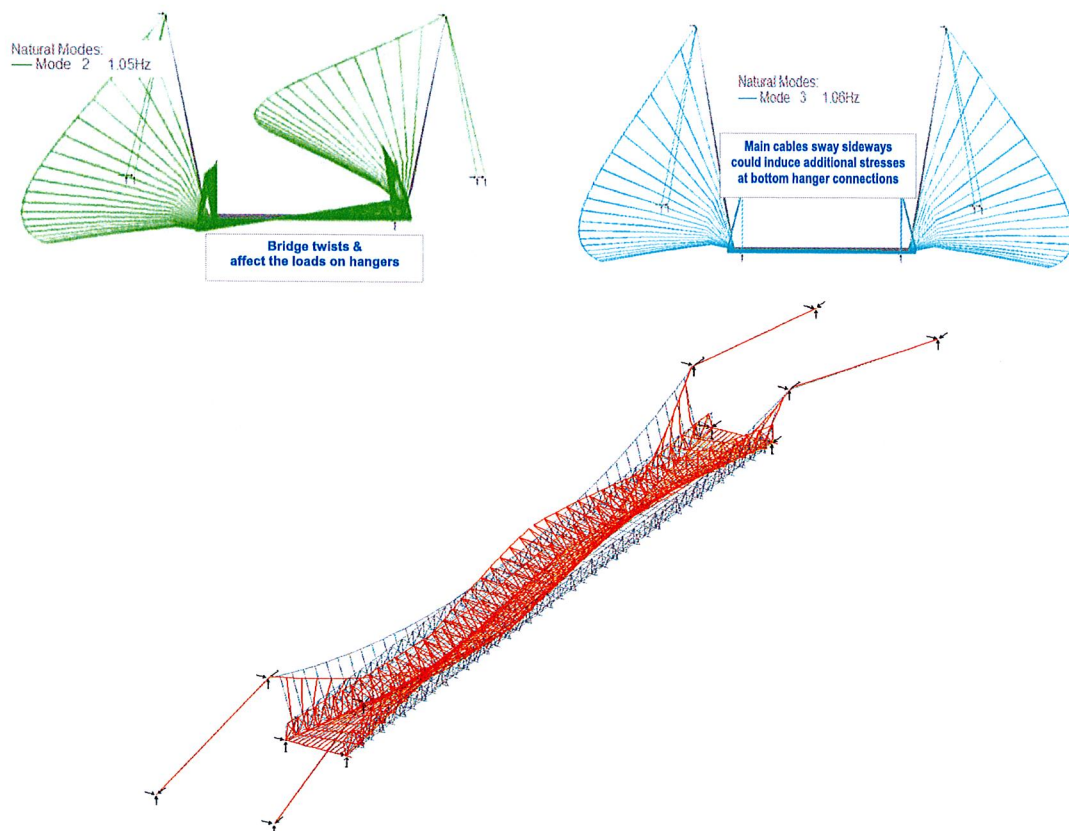
Some complex behaviours due to overloading

Overloading this bridge had caused some complex behaviours. The bridge bounces up and down, sways and twists.

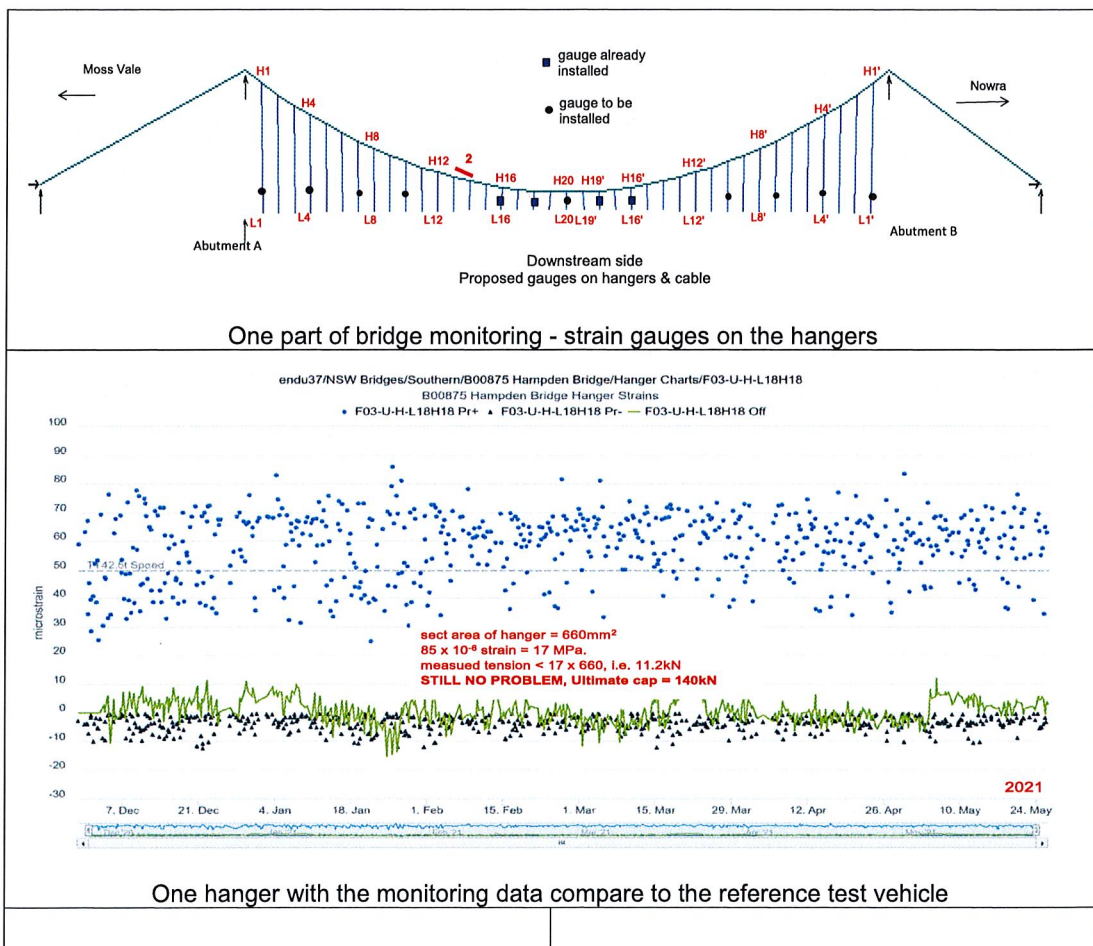
Ambient monitoring was installed on the bridge. This monitoring was carried out after a load performance test using a known test vehicle. Strain instrumentations of some parts (i.e. hangers, splice plates, chords and cables) provided data remotely. This had helped the safe operation. The disadvantage was that only limited parts of the bridge could be monitored. Visual inspections were still required.

Realistically, there are constraints to ambient monitoring. It is simply not feasible to monitor every part of the bridge. Visual inspection shall continue as a vital activity.
