## **INQUIRY INTO WINDSOR BRIDGE REPLACEMENT PROJECT**

**Supplementary  
Submission  
No 114b**

**From:** Peter Nicholson  
**Sent:** Thursday, 19 April 2018 6:09 PM  
**To:** Portfolio Committee 5  
**Subject:** Windsor Bridge project

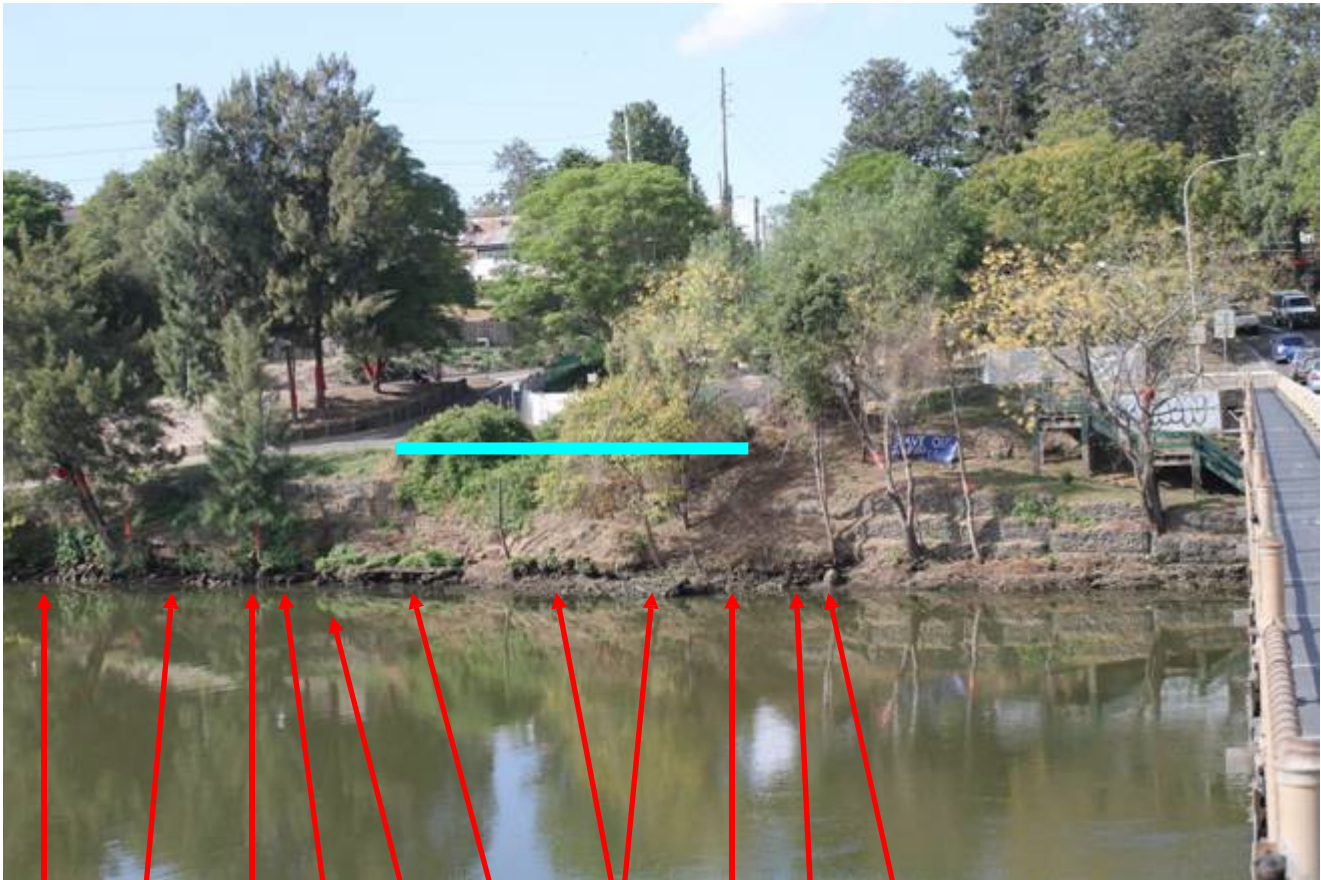
Location of photos

- Photo 1
- Photo 2
- Photo 3
- Photo 4
- Photo 5
- Photo 6
- Photo 7
- Photo 8
- Photo 9
- Photo 10

The blue line approximates the location of the replacement bridge. View from bridge south to Thompson Square.
