INQUIRY INTO IMPACT OF THE ROZELLE INTERCHANGE

Organisation: Inner West Bicycle Coalition

Rozelle Interchange and Parklands Cycling Defects and Recommendations Report February 2024

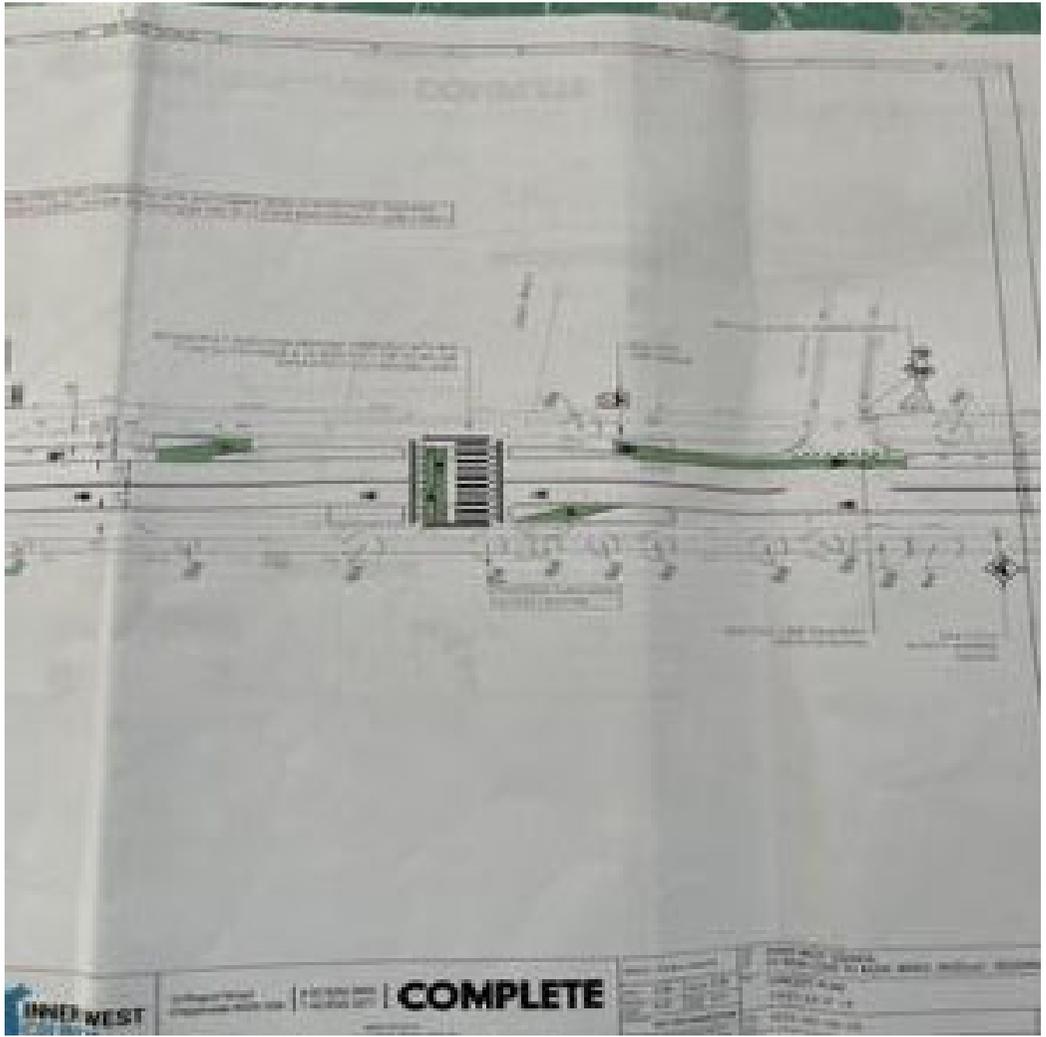
Item	Problem	Recommendation	Illustration
18 a	See the Ryan St crossing design by Complete Urban for Lilyfield Rd cycleway.

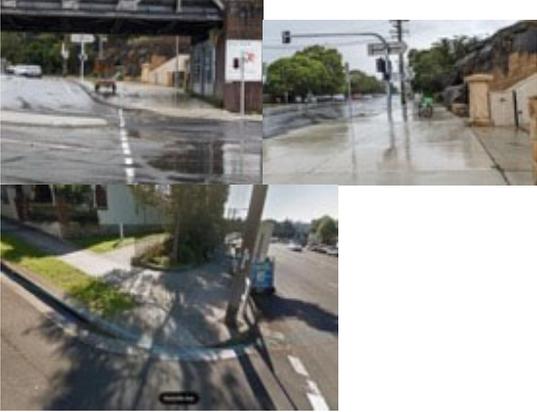
Item	Problem	Recommendation	Illustration
26	Underpass of Light Rail at Railway Pde remains closed stopping access to waterfront path	Open to allow movement of pedestrians and cyclists at grade access to Blackwattle Bay, Rozelle Bay path and James Craig Rd.
