## FERRY SAFETY INVESTIGATION REPORT

# COLLISION OF THE MANLY FERRY *COLLARROY* NUMBER 3 WEST WHARF, CIRCULAR QUAY 4 MARCH 2005

**OTSI File Ref: 03545**

**25 November 2005**

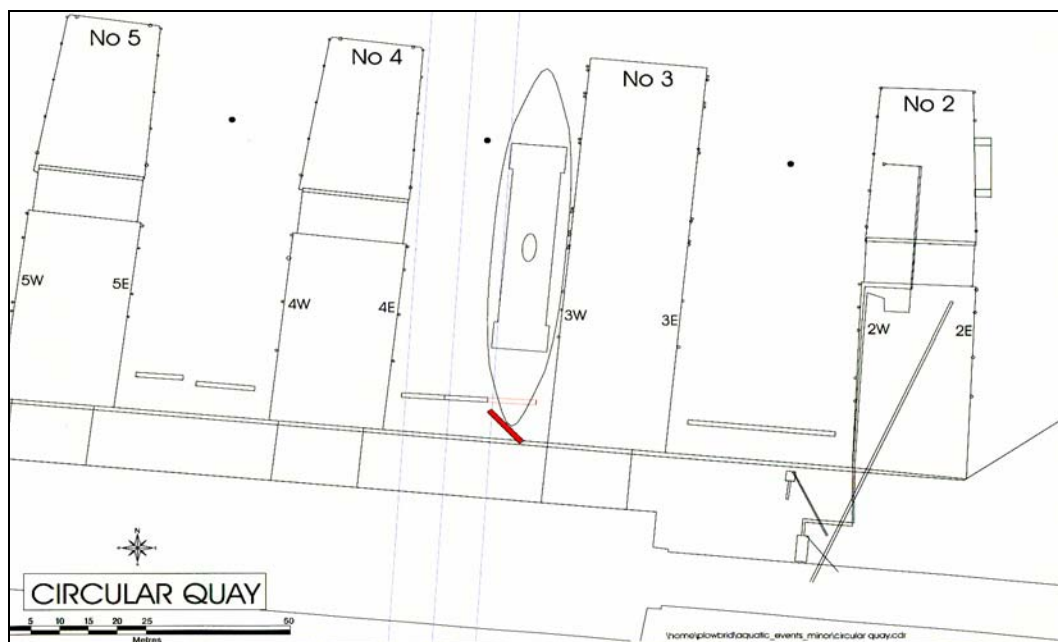
**Figure 3: Location Diagram (Courtesy NSW Maritime Authority)**

2.8 Circular Quay is Sydney's busiest wharf facility. It is sited at the Southern end of Sydney Cove and comprises five, 78.5 metres long, pile-supported piers and pontoon wharves, aligned North-South, providing both access and egress to ferry and charter vessel passengers. More than ten vessel movements may occur in Sydney Cove concurrently and in recent years, there has been an increase both in traffic frequency and the size of vessels operating therein. Significantly, Circular Quay is less than 300 metres wide at its Southern end. The facility's layout, showing *Collaroy's* final position, is shown at Figure 3.
