RAIL SAFETY INVESTIGATION REPORT

**DERAILMENT OF CITYRAIL PASSENGER SERVICE
K496**

UNANDERRA

24 JANUARY 2009

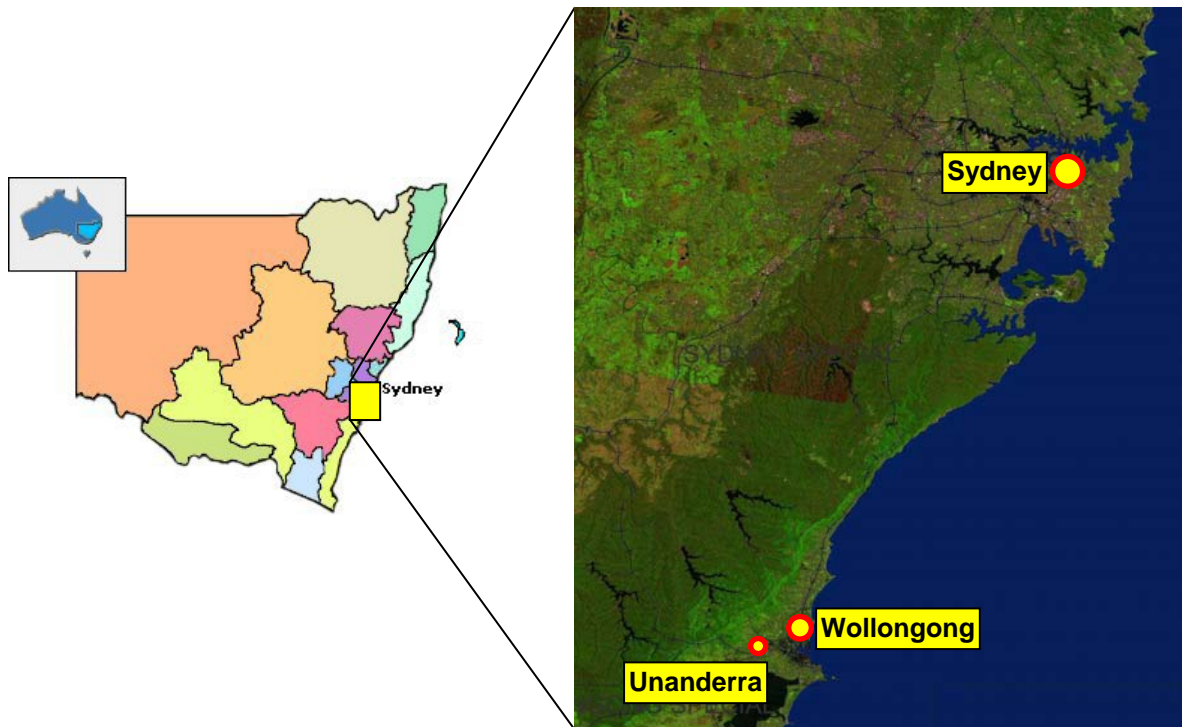
Figure 1: Incident location

- 1.13 The derailment occurred 200m North of Unanderra on the 'Branch' line connecting Nowra, via Kiama, to the Illawarra line at Wollongong. Unanderra is located in the Illawarra region of NSW, approximately 73km South of Sydney and approximately 5km South of the Wollongong CBD (see *Figure 1*).

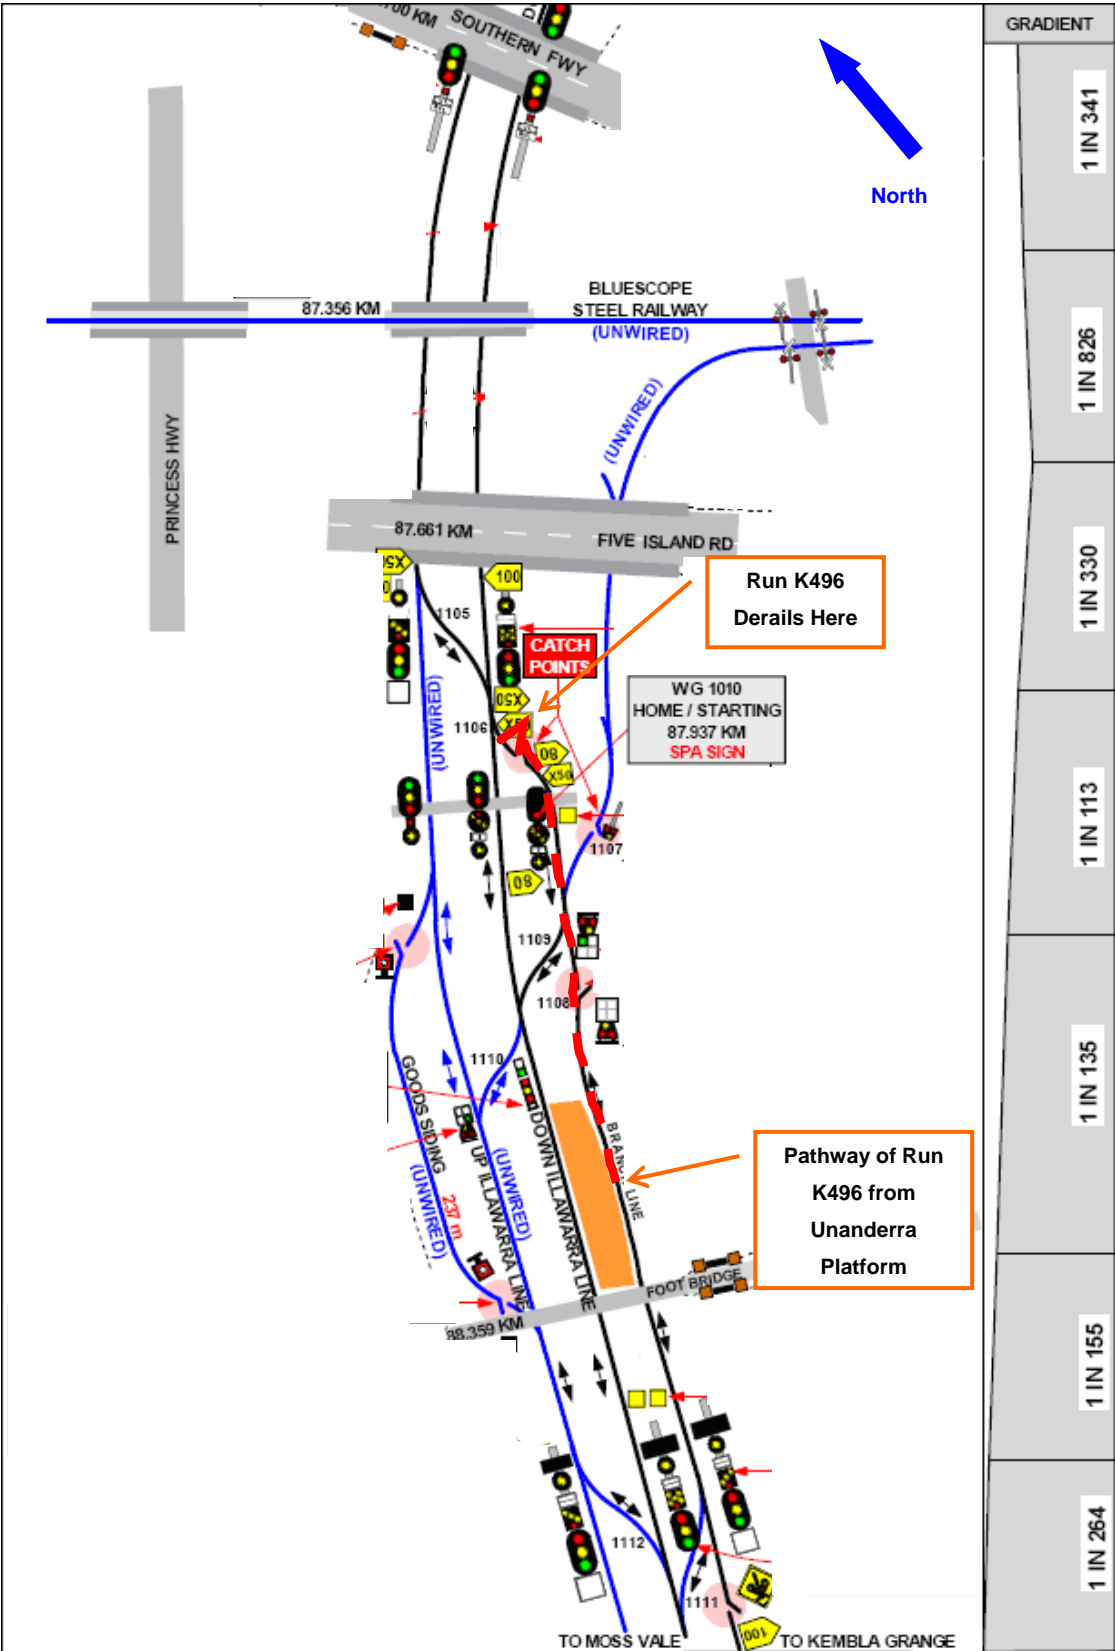
Figure 2: RailCorp Diagram of Track and Signal Layout at Unanderra

- 1.19 Unanderra is a junction within the RailCorp intercity rail network where the South Coast Branch line (from Nowra) and the Moss Vale to Unanderra Main lines join the Up and Down Illawarra lines (see *Figure 2*). The main tracks around Unanderra have overhead wiring and the related signalling functions are normally controlled remotely from Wollongong Signalling Complex⁷.
- 1.20 The immediate area surrounding the site of the derailment is relatively flat and the line is relatively straight with a slight falling grade as the train approaches Signal WG1010. The track speed on approach to Unanderra Station is 80km/h, with a turnout speed of 50km/h through 1106 crossover, situated just beyond Signal WG1010 and 1106 catch-points.
