# Rail Safety Investigation Report

## UNANDERRA

**Signal Passed at Danger resulting in derailment of Pacific National Service B9162.**

Issue Date: 28 July 2004

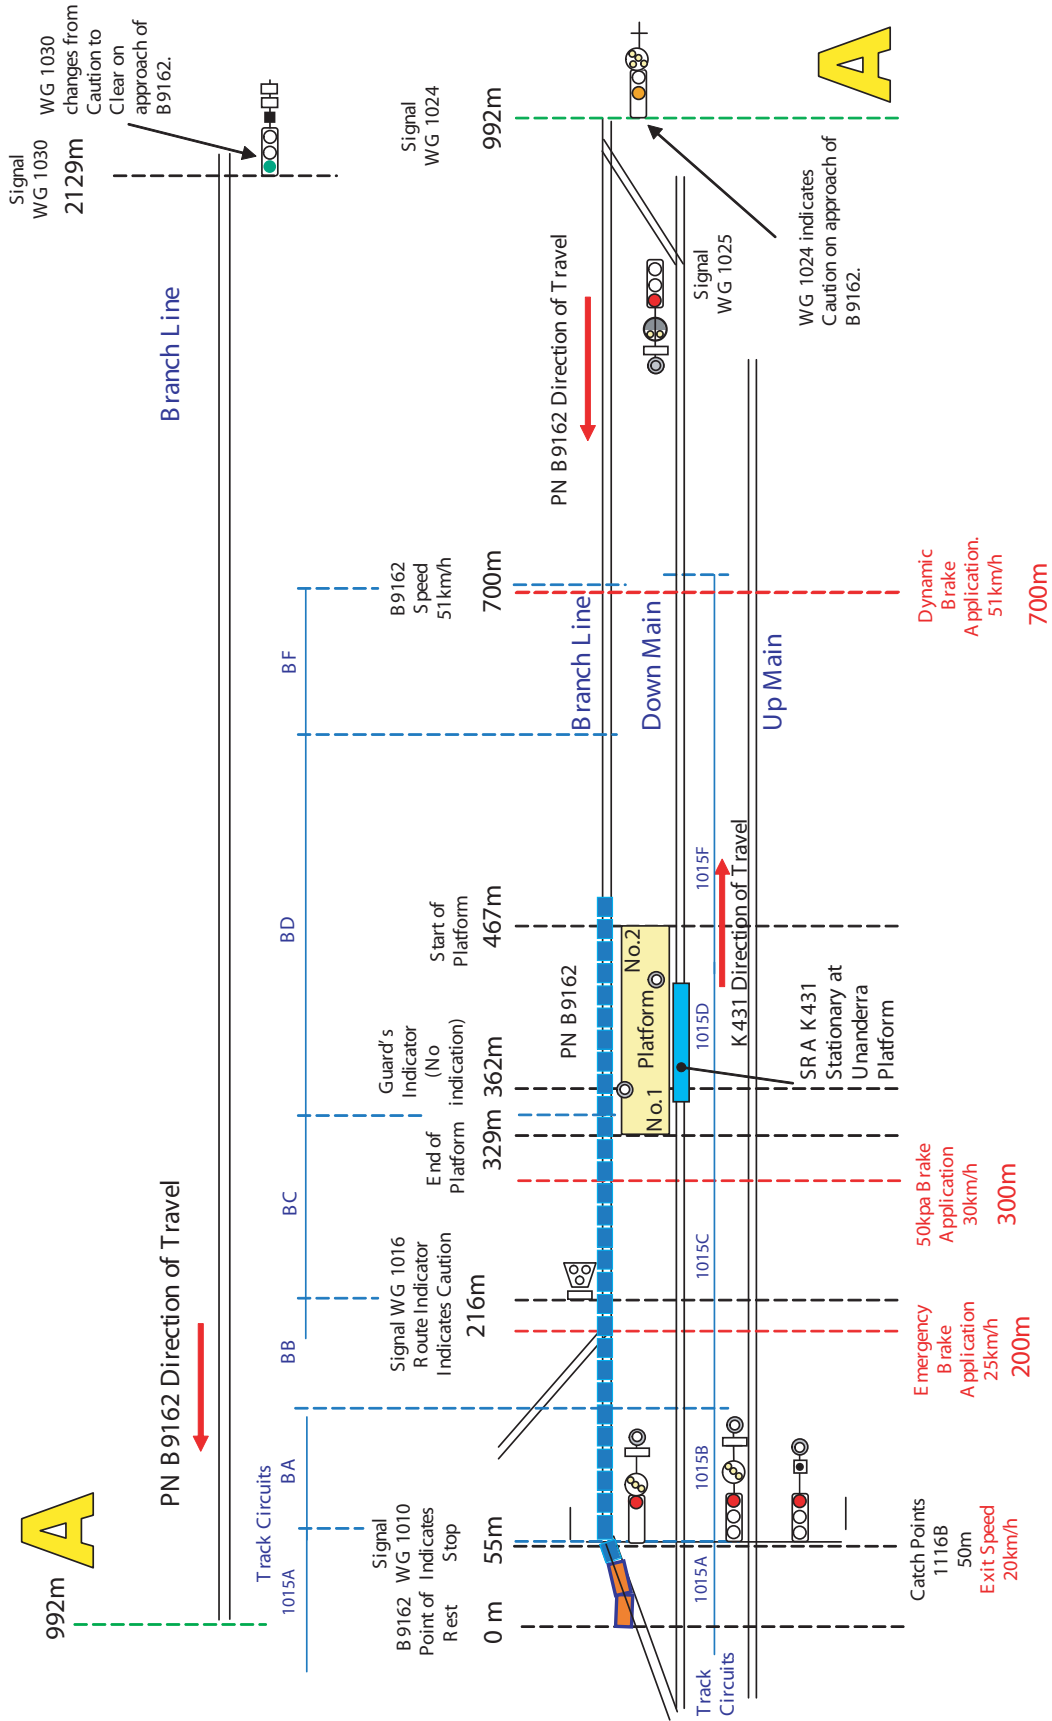
Diagram approximate scale 1cm : 50m

Note: All distance measurements are referenced from the lead Locomotive 8127 point of rest (POR) at 0m on B9162. Refer to Appendix 8.7 for calculation of these distances.

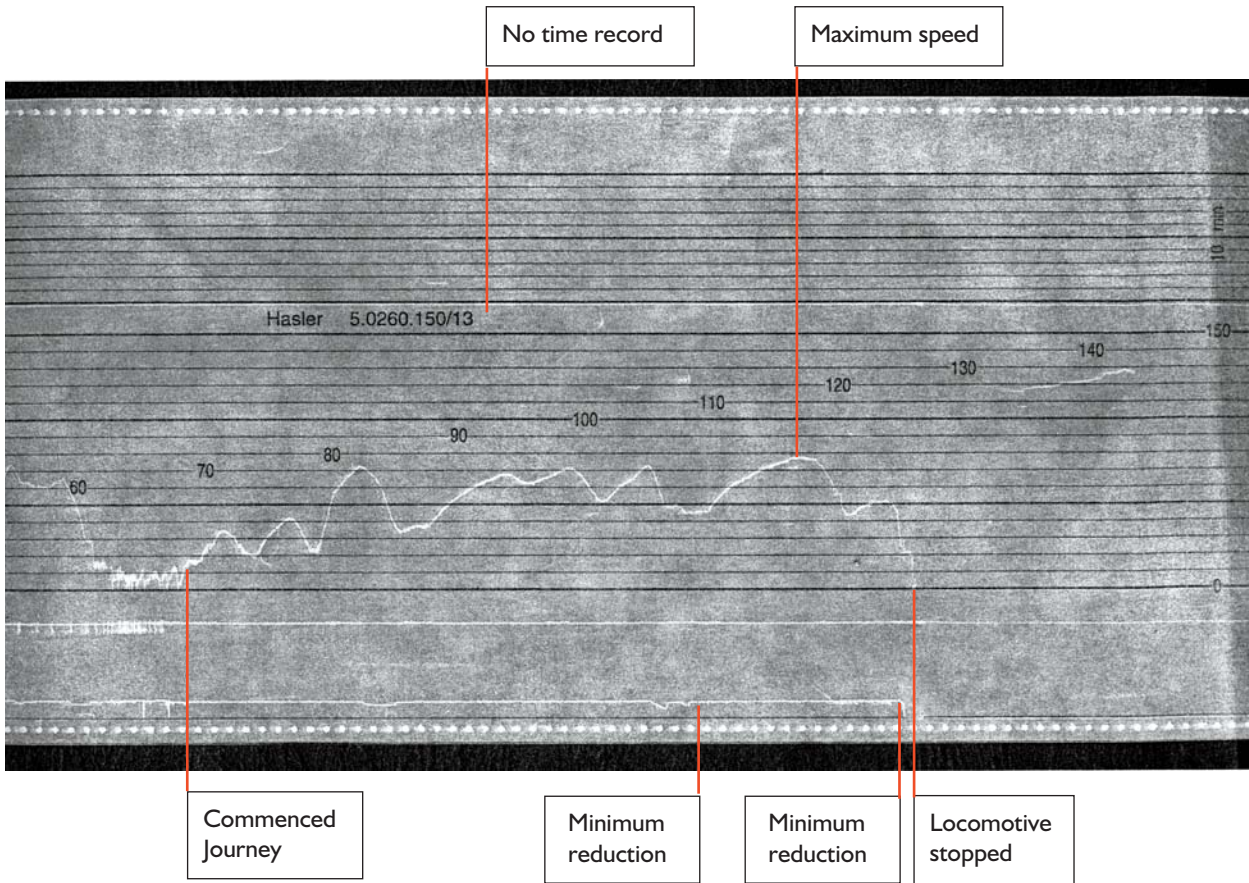
8148

At approximately 23.3 km's the speed of the locomotive drops suddenly from 20km/h to zero. The rate of deceleration would indicate that there was an outside influence brought to bear on the locomotive.
