RAIL SAFETY INVESTIGATION REPORT

RUNAWAY OF ROLLING STOCK

ENFIELD YARD

3 MAY 2011

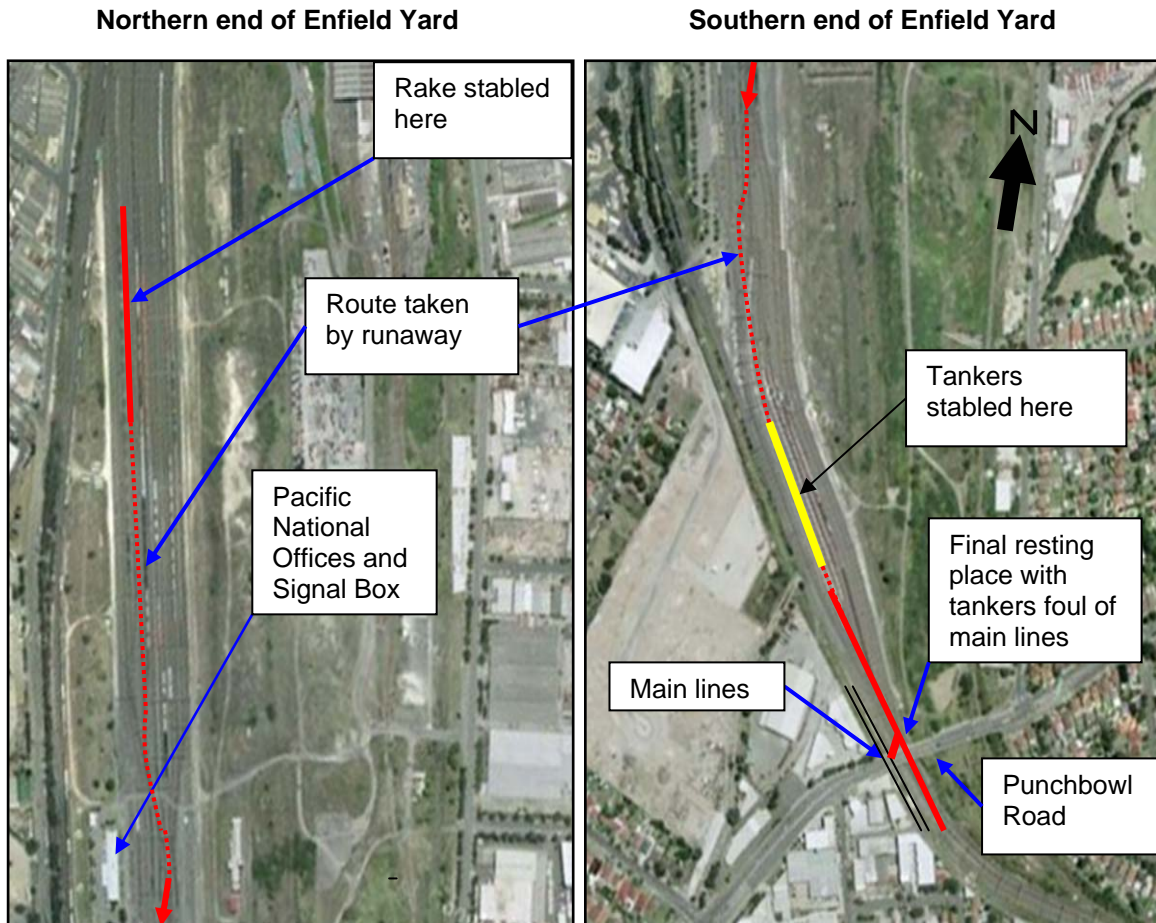
Photograph 2 : Contiguous aerial views of Enfield Yard

- 1.8 The signals within the yard are controlled from Enfield Signal Box which is located within the Pacific National offices in the yard. However, some areas within the yard are neither track circuited nor signalled which means that the signaller has no visibility, on his mimic board², of the location of rail traffic or rolling stock in those areas.
- 1.9 Overhead wiring (1500V) is in place over much of the yard, including the incident site, but is generally little used. At the time of the incident, the 1500V power supply to the yard was isolated (turned off) across the whole yard and had been since 12 October 2010 to facilitate the construction of a major road bridge across the middle of the yard.
- 1.10 Double main lines run past to the West of the yard. The main line does not have any passenger services scheduled on it.

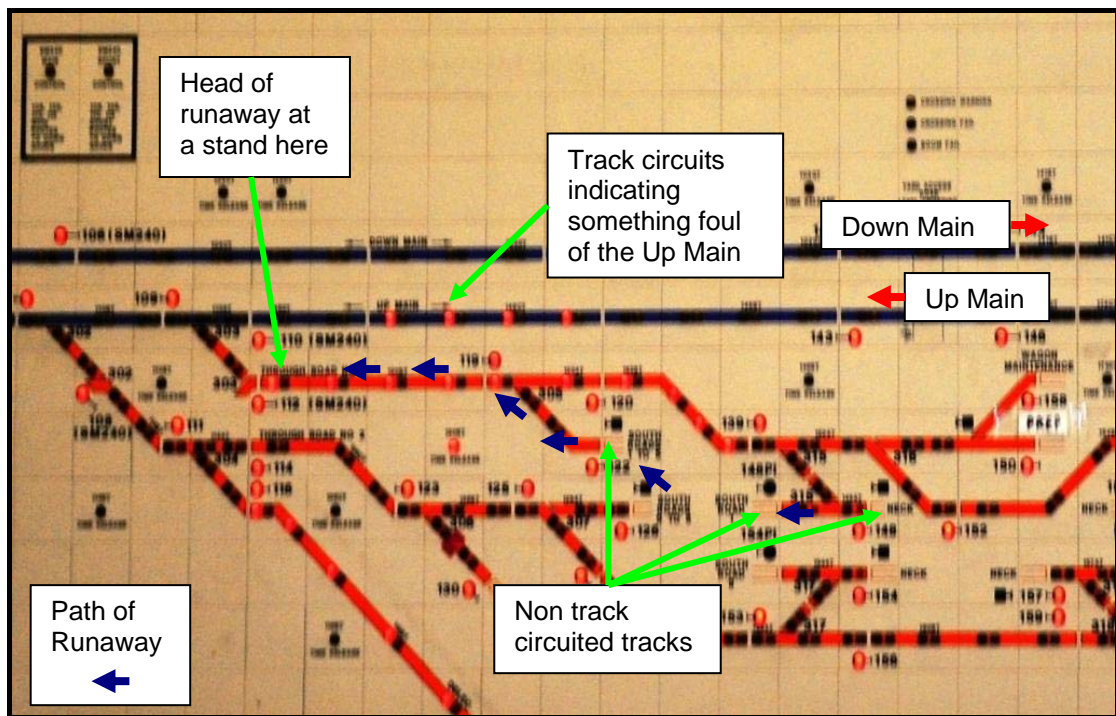
Photograph 7: Enfield Signaller's mimic board

1.32 The Signaller indicated to the Train Controller that the exact circumstances of the derailment were not clear and neither was the current location of the derailed wagons; the Down Main line appeared to have something foul of it as his display was indicating that something was occupying a section of track (see *Photograph 7*). At this time, the Terminal Operator had not yet informed the Signaller that both main lines were blocked.

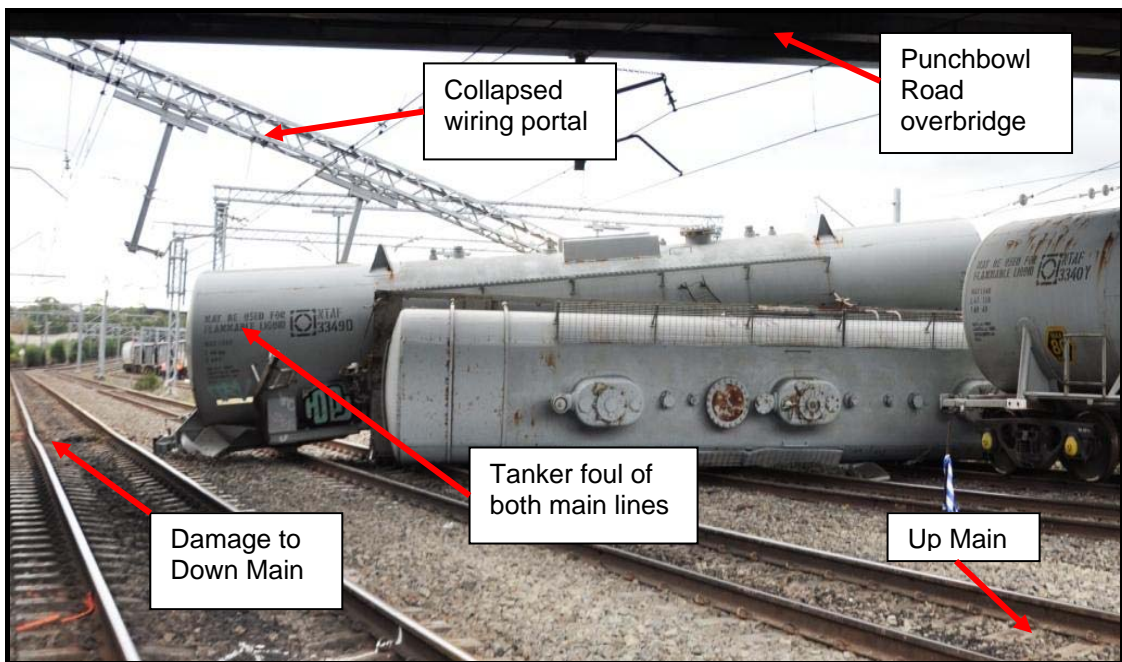
Photograph 8: View in a northerly direction, under Punchbowl Road overbridge

- 1.34 At 12:56:14pm, the Train Controller received an assurance from the Enfield Signaller; “*we are definitely clear of the Down Main*”. The Train Controller asked the Area Controller at Sydenham to “*take the block off and get CA69 going*” (i.e., advance the train towards the incident site). This assurance was based on the Signaller's mimic board display without verification from personnel at the incident site. However, during the three-way conversation between the Train Controller, the Area Controller and the Signaller at 12:57:45pm, the Enfield Signaller interjected: “*I have now been told the stanchion (overhead wiring portal) is down over both tracks ... so the whole thing is blocked*” (see Photograph 8). At this point the Train Controller rescinded his earlier instruction to advance CA69.
