**Office of Transport Safety Investigations**

## **LEVEL CROSSING COLLISION REPORT**

**PRIVATE LEVEL CROSSING at 594.680KMS**

**1 SEPTEMBER 2010**

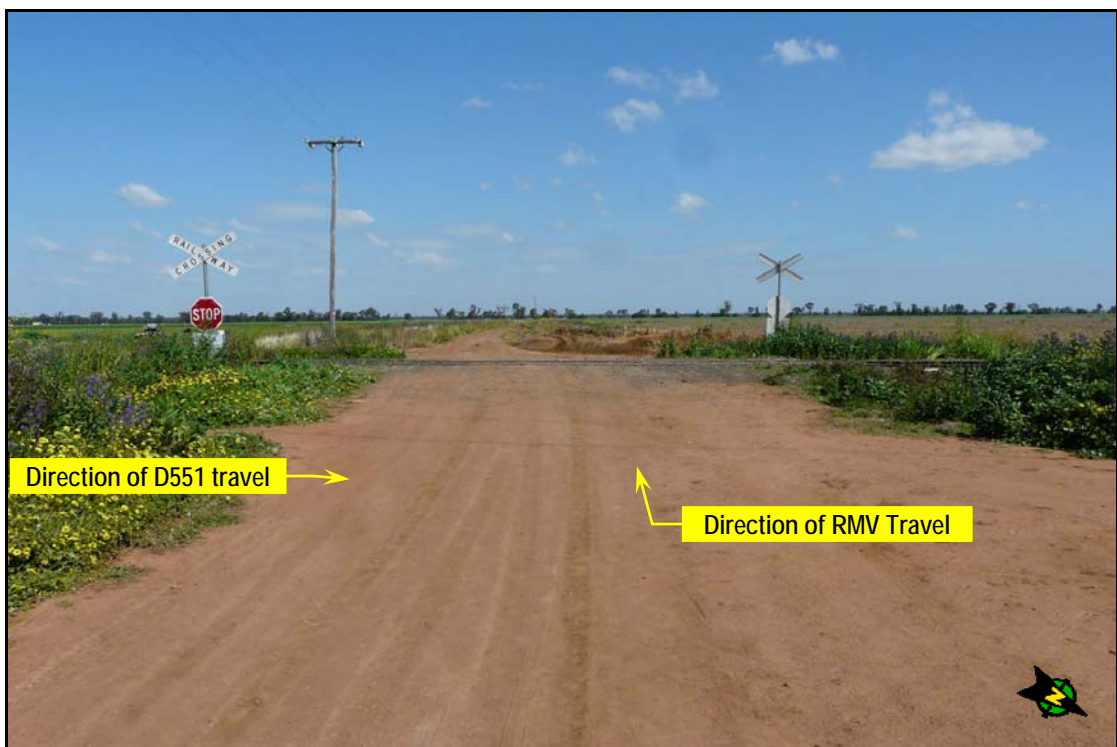
**Photograph 1: Approach to the crossing**

- 1.3 The level crossing is designated by the Australian Rail Track Corporation (ARTC) as a “*private accommodation crossing*” and is located on a straight section of the single line rail corridor<sup>1</sup> which divides a farming property. It is part of a private road system that provides the property owner with access from the main portion of the property to paddocks and farming infrastructure located on its Southern side (see *Photograph 1*). Historical records indicate that the crossing has been at the location since the line was built and, as the establishment of the crossing was a statutory requirement, there is no interface agreement between the track owner and property owner.

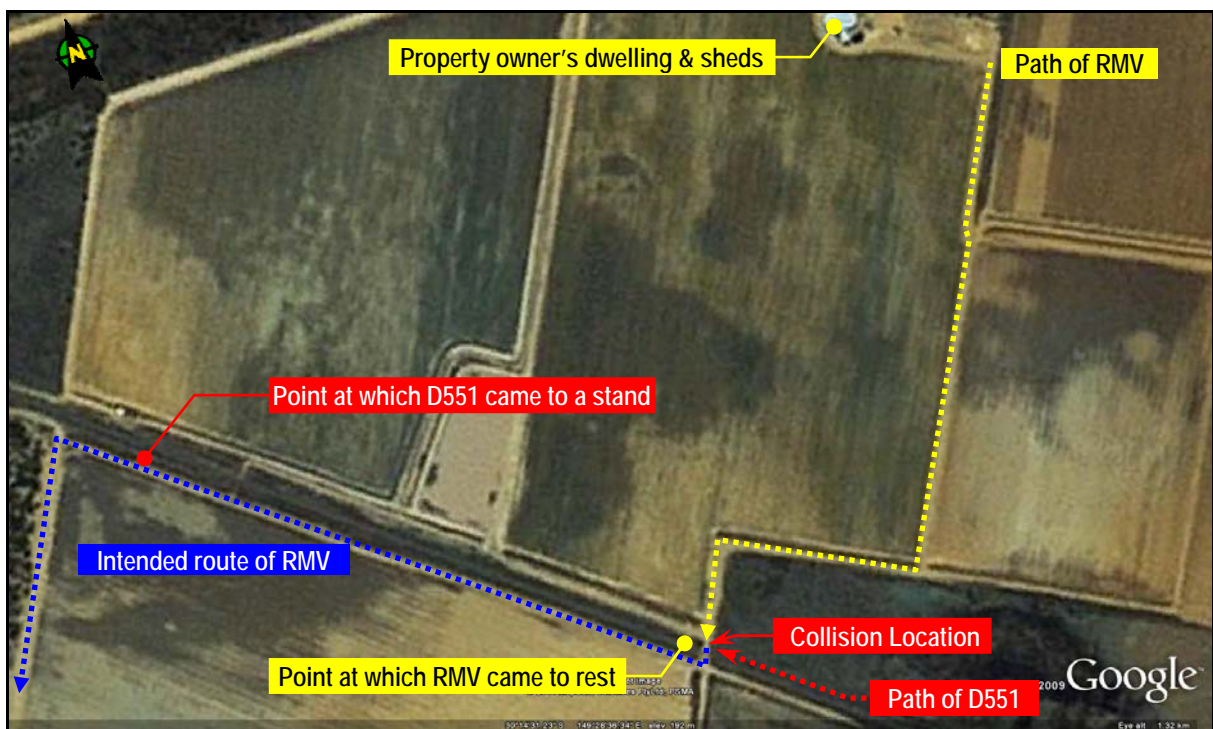
**Figure 2: Overview of crossing and path of RMV**

- 1.4 The crossing is one of eight private crossings marked on the current track diagram for the immediate section between Culgoora (583.441kms) and Wee Waa (598.959kms). It is also listed in the current ARTC Local Appendix: North – Volume 4 as Rhoden's (private) crossing, although at 594.130kms instead of 594.680kms.<sup>2</sup>
- 1.5 In the direction the RMV was travelling, the approach road runs from generally North-East to South-West at an angle of approximately 110° to the track but then bends close to the crossing so as to intersect the rail line at 90°. Immediately after the crossing on the Southern side, the road branches in three directions (see *Figure 2*).
- 1.6 It is believed that the driver of the RMV was intending to turn right immediately after the crossing to take the route to a silo which he had been cleaning out over previous days.

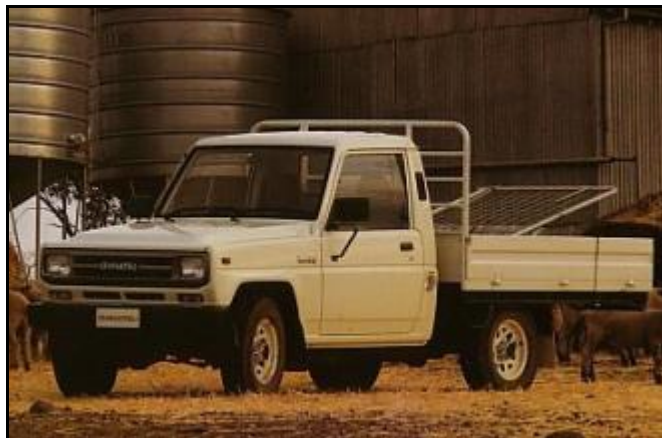
Photograph 5: Daihatsu “Rocky” 4X4

- 1.17 The RMV was a NSW registered 1992 model Daihatsu “Rocky” 4X4 flat tray utility owned by the deceased (see *Photograph 5*). It was carrying a variety of hand tools and equipment associated with the cleanout of the silo.

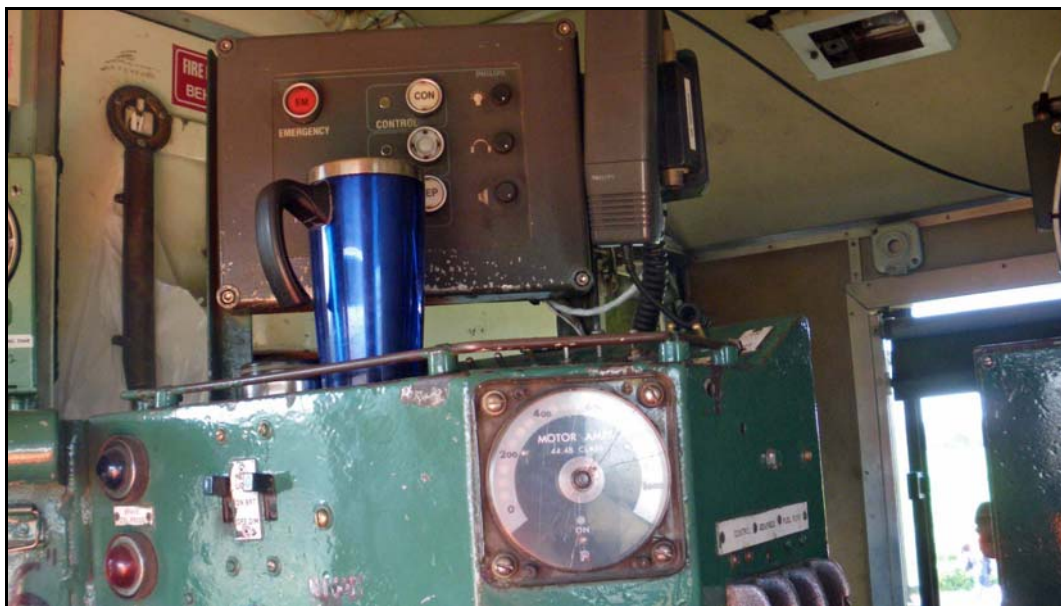
**Photograph 9: Driver's cross cab view to the RMV approach direction**

- The marker light and number box light switches on 4886 were in the “on” position with the respective globes illuminating when battery power was restored to the locomotives. The marker lights were set to white, indicating the front of the train.
- Due to the configuration of the cab of 48 Class locomotives, the driver had no view of the approach to the crossing by the RMV (see *Photograph 9*).
- The Assistant Driver’s view of the approach to the crossing by the RMV was partially obscured by the cabin wall and entry door, and a scratched windscreen (see *Photograph 10*). However, 4886 was operating short end leading which provides the least restricted view for the crew.
