## **RAIL SAFETY INVESTIGATION REPORT**

**MONORAIL COLLISION**

**DARLING PARK**

**27 FEBRUARY 2010**

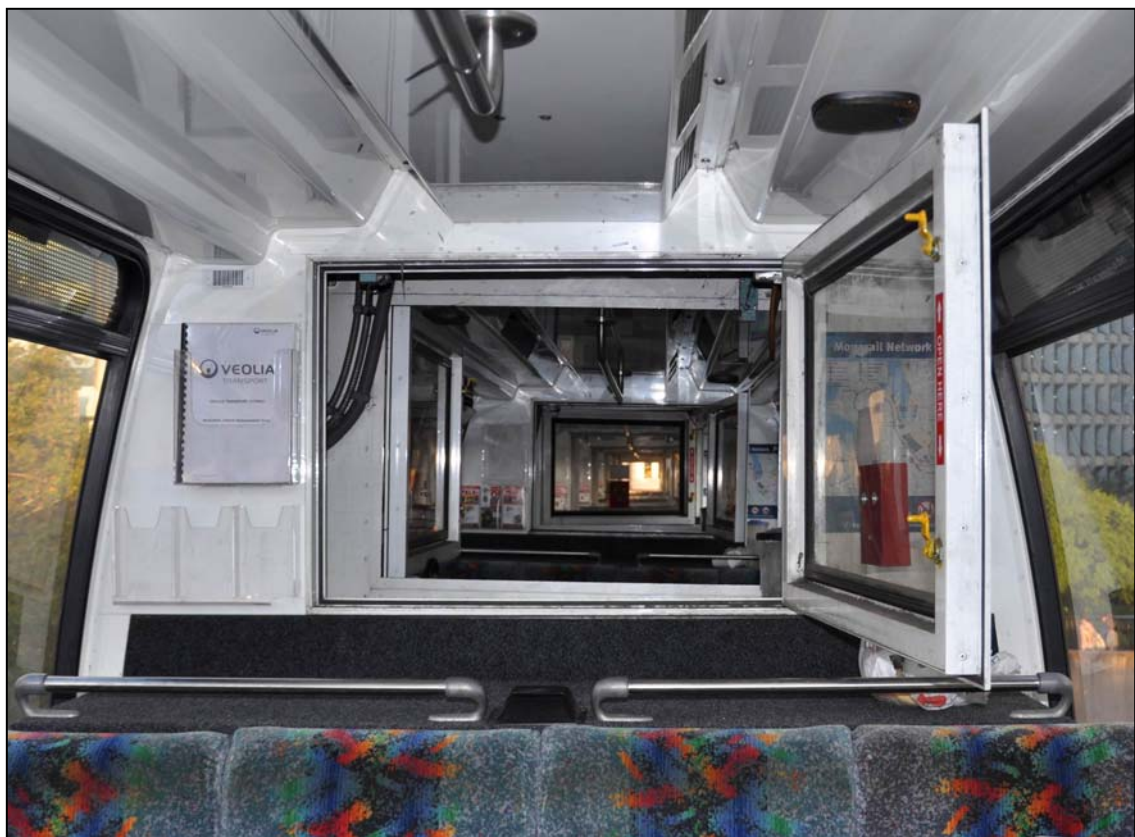
**Photo 3: Emergency access window between monorail carriages**

- 1.14 NSW Police received notification of the collision at 4:07pm and arrived at the scene at 4:19pm. Passengers on Monorail 1 were evacuated by the Police Rescue Unit through the emergency access windows between carriages to the front of the monorail (see *Photo 3*). Here they were assisted through the front window of the driver's cab onto the platform.
- 1.15 NSW Ambulance was notified of the collision at 4:10pm with the first unit arriving on the scene at 4:27pm. Four passengers on Monorail 1 were injured.

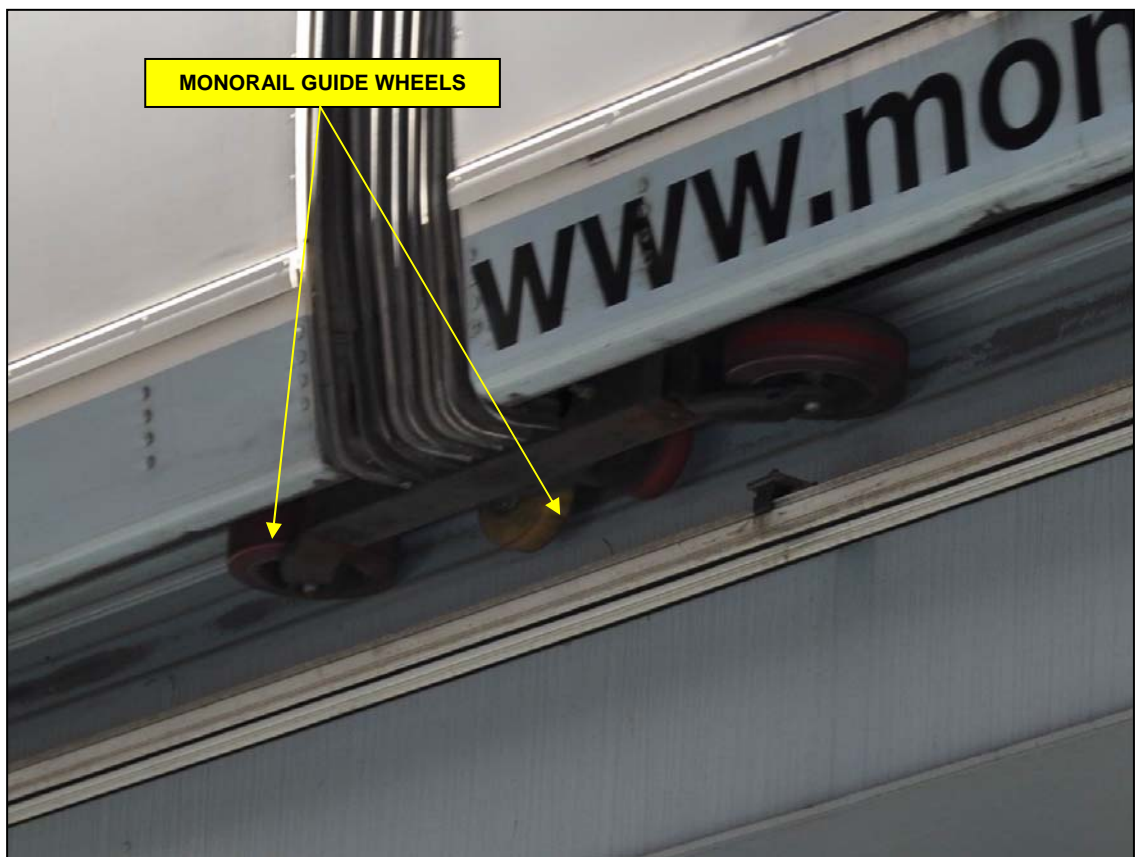
Photo 5: Monorail guide wheels

sets of guide wheels which are located underneath the drive wheels and also at each end of the monorail (see *Photo 5*). Each monorail measures approximately 2.6m high, 2m wide and 32m in length. It has a rated maximum speed of 9.16m/s.

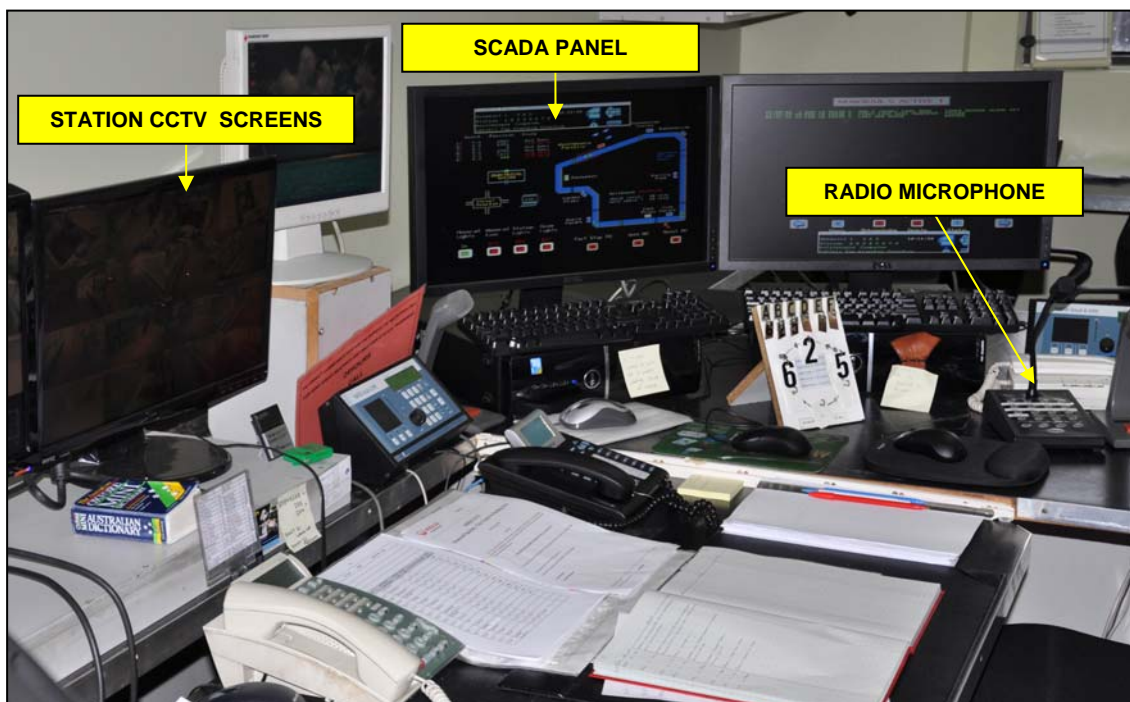
- 1.29 **Monorail Control Room.** The operation of the monorail system is controlled from a control room located above the maintenance facility. A control panel operator oversees the operation of the system via a computer mimic panel also known as a SCADA (see *Photo 6*). This shows the real time position of each monorail. The control panel operator is able to contact each monorail via two-way radio.

**Photo 6: Monorail control area**

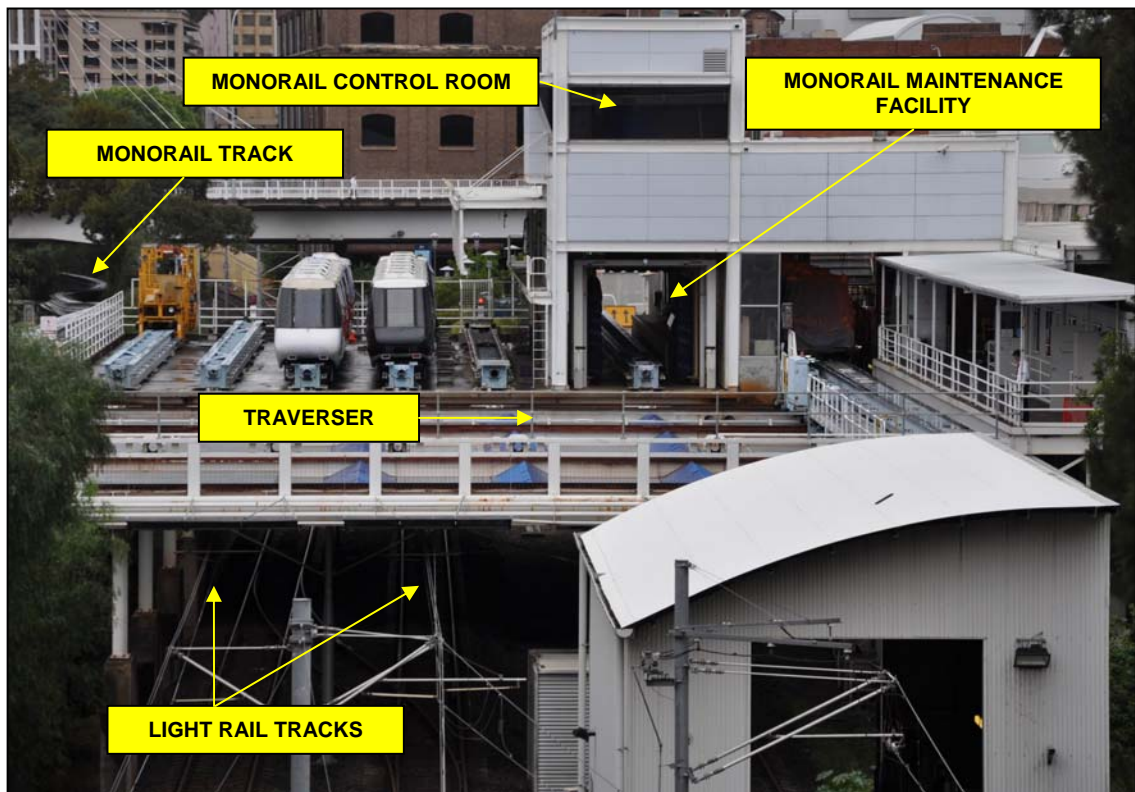
- 1.30 **Monorail Stations.** There are eight monorail stations: Harbourside, Convention, Paddy's Market, Chinatown, World Square, Galeries Victoria, City Centre and Darling Park. The maintenance facility is located between Convention and Paddy's Market stations. Monorails are moved on and off the track at the facility via a traverser (see *Photo 7*).

**Photo 7: Monorail Maintenance and Control Facility**

- 3.7 The maintenance of the monorail and track is conducted in-house. There is a dedicated service area for one monorail and space to store five monorails outside the maintenance facility (see *Photo 7*). At the maintenance facility, all detected faults, repairs and maintenance tasks are entered into both a written log book and a computerised maintenance history. Veolia could not supply all of the relevant records when requested as some entries had been inadvertently disposed of during a recent upgrade of the computer system. In particular, the signed job sheet that was associated with the out-of-service tag found on the Autopilot in Monorail 1 after the collision could not be provided.

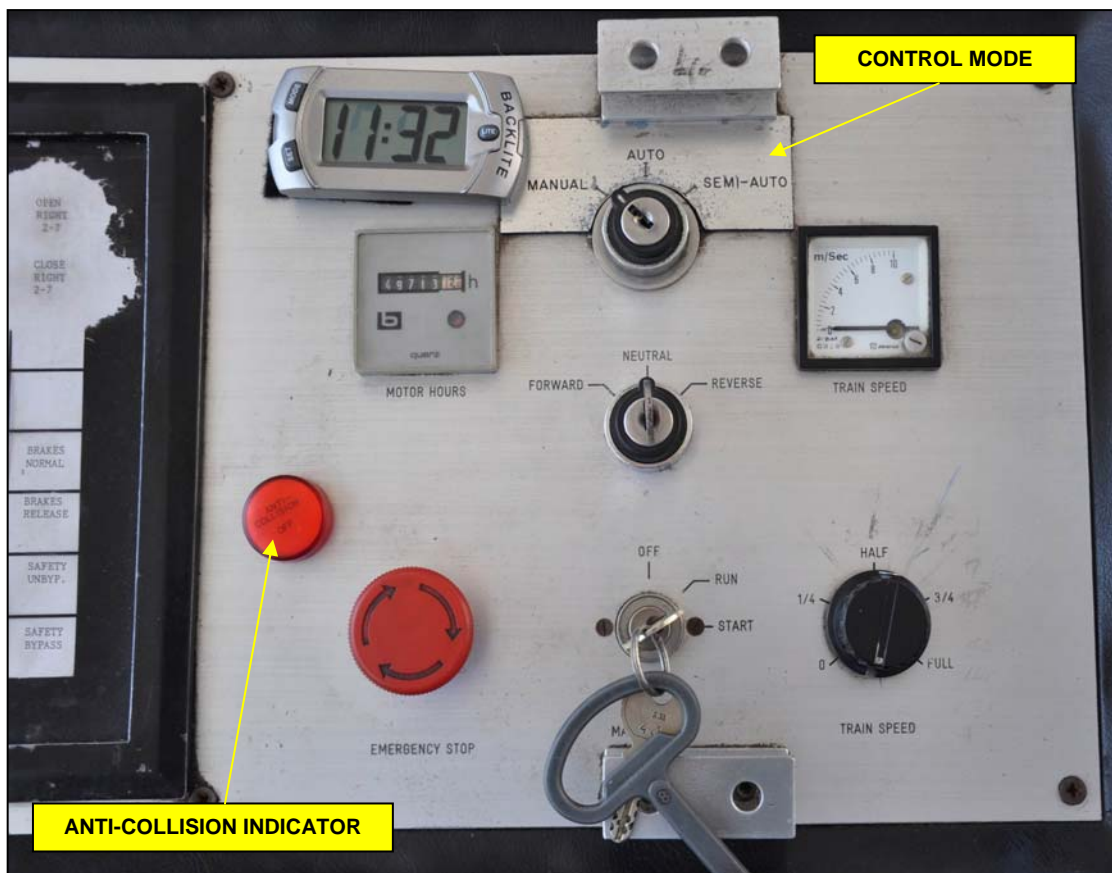
- 2.13 Originally the system was intended to be able to operate in three different control modes: automatic, semi-automatic and manual, with automatic the preferred mode of operation. The selection of manual mode was designed to be done when the monorail was stationary and only on authority of the controller. A dashboard key-operated switch controls the modes (see *Photo 9*).

**Photo 9: Monorail dashboard (right side)**

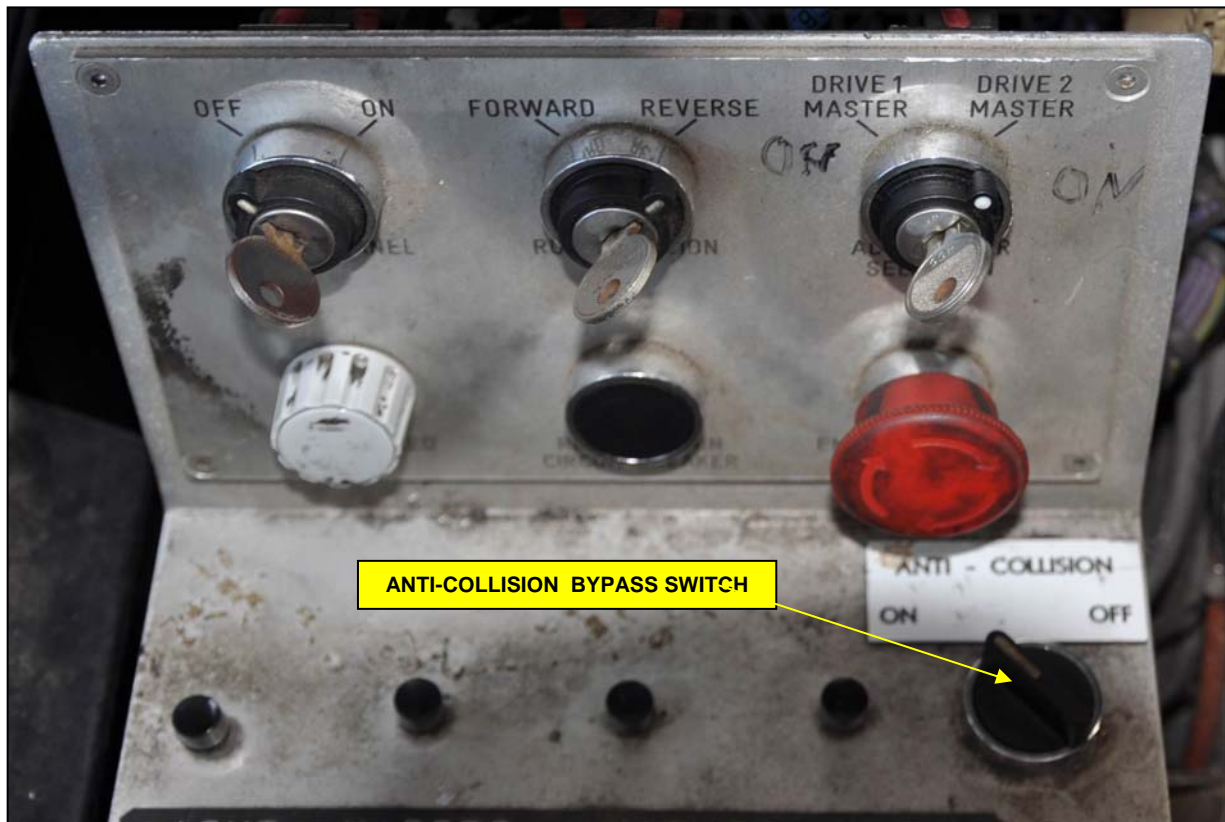
- 2.21 In this incident, the ACES system did not stop the monorail in time to prevent the collision. One explanation suggested by Veolia was that the anti-collision system was bypassed by the Driver after the alarm sounded since the switch to this can be accessed by the driver. It is located on a maintenance panel on the driver's dashboard under a secured lid (see *Photo 10*). The drivers have the key and are instructed to access the switch at the direction of the controller in the event of a system failure or if a monorail-to-monorail tow is required.

**Photo 10: Monorail Maintenance Control Panel**

- 2.23 There is no evidence, therefore, to support the contention that the anti-collision system was bypassed. It is unfortunate that the data from the control room was not recorded as it would have shown whether or not the switch was changed in the minutes leading up to the collision. Both the Driver and the Relief Driver in Monorail 1 denied that the anti-collision bypass switch was turned off prior to the collision. It would be an unusual action to be performed with the anti-collision alarm sounding and limited visibility of the station ahead.

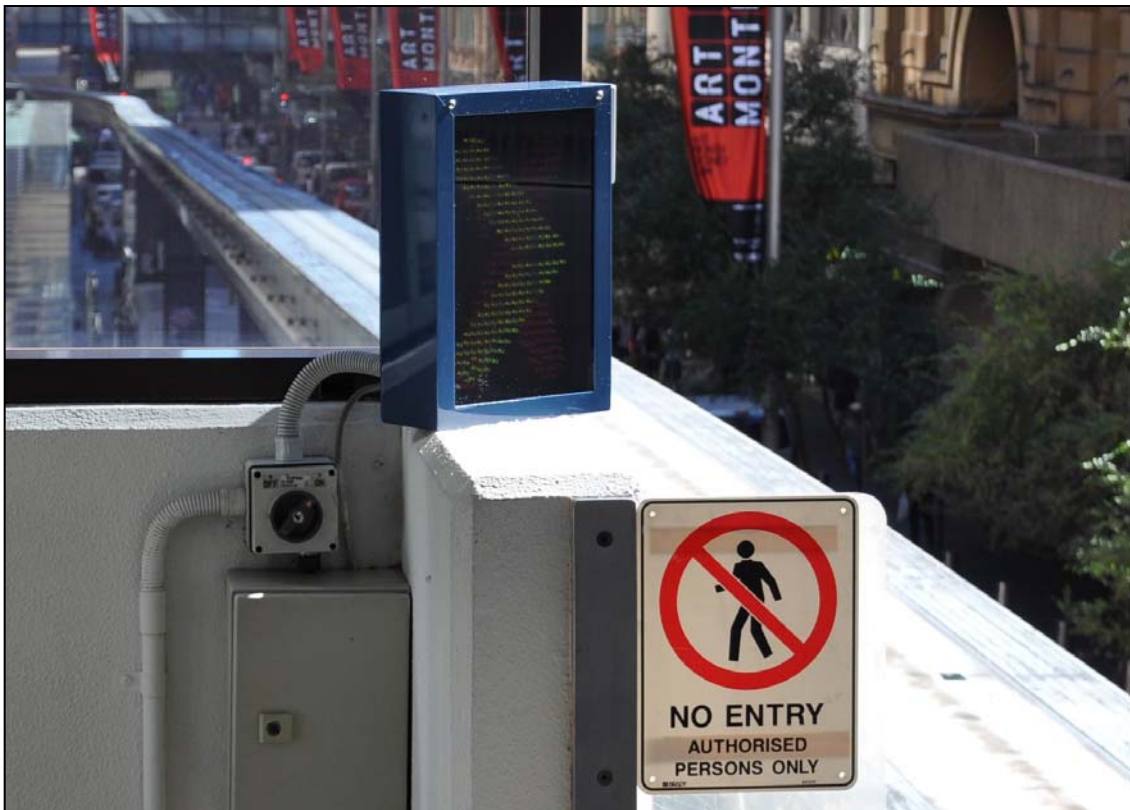
- 3.5 **Signalling system.** Unlike those used in conventional railway networks, there is no signalling system in place on the monorail loop. However, at some stations, there is a timer signal which can be altered depending on the number of monorails operating on the loop (see *Photo 12*). The signal indicates to a driver that the monorail ahead of it has departed more than two minutes before the monorail at the timer signal. This system relies on each driver remembering to press the timer button on departure from the station. Like the CCTV system, it cannot give any indication of a stationary monorail in the section ahead. Prior to the installation of the timer signal system, a different signalling system had been trialled at Paddy's Market Station using sensors to relay information to a signal to indicate if the section ahead was occupied, but the trial found the system to be ineffective.

**Photo 12: Signal for drivers to proceed**
