# FERRY SAFETY INVESTIGATION REPORT

**FERRY *PEMULWUY* LOSS OF CONTROL  
SYDNEY HARBOUR, NSW  
2 JULY & 23 NOVEMBER 2020**

**Released under the provisions of  
Section 45C (2) of the *Transport Administration Act 1988* and  
Section 46BBA of the *Passenger Transport Act 1990*  
*Investigation Reference 04821***

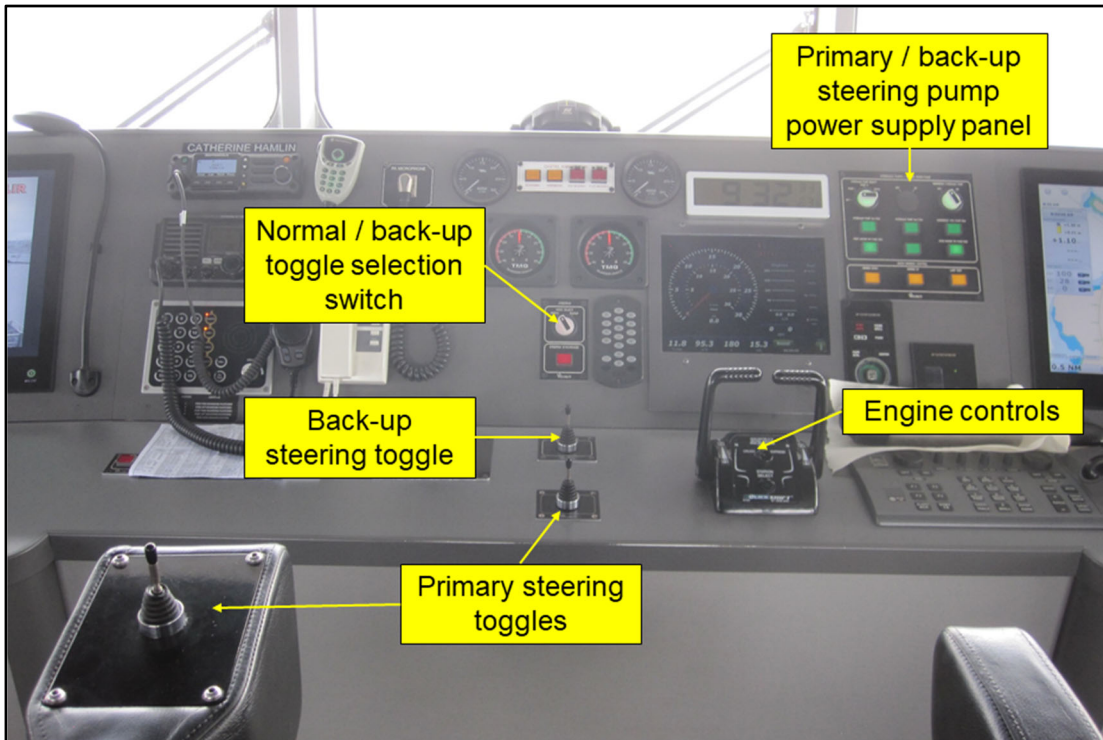
Figure 8: Main control position of an Emerald class vessel

- 1.25 *Pemulwuy* was controlled from one of three positions in the wheelhouse, the centre helm and two wing stations. All three positions incorporated throttle and steering controls (see *Figure 8*). A fourth steering control was located on the armrest of the master's seat at the centre helm position which allowed the master to navigate while seated. The two wing controls were mainly utilised for berthing operations. These four toggles were on the normal (primary) steering circuit.
- 1.26 All four primary steering toggles were connected in parallel on a 24-volt direct current (DC) circuit. When the normal steering circuit was selected, a movement of any toggle would alter the rudder angle. As all toggles are active on the circuit, a closed circuit failure of any one, could cause the entire circuit to stop responding.

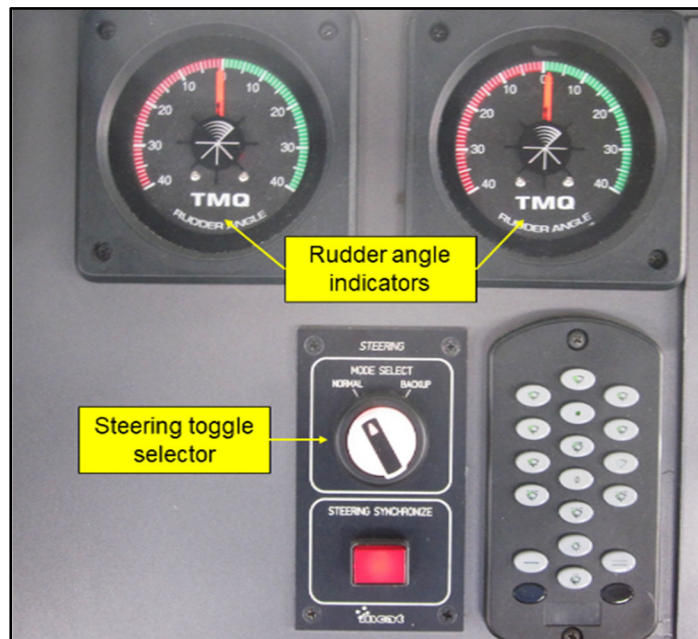
Figure 9: Primary/back-up toggle selector panel in detail

- 1.27 A back-up steering toggle was located at the centre helm position in case of a failure in the normal steering circuit. This toggle was on a separate 24-volt DC circuit. The master could swap between the normal and back-up steering toggle circuits through a dashboard mounted selector switch (see *Figures 8 & 9*).

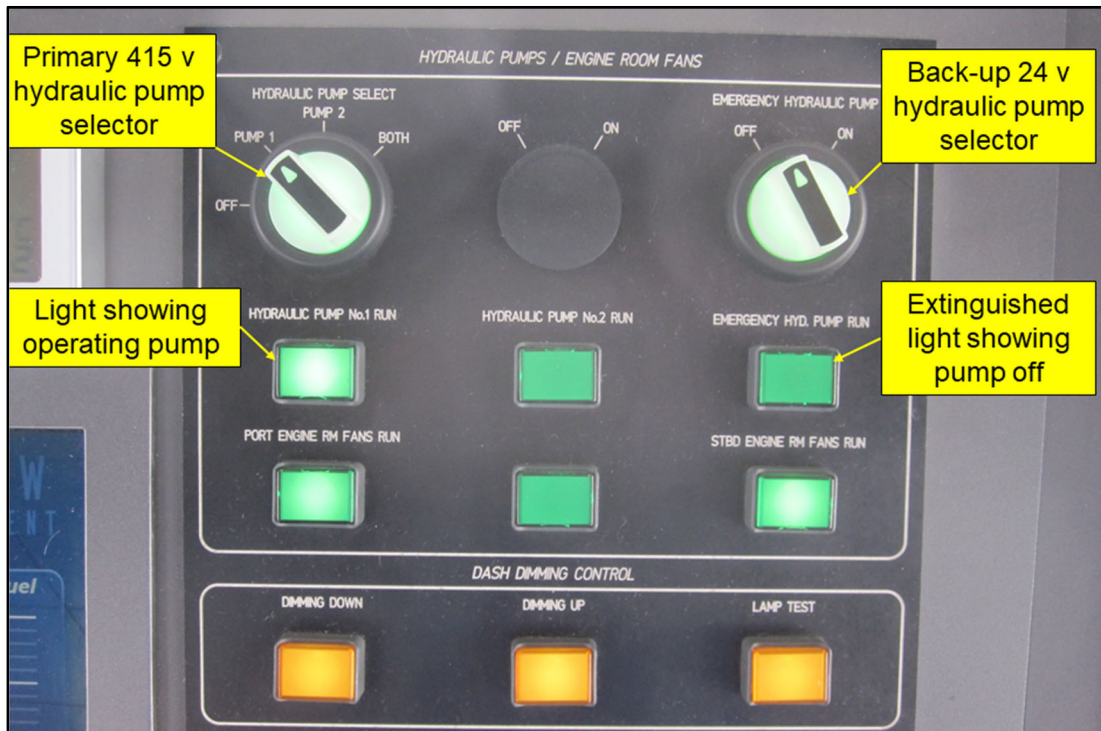
Figure 10: Steering power supply panel in detail

- 1.28 In normal operations, two 415-volt alternating current (AC) hydraulic pumps provided power for the steering hydraulics. A separate back-up system, powered by an independent 24-volt DC hydraulic pump, offered redundancy to power the steering system. The activation and selection of primary or back-up power supply was on a panel located on the dash to the right of the main control position (see *Figures 8 & 10*).

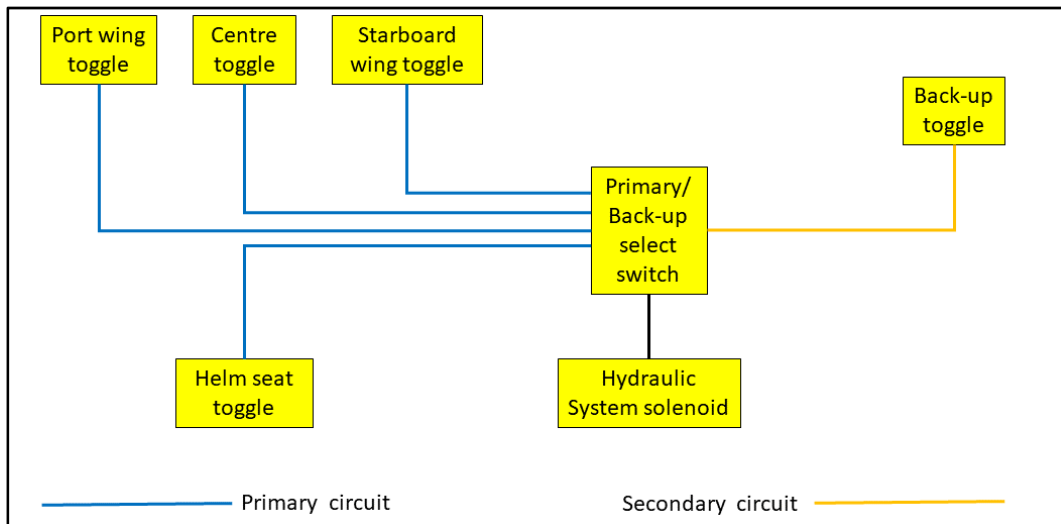
Figure 11: Simplified 24V DC steering system

- 1.29 If a master suspected a failure of the primary power supply, activation of the back-up supply consisted of two steps: the main hydraulic pump selector needed to be switched off and then the back-up pump switched on.
- 1.30 If a master suspected a failure in any of the four primary toggle controllers, they could switch to the back-up steering circuit. This activated the back-up toggle to steer the vessel utilising whichever steering pump was active (see *Figure 11*).
