Office of
Transport Safety
Investigations

Safety Investigation Report

**Engine Bay Fire
Heatherbrae**

19 September 2019

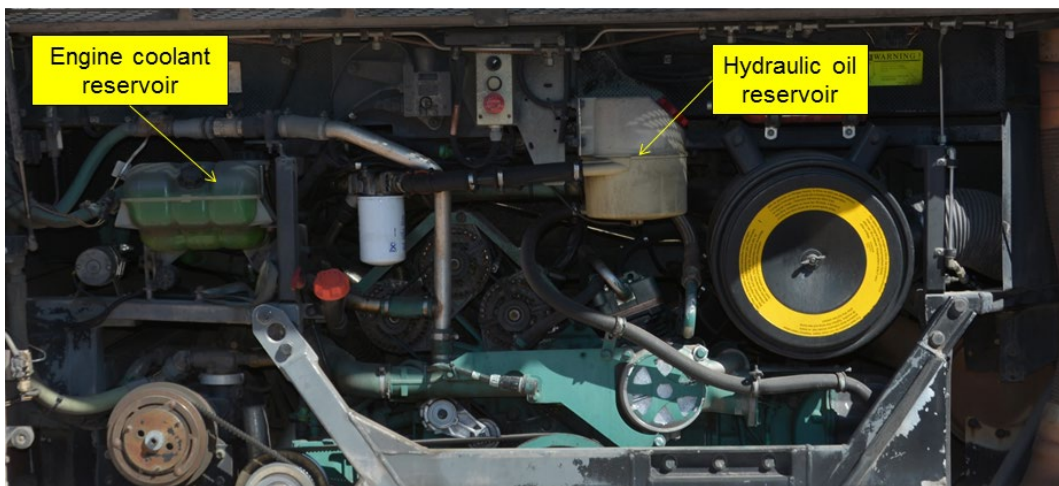
Figure 4: Engine bay of similar model bus

2.5 For comparison, a similar model bus is pictured in *Figure 4*.

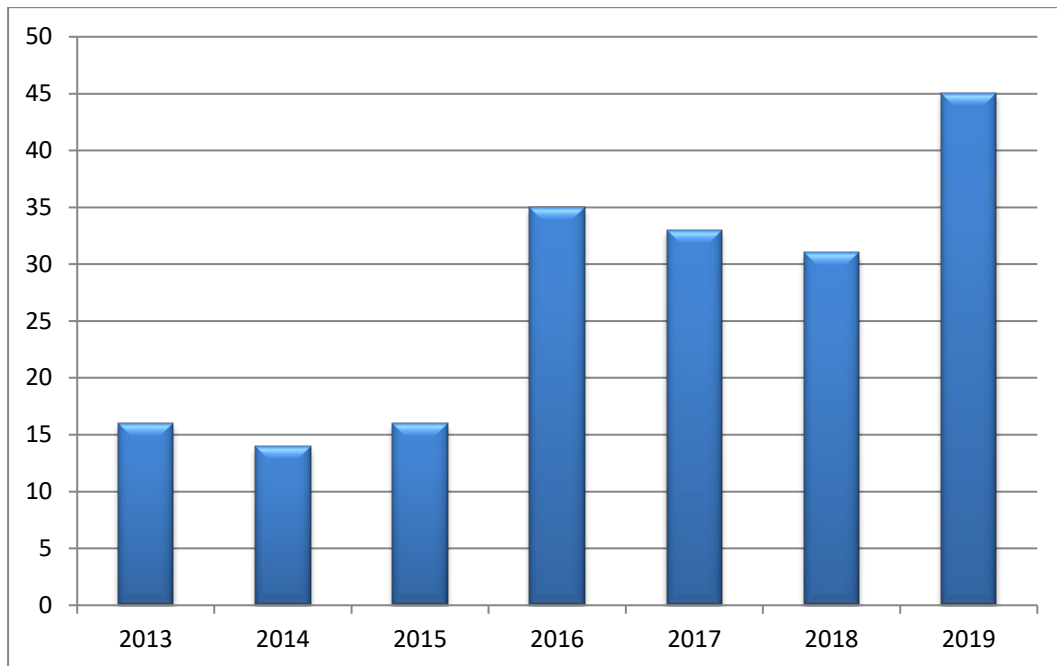
Figure 10: Number of engine bay fire incidents 2013 to 2019

- 2.11 OTSI made recommendations that consideration be given to position the extinguishers in a readily accessible location in compliance with applicable standards, but not within the confines of the engine bay area.
- 2.12 The number of fires and thermal incidents initiating in the engine bay for the period 2013-2019 is shown below (*Figure 10*).
