**Office of
Transport Safety
Investigations**

Safety Investigation Report

**Bus Fire MO5103
Campbelltown, NSW
16 August 2021**

Investigation Reference I02009

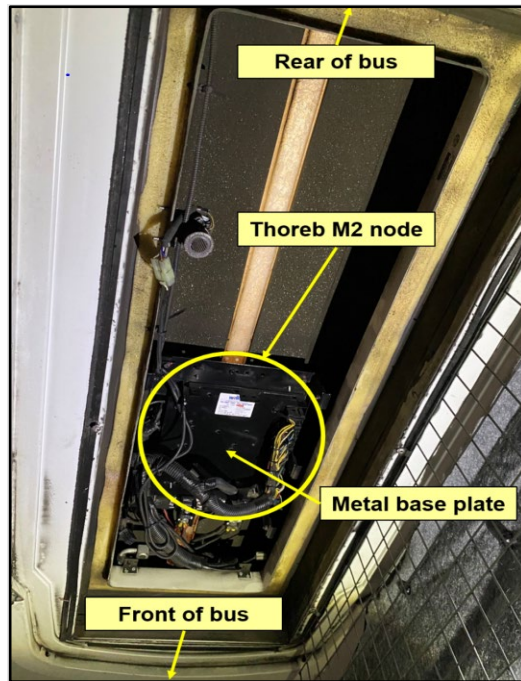
Figure 6: Roof location of Thoreb M2 Node in A/C system (in normal operating position with grill open)

Behind the grill was a filter, then the Thoreb M2 node and wiring harness installed in a recess (Figure 6 and Figure 7 of exemplar bus). The node was on a hinged panel to enable it to be pivoted out of the recess for maintenance.

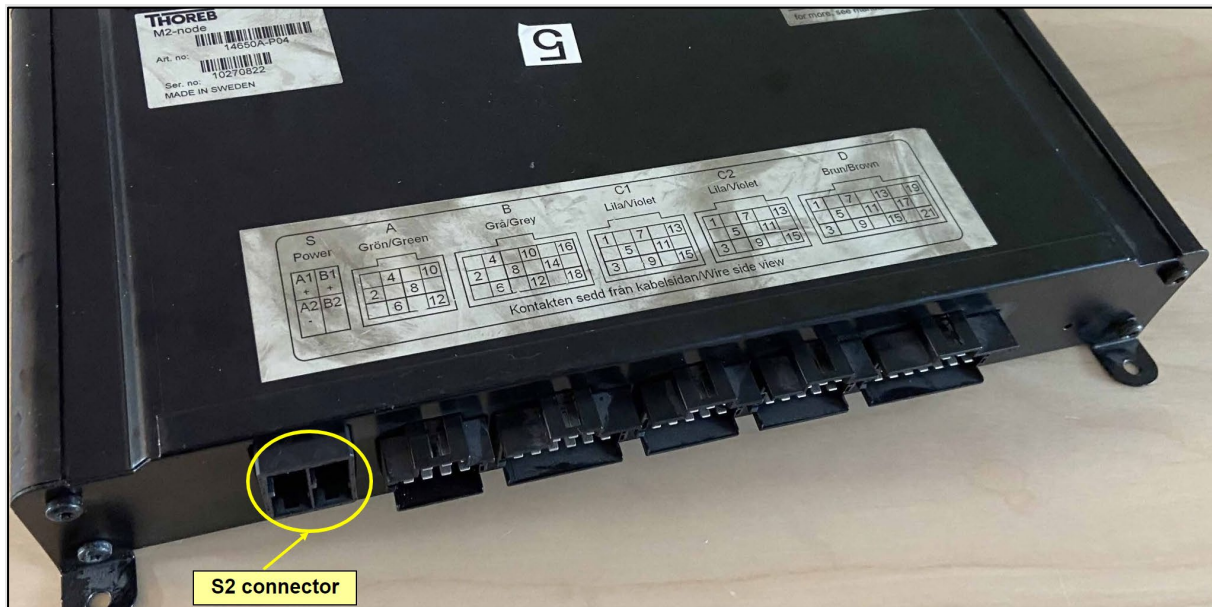
Figure 8: Exemplar Thoreb M2 node – external view

The node was encased in black anodized aluminium (Figure 7 and Figure 8), and had six connectors:

- three for inputs and outputs
- two for communication
- one S2 connector for power supply.

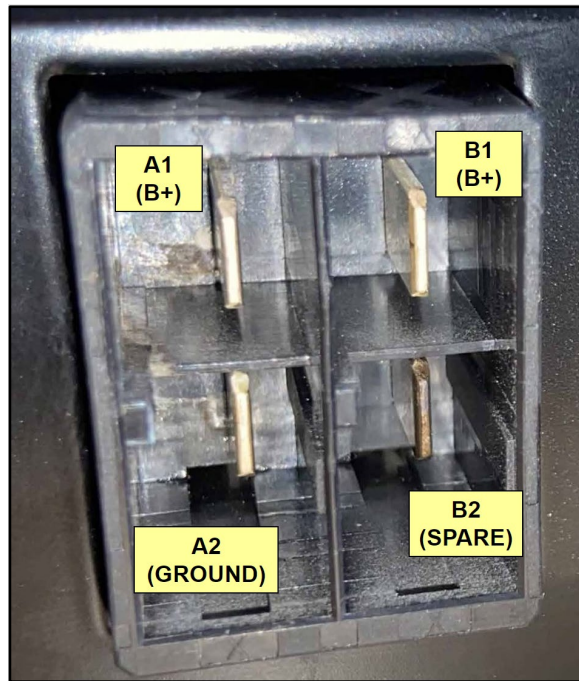
Figure 9: Exemplar Tyco D-5200Mα High Current Type S-Connector showing tab posts

There were four copper alloy contacts/receptacles and associated tab posts, finished in silver plating with underplated nickel. The housing was UL 94V-0 rated, glass fibre reinforced polyester.

The node had two separated power supply connections in the S-Connector (two B+ (A1 and B1)) and Ground (A2). The fan and blower current were directly wired to ground within the A/C system. In this A/C configuration, the bottom right receptacle (B2) was not in use (Figure 9).

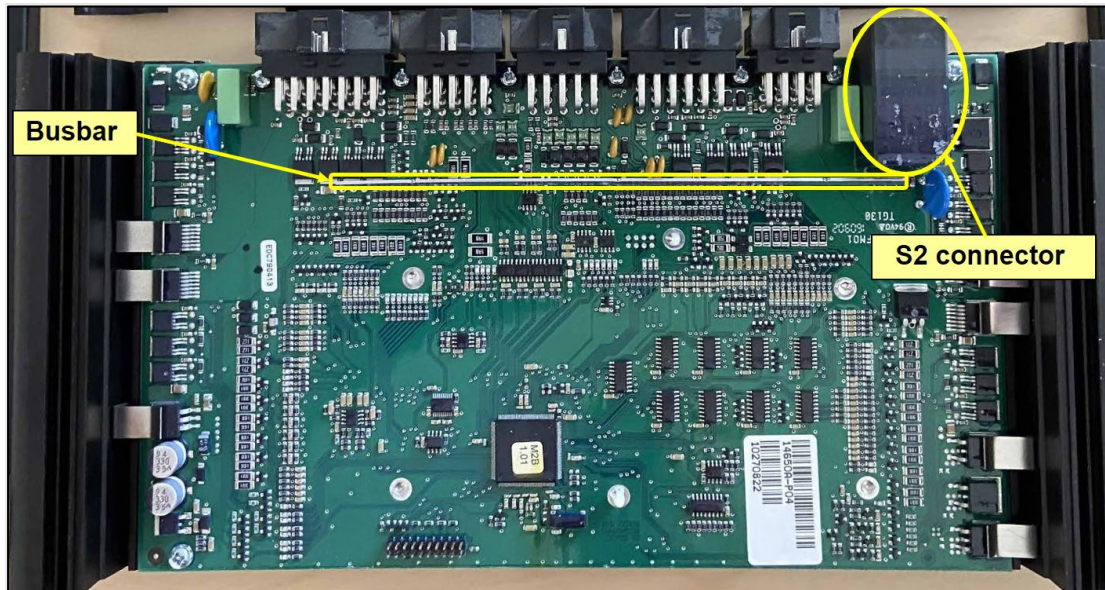
Figure 11: Thoreb M2 node circuit board

1.39 The Thoreb M2 node was configured with a single metal electrical busbar⁴ (Figure 11).
