# Derailment of freight train 4BM4

Nana Glen, New South Wales, on 25 February 2021

**ATSB Transport Safety Report**  
Rail Occurrence Investigation (Systemic)  
RO-2021-004  
Final – 6 June 2023

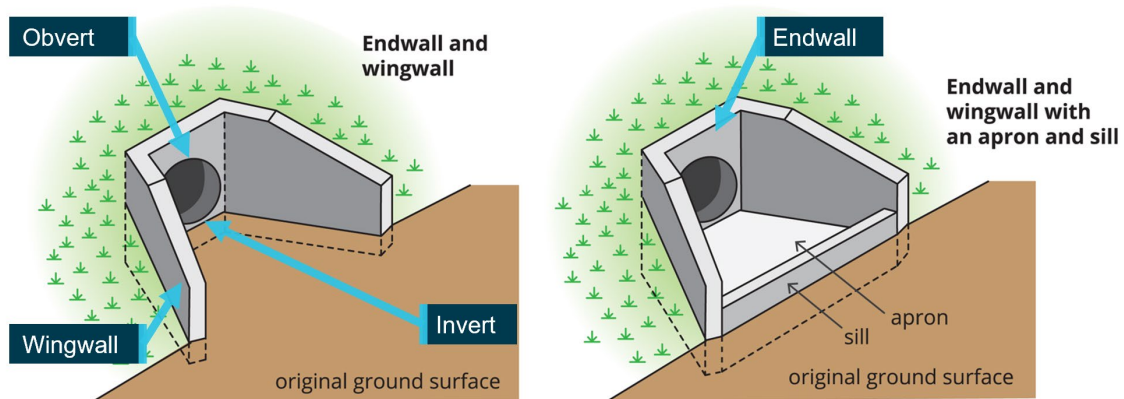
**Figure 16: Culvert endwall structure**

The inspection criteria included checking the culvert for subsidence, cracking, blockage and deformation or broken / separated joints. The inlets and outlets were also checked for cracking of the headwalls and wingwalls, scouring under the apron and heaving of the floor (Figure 16). Defects were defined based on the size or type of defect with a corresponding defect category. Depending on the defect size, the response ranged from monitoring to immediately stopping trains. Culverts that were blocked by more than 20 per cent were required to be reported, while less than 20 per cent could be monitored.

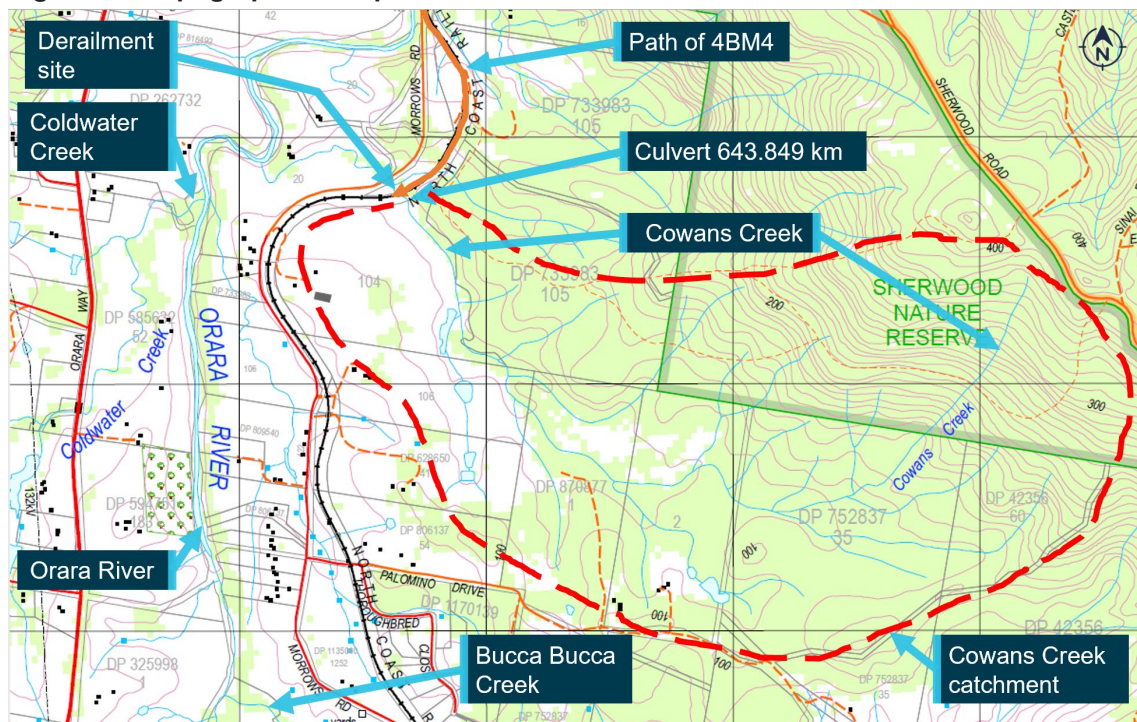
**Figure 20: Topographical map and Cowans Creek**

The large culvert at 643.849 km permitted Cowans Creek to flow through the embankment towards the Orara River. Cowans Creek ran in a northerly direction and was fed by runoff water coming from the south-east and flows coming off the steep escarpment which rises to approximately 300 m above the derailment site (Figure 20). The approximate catchment<sup>46</sup> size for Cowans Creek required to discharge through the culvert at 643.849 km was approximately 400-450 ha or 4-4.5 km<sup>2</sup>.

Public records suggested that a railway embankment at Nana Glen had been washed away during the 1950 floods, however, the location was not noted.<sup>47</sup>
