**Submission  
No 62**

## **MOTOR VEHICLE REPAIR INDUSTRY**

# INQUIRY INTO THE MOTOR VEHICLE REPAIR INDUSTRY IN NEW SOUTH WALES

Ian Faulks  
Safety and Policy Analysis International

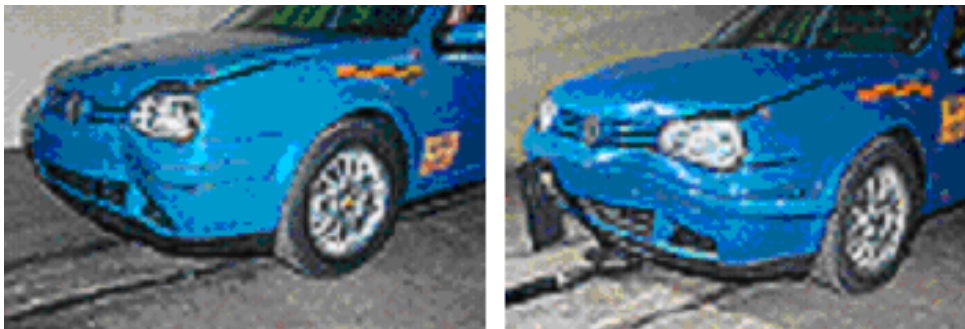
VW Golf IV—Identical deformations following AZT crash repair test on passenger vehicle in original condition (above) and following correct repairs (below).

All tests at the AZT were carried out with an approx. 15 km/h frontal crash and demonstrated only minimal differences in deformation response, deceleration and repair costs following both crashes. The damage, for example, to the cross members, longitudinal members and wheel housing extension were virtually identical.

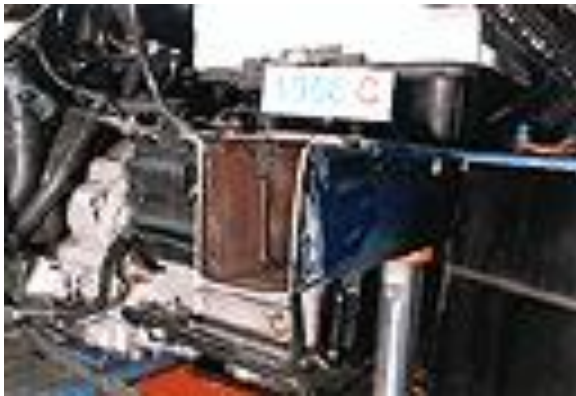
VW Golf IV – Following second crash in repaired vehicle. Replaced part weld on longitudinal member from previous repair is completely undamaged.

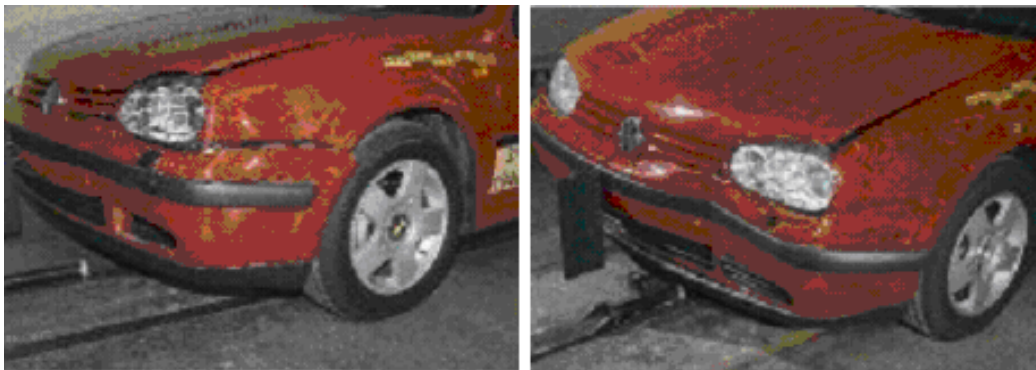
After the AZT crash repair test: Identical deformation of the vehicle, original (above) and after professional repair (below). Photo: Allianz Versicherung

The two crashes showed only slight differences in deformation behaviour, in deceleration, in the safety of passengers and in repair costs. According to Anselm, this is the reason why the insurance industry justifiably attaches a lot of importance to professional repair work that takes into account the guidelines of automobile manufacturers and the approved work methods of the panel beating trade. For partial replacements in the structural area, the specifications of the manufacturer must be complied with. In the event of sharp-edged deformations, e.g. bending or buckling, the affected structural parts would have to be replaced; for safety reasons these elements should not be repaired.
