Office of  
Transport Safety  
Investigations

**BUS FIRES IN NEW SOUTH WALES IN 2020**

Released under the provisions of  
Section 45C (2) of the *Transport Administration Act 1988*

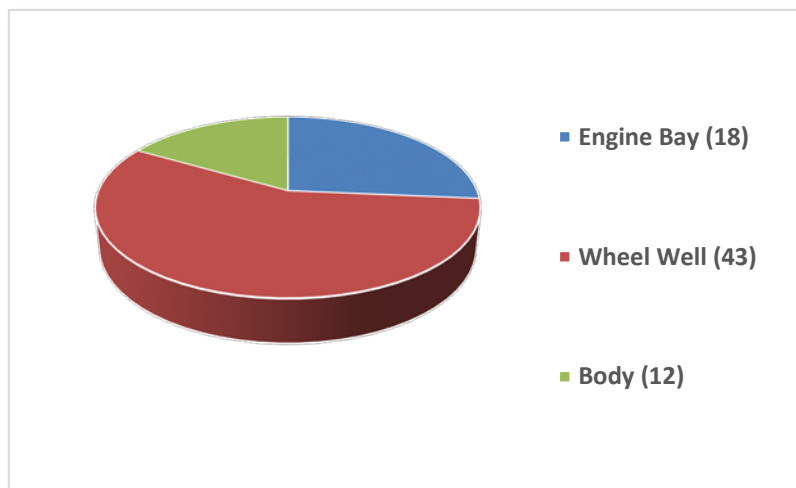
In 2020, the majority of fire and thermal incidents (57%) originated in the wheel well area. The engine bay had 26% and the body had 17%. Figure 7 shows the originating area of all incidents in 2020.

Figure 7: Location by origin 2020

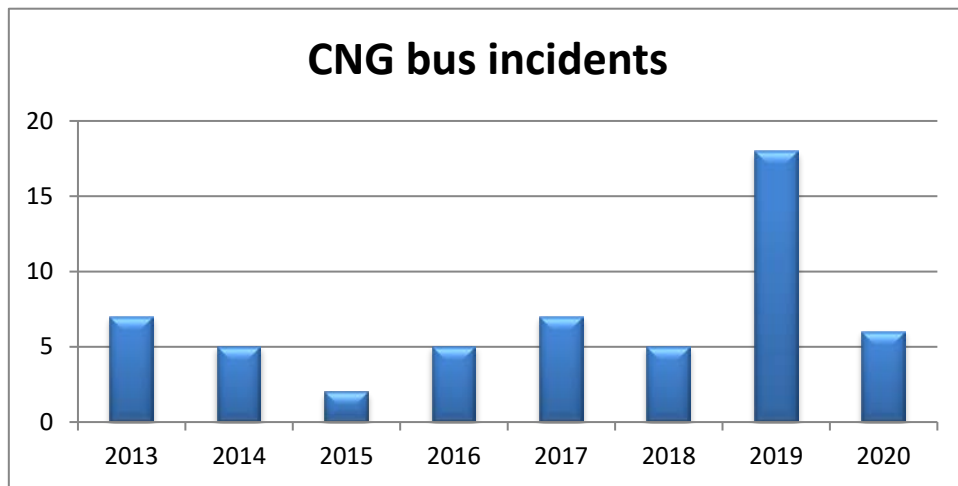
In 2020, there were six incidents involving CNG-fuelled buses. The number and causes of fire and thermal incidents involving CNG-fuelled buses is shown in Figures 14 and 15. There was a significant decrease in incidents involving CNG buses from 2019. Contributing to this is the retirement of approximately 300 CNG buses from the original fleet total of 657 over the past three years. It should be noted that the cause of most of these incidents was unrelated to the fuel type.

Figure 14: Number of CNG bus incidents 2013-20

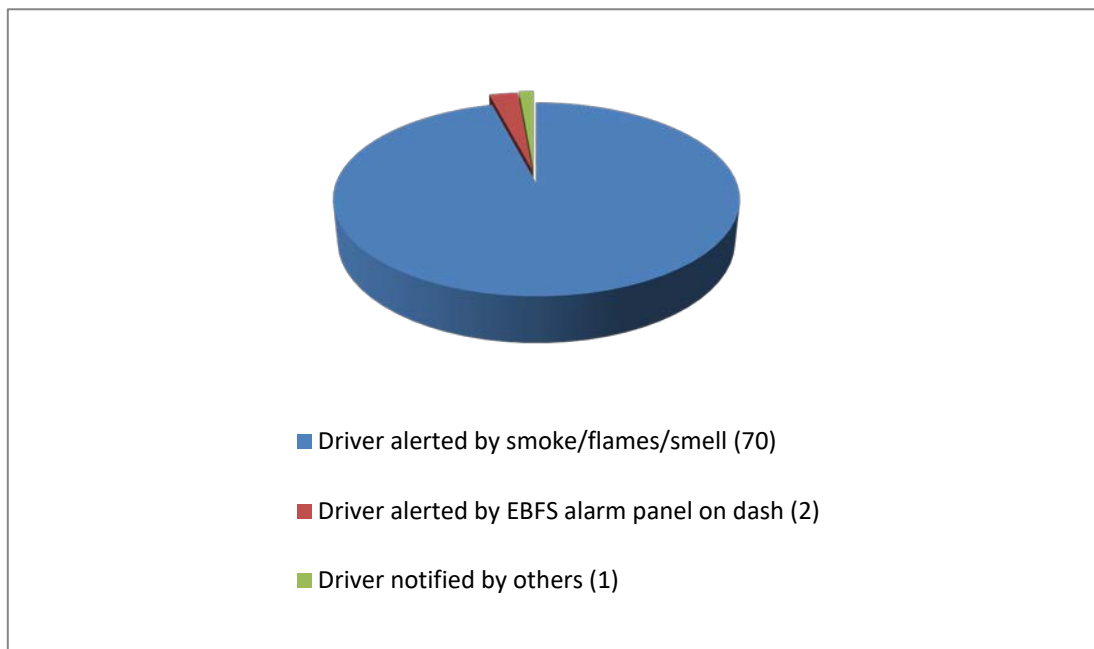
The data for the detection of incidents in 2020 are shown in Figure 17.

Figure 17: Detection of incidents 2020

In 2020, bus drivers were the first to either see or smell smoke or see flames on 96% of occasions. This highlights the importance of the driver's role in detecting the fire and acting accordingly. In the remaining occasions, the driver was alerted by the activation of the EBFS alarm on two occasions and once by a passing motorist.
